Peace Project Water Use Plan

WILLISTON TARGETED DEBRIS MANAGEMENT

GMSWORKS#22 – 2022 Final Report

GMSWORKS#22 – 2022 Final Report: 2022

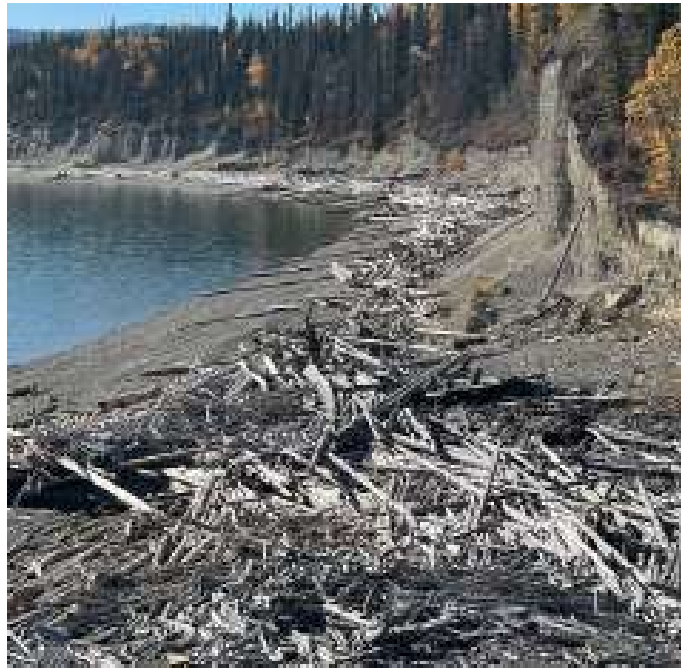
Figure 21: Tsay Keh Dene before debris cleanup

There was a lot of new debris on this beach all the way from Hydro Creek to Pelly's dump. As the water was so low, more beach area was accessible compared to previous years. One excavator was used for most of the project with a little help from 2 other machines at the end.

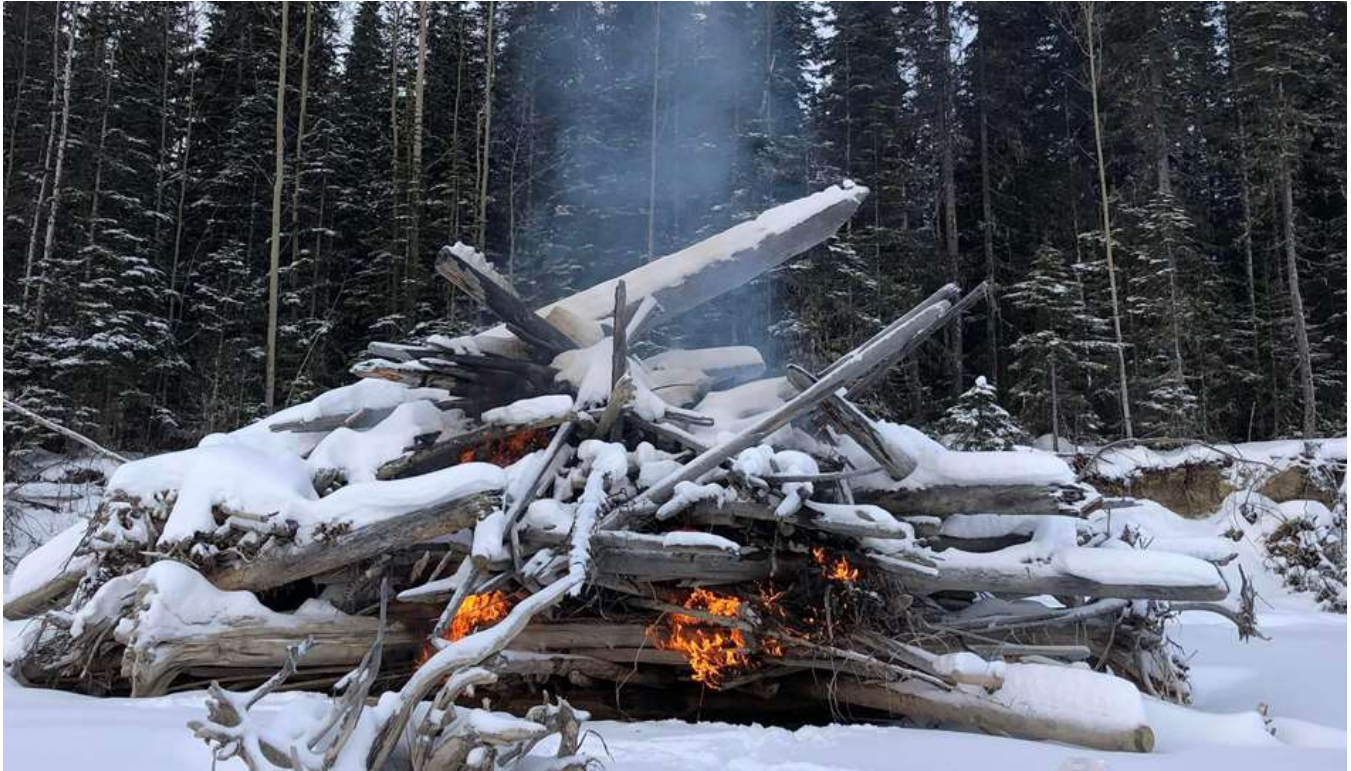
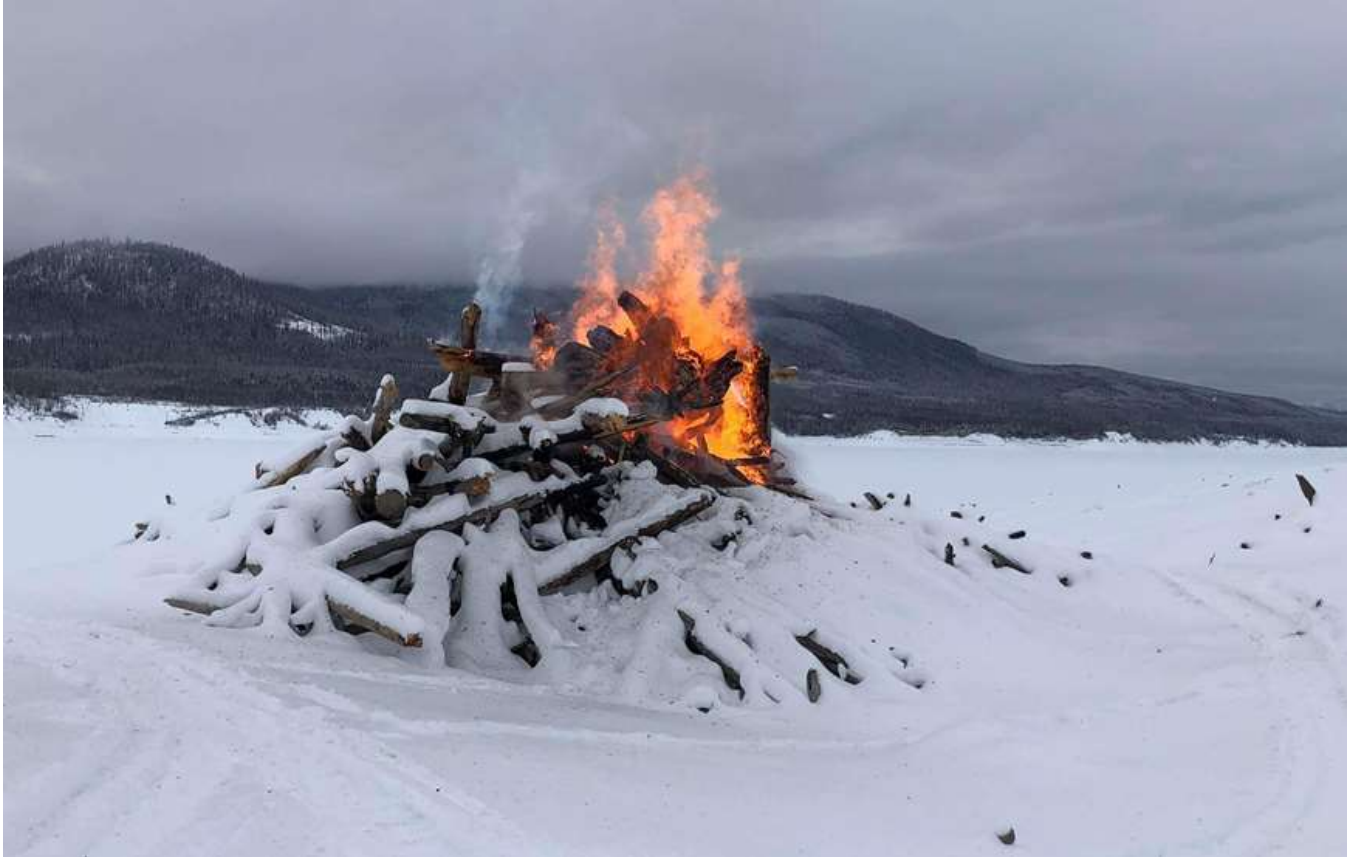
Figure 29 : Assorted Pictures of Winter 2022 Pile Burning top Is from Stromquist and bottom Is from Billy's Bay

More cleanup from Factor Ross to Coreless of old burned piles (scattered) that did not completely burn.
