Columbia River Project Water Use Plan

CLBWORKS-30A Cartier Bay Site 15a Engineering Services

Construction Completion Report

Final Report
June 21, 2024
KWL Project No. 0478.237

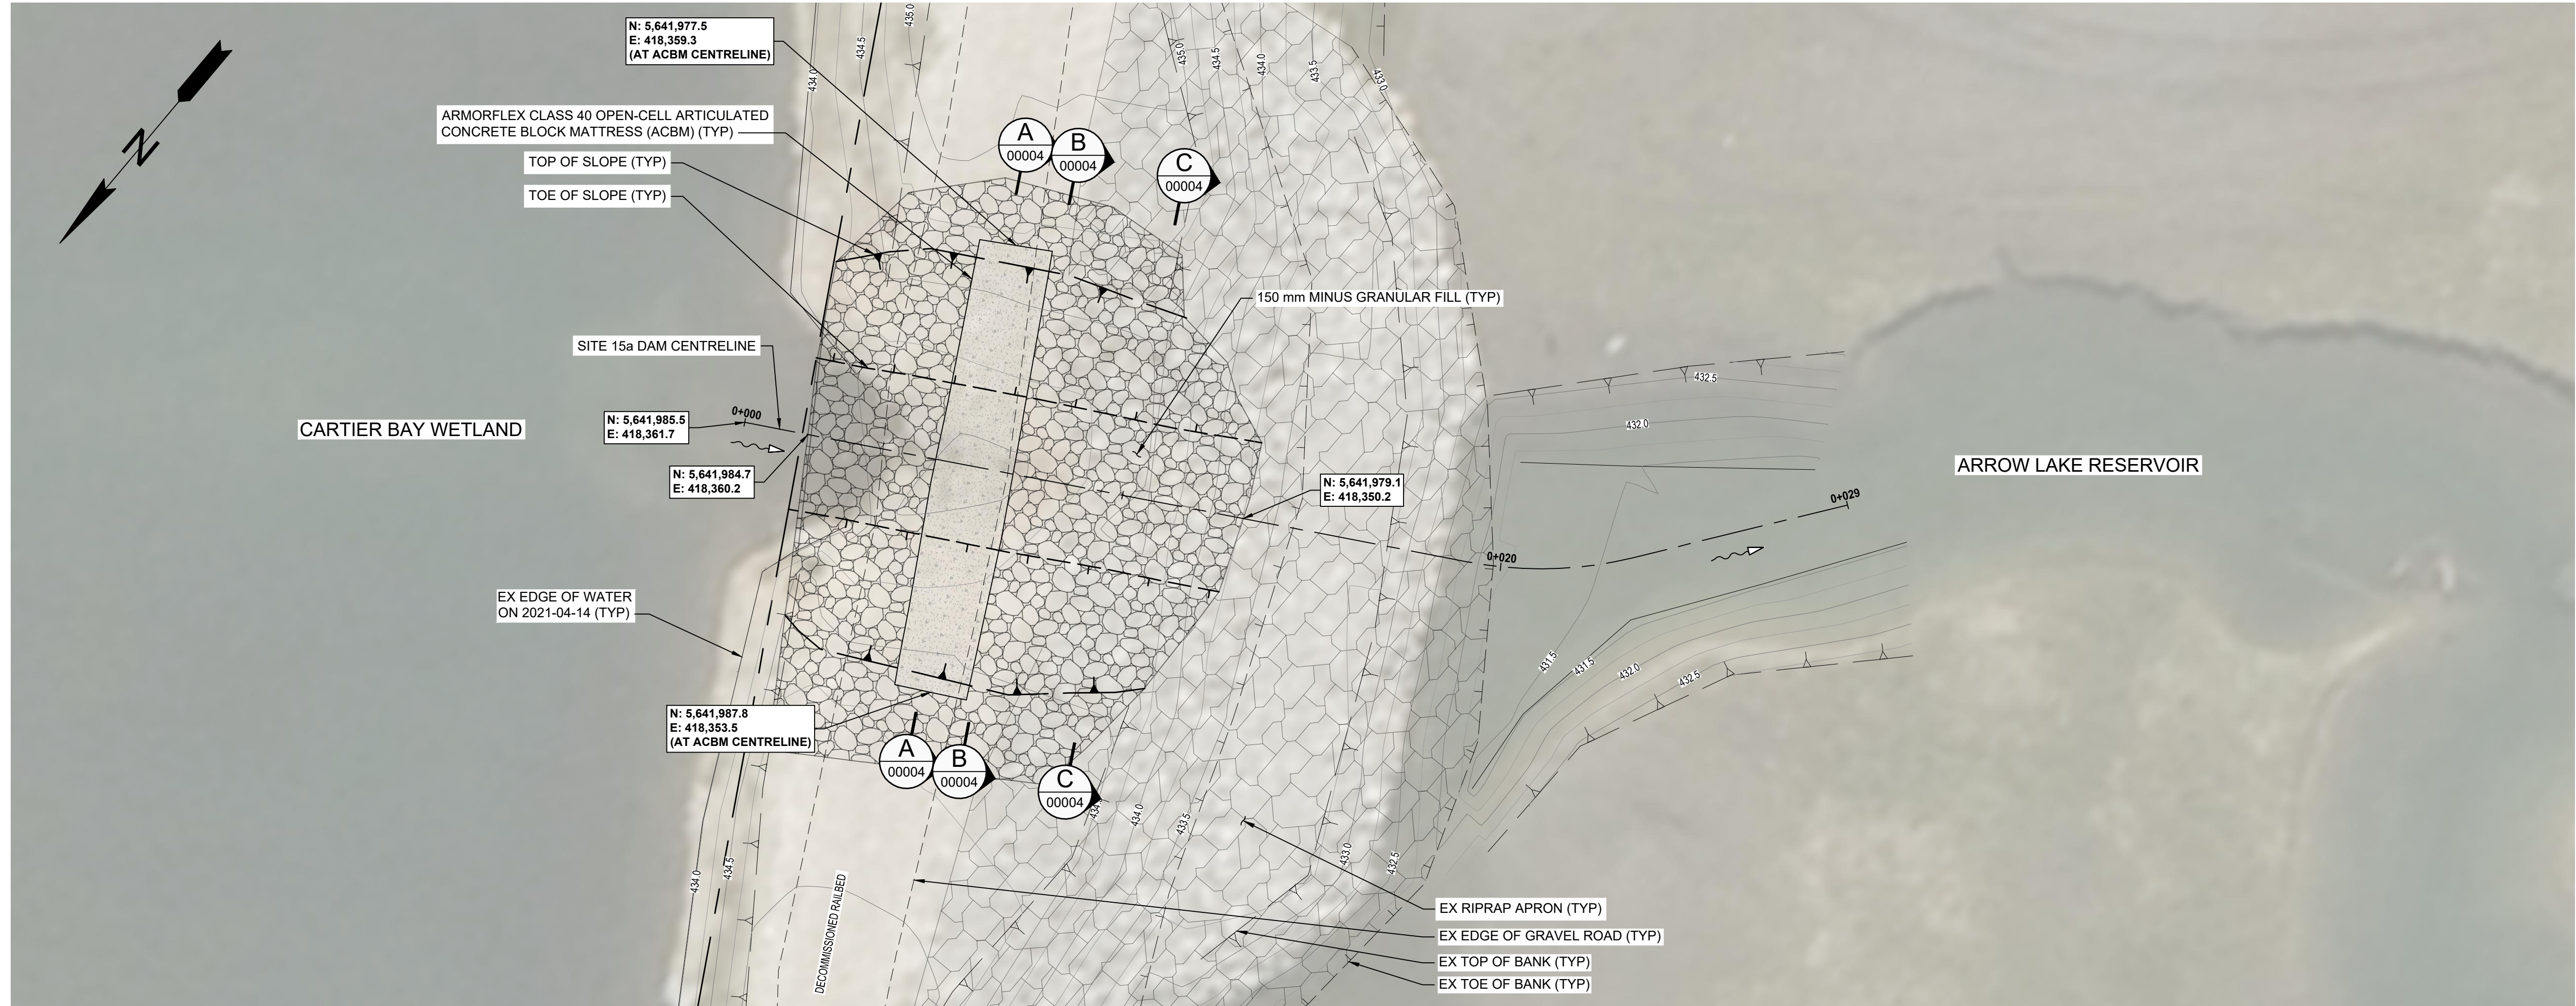
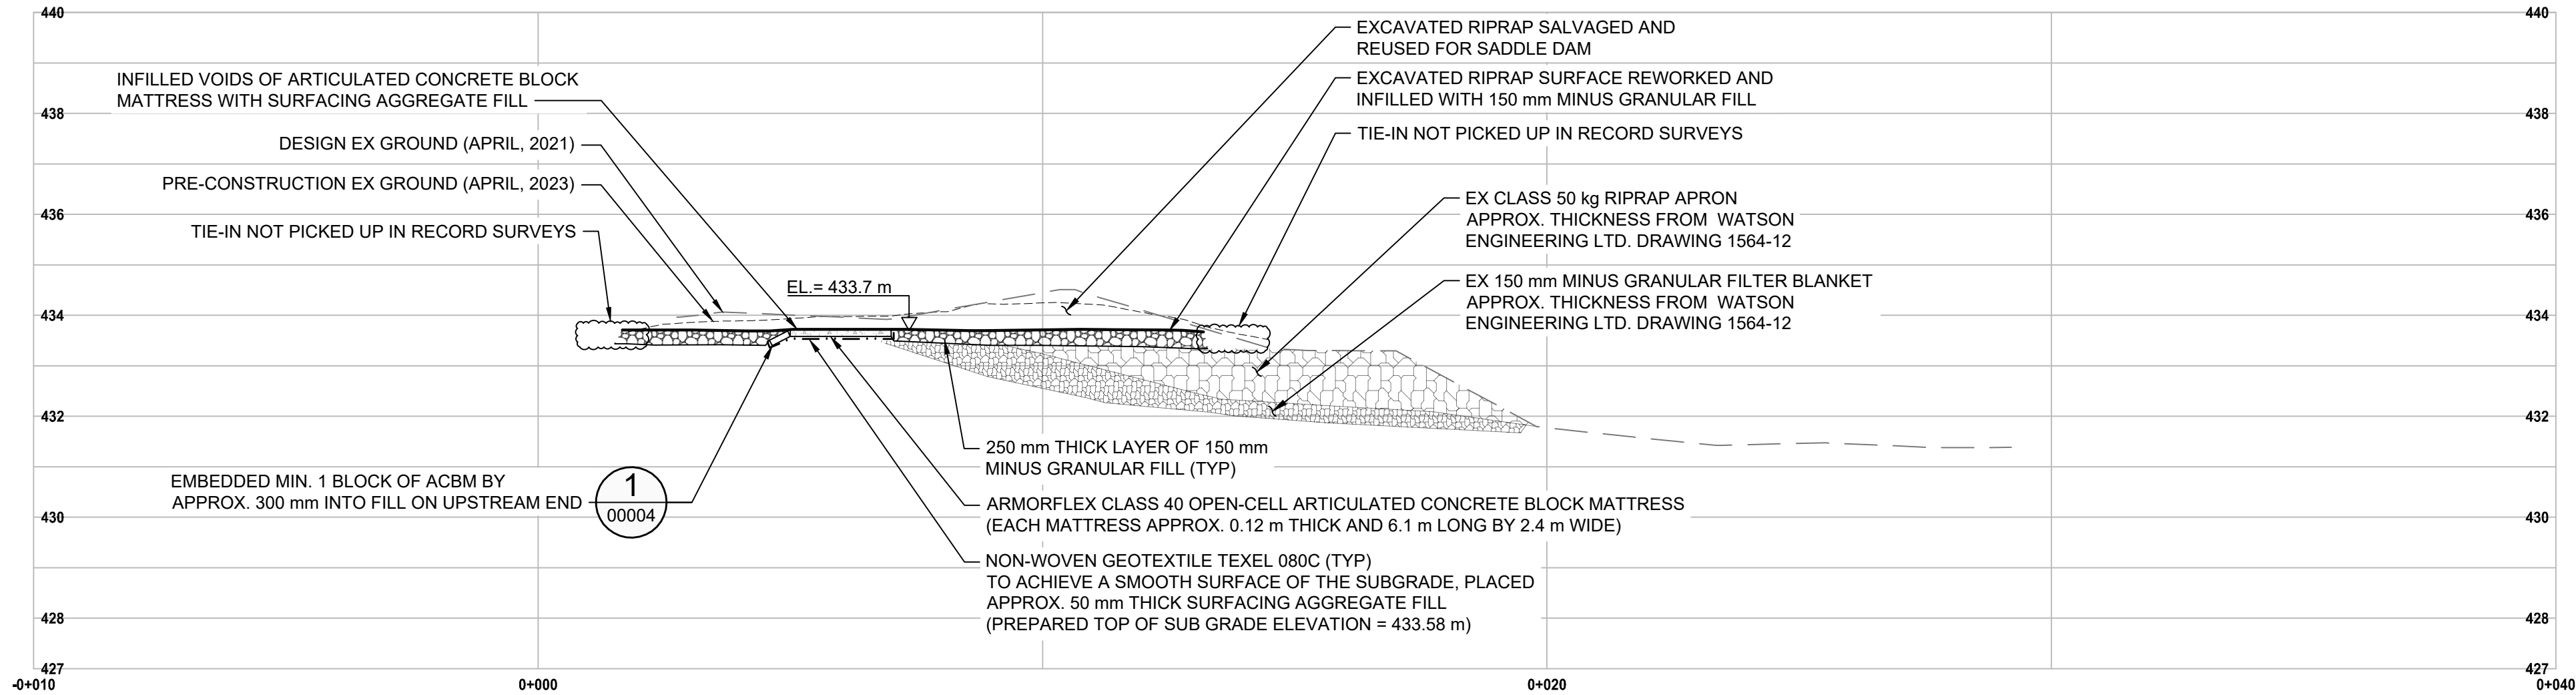
As reservoir levels began to draw down in late 2023, it was observed by BC Hydro staff that some fish had become stranded on the downstream end of the dam outlet. Temporary measures including exclusion netting at the wetland side of the outlet were installed to prevent further fish entering the outlet and becoming stranded.

A site visit was conducted by Liam Mackle (KWL) and Tysyn Olynyk (BC Hydro) on September 25, 2023 to assess the site and take some elevation point measurements across the outlet. It was found that while the top of the ACBM met the design elevations and fell within the specified tolerance, the 200 mm minus fill on the wetland side of the outlet had several low areas of up to 12 cm below the design elevation. KWL recommended using excess fill that had been placed on the north and south embankment side slopes at the top of the dam outlet to fill the low spots and create a more uniform surface across the outlet length and within the specified design tolerance. These findings are summarized in a Daily Field Review Report in Appendix B, and shown in Appendix C, Photos 17-20. The repair work was completed by a BC Hydro crew in November 2023.

SITE 15a DAM - PLAN
1:100

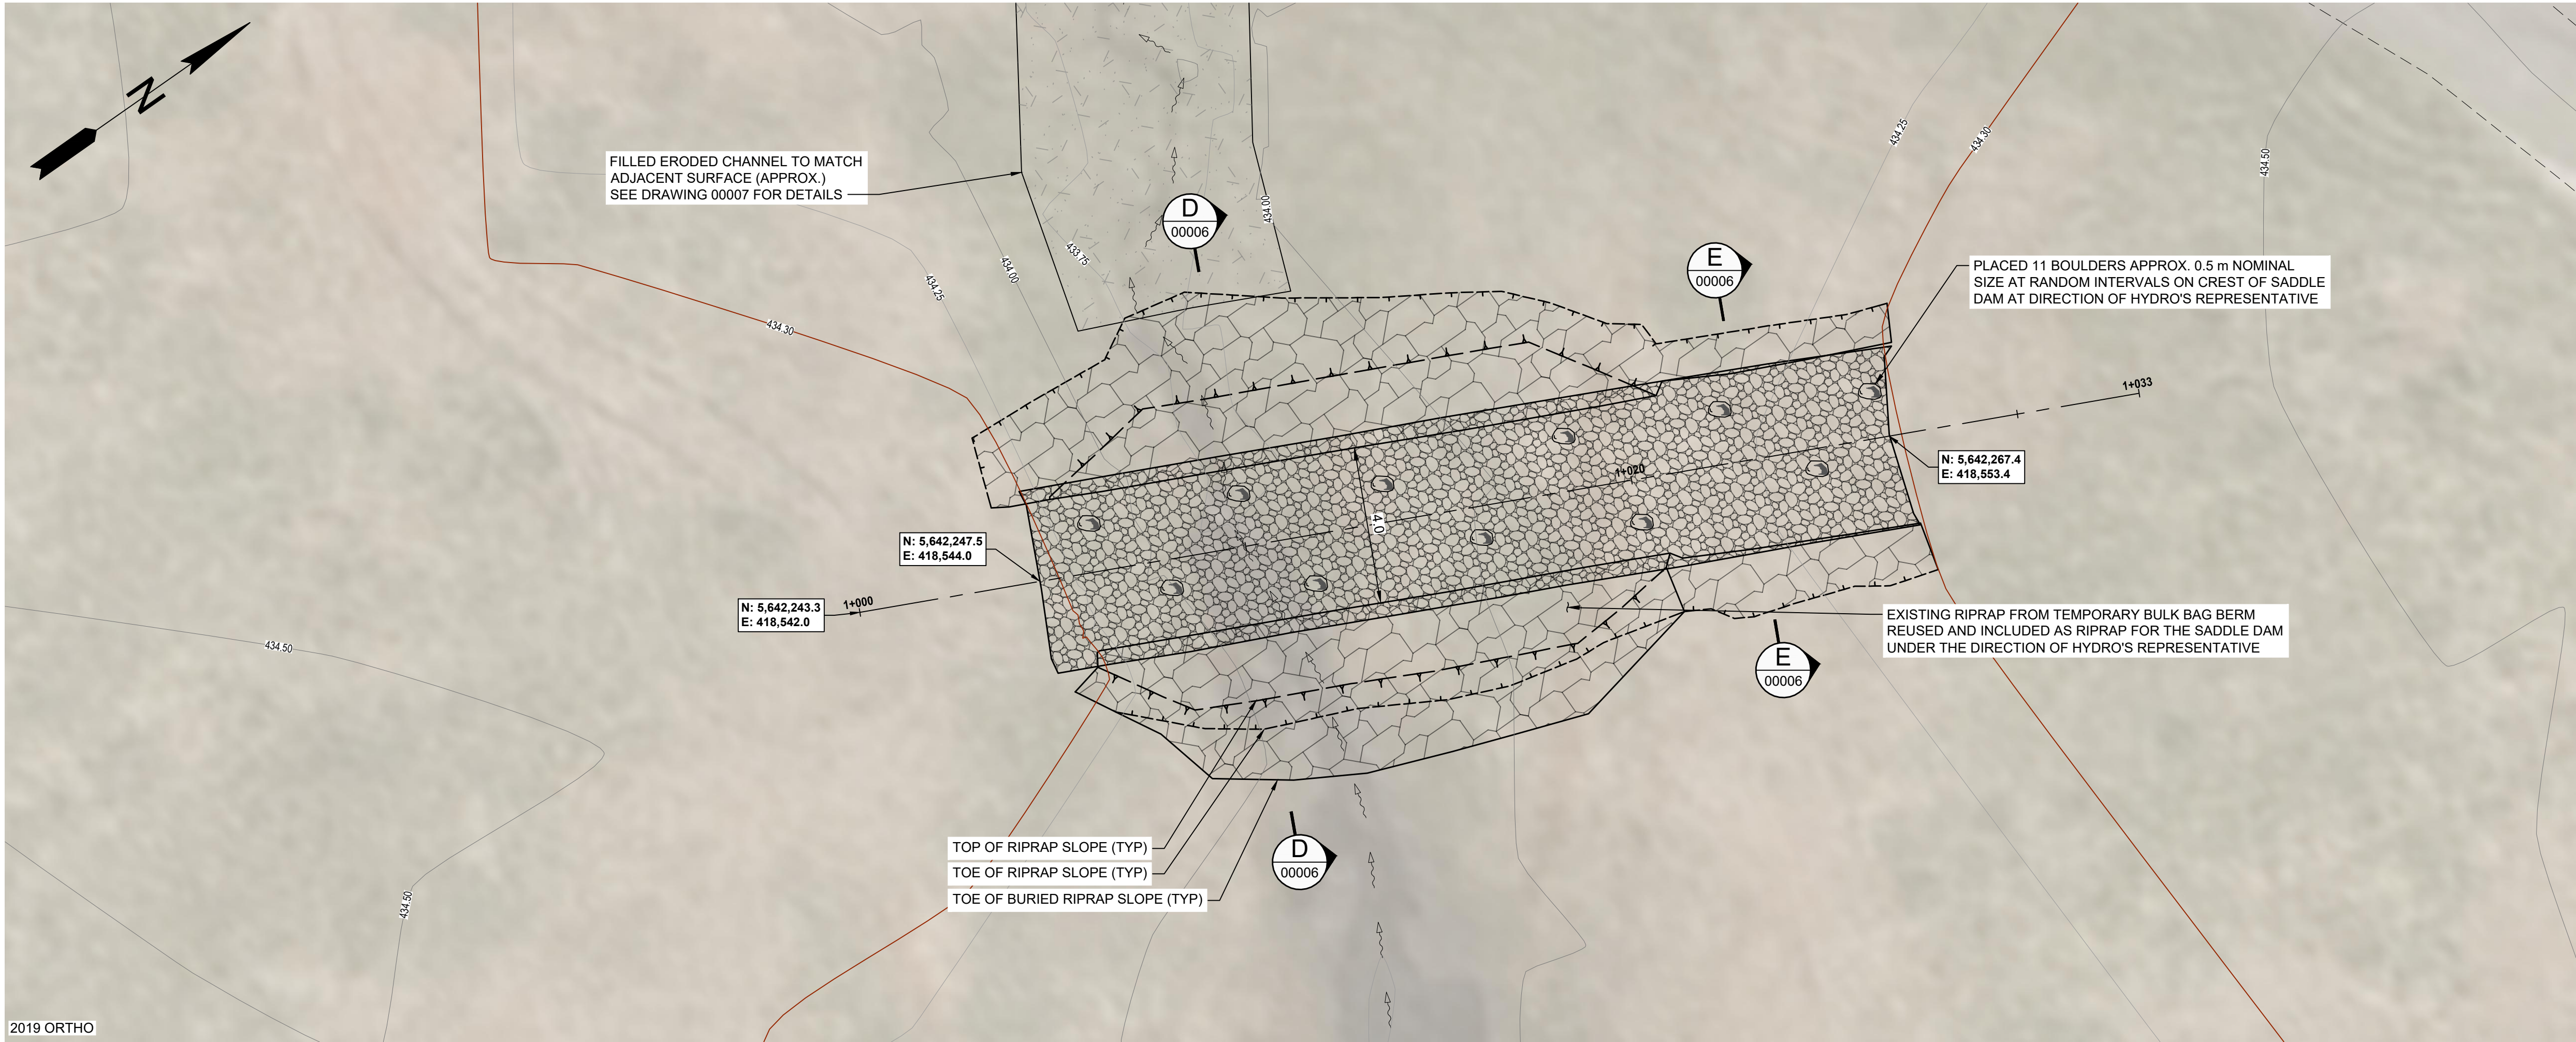
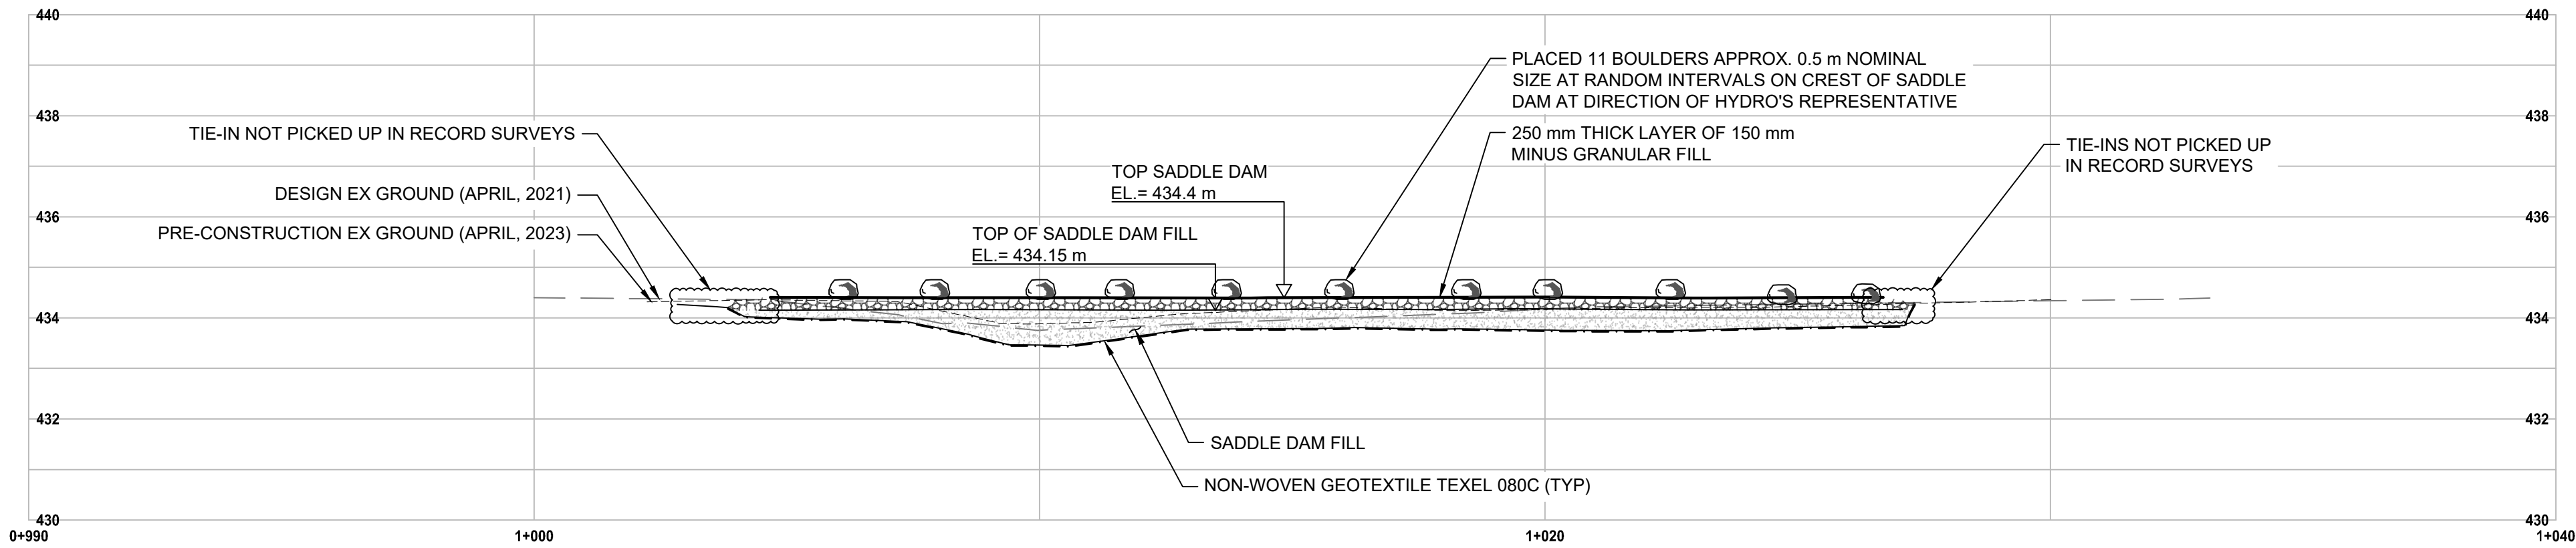
During reservoir inundation in spring 2023, water was observed by BC Hydro staff to be flowing around the south end of the saddle dam to enter the wetland, leading to concerns about potential erosion in the area as it is unvegetated in that location. This area may have been a low point before construction of the saddle dam; however construction equipment and activities likely compacted the area further creating a depression that allows for a localised concentrated water flow. Some flow was also observed around the north end of the saddle dam, however that area is vegetated with established reed canary grass and erosion is less of a concern at that location.

The site visit conducted on September 25, 2023 with Liam Mackle (KWL) and Tysyn Olynyk (BC Hydro) found no evidence of erosion on either end of the dam, and it was recommended that the south side of the saddle dam be planted with reed canary grass to reduce the risk of future erosion per the Daily Field Review Report in Appendix B.

AREA B SADDLE DAM - PLAN
1:100

- Place additional soil and reed canary grass (seed or transplant) at the low area on the south side of the Area B Saddle Dam. Following this work, the area should be monitored for signs of erosion, and the potential need for additional mitigation or repairs.
- Conduct monitoring as recommended in the Detailed Design Report (Table 5-2) to evaluate project success in the long term.
- The north bank should continue to be monitored to identify if any other potential topographic low areas with concentrated flow that could potentially lead to erosion develop over time (in addition to Area C).
- An updated operations and maintenance plan should be developed by a qualified professional(s).

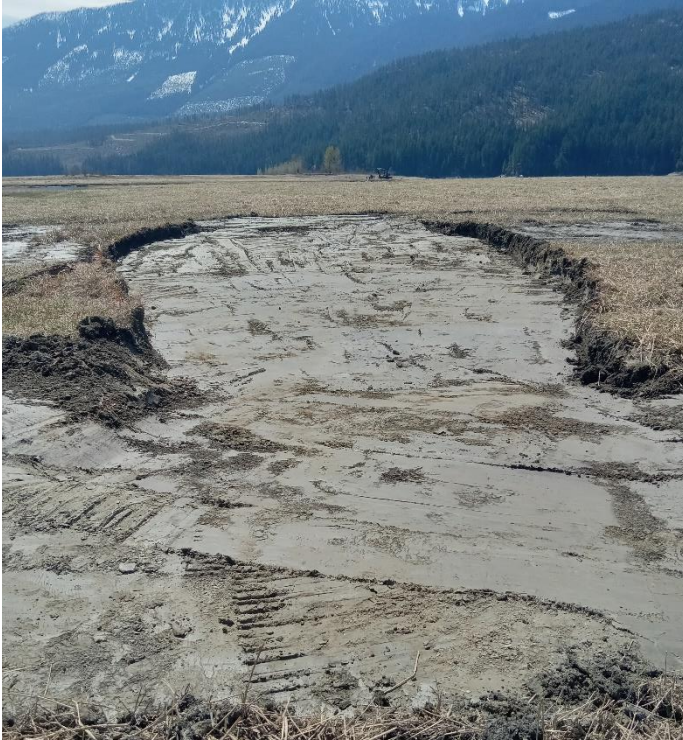
- Saddle dam subgrade surface smooth
- Lots of organics have been dug out and some still on the surface
- Excavation 0.6 m deep in center, 0.4 m deep at edges. Approx 11 m across, 23 m width (paced off, survey not on site)
- Eroded channel filled in, top is quite flat
- Road repair has not started

Saddle dam excavation footprint, looking west

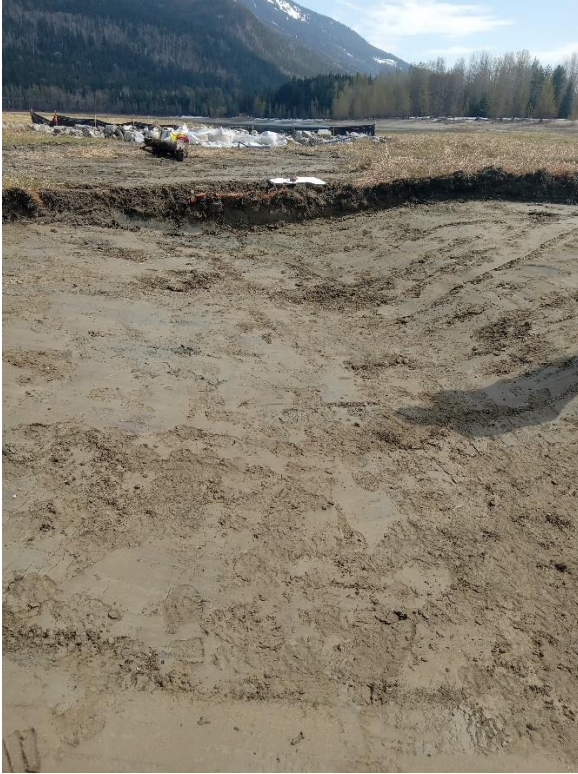
Saddle dam excavation/subgrade, looking north. Bulk bag barrier still in place:

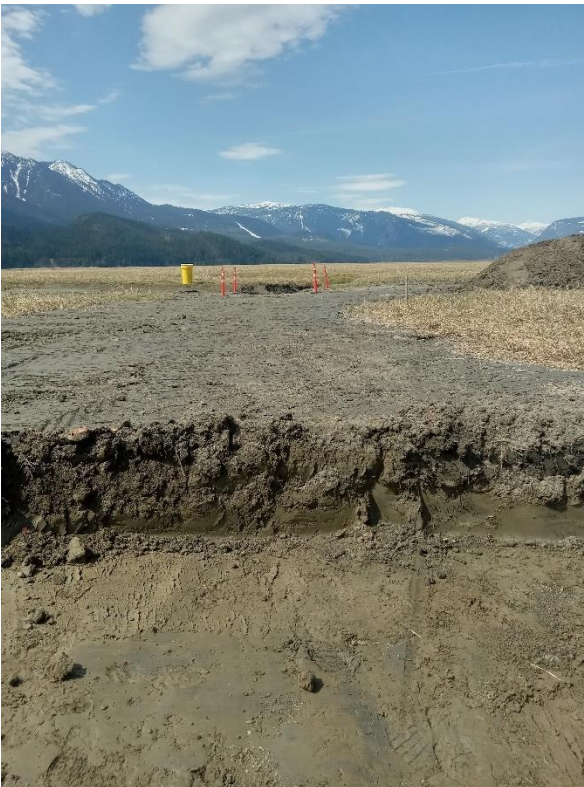
Looking south along filled eroded channel:

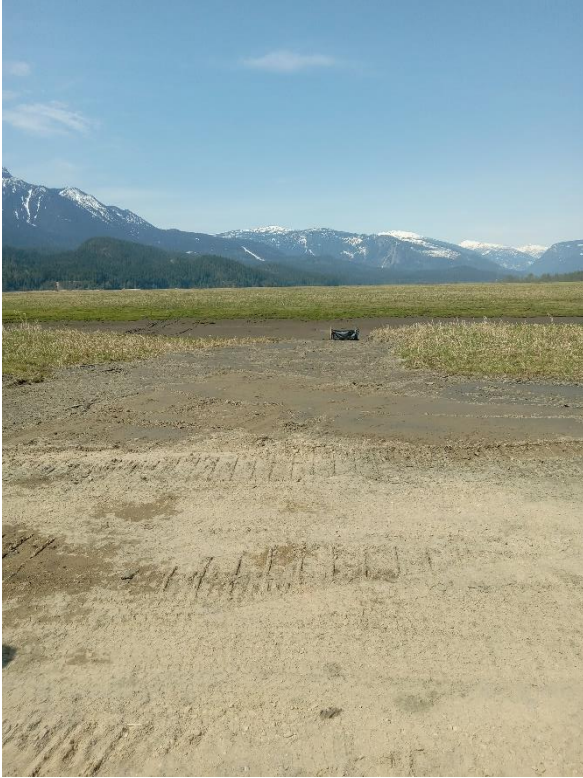
Area B road repair and eroded channel filled north of road, looking north:

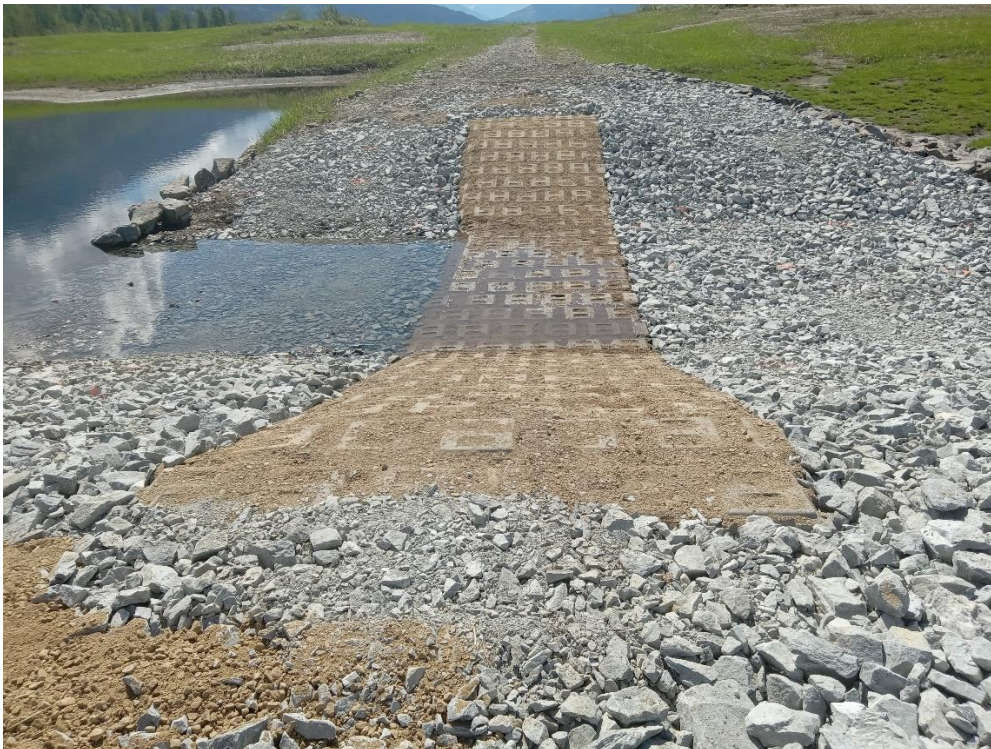
Finished Site 15a outlet, looking south:

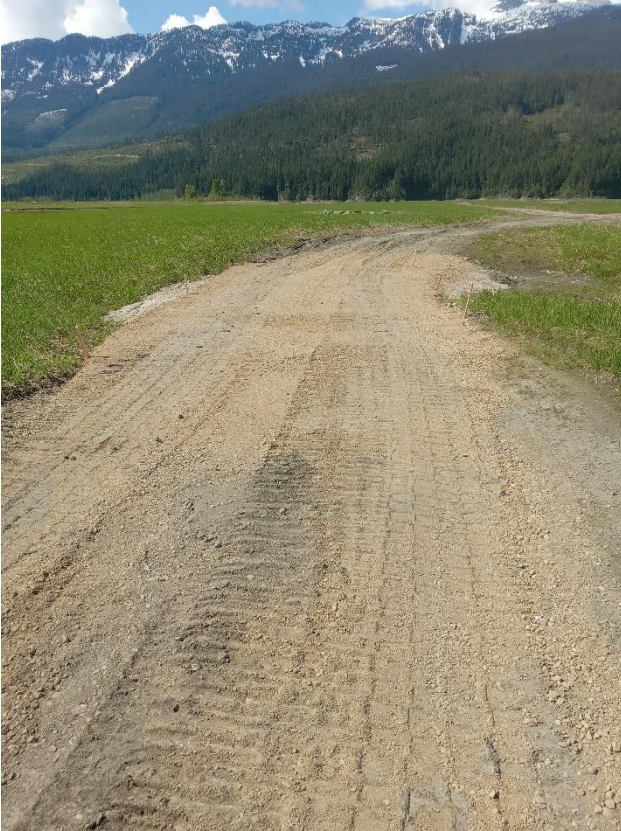
Finished Area A road raise, looking west:

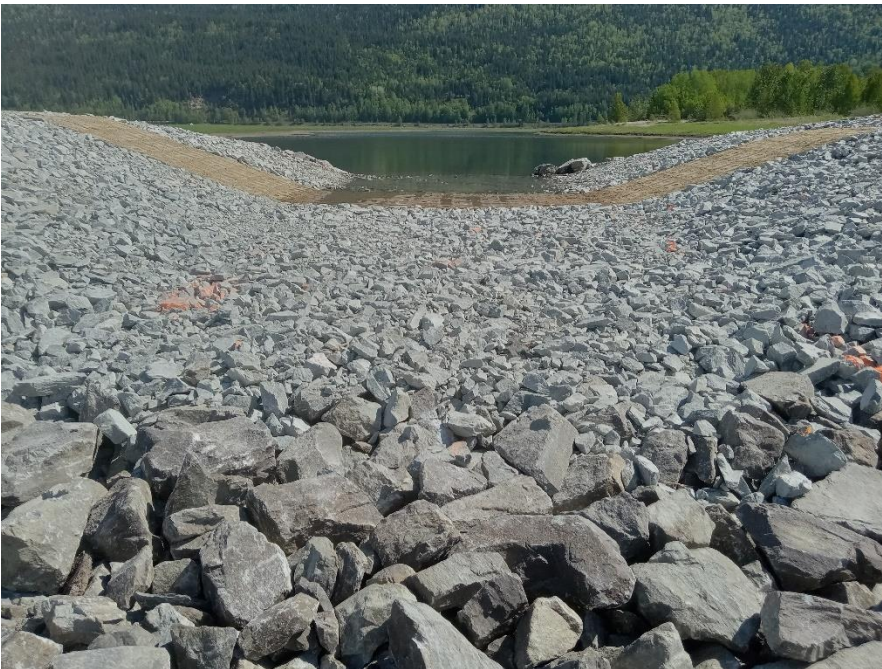
Finished Site 15a outlet, looking east:

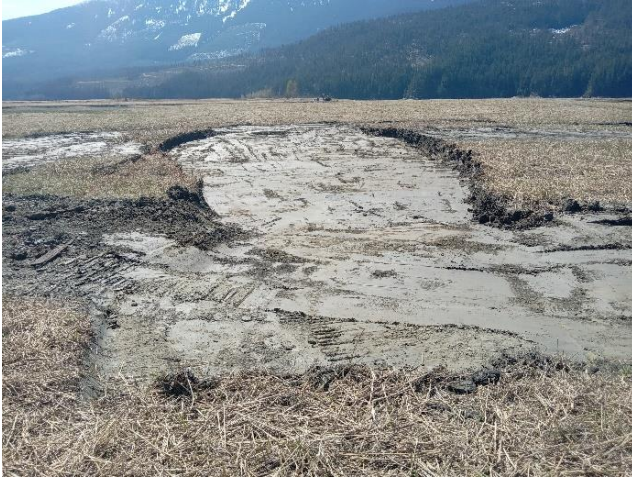
Photo 1: Excavated saddle dam footprint and prepared subgrade at Area B saddle dam. Looking west. April 30, 2023.

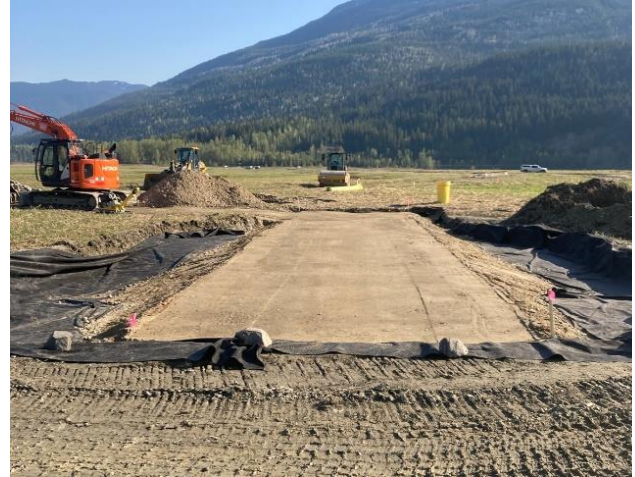
**Photo 2: Placement of saddle dam fill at Area B saddle dam. Looking east. May 3, 2023.
Photo provided by BC Hydro**

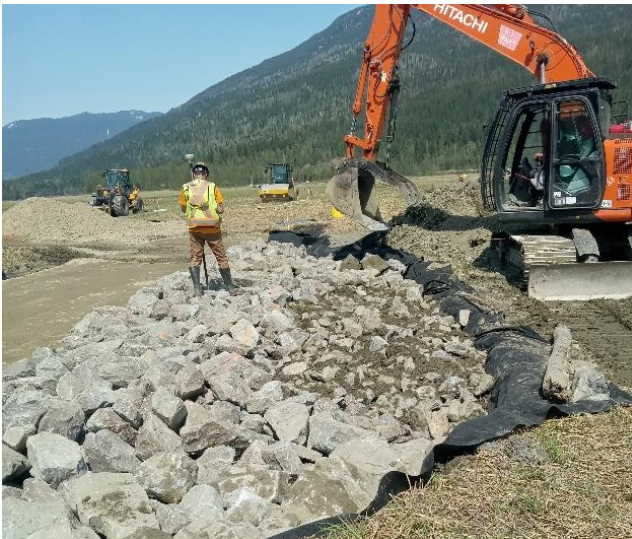
Photo 3: Placement of riprap on the south slope of the Area B saddle dam and filling voids. Looking east. May 3, 2023.

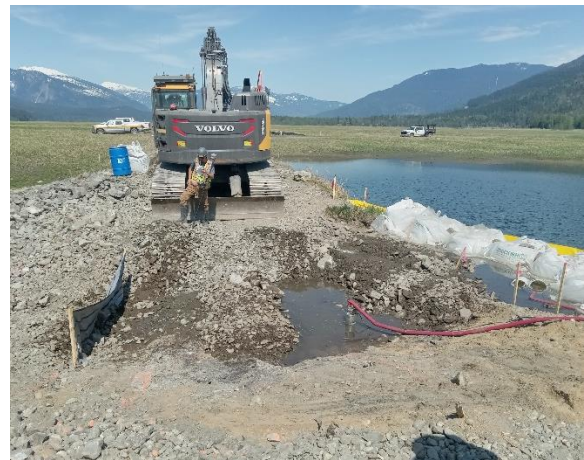
Photo 4: Excavation of the Site 15a outlet in progress. The cofferdam can be seen to the left in the photo. Looking north. May 4, 2023.

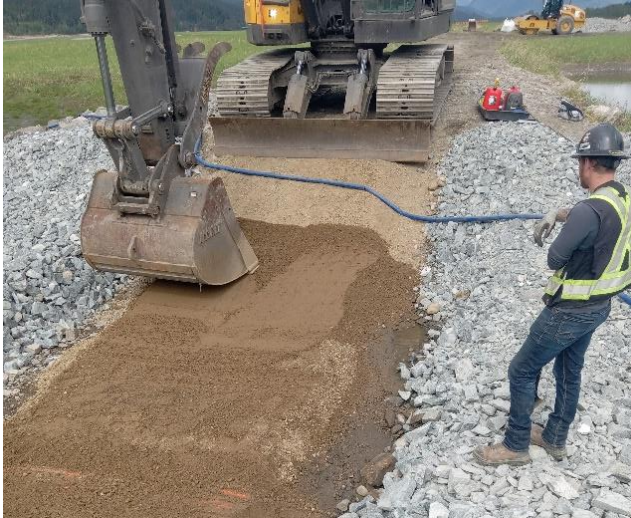
Photo 5: Preparation of the subgrade for the ACBM's at the Site 15a outlet in progress. Looking north. May 8, 2023.

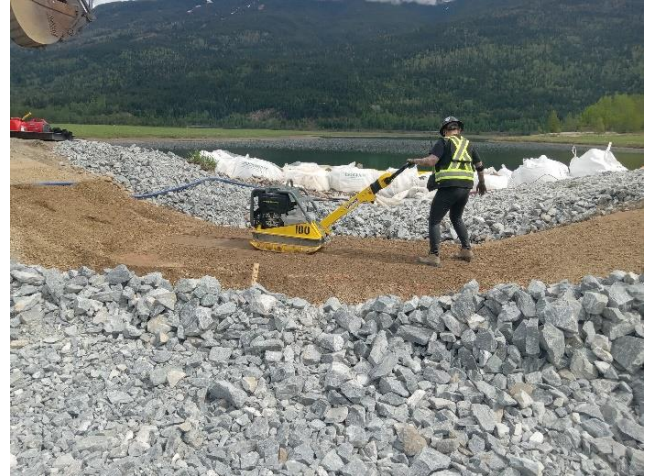
Photo 6: Preparation of the subgrade for the ACBM's at the Site 15a outlet in progress. Looking east. May 8, 2023.

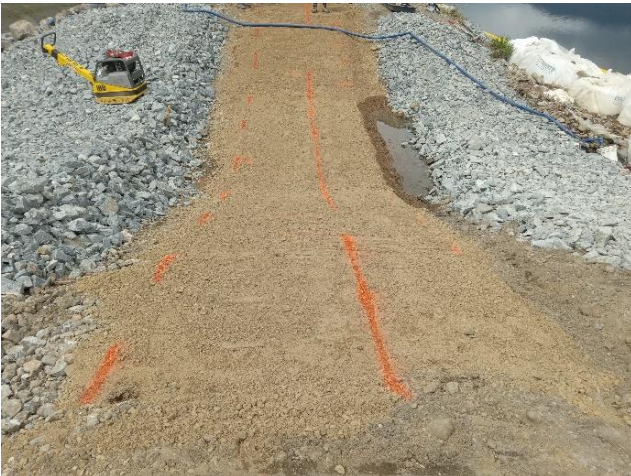
Photo 7: Finished subgrade prior to placement of the ACBM's at the Site 15a outlet. Looking north. May 8, 2023.

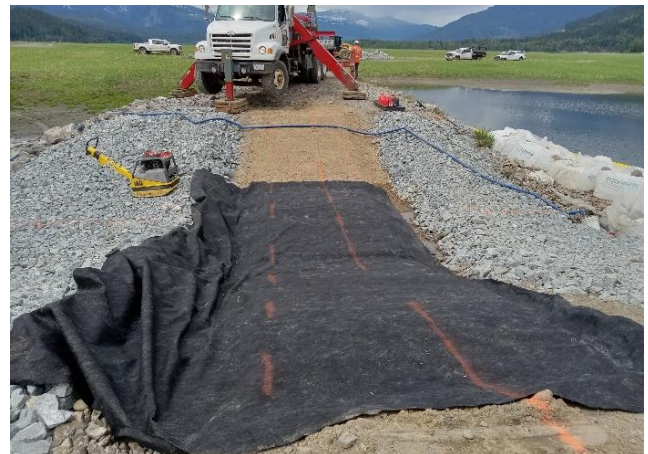
Photo 8: Placement of geotextile over the subgrade prior to placement of the first ACBM at the Site 15a outlet. Looking north. May 8, 2023.

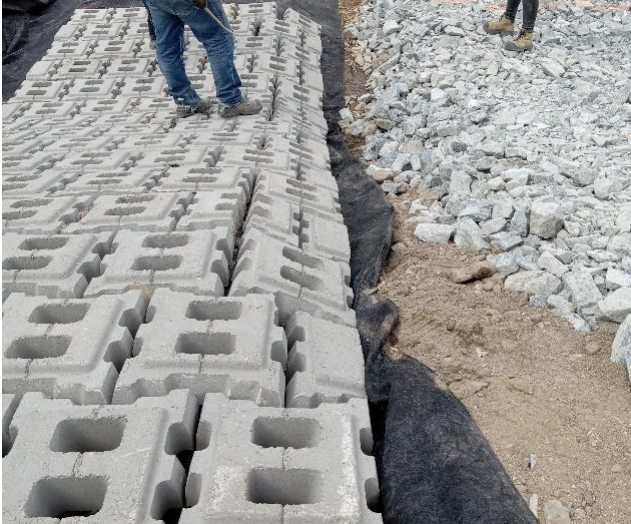
Photo 9: The first ACBM after placement. The upstream/eastern row of blocks was placed on an angle for embedment in granular material. Looking north. May 8, 2023.

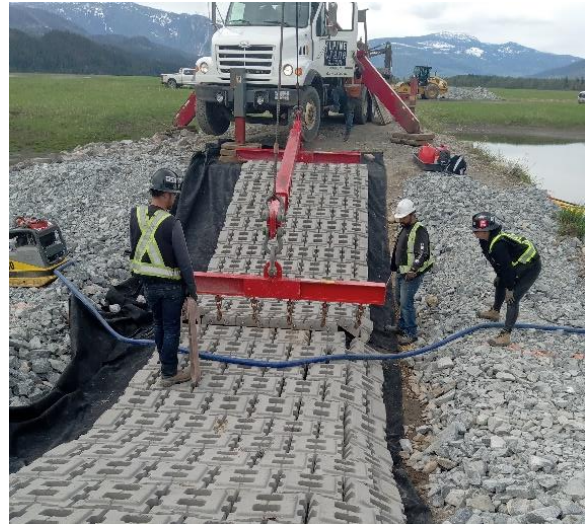
Photo 10: Placement of the second ACBM to contact the first in the middle of the Site 15a outlet. Looking north. May 8, 2023.

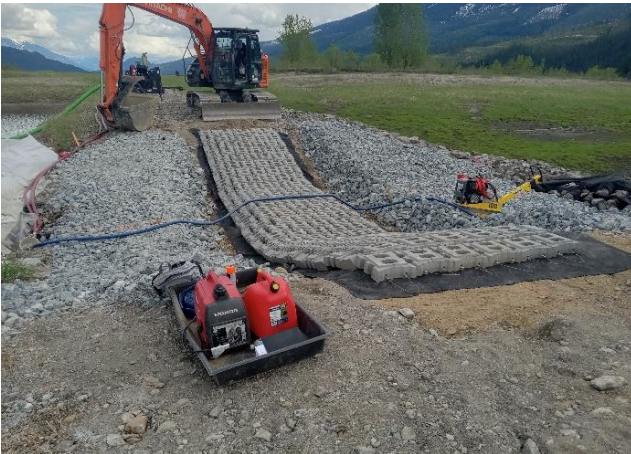
Photo 11: Both ACBM's at the Site 15a outlet in place prior to covering with surfacing aggregate. Looking south. May 8, 2023.

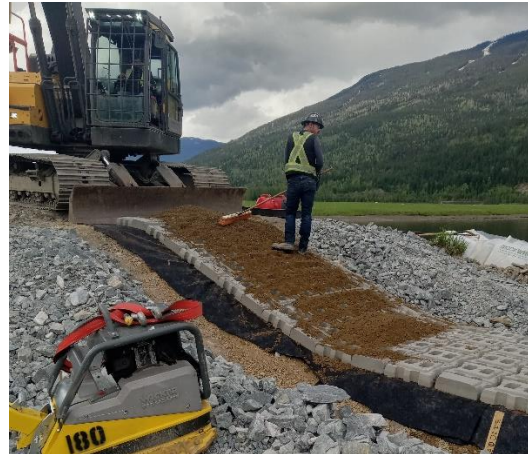
Photo 12: Filling the ACBM open cells with 25 mm minus surfacing aggregate at the Site 15a outlet. Looking northeast. May 8, 2023.

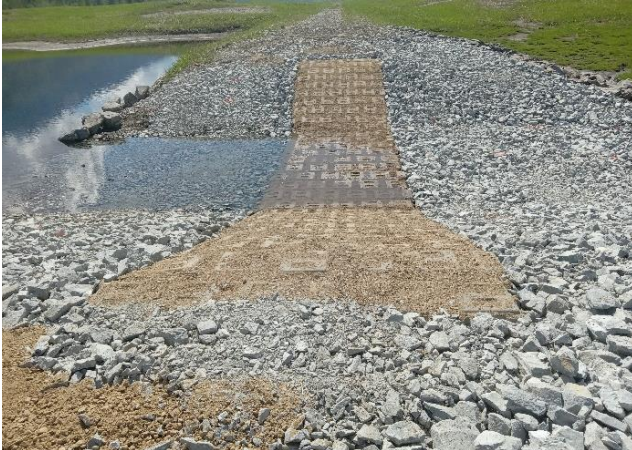
Photo 13: Finished Site 15a outlet immediately following removal of the cofferdam. Looking south. May 11, 2023.

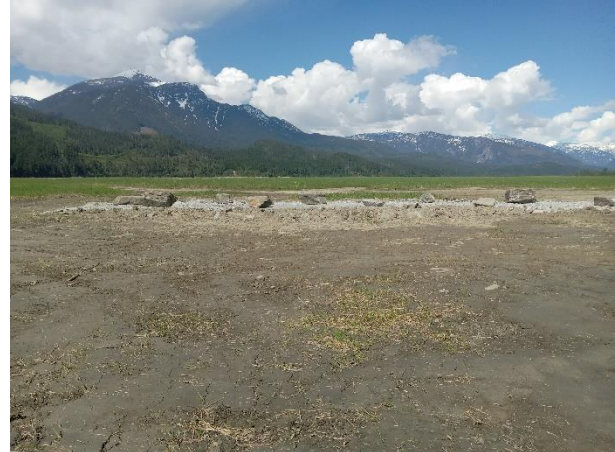
Photo 14: Finished saddle dam at Area B. Looking north. May 11, 2023.

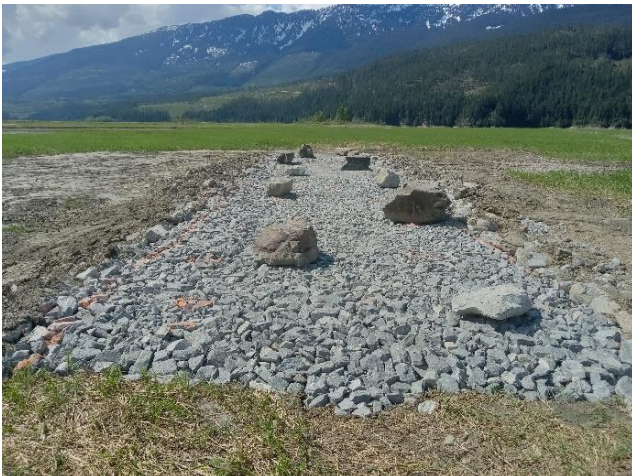
Photo 15: Finished saddle dam at Area B. Looking west. May 11, 2023

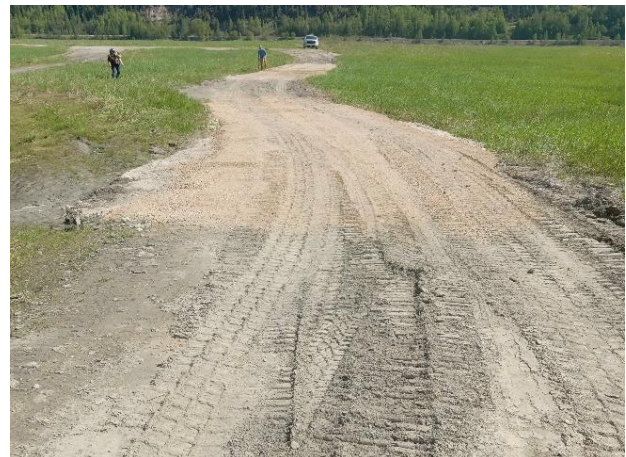
Photo 16: Area A road repairs. Looking east. May 11, 2023

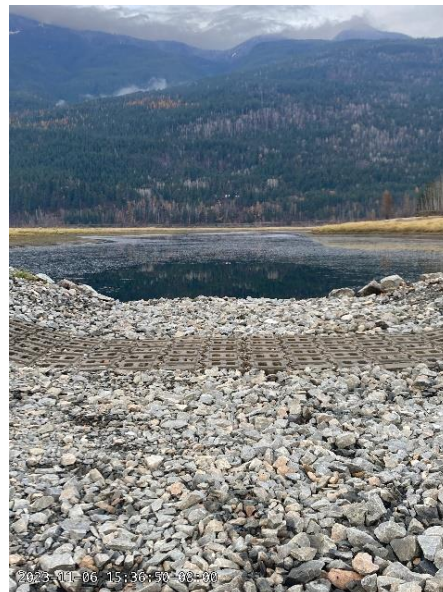
Photo 20: Wetland side of Site 15a inlet filled to provide a more uniform surface across its length. November 6, 2023.

It is recommended that excess 200 mm material used on the side slopes and on the downstream side be moved to the wetland inlet side of Site 15a to provide a more uniform surface across its length.

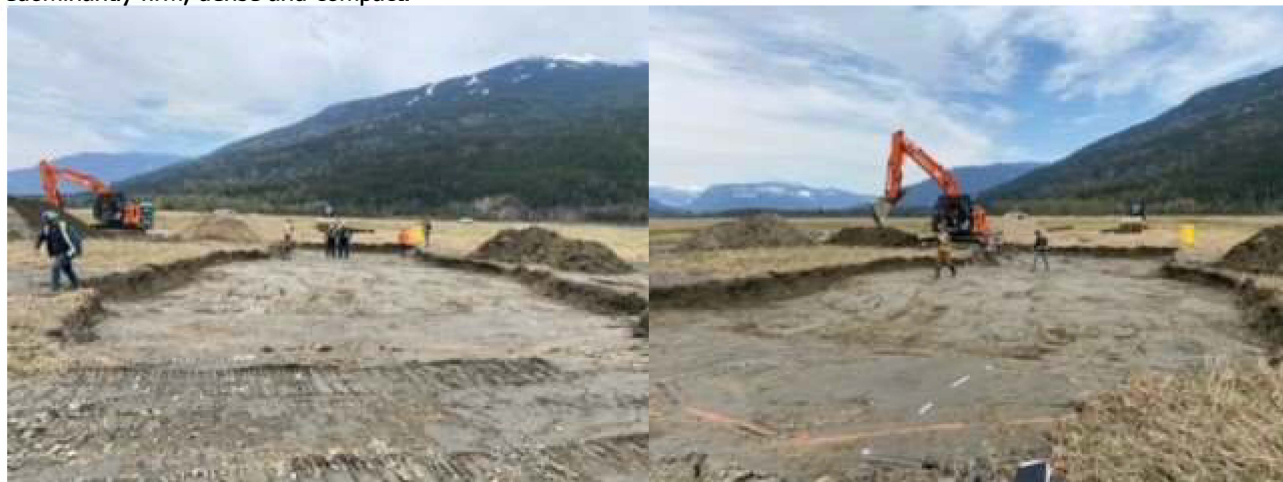
Subgrade inspected prior to geotextile and saddle dam/75mm minus pit run fill and approved for install. Base conditions were predominantly firm, dense and compact.

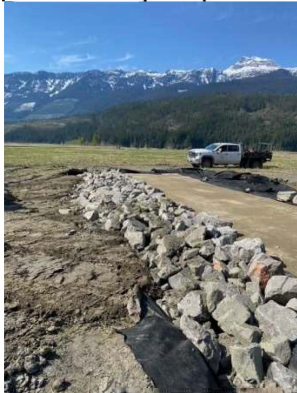
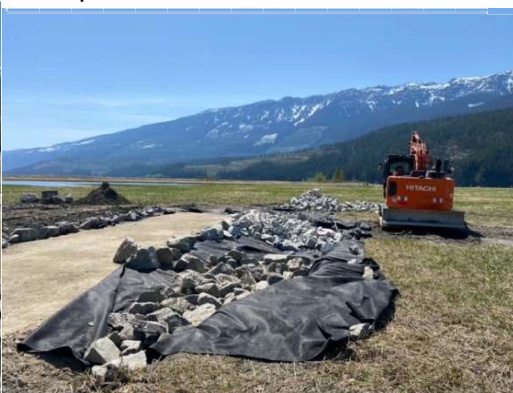
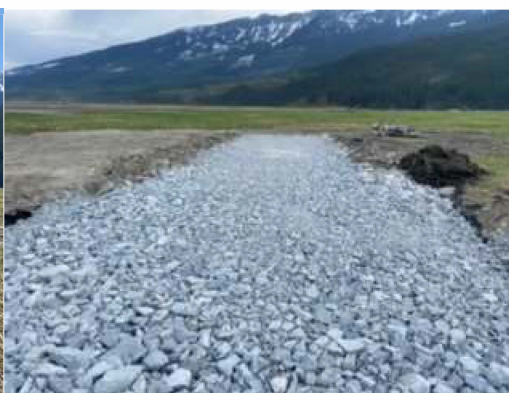
Subgrade inspected prior to 200mm Minus Granular Fill placement and approved for install. Base conditions were predominantly firm, dense and compact.

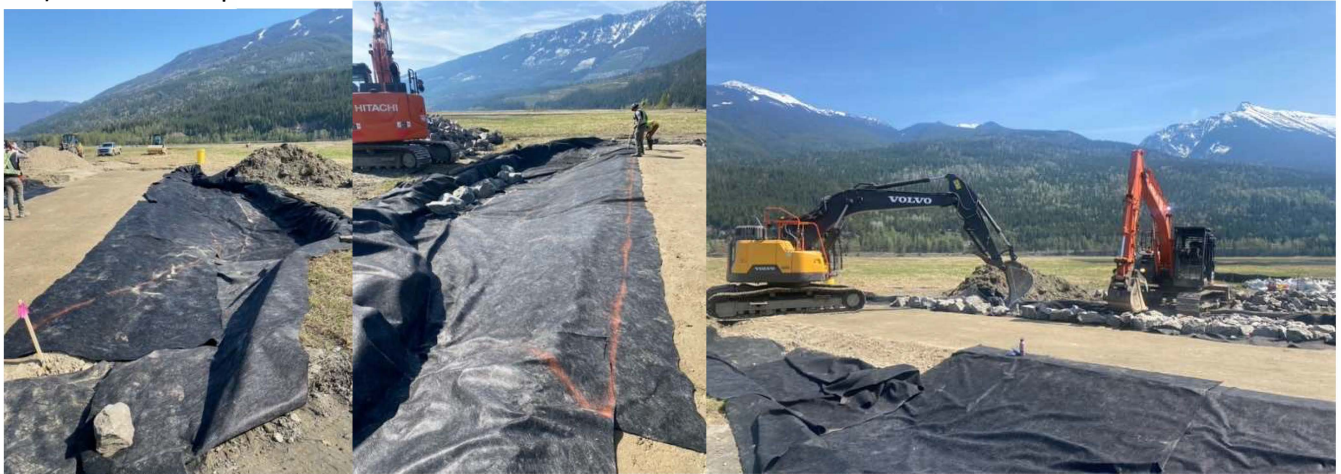
Subgrade inspected prior to riprap and geotextile placement and approved for install. Base conditions were predominantly firm, dense and compact.

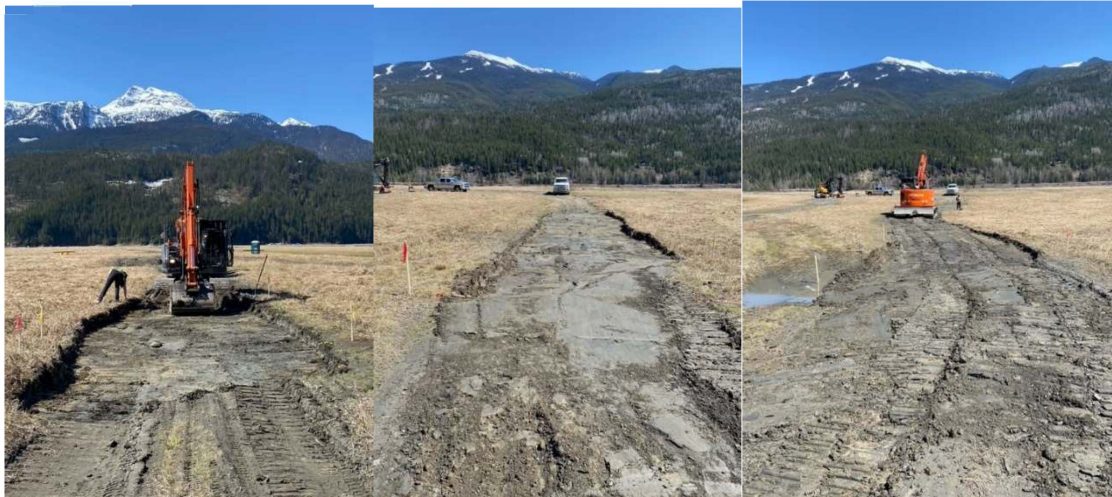
Subgrade inspected prior to 75mm minus pit run fill and approved for install. Base conditions were predominantly firm, dense and compact.

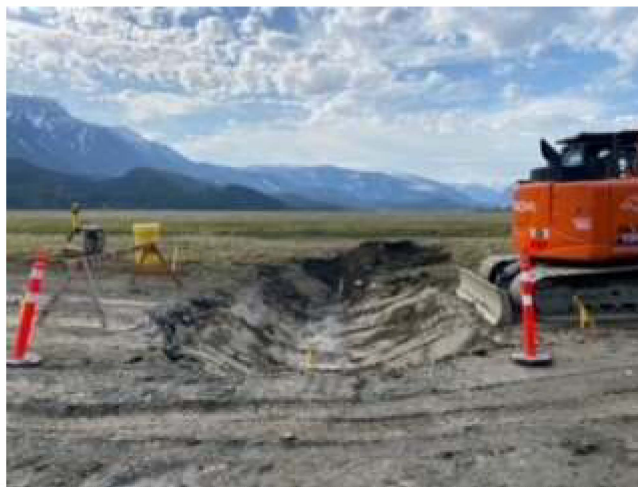
Subgrade inspected prior to 75mm minus pit run fill and approved for install. Base conditions were predominantly firm, dense and compact.

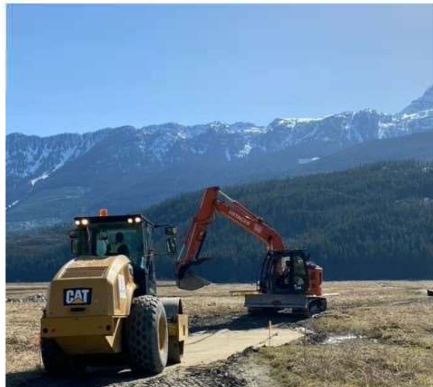
Subgrade inspected prior to 25mm minus surfacing aggregate and approved for install. Base conditions were predominantly firm, dense and compact.

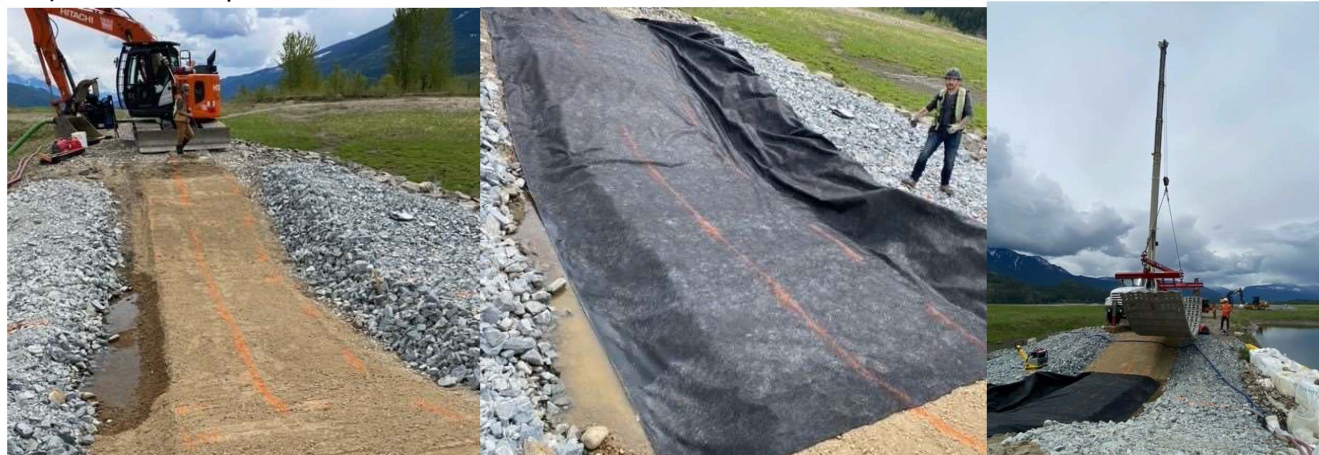
Subgrade inspected prior to geotextile and ACBM placement and approved for install. Base conditions were predominantly firm, dense and compact.

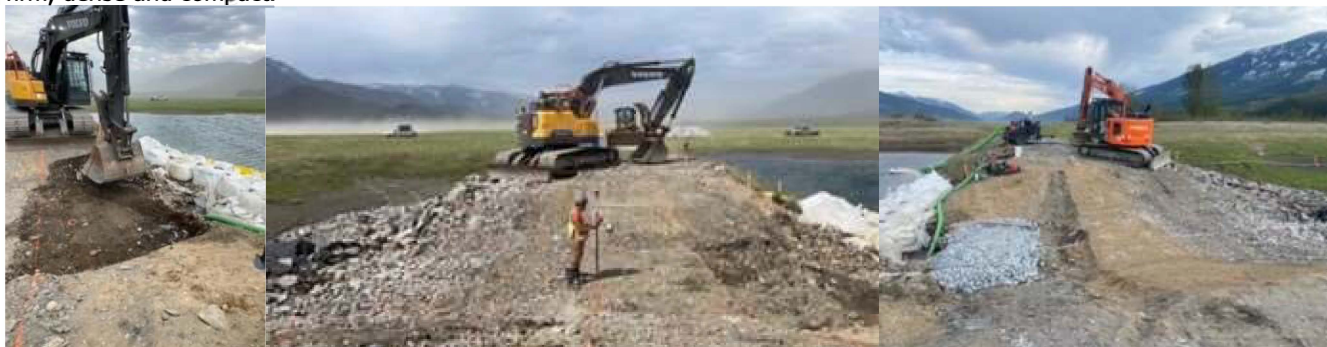
Subgrade inspected prior to 200mm Minus Granular Subgrade and approved for install. Base conditions were predominantly firm, dense and compact.
