Columbia River Project Water Use Plan

Mid Columbia Erosion Protection and Monitoring

Reference: CLBWORKS-35

2013 Progress Report

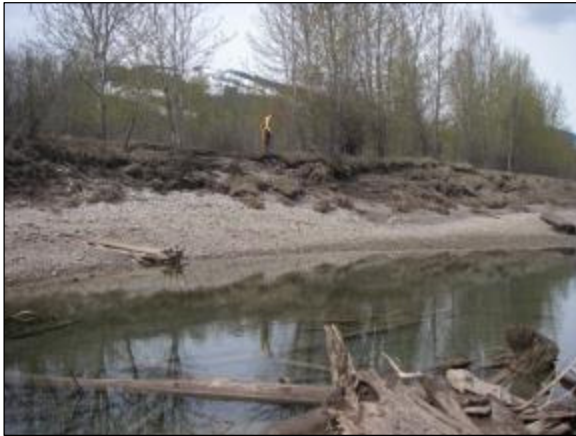
- Minimal erosion/deposition has occurred on the bank at both control sites; and
- Some minor undercutting of the bank leading to toppling of grassy blocks has occurred at the downstream control site.

**Photo 4-6: Site A1 Upstream Control
(April 23, 2013)**

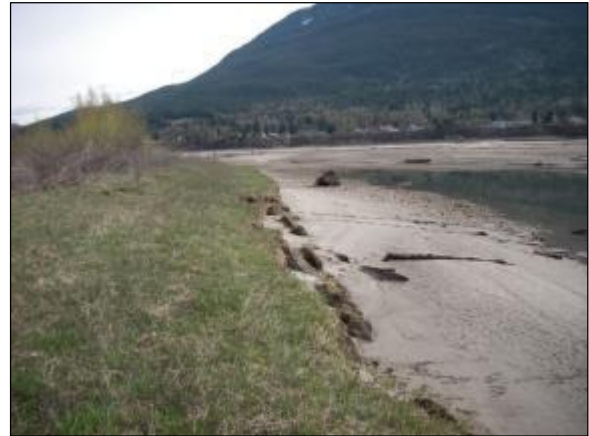
**Photo 4-7: Site A1 Downstream Control
(April 23, 2013)**

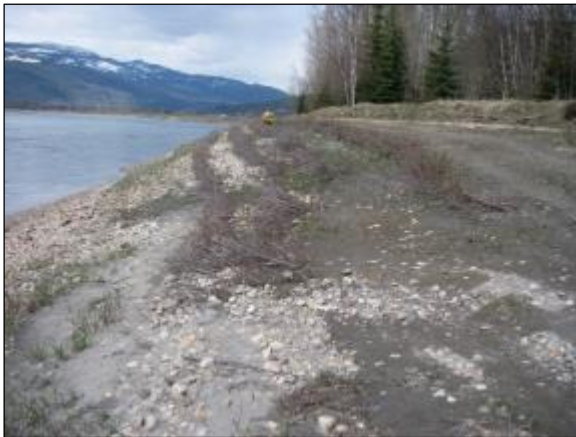
- Minor erosion/deposition has occurred within the mid and lower banks around the brush layers;
- Minor erosion has occurred on the upland slope above the brush layers;
- New growth on the brush layers is moderate (Photo 4-19); and
- Survival rate of the planted potted trees and shrubs is moderate.

Photo 4-18: Site B (April 24, 2013)

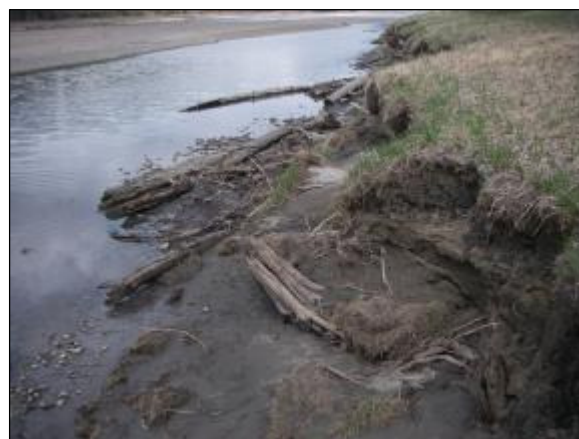
Photo 4-30 Site C Downstream Control
(April 24, 2013)

- 2012 to 2013 erosion pin measurements are presented in Figure 4-7;
- On average, the erosion pin data indicate modest deposition for both control sites (about 5 cm and 9 cm) for the 2012 to 2013 period;
- 2012 to 2013 and 2011 to 2013 cross-section measurements for Site C Control are summarized in Table 4-16, below. Cross-section plots are presented in Figure 4-8; and
- Δx Midpoint means indicate erosion, generally, for both the more recent and the project-to-date timeline, except in the middle elevation band of the upstream control section. Both erosion and deposition trends appear to be mostly progressive (larger values in the project-to-date period).

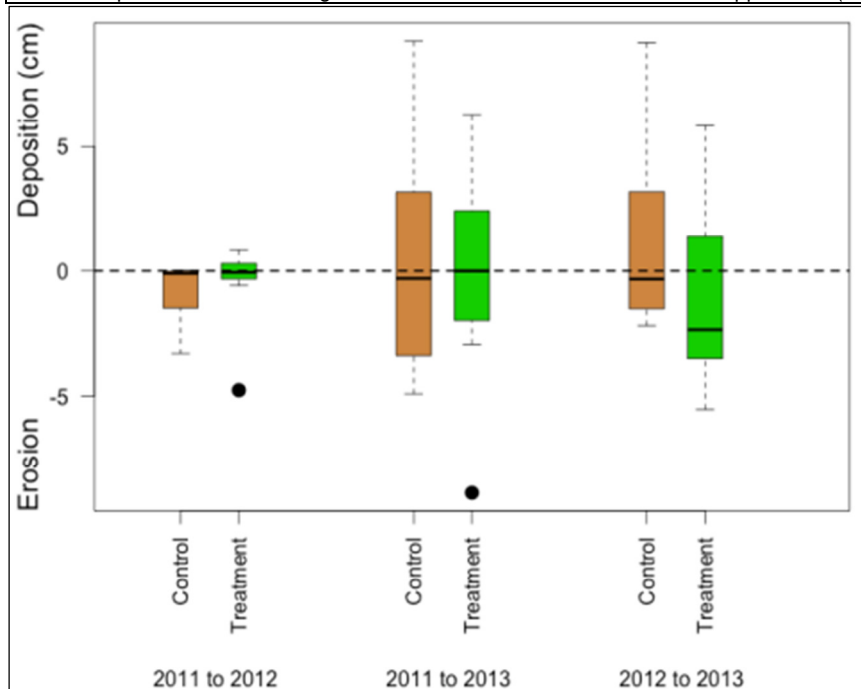
Figure 4-9: Change in Pin Length for Different Time Periods for All Sites

The Student's one-sample t test was used to test the statistical significance of the mean difference in pin length changes. Summary results are presented in Table 4-18. It should be noted that the sign of the test statistic ($C - T$) does not indicate erosion if negative, due to the effect of the algebraic expression.

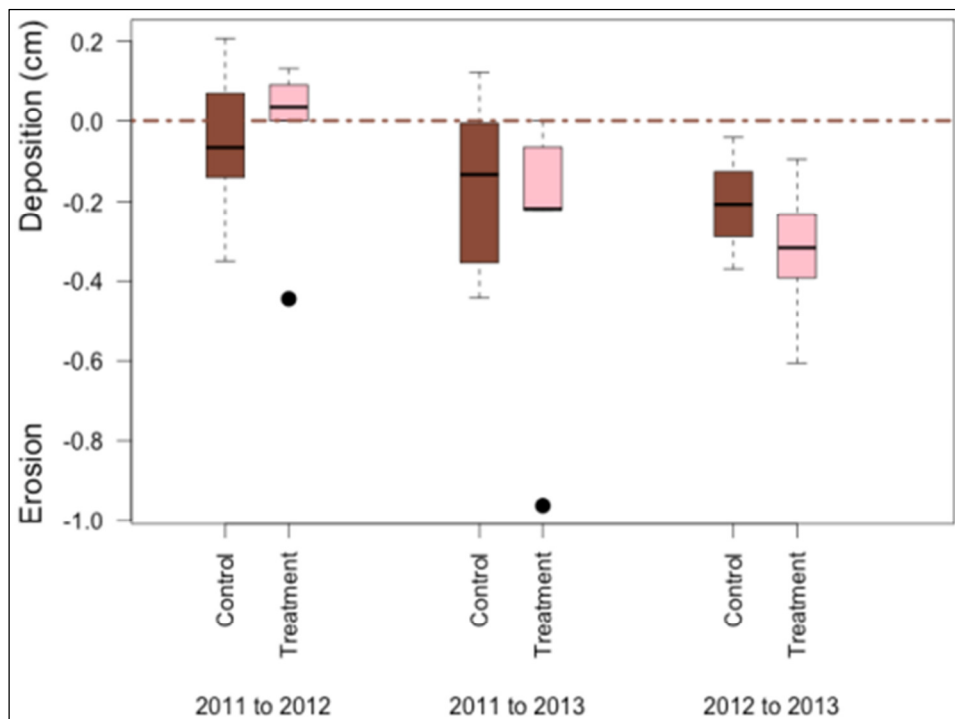
Figure 4-11: Bank Change (Δx midpoint) Measured over Three Time Periods

Table 4-19 presents a summary of mean change (Δx midpoint) for each site and time period. The same data are presented graphically, in Figure 4-11. As indicated, for the 2012 to 2013 time period, all of the control and treatment sites experienced erosion. Over the longer 2011 to 2013 period, the majority of treatment and control sites experienced erosion (2 of 7 control sites and 1 of 5 treatment sites showed no change or deposition).

The Students one-tailed t test was used to test the statistical significance of the mean difference in Δx midpoint between treatment and control sites. Summary results are presented in Table 4-20. As indicated below, none of the time periods yielded a statistically significant difference.

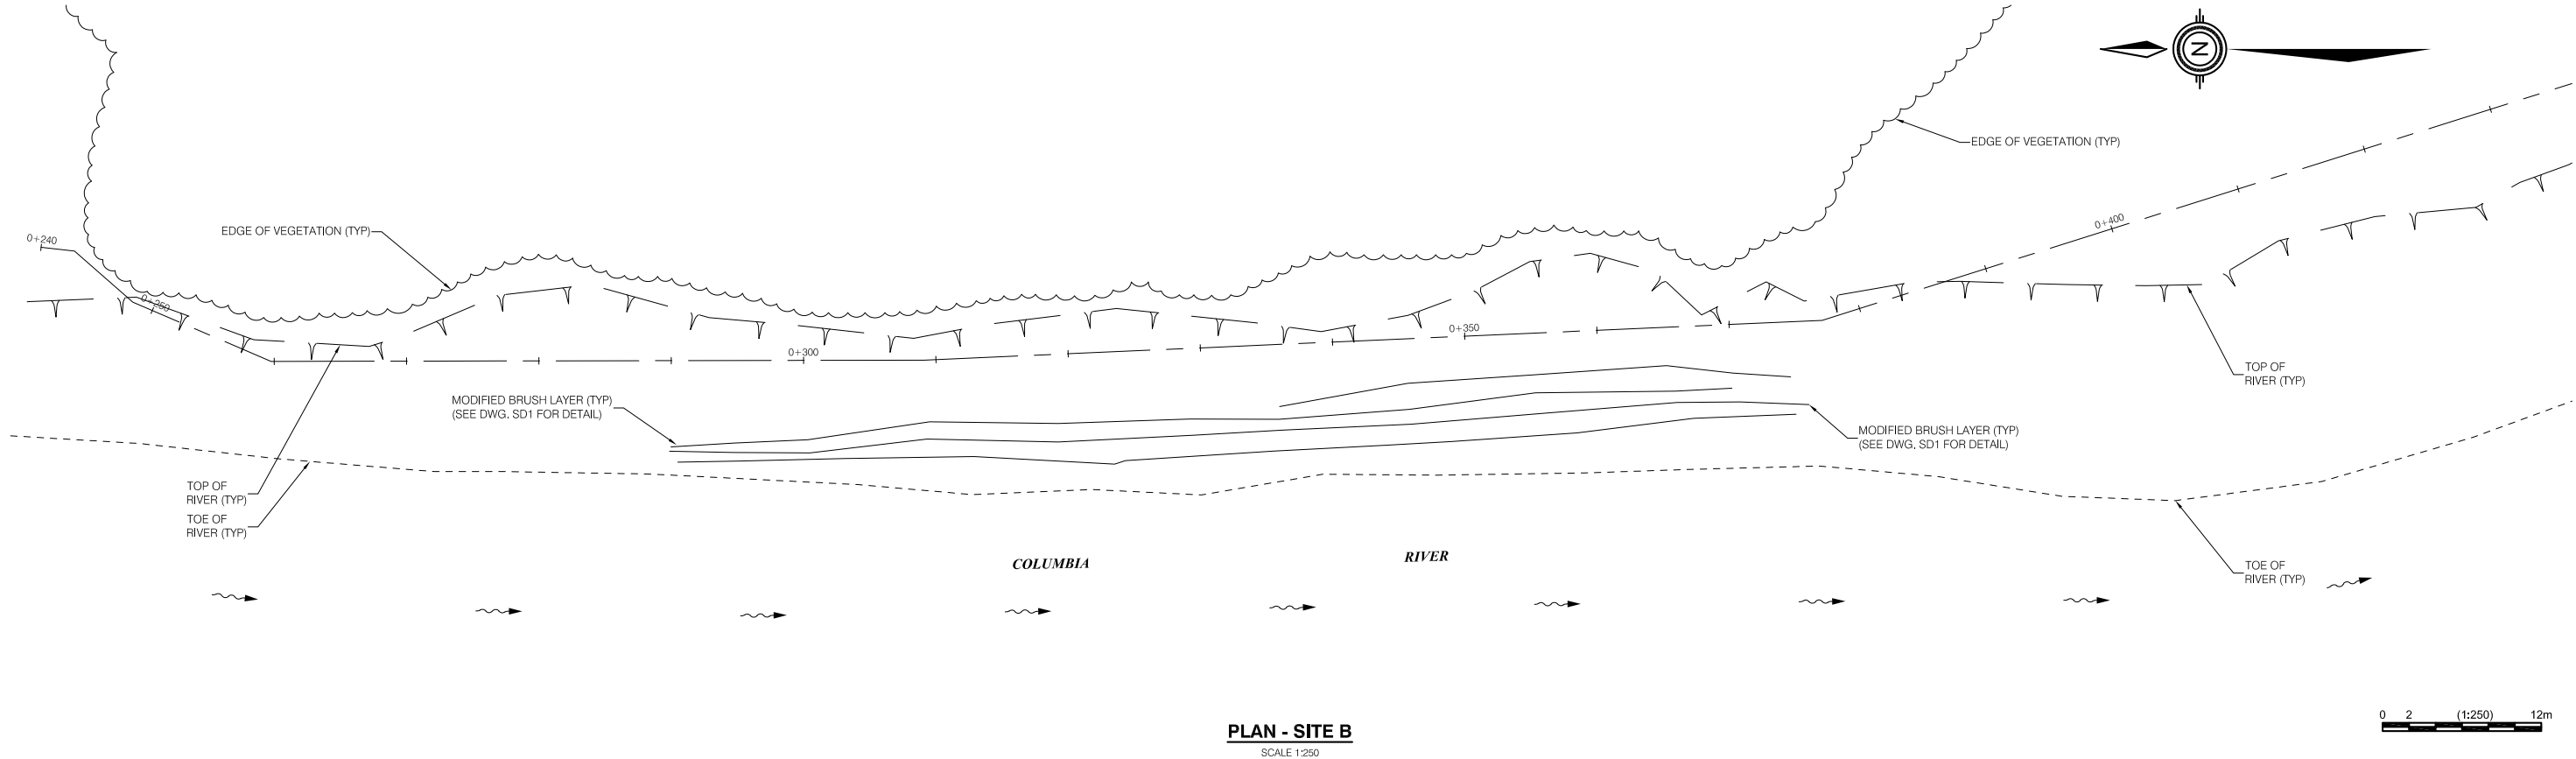
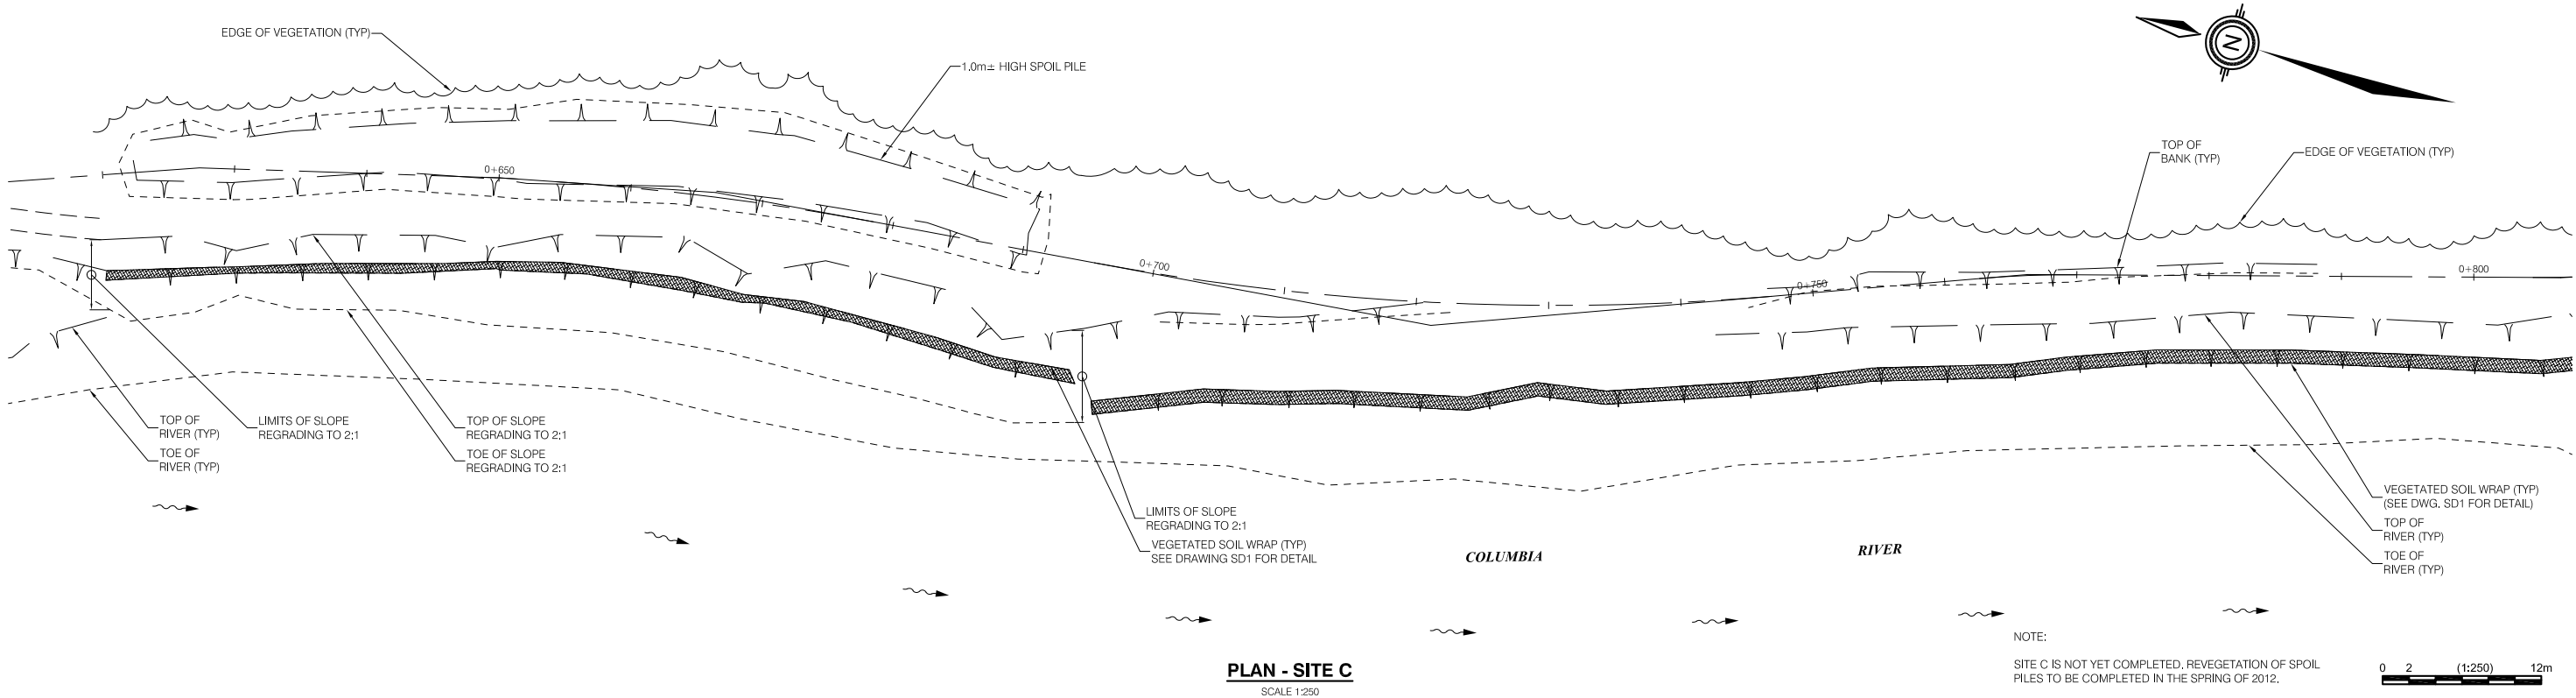
NOTE:
SITE C IS NOT YET COMPLETED, REVEGETATION OF SPOIL
PILES TO BE COMPLETED IN THE SPRING OF 2012.
