Columbia River Project Water Use Plan

**Mid-Columbia River Bank Erosion Protection and Monitoring
Program**

Reference: CLBWORKS #35

Final Report

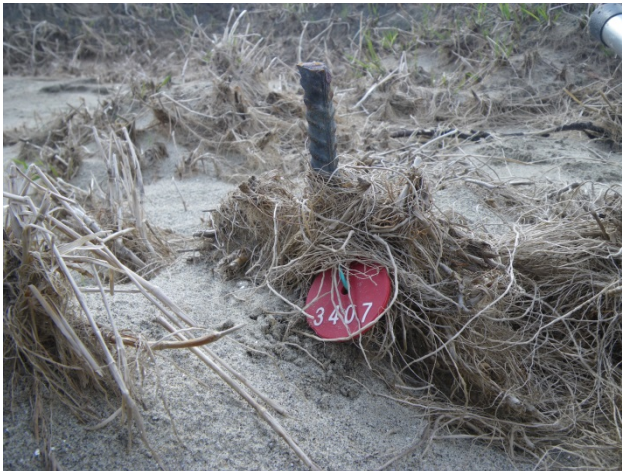
Photo 4-1: Example Erosion Pin Showing Identifier Tag (April 2012).

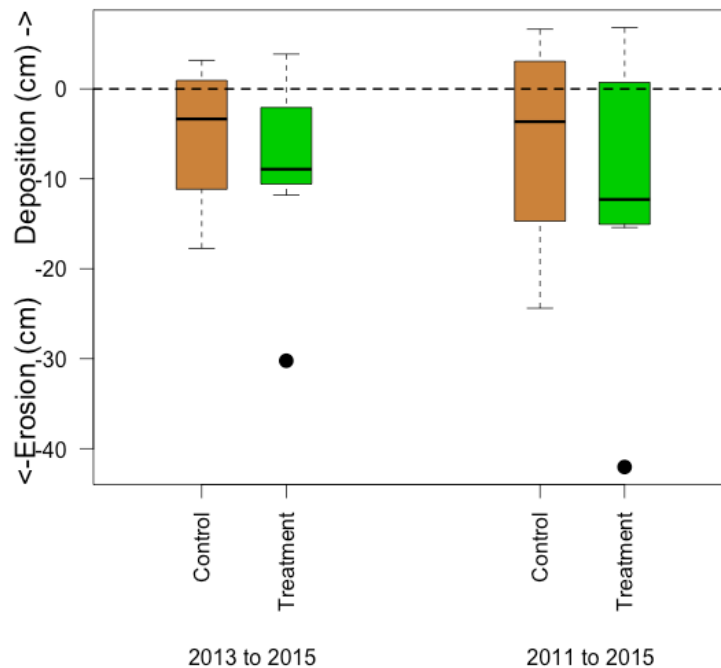
Figure 4-2: Change in Pin Length for All Sites for Most Recent Monitoring Period (2013-2015) and Full Project Period (2011-2015)

The results in Table 4-1 are presented in Figure 4-2 as a 'box-and whisker' plot. In interpreting Figure 4-2 (and other box-and-whisker plots contained in this report), please note the following points:

The Student's one-sample t test was used to test the statistical significance of the mean difference in pin length changes. Summary results are presented in Table 4-2. It should be noted that in Table 4-2 a negative sign of the test statistic ($C - T$) does not indicate erosion due to the effect of the algebraic expression.

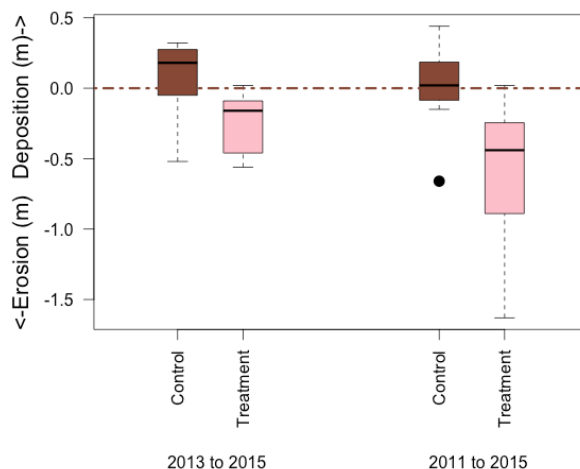
Figure 4-3: Bank Change (Δx midpoint) For All Sites for Most Recent Monitoring Period (2013-2015) and Full Project Period (2011-2015)

The results in Table 4-3 are summarized graphically in Figure 4-3, below.

The Students one-tailed t test was used to test the statistical significance of the mean difference in Δx midpoint between treatment and control sites. Summary results are presented in Table 4-4. It should be noted that in Table 4-4 a negative sign of the test statistic ($C - T$) does not indicate erosion due to the effect of the algebraic expression.

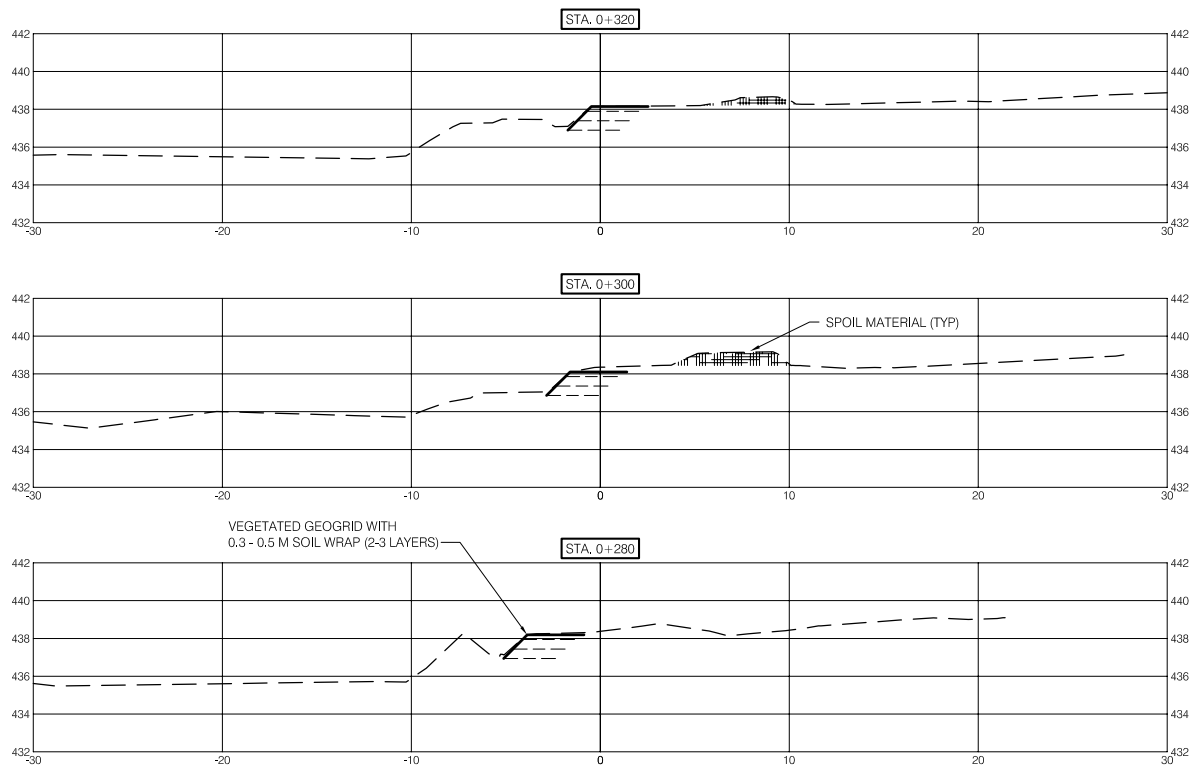
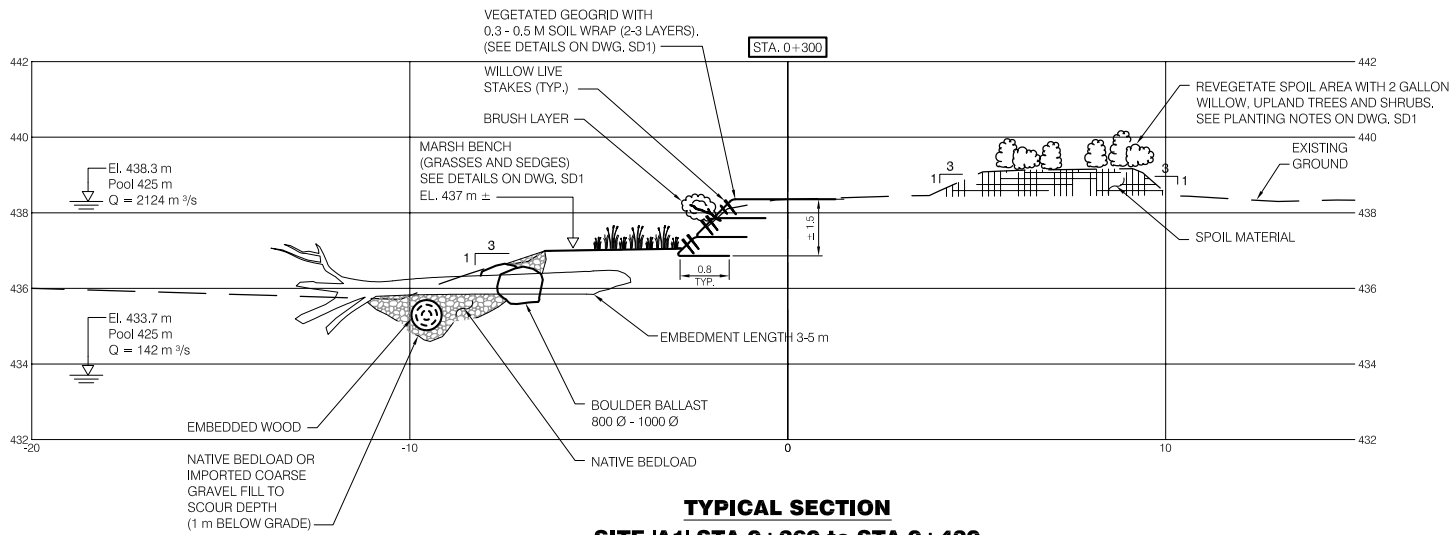
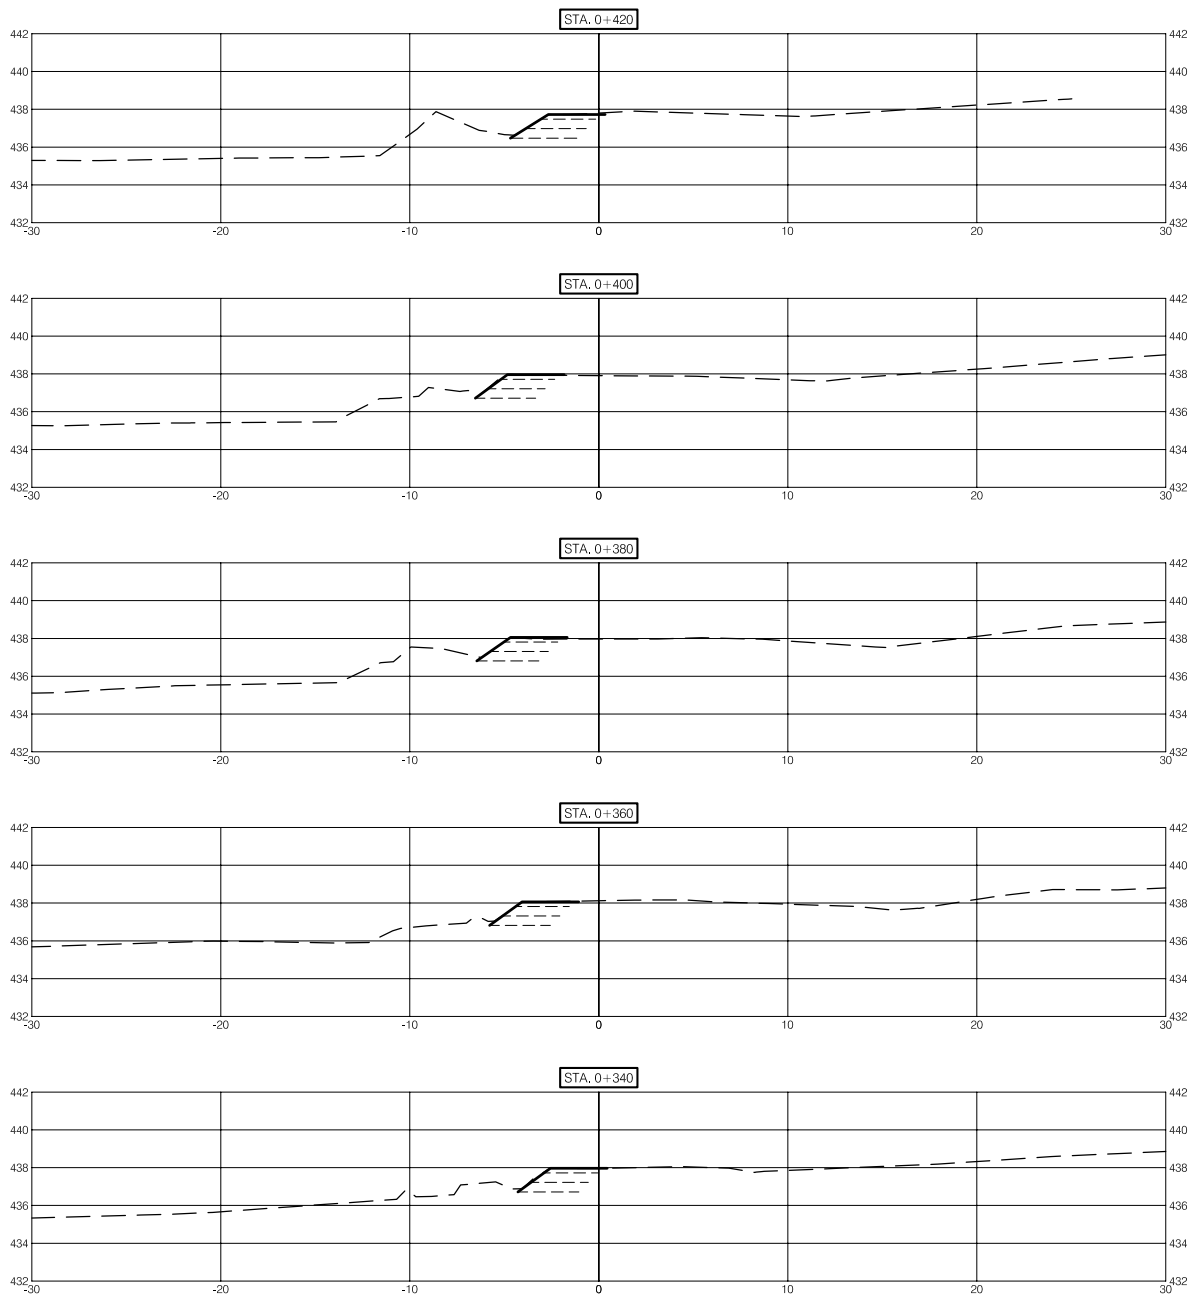
TYPICAL SECTION
SITE 'A1' STA 0+260 to STA 0+420
SCALE 1:100

NOTE:
SITE A1 IS NOT YET COMPLETED. INSTALLATION OF
EMBEDDED WOOD, MARSH BENCH AND REVEGETATION OF
SPOIL PILES TO BE COMPLETED IN THE SPRING OF 2012.

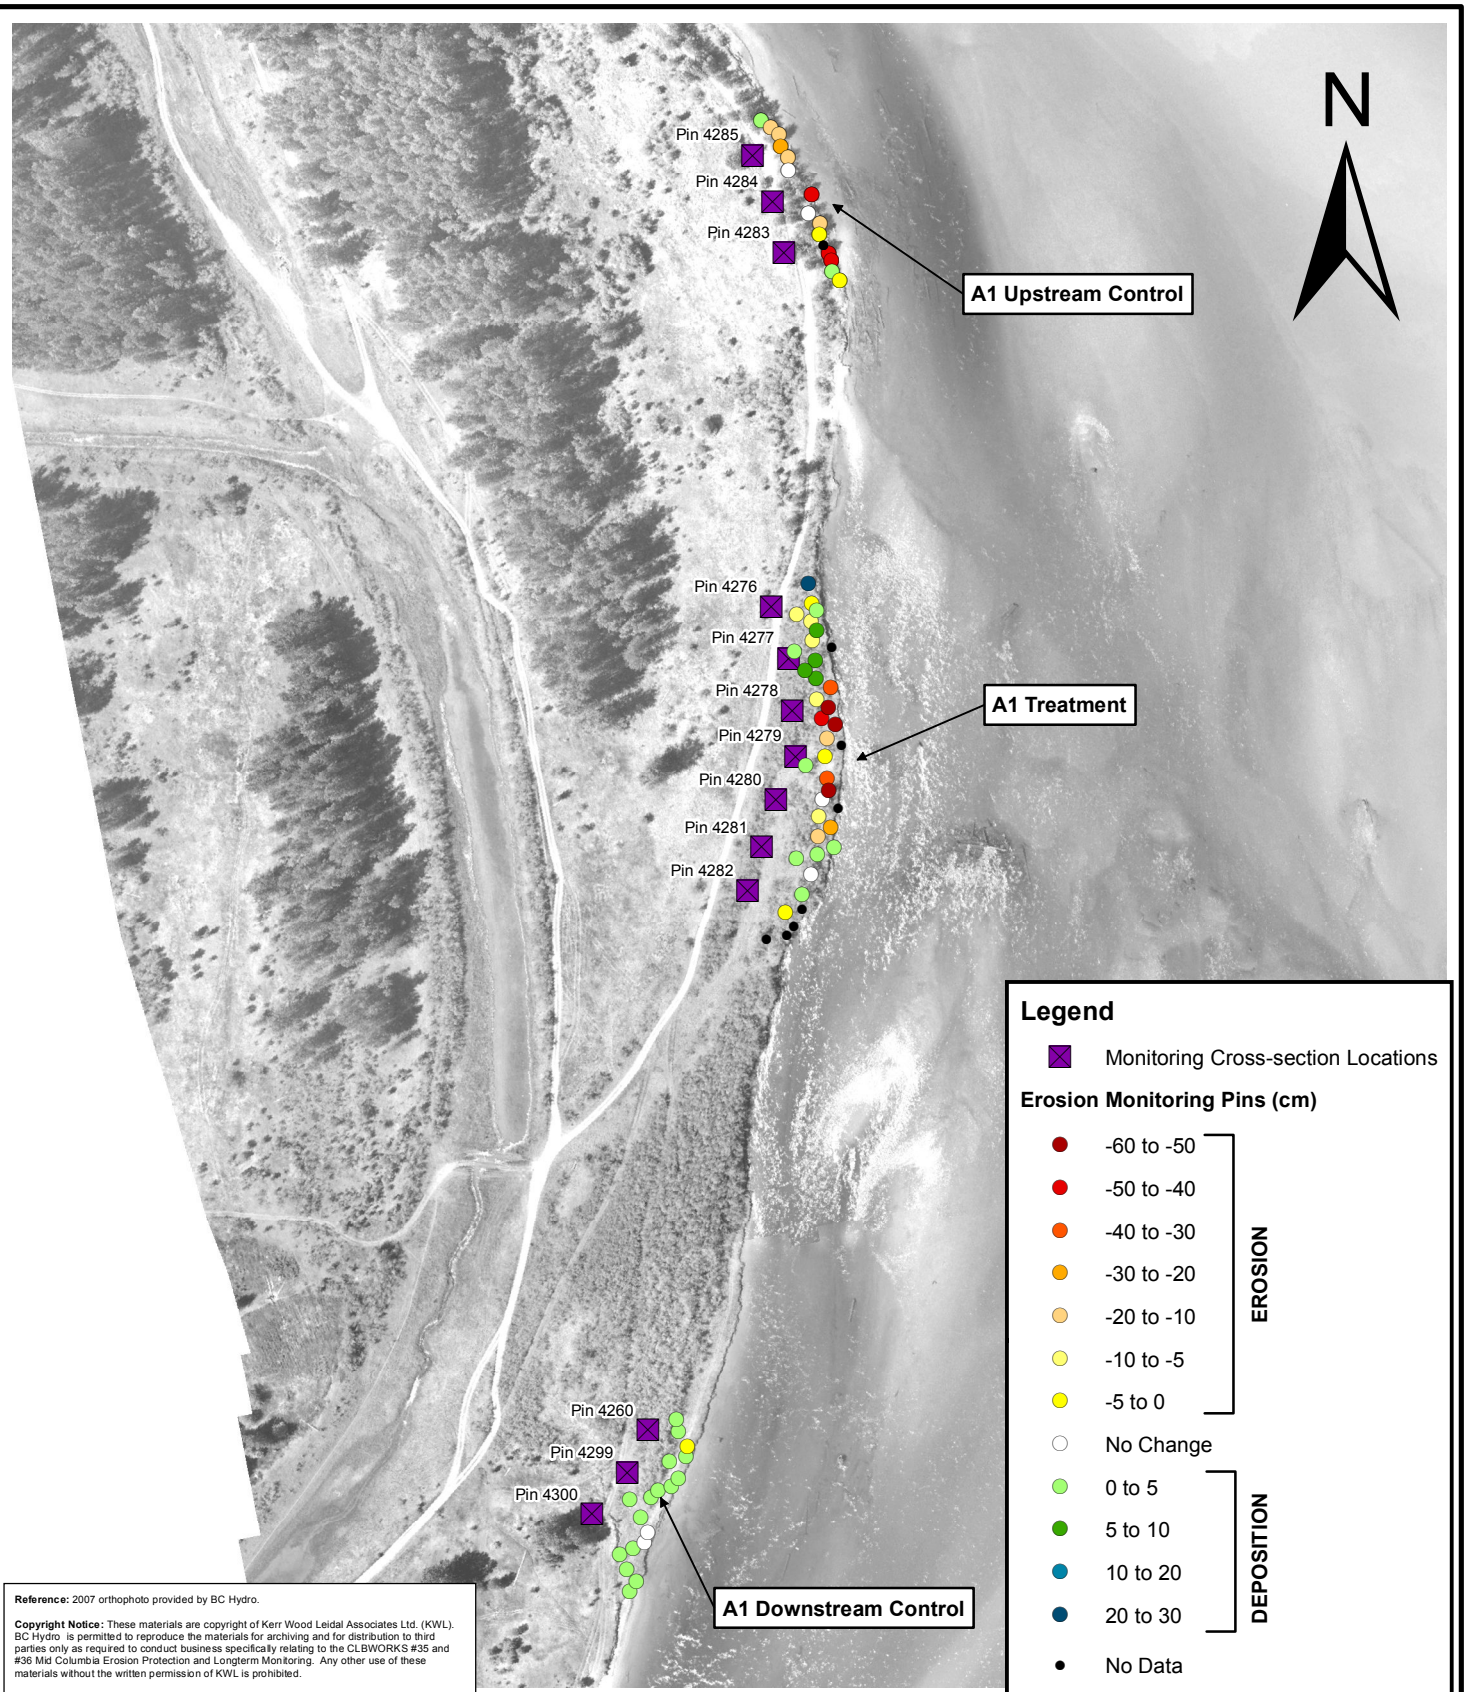
Table 4: Mean Cross-section Δx Midpoint Values for Site A1 Control (Upstream and Downstream)

Elevation Band	2013 to 2015		2012 to 2015 (Total)	
	A1 U/S Control (m)	A1 D/S Control (m)	A1 U/S Control (m)	A1 D/S Control (m)
Upper	-0.07	0.05	-0.12	-0.08
Middle	-0.20	0.54	-0.16	0.34
Lower	-0.05	-0.06	-0.16	-0.19

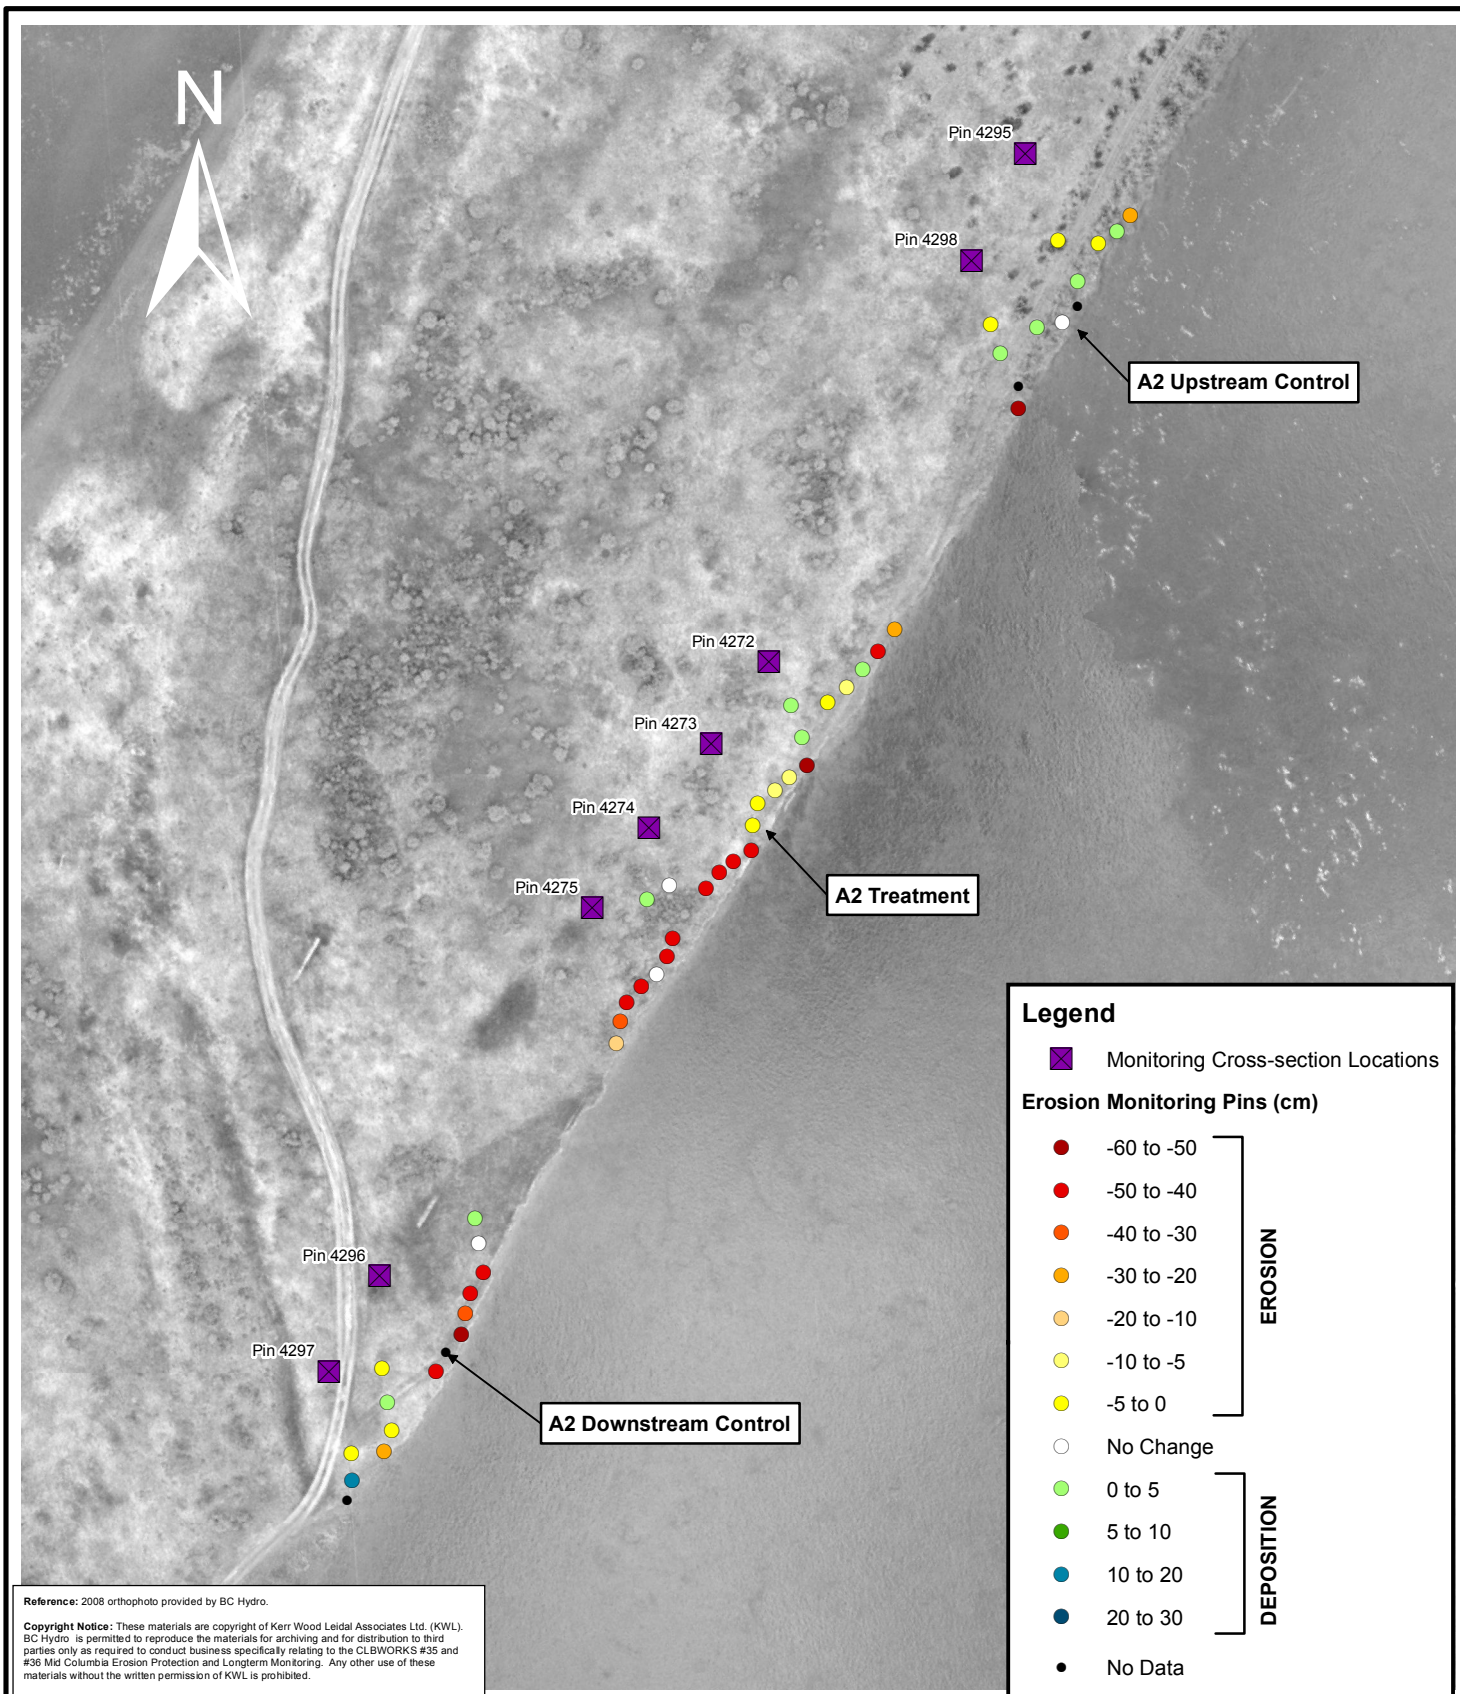
Elevation Band	2013 to 2015		2011 to 2015 (Total)	
	A2 U/S Control (m)	A2 D/S Control (m)	A2 U/S Control (m)	A2 D/S Control (m)
Upper	1.25	-0.75	0.61	-0.14
Middle	-0.26	-0.35	-0.77	-1.17
Lower	-0.14	-0.46	0.24	-0.67

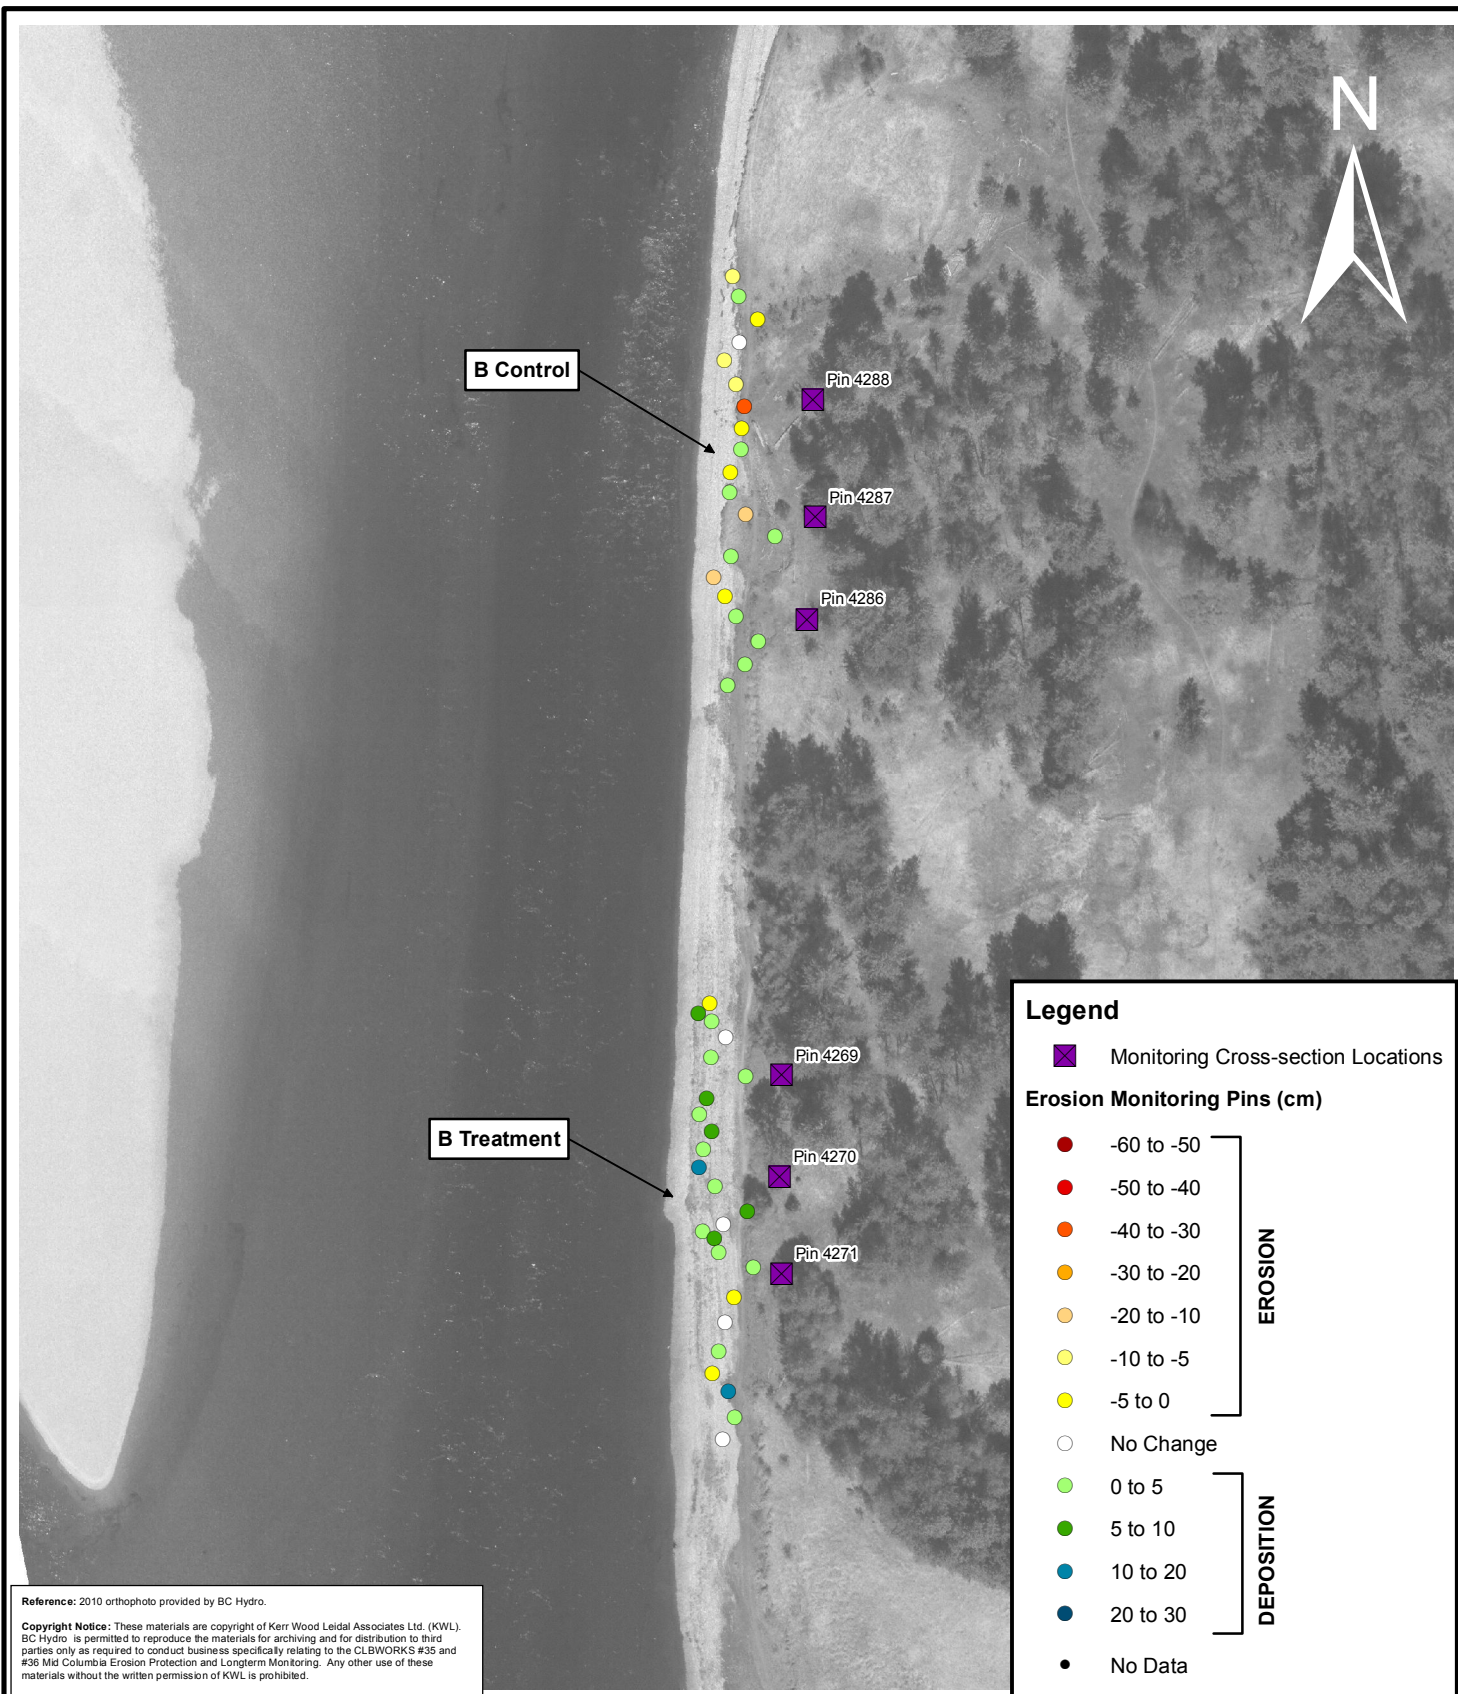
Figure 5

2013 to 2015 Erosion Pin Data for Site B (Treatment and Control)

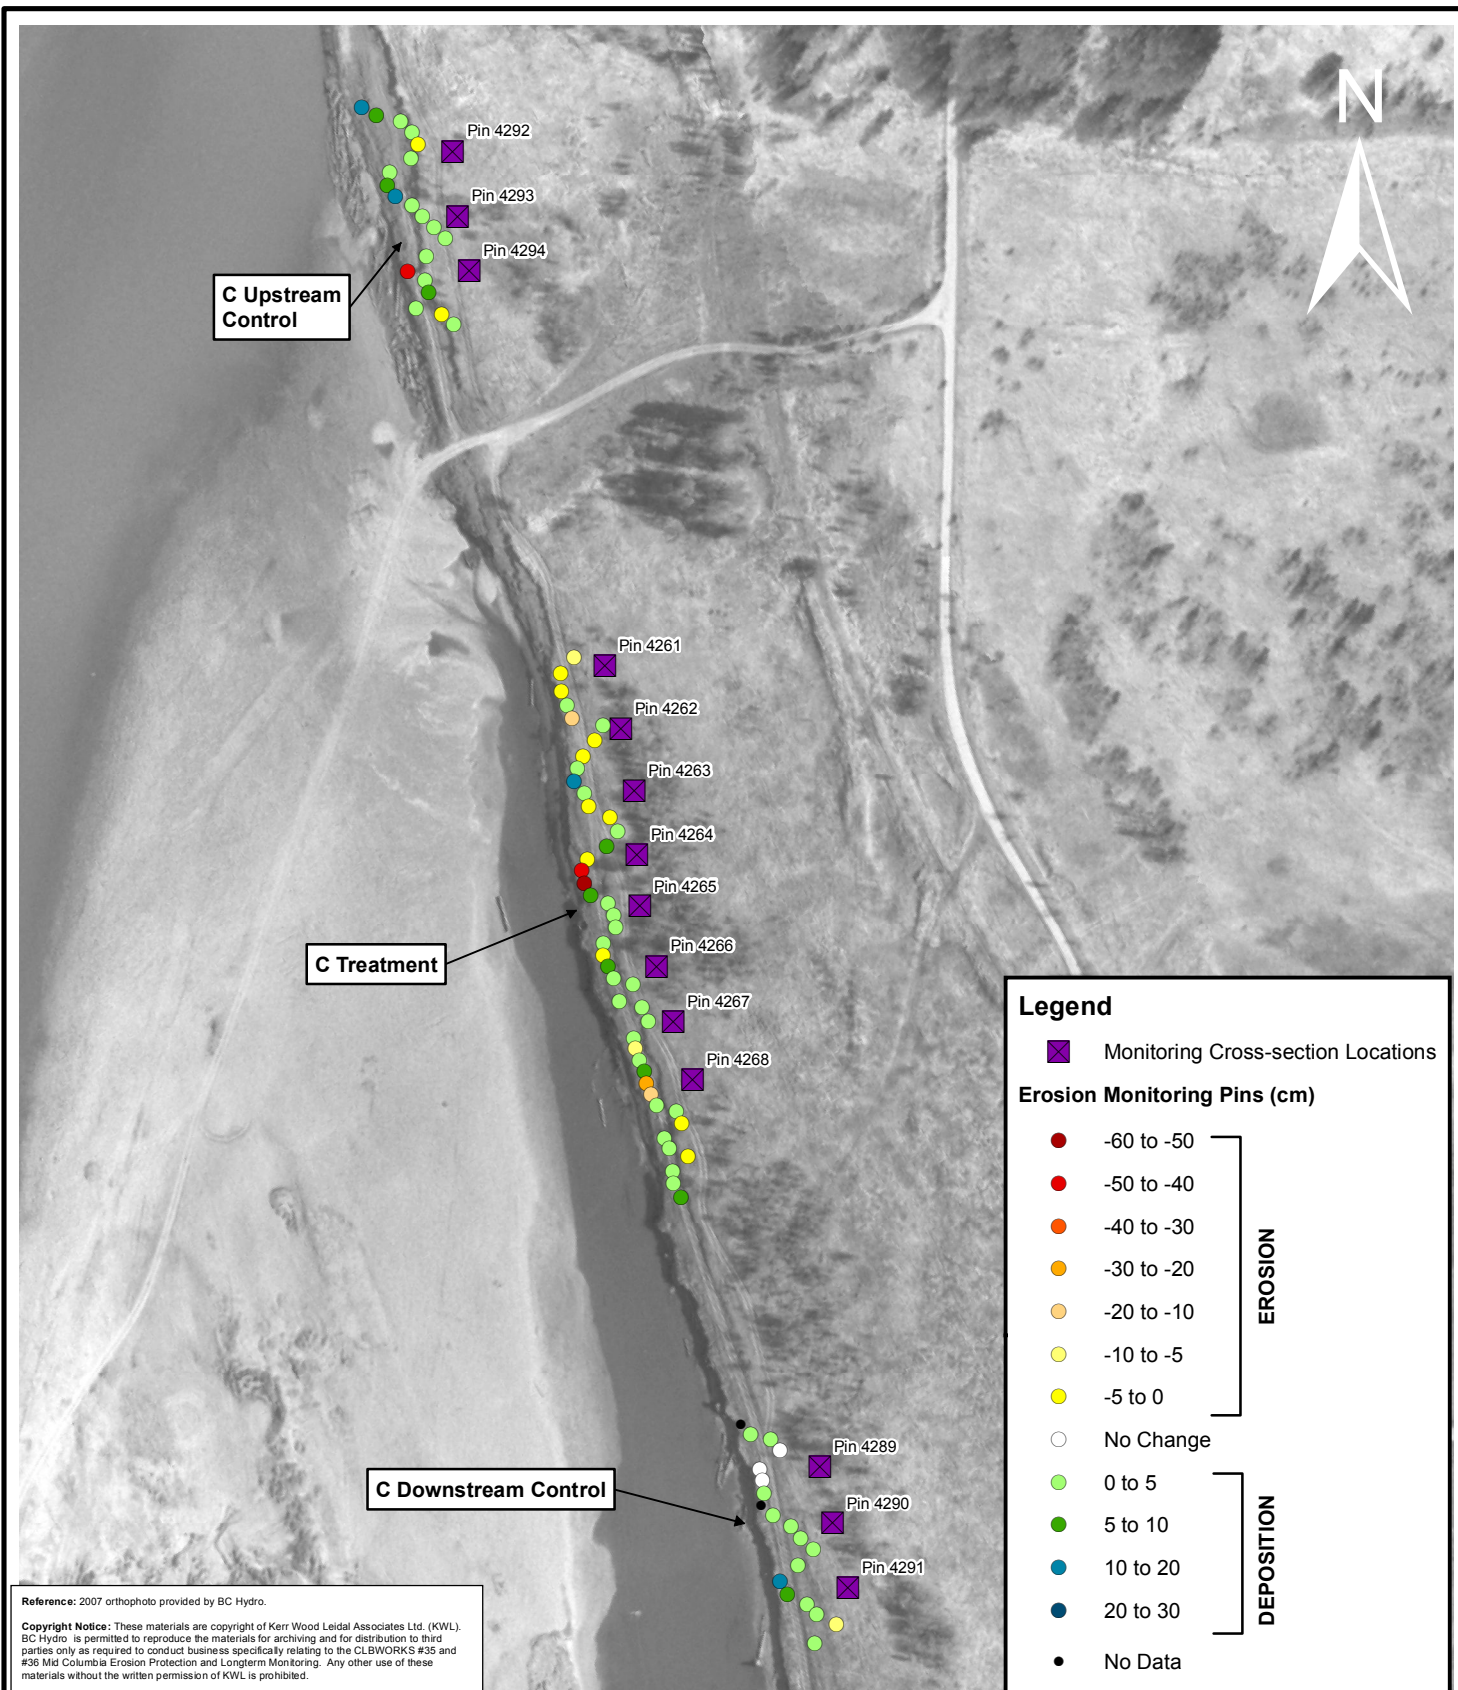
Table 16: Mean Cross-section Δx Midpoint Values for Site C Control (Upstream & Downstream)

Elevation Band	2013 to 2015		2011 to 2015	
	C U/S Control (m)	C D/S Control (m)	C U/S Control (m)	C D/S Control (m)
Upper	0.23	0.63	0.43	0.87
Middle	0.17	0.42	0.99	-0.44
Lower	0.37	-0.10	-1.16	N/A
