Columbia River Project Water Use Plan

Kinbasket & Arrow Recreation Management Plan

Mid Columbia Erosion Protection and Long-Term Monitoring

2012 Progress Report

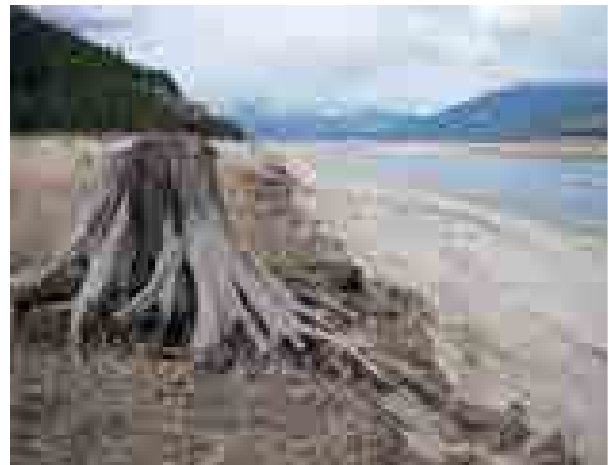
The bank is relatively steep, as shown in Photos 3-15 and 3-16. The water level at the time of the 2011 field visit was 2 m higher than the low water level at the site.

Photo 3-16: Looking upstream at steep, eroding bank (MON 8, April 18, 2011).

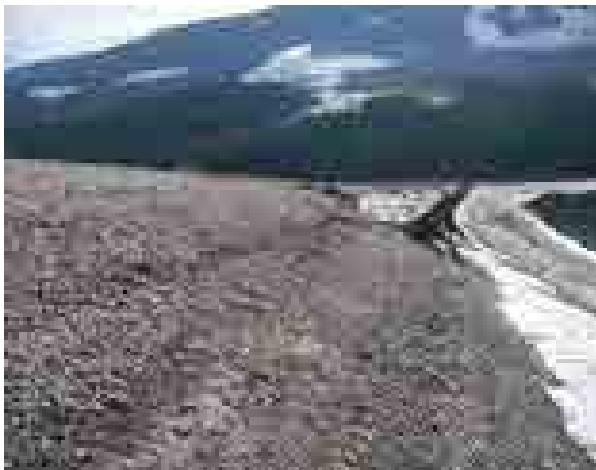
As indicated in Figure 3-12, the site experienced very little change between installation (2010) and the 2012 re-survey, with a general trend of deposition. The average change in pin exposure for 2012 was negative at 0.1 cm; however, the total trend since 2010 has been depositional (positive) at 0.4 cm. Very little change can be detected from the cross-sectional surveys; however, the trends match the pin observations with deposition in 2011, erosion in 2012, and almost no net change since 2010 (-0.03 m). Observations, such as Photo 3-20 below, suggest that wave action is the primary erosion mechanism.

Photo 3-19: Looking downstream along bank (MON 10, April 11, 2012).

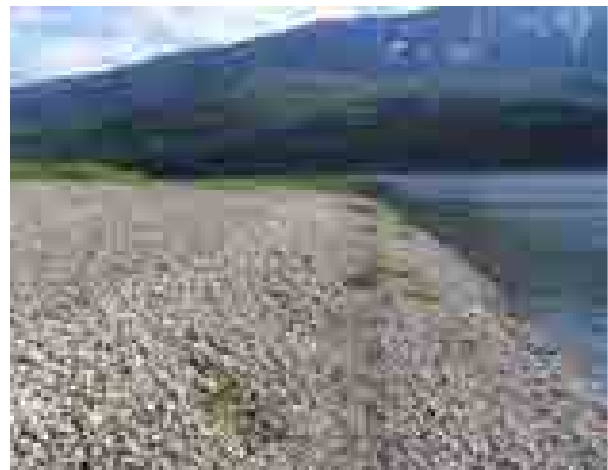
Photo 3-20: Looking downstream along bank (MON 10, June 1, 2011).

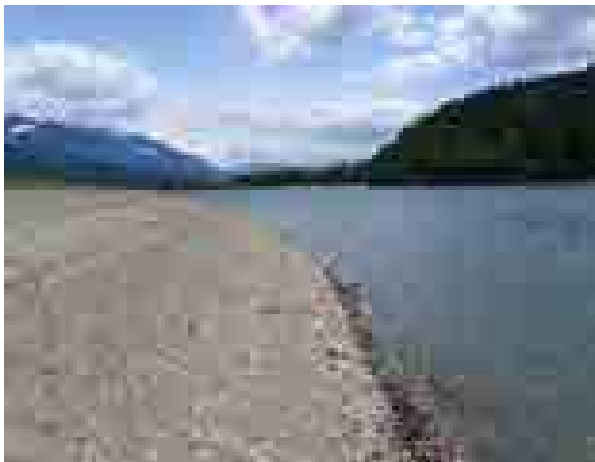
In 2012, the very low water levels allowed topographic survey that extended below the first 2010 topographic survey. Based on pin exposure there is moderate erosion in the mid-bank resulting in deposition on the lower pins (Figure 3-14). As a site, the average pin exposure varied slightly from year to year with +1.5 cm in 2011 and -0.6 cm in 2012, or a net change of +3.4 cm. The cross-sectional data is consistent through all time periods and is -0.06 m for 2011 to 2012 or a total change of -0.06 m (-6 cm). This site is strongly influenced by the reservoir level and wave effects. There is a very distinct stepped face to the gravel bank that is formed and observed each year.

Photo 3-23: Looking downstream along bank (MON 12, June 2, 2011).

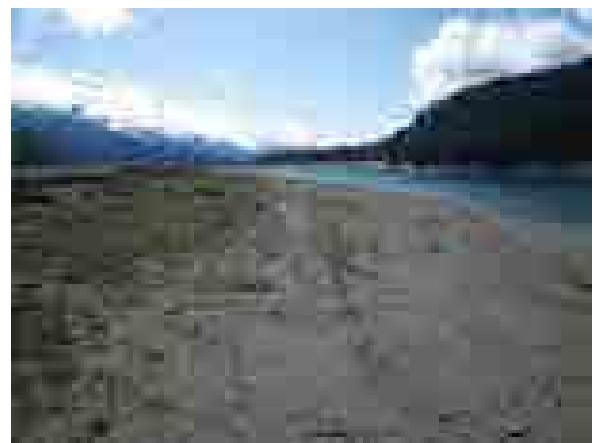
Photo 3-24: Looking downstream along bank (MON 12, April 19, 2012).

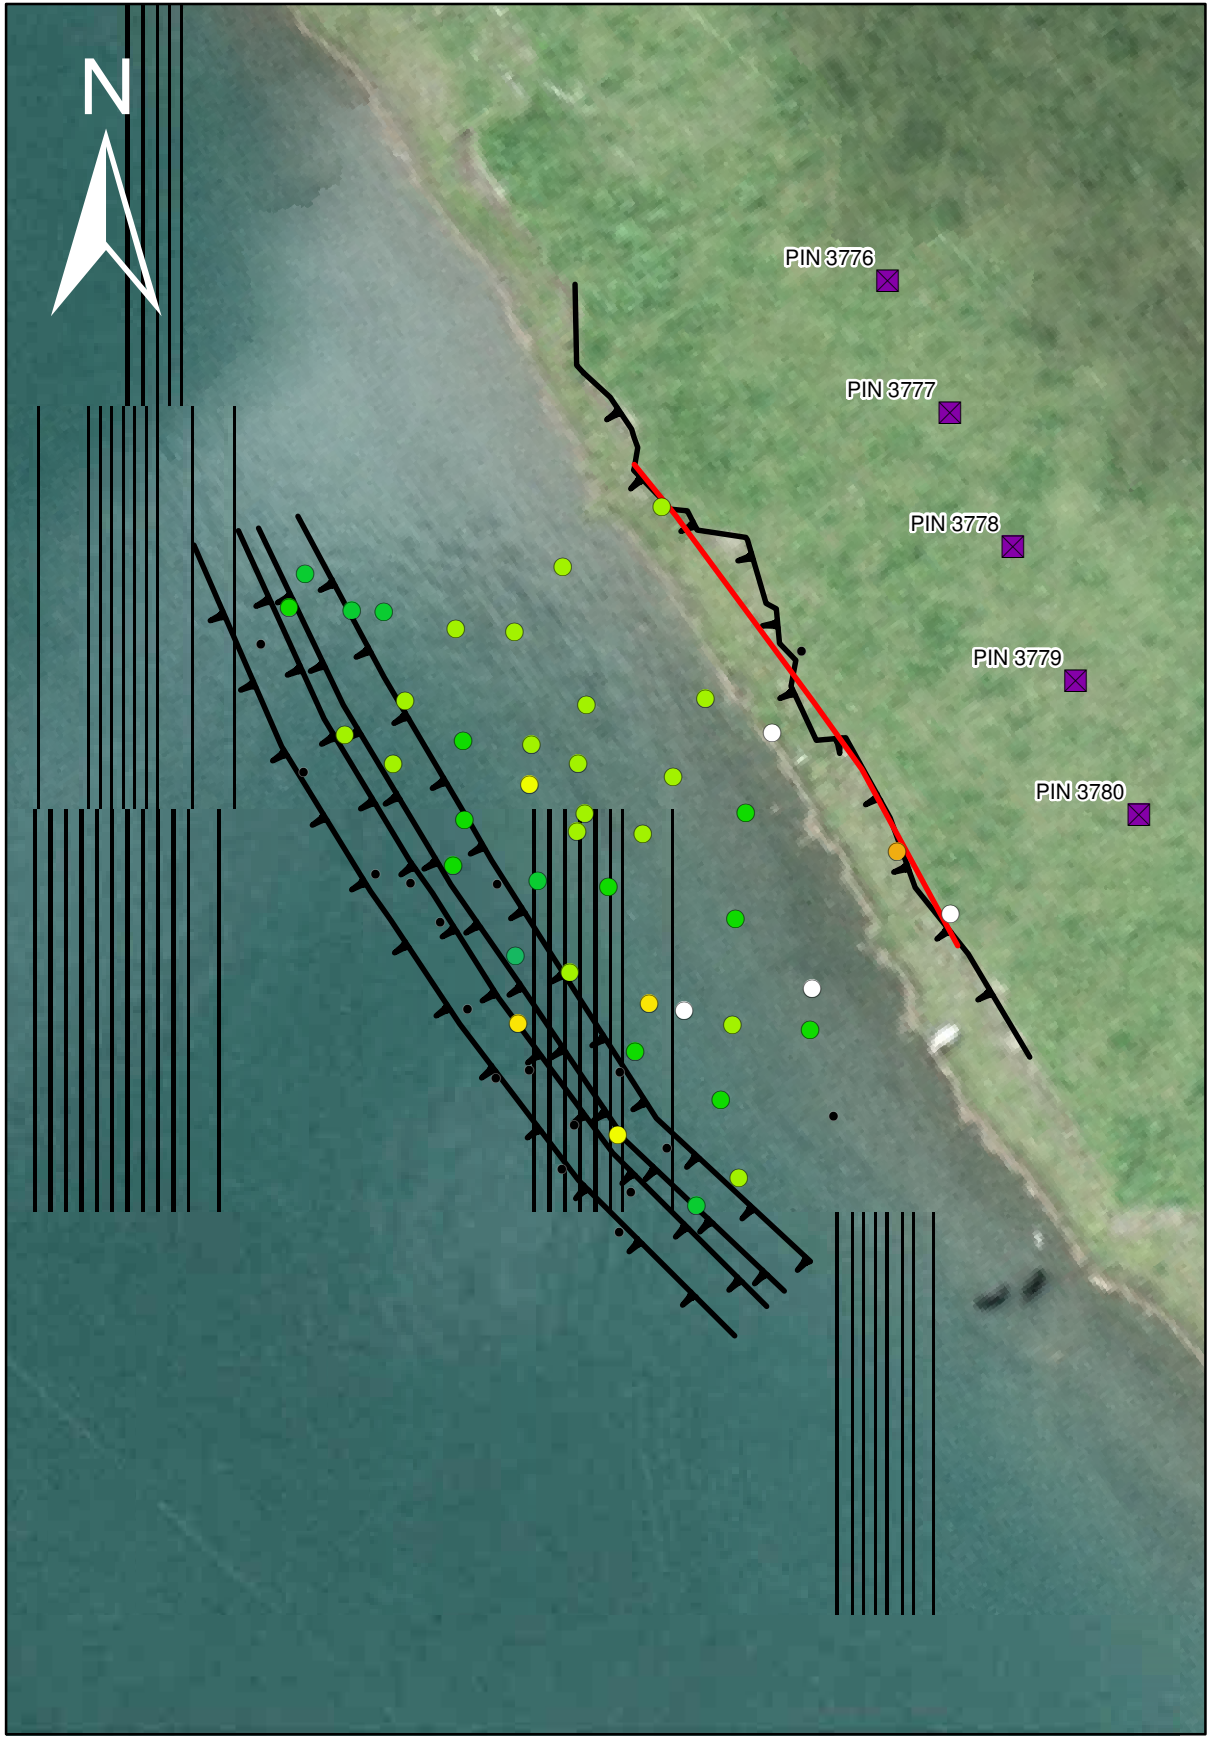
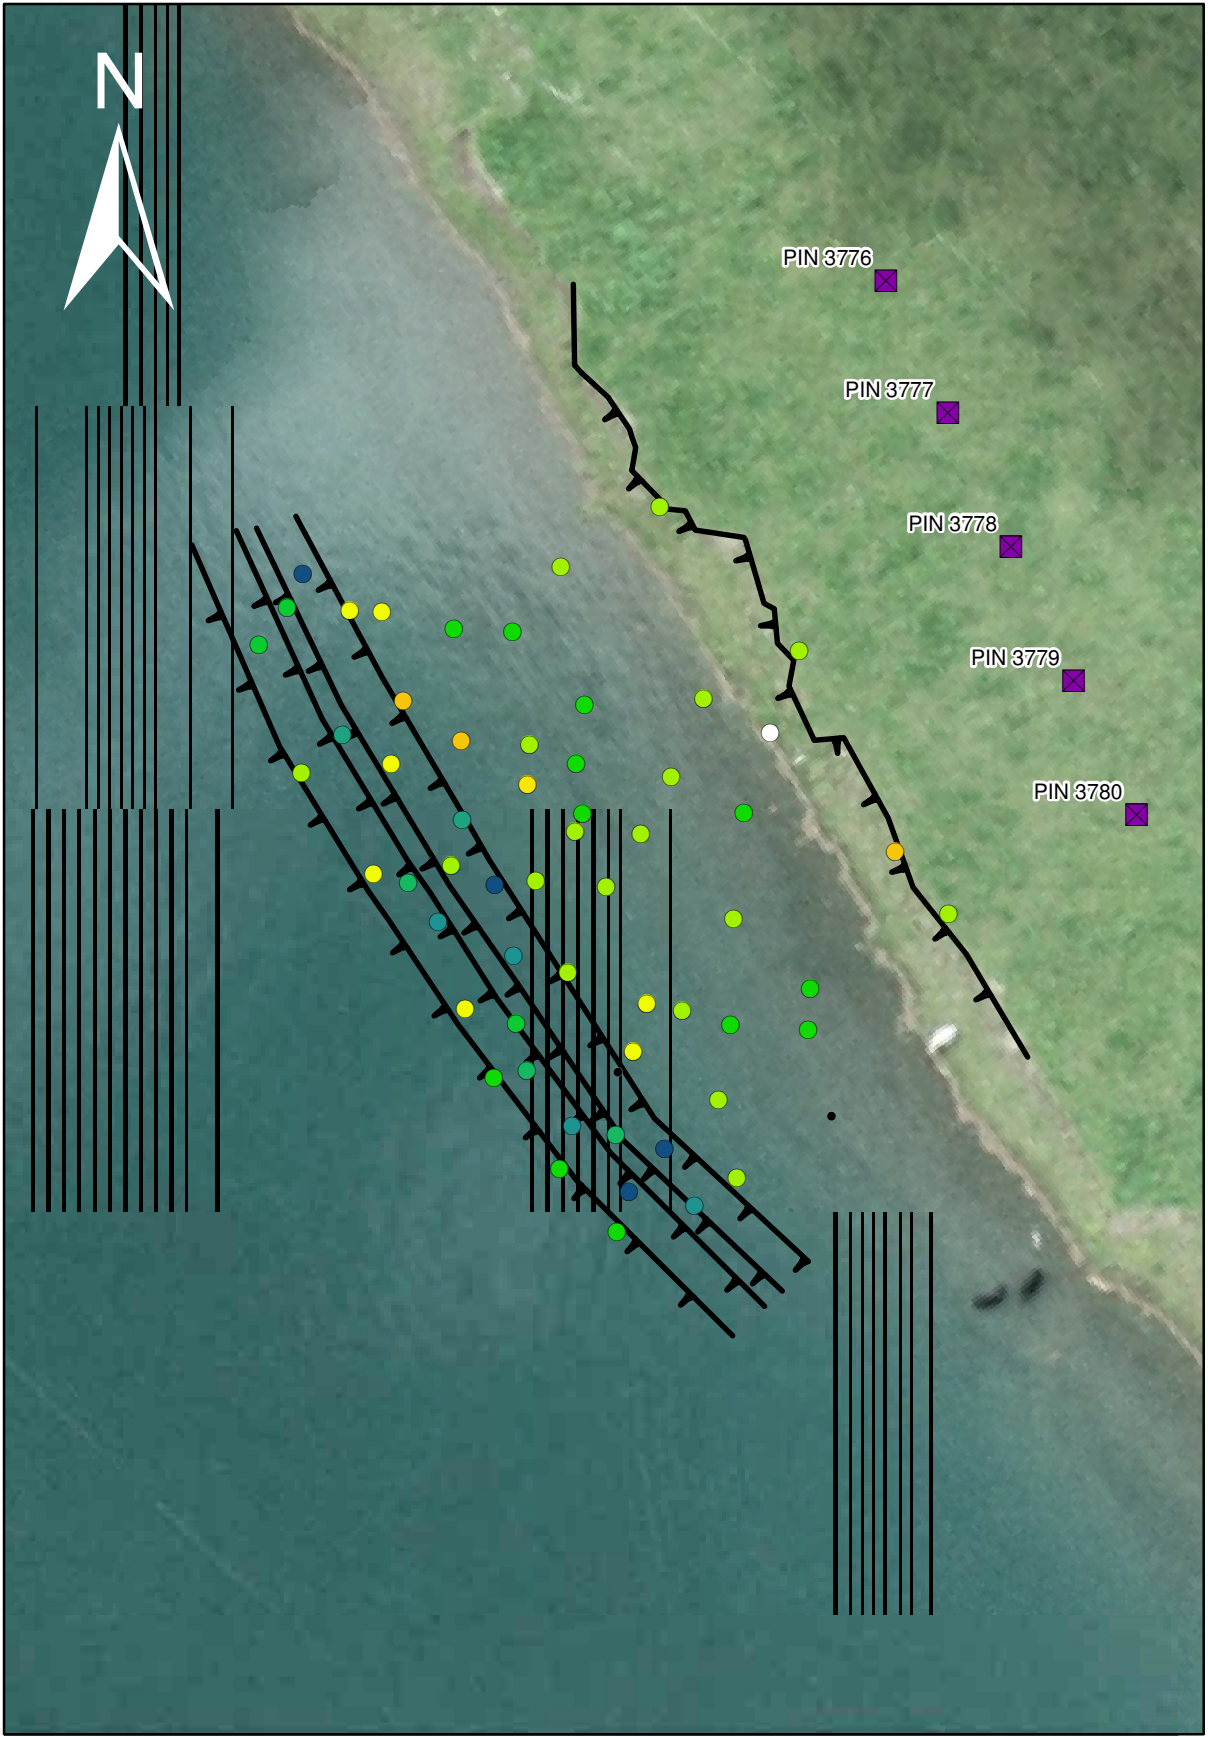
Figure 3-14

Erosion Monitoring Pins - Change 2011 to 2012

Erosion Monitoring Pins - Change 2010 to 2012

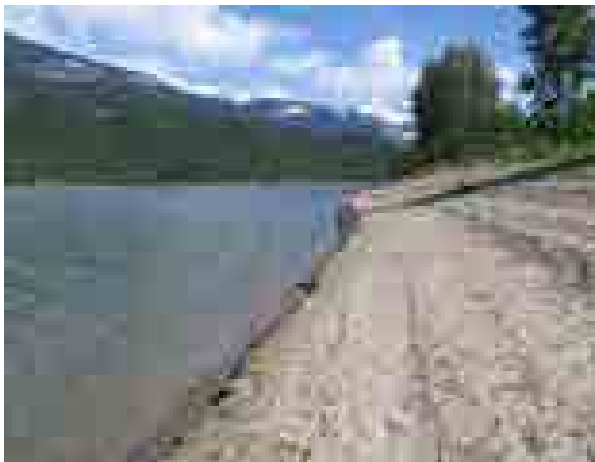
A high percentage of pins was recovered at Site 13 in both monitoring years, pin exposure alternated from minor deposition (0.8 cm) to minor erosion (-0.2 cm) from 2011 to 2012. The net average pin exposure for two years is deposition with average exposure of +0.8 cm. The erosion and deposition is well distributed as is seen in Figure 3-15. Based on cross-sectional data, Site 13 had an average of no change in 2011, and an average 0.18 m of deposition between 2011 and 2012. This is likely due to some shifting material on the bank; however Site 13 is very stable comparatively. Site 13 does have a similar stepped bank profile, similar to Site 12, but far less pronounced. The photos below indicate that the strong stepped profile in 2011 is much more subtle in 2012.

Photo 3-25: Looking downstream along bank (MON 13, June 2, 2011).

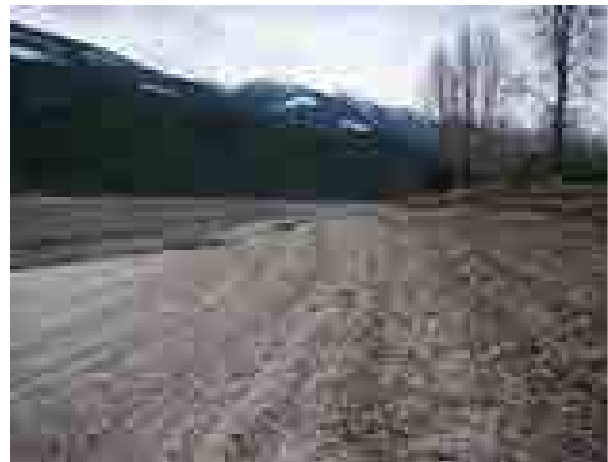
Photo 3-26: Looking downstream along bank (MON 13, April 19, 2012).

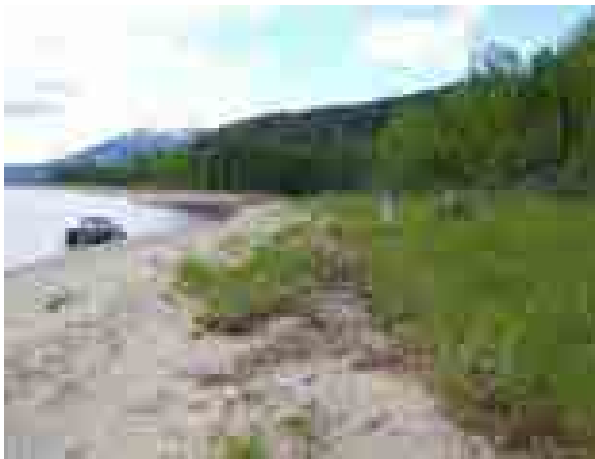
Pin recovery at MON 14 was very low (Figure 3-16) because the nearby landowner removed the majority of the pins. The cross-sections show both modest erosion (cross-section 2 and 3) and modest deposition (cross-section 5). The average change in pin exposure is -5.6 cm, and based on observations this site is eroding. Site 14 was not visited in 2012 to avoid potential conflict. While the pin data cannot be replicated, the cross-section survey could be repeated in 2014 to determine larger cross-sectional changes.

Photo 3-27: Looking upstream along bank (MON 14, June 2, 2011).

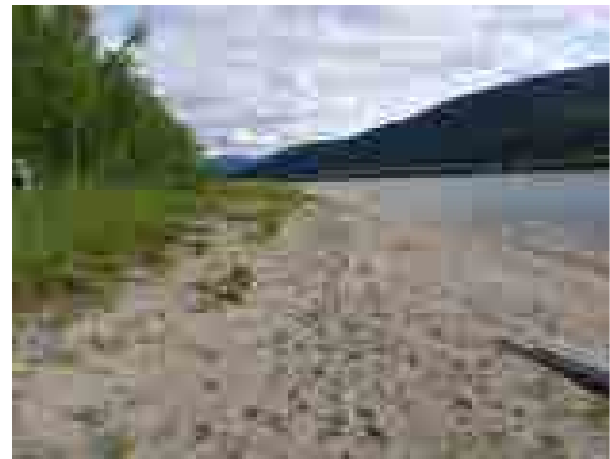
Photo 3-28: Looking downstream along bank (MON 14, June 2, 2011).

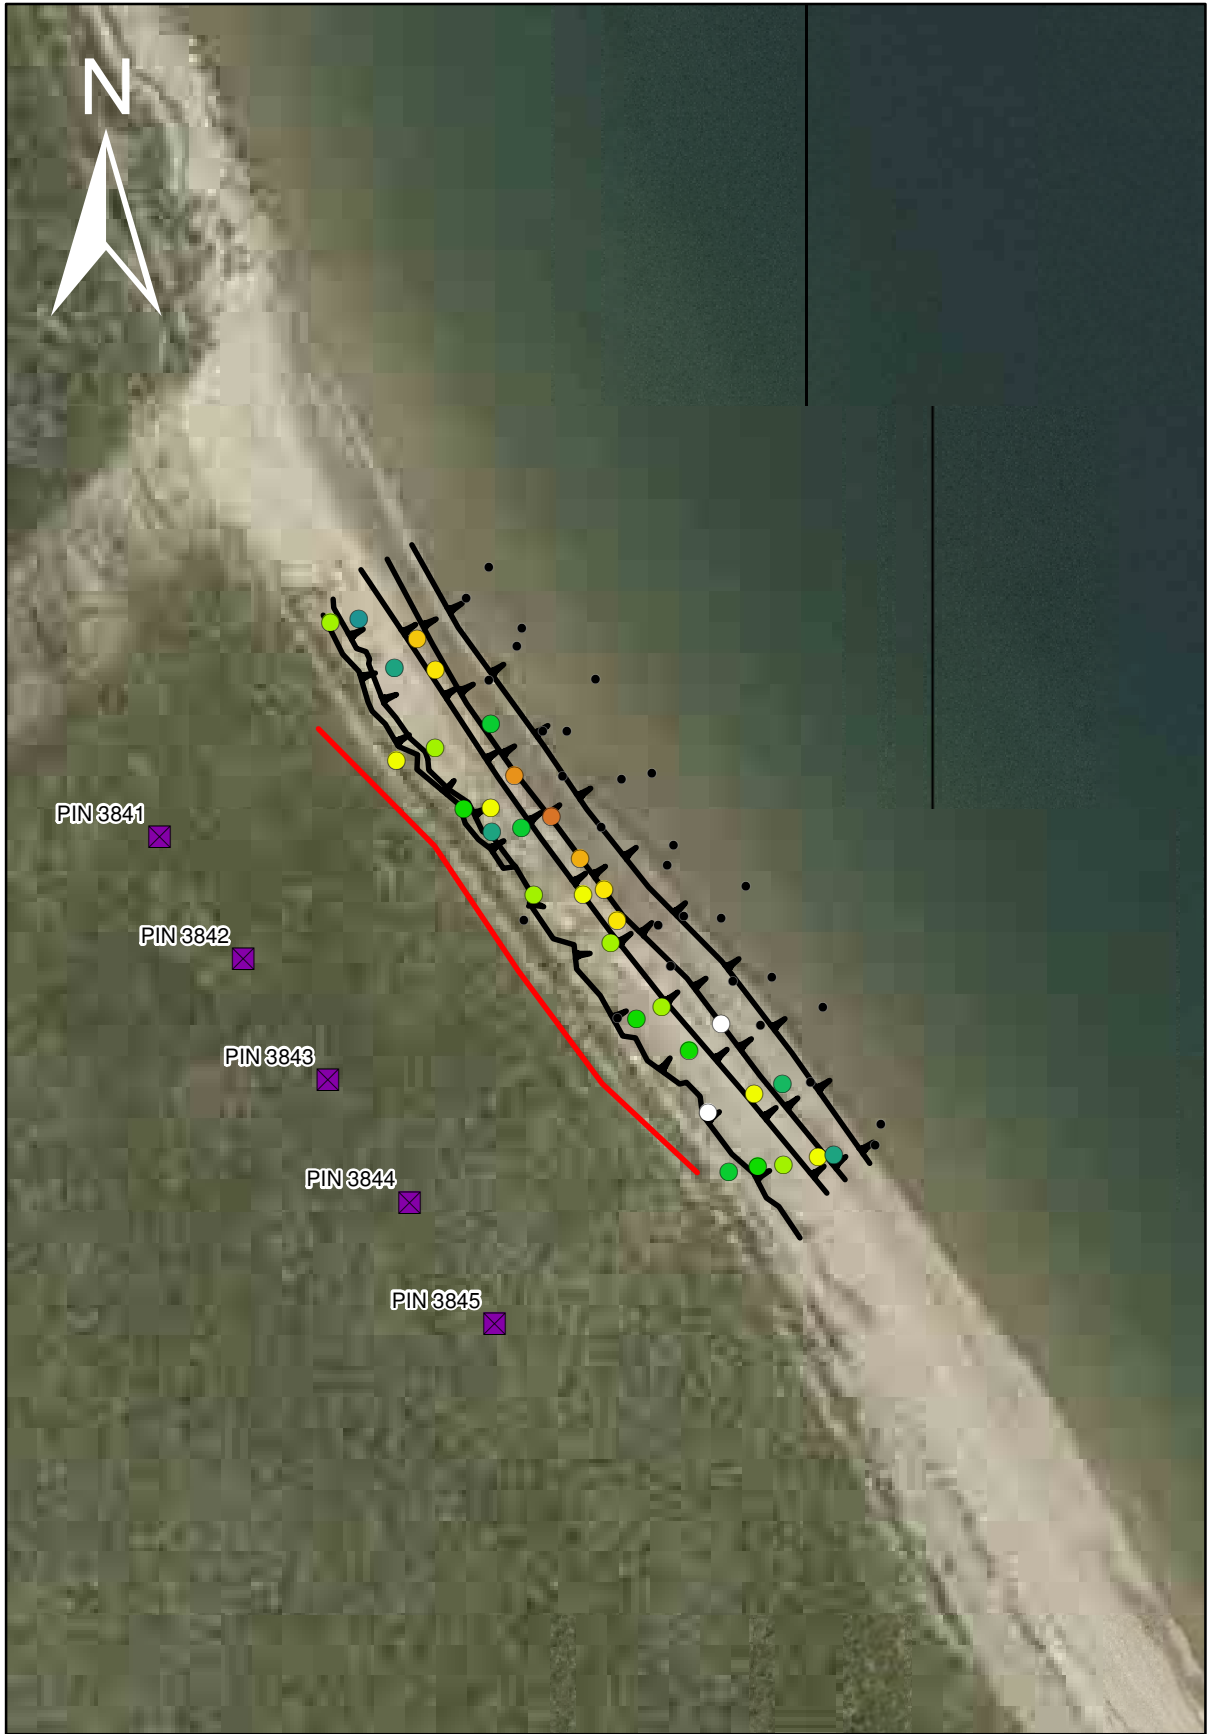
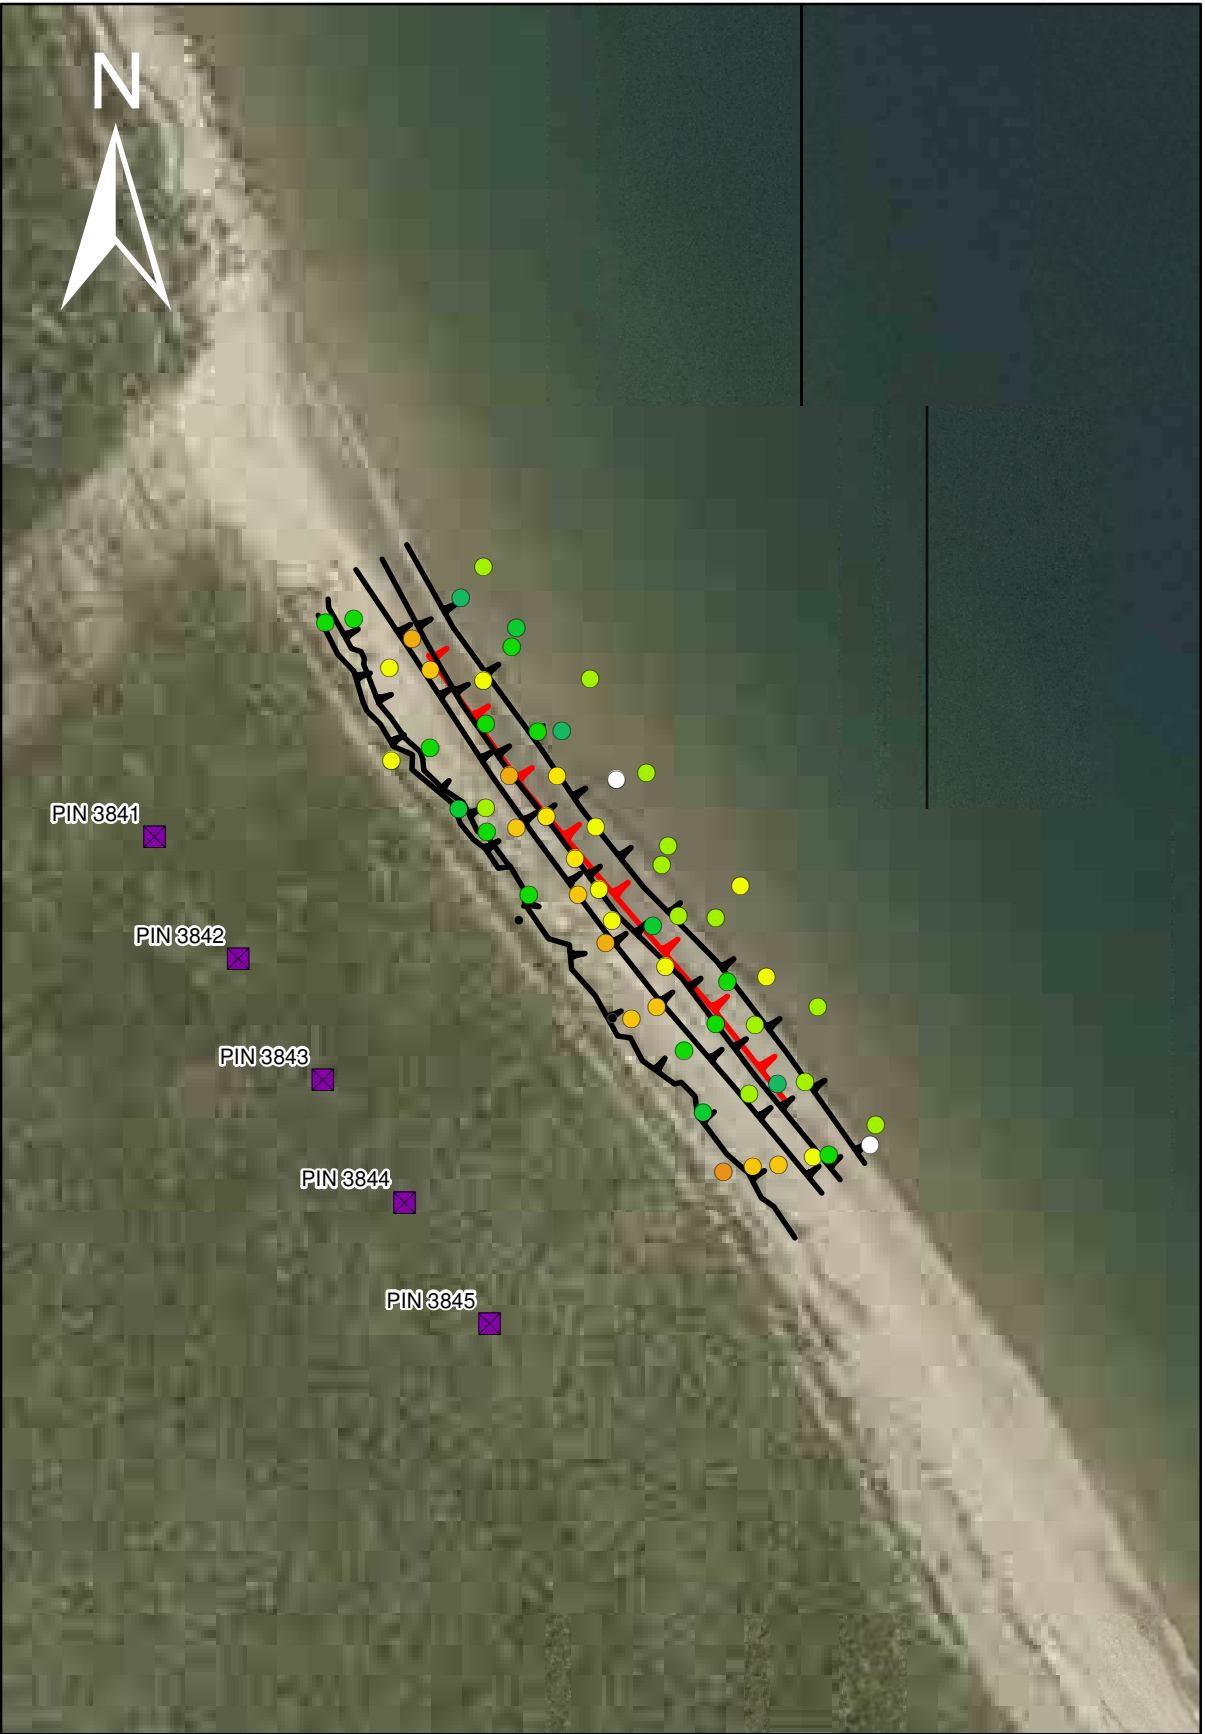
Figure 3-16

Erosion Monitoring Pins - Change 2011 to 2012

Erosion Monitoring Pins - Change 2010 to 2012

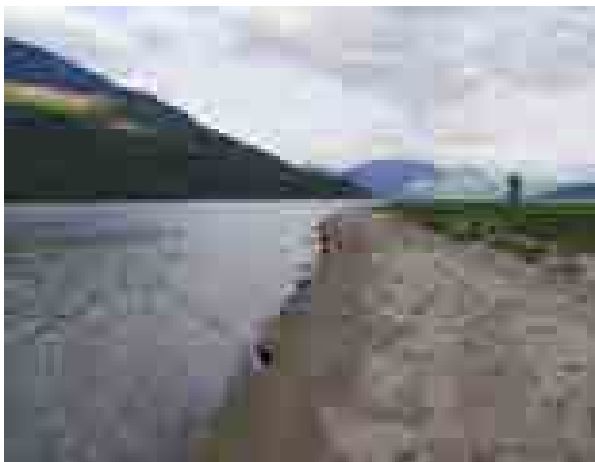
During the 2012 monitoring period, the very low water levels allowed survey of more bank than what was exposed in 2010. A very large percentage of pins were relocated, and the average interannual pin exposure decreased from -7.0 cm to -1.9 cm likely due to measurement of the lower elevation pins (Figure 3-17). The total average pin exposure for two years is -4.7 cm. Based on cross-sectional data, the very high erosion in -1.64 m between 2010 and 2011 changed trends to be +0.01 m in 2012. The net cross-sectional change for the site from 2010 to 2012 is -1.01 m. Maximum loss of floodplain was largest between 2010 and 2011 and was as high as 5 m in some locations.

Photo 3-29: Looking downstream along bank (MON 15, June 2, 2011).

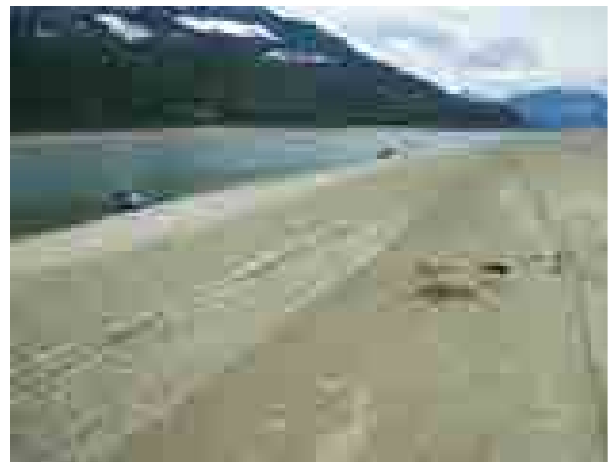
Photo 3-30: Looking downstream along bank (MON 15, April 19, 2012).

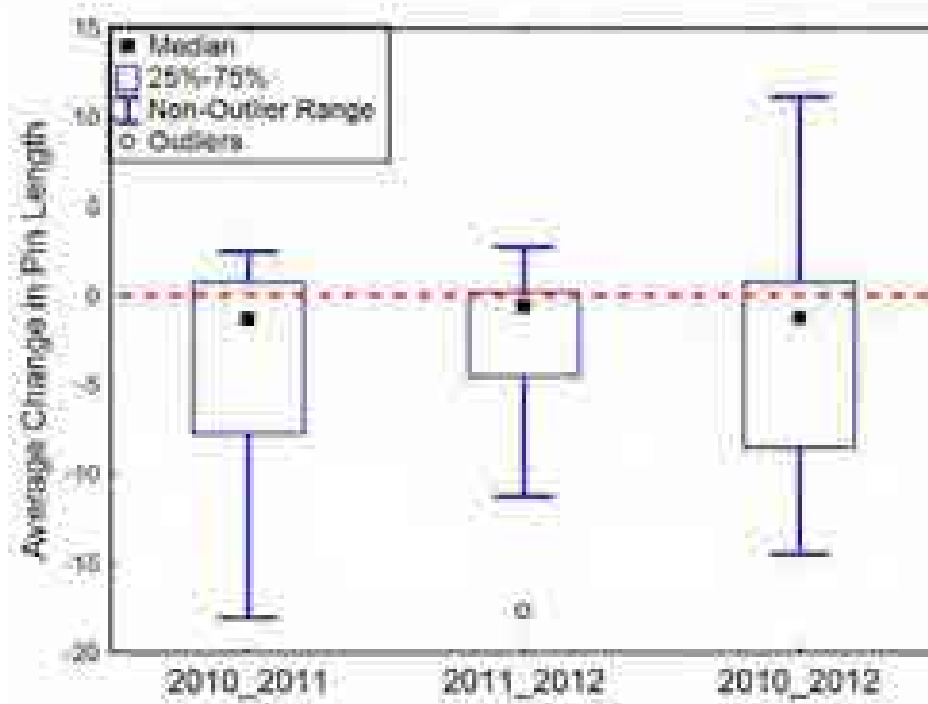
Figure 3-21: Average change in pin length (cm) at monitoring sites.

Shown are changes in the height of erosion pins from 2010 to 2011, 2011 to 2012 and 2010 to 2012. Negative values indicate erosion, positive values indicate deposition. See Table 3-2 for average values and number of sites.

Measurements made for pins and for profiles in general agreed, and most measurements indicated erosion. For the pins, a statistically significant change was observed from the 2010 to 2011 (-3.94 cm average of all sites), but the trend was not significant for 2011 to 2012 or 2010 to 2012.

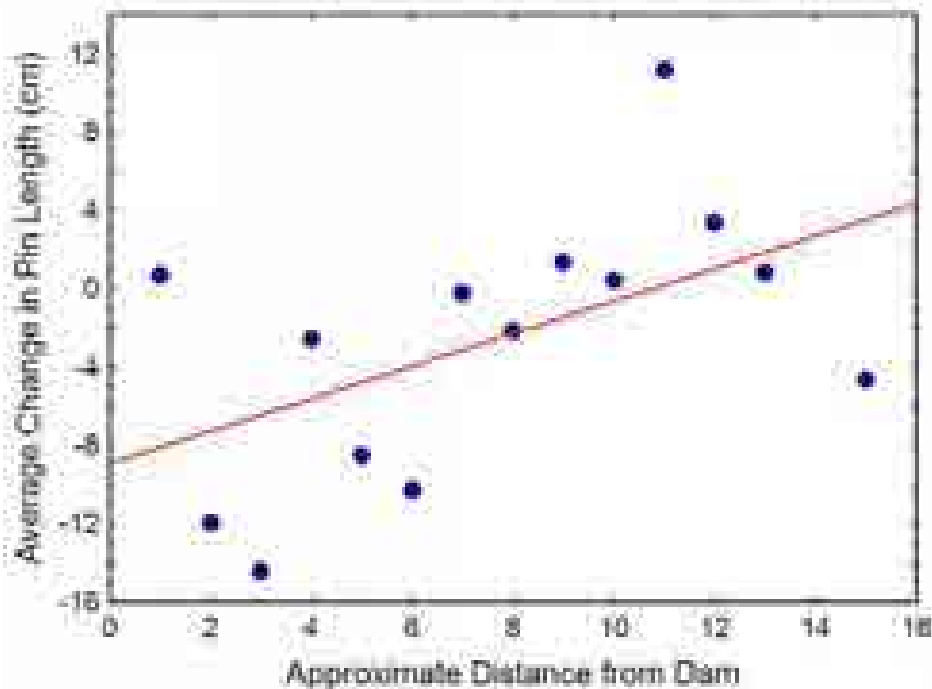
to furthest downstream toward Shelter Bay. Sites closer to the dam were significantly more eroded compared to sites downstream that had more deposition (Figure 3-22; Spearman's correlation coefficient = 0.55, $p < 0.05$).

Figure 3-22: Sites closest to the dam had higher pin erosion, and sites further downstream had greater deposition (Spearman's correlation = 0.55, $p < 0.05$)

Sites are rank ordered according to distance from the dam. Shown are changes in the exposed length of erosion pins from 2010 to 2012; negative values indicate erosion, positive values indicate deposition.
