**CLBWORKS-30A Arrow Lakes Reservoir: Implementation of
Wildlife Physical Works – Revelstoke Reach**

***ARROW LAKE RESERVOIR, SITE 6A ENGINEERING SERVICES
West Arm Headcut Mitigation – Conceptual Design Options***

Technical Memorandum

RE: **ARROW LAKE RESERVOIR, SITE 6A ENGINEERING SERVICES**
West Arm Headcut Mitigation – Conceptual Design Options
Our File 478.240-300

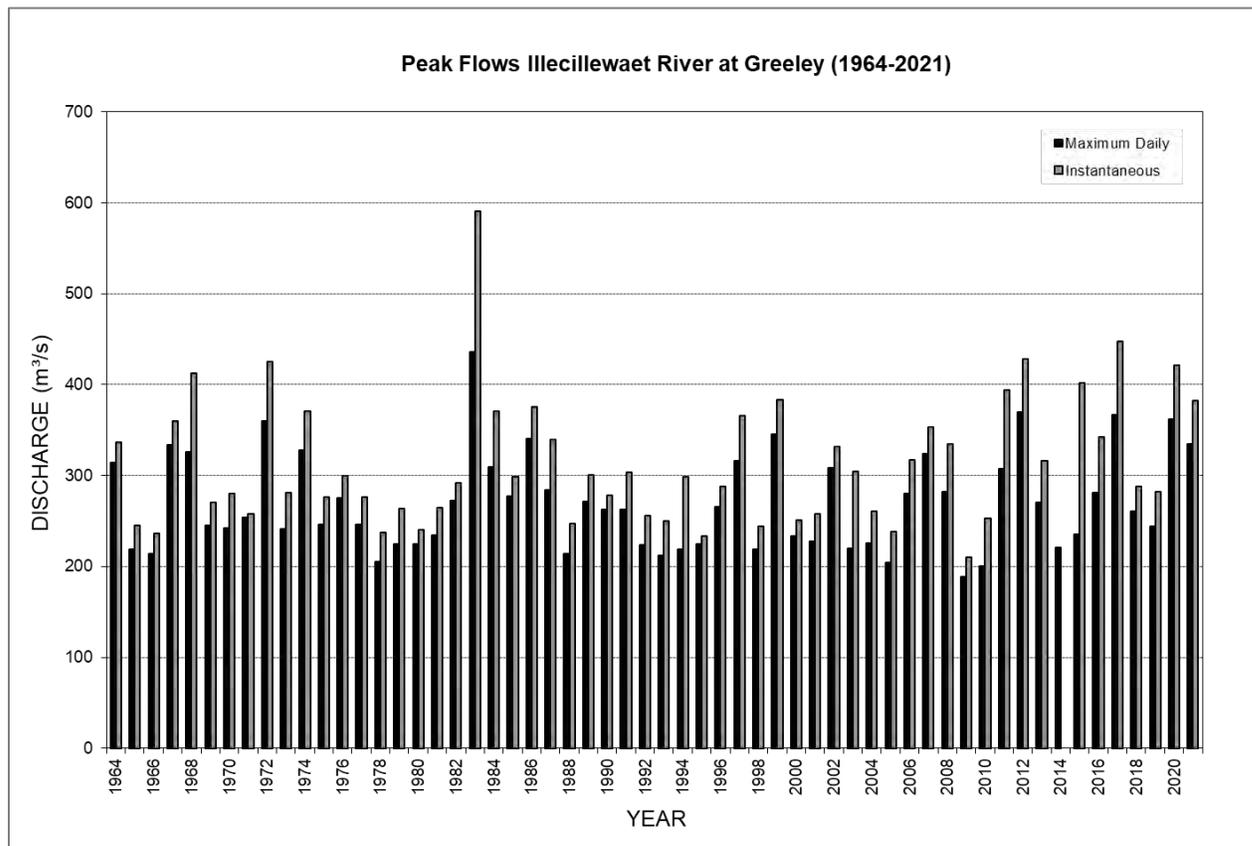
Figure 6: Peak Flows Illecillewaet River at Greeley (WSC Station 08ND013)

In 1983, the Illecillewaet River, the mouth of which, at its confluence with the Columbia River, is located approximately 1 km upstream of the eroded channel mainstem experienced the largest peak flood event on record (see Figure 6). The record is from 1964-2021 and based on Water Survey of Canada (WSC) Station Illecillewaet River at Greenley (08ND013), located approximately 10 km upstream of the confluence of the Illecillewaet River with the Columbia River. It is suspected that the headcut erosion feature may have formed as a result of the 1983 flood event. This peak flow during the 1983 flood occurred on July 12. Based on reservoir levels recorded at Nakusp (WSC Station 08NE104), the water level in Arrow Reservoir was approximately 438.6 m on that day and had been rising rapidly over the preceding days, suggesting the site may have been partially inundated during the peak flood on the Illecillewaet River. Due to the higher ground located immediately south of the headcut area, high water levels and flows from the Illecillewaet River or other local catchments may have been funnelled along the path where the headcut formed.

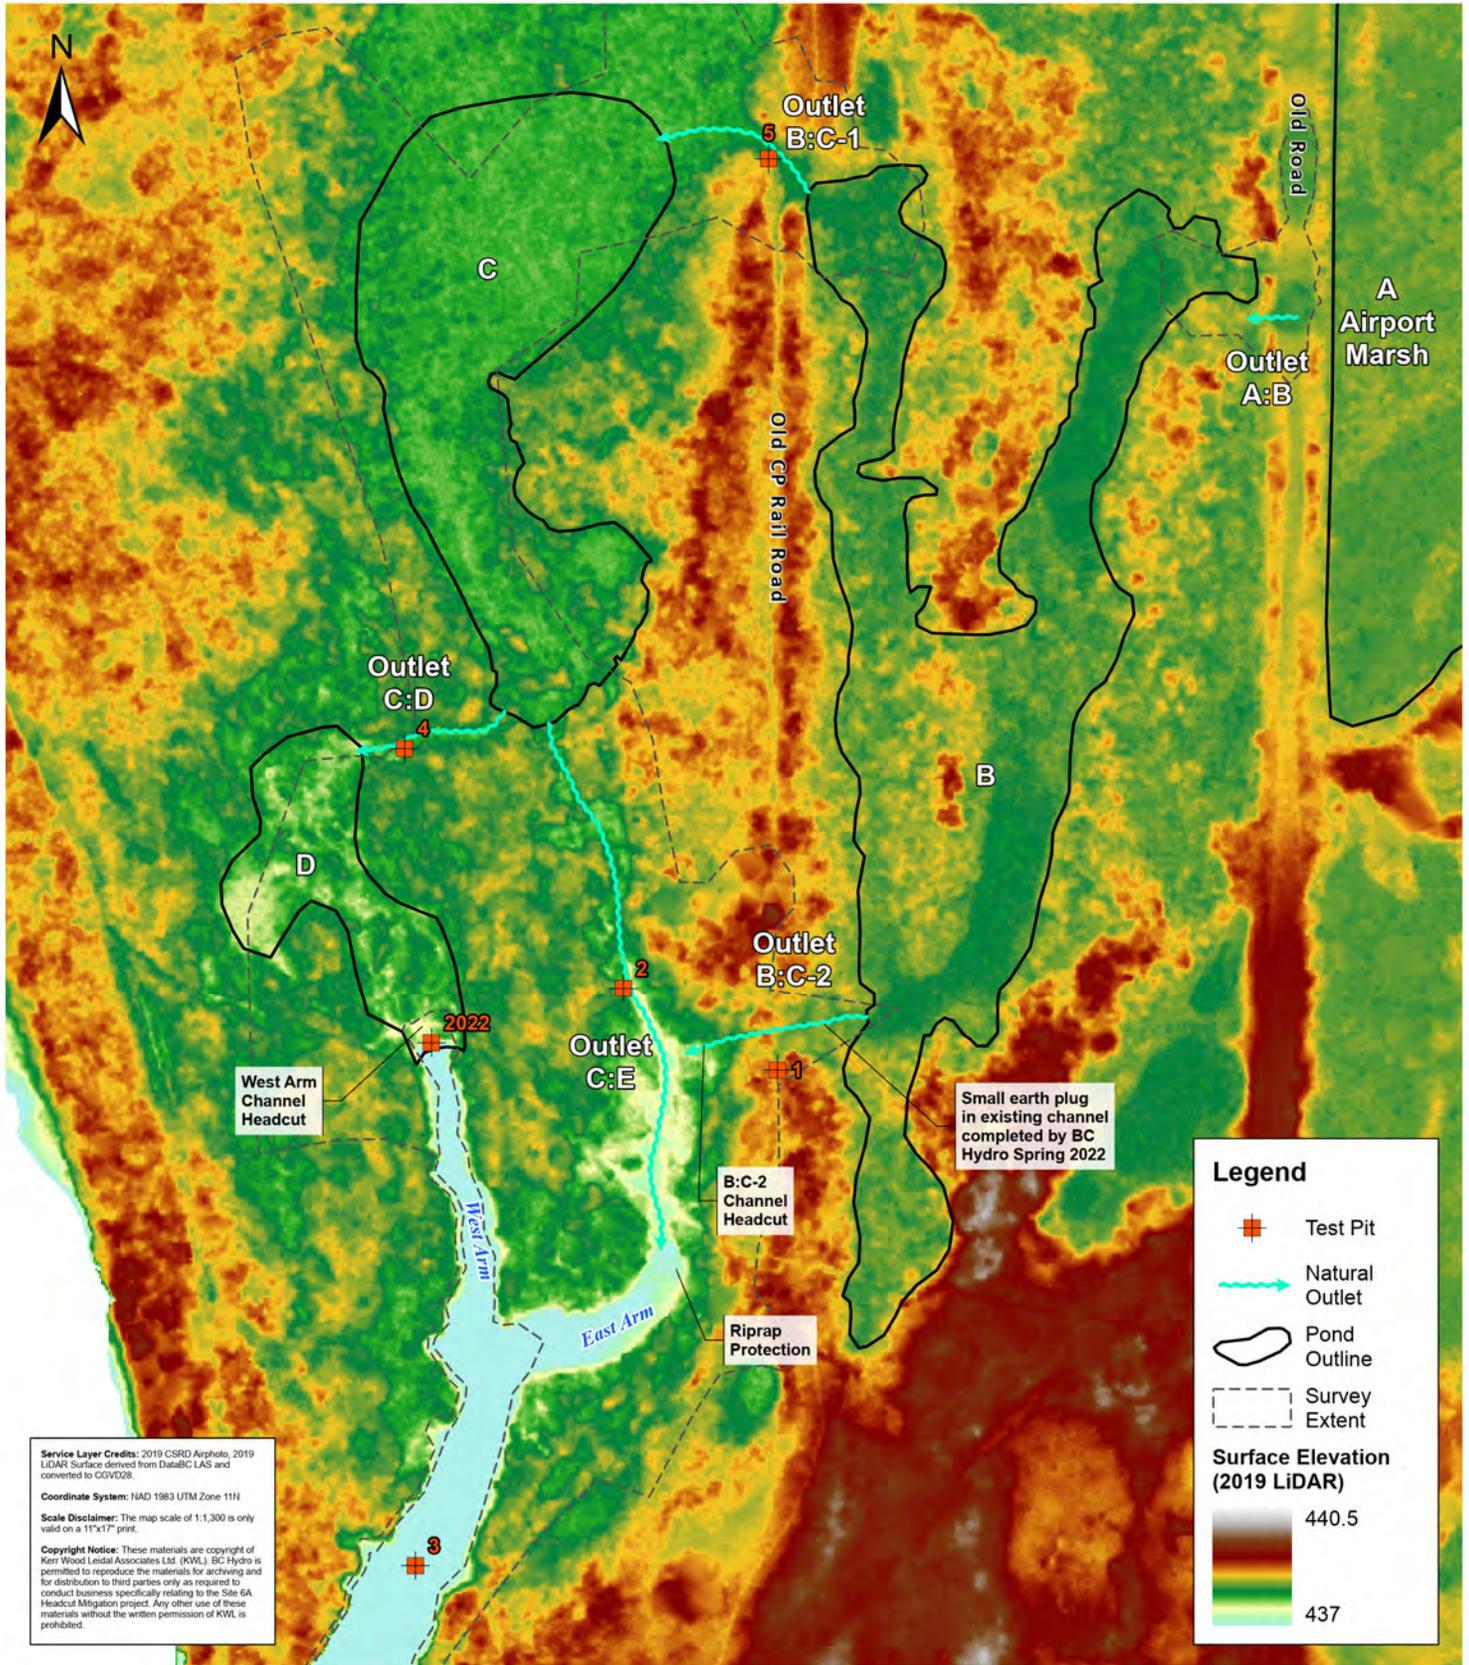
Figure 2

- Vegetation around the site is predominantly grass or sedge, with limited woody shrubs and trees at higher elevations (above 438.3 m).
- The Airport Marsh (Pond A in Figure 2) is separated from the lower ponds by the old road embankment. When on site in 2022 and 2023, water was seen flowing over the old road at a small wooden pedestrian bridge over a depression in the road. The surface of the old road was compact sand with gravel consistent with materials that may be expected for a road base, with limited areas with broken asphalt. No erosion was observed at the overflow.

- Pond B has two overflow/outlet points, labelled B:C-1 and B:C-2 on Figure 2, which are the northern and southern outflows respectively. The pond is impounded by the old CP rail bed on the west side, which cuts across the site and is parallel to the old road.

- Shallow test pits were hand-dug at six locations (shown on Figure 2), including one in April 2022 (labelled 2022) and five in May 2023 (labelled 1-5):

Surface water from Airport Marsh (Pond A) flows west over a former road (the old Arrow Lakes highway) into Pond B, which flows over the old CP rail embankment at two locations (B:C-1 and B:C-2 on Figure 2). Water that flows through B:C-1 goes to Pond C, where it either flows south to the East Arm or west to Pond D and the West Arm. Water that discharges at B:C-2 flows along a grassy swale (channel C:E on Figure 2) to the East Arm. Depending on the volume of water inflow to the area, water elevations in the ponds and associated water flow routes and quantities vary. Notably, B:C-1 is the lowest elevation and primary outflow for Pond B, but if water elevations are high enough, water also flows at B:C-2. The Pond C outlets have similar elevations and water flows out at both outlet channels. The spill elevations (elevation at which water begins to flow downstream into a channel or outlet) have been estimated for each outlet based on base plan topography and are shown in Table 1.
