Columbia River Project Water Use Plan

Kinbasket Reservoir Monitoring of Revegetation Efforts and Vegetation Composition Analysis

2021 Post-Surcharge Survey of Vegetation Monitored Under CLBMON-9: Yearly Report

May 25,2022

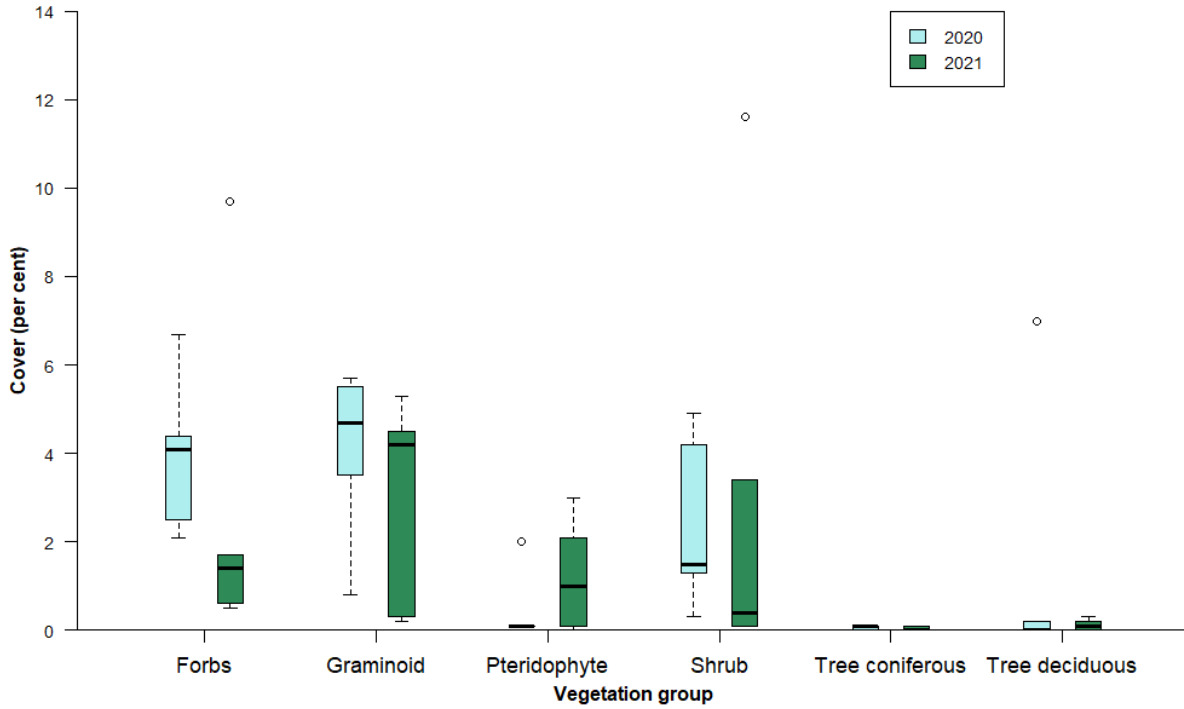
Most mounds continued to support a low-density cover of naturally established native and non-native vegetation (Figure 8, Appendix: Table 1), consistent with findings from previous survey years (Miller and Hawkes 2020, 2021). However, the canopy coverage of the different plant groups (forbs, graminoids, shrubs, etc.) was substantially reduced compared to 2020 as was the overall species richness of plant groups such as forbs, graminoids, and shrubs (Figure 9, Figure 10 [top panel]). Some naturally established woody species that were found still growing on the mound tops included red-osier dogwood (*Cornus stolonifera*), prickly rose (*Rosa acicularis*), red raspberry (*Rubus ideaus*), short-fruited willow (*Salix brachycarpa*), MacCalla's willow (*S. maccalliana*), dusky willow (*S. melanopsis*), and Mackenzie willow (*S. prolixa*).

Figure 9. Per cent canopy cover of different plant functional groups on the Bush Causeway (north) mounds in 2020 and 2021.

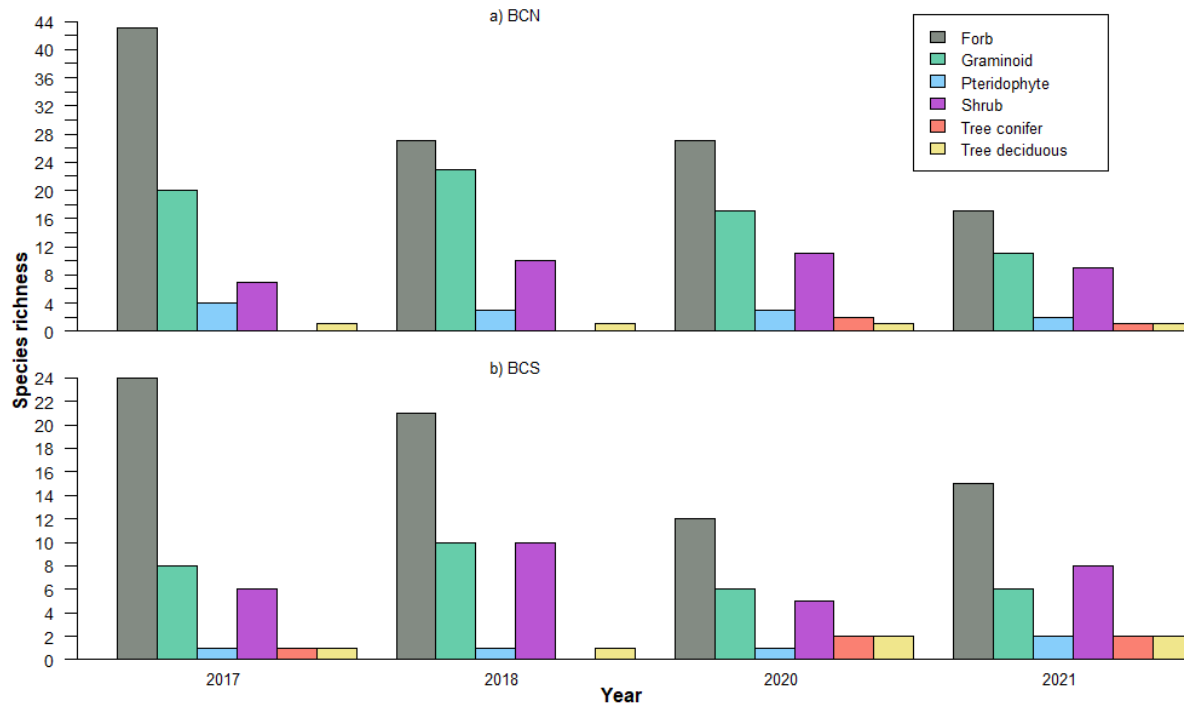
Figure 10. Number of species per plant functional group recorded on the Bush Causeway mounds from 2017 to 2021. (a) Bush Causeway north (BCN) mounds; (b) Bush Causeway south (BCS) windrows.

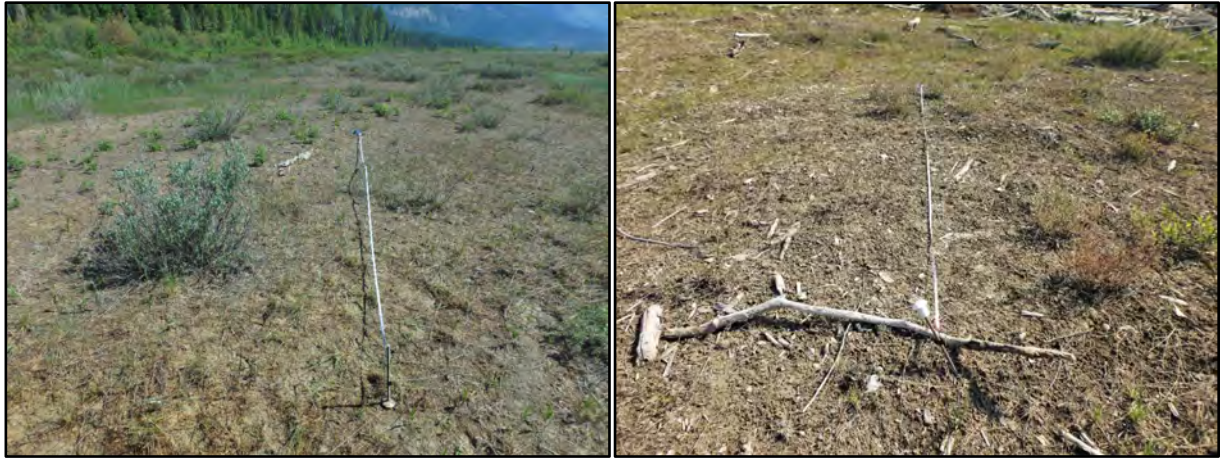
Figure 12. Examples of shrub circular plots at Bush Causeway first established as part of the CLBMON-61 program and currently being monitored under CLBMON-9.

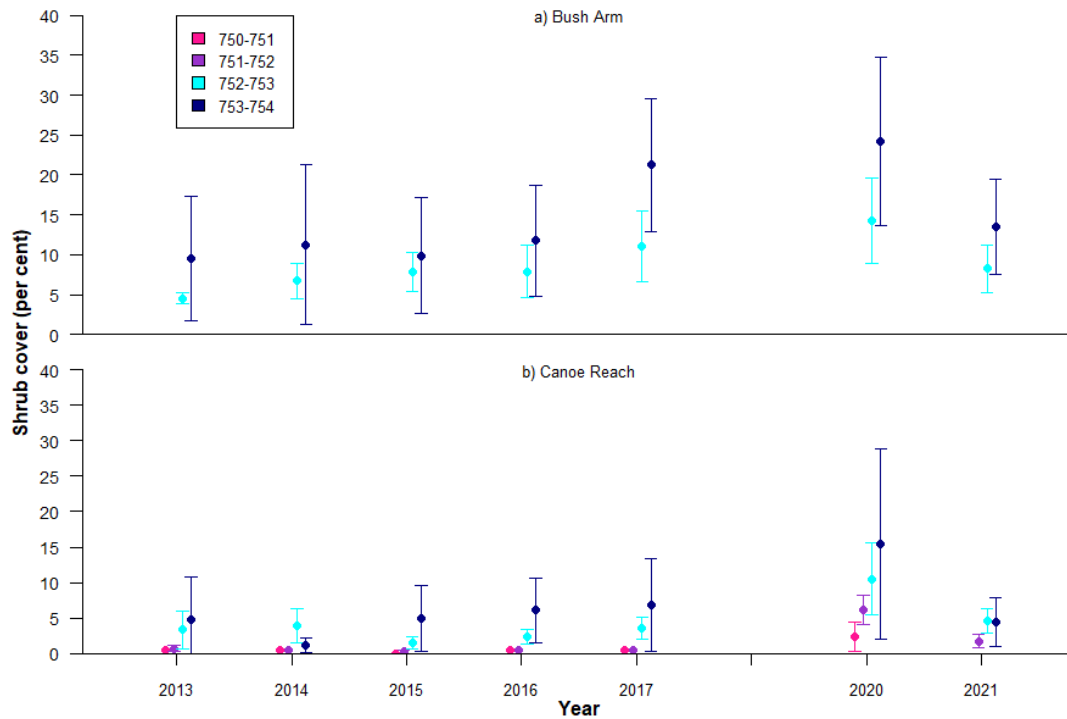
Shrub covers within the CLBMON-61 (circular plot) transects (Figure 12) fell markedly in 2021 compared to 2020 (Figure 13, top panel), likely in direct response to the 2020 high-water (surcharge) event (Figure 1). The average shrub cover in the topmost elevation band (753-754 m) dropped from ~25% to ~15% (a 40% decline). A similar trend occurred within the 752-753 m elevation band. This decline is in contrast to the steady trend of increasing average covers observed between 2014 and 2020, the period coinciding with the sequence of lower reservoir inundation years prior to 2020 (Figure 1). The difference among years in shrub cover at Bush Arm was statistically significant (ANOVA: $F=5.65$, $p=0.0004$).

Figure 13. Box plots showing the variation in woody shrub cover over time (2013-2021) at different elevations of the drawdown zone, as recorded in sample plots at (a) Bush Causeway (Bush Arm) and (b) Valemount Peatland (Canoe Reach).

The assessments of shrub cover and diversity at Valemount Peatland (Figure 25) yielded similar findings as for Bush Causeway, above. Shrub covers were notably lower in 2021 than in 2020 (Figure 13, bottom panel), coinciding with prolonged late summer inundation in 2020. The average shrub cover in the topmost elevation band (753-754 m) dropped from ~17% to ~5% (a 70% decline). Similar patterns of change were observed within the lower elevation bands. The decline from 2020 to 2021 is in contrast to the steady trend of increasing average covers observed between 2015 and 2020, the period coinciding with the sequence of lower reservoir years prior to 2020. The difference among years was statistically significant (ANOVA: $F=5.65$, $p=0.0004$).

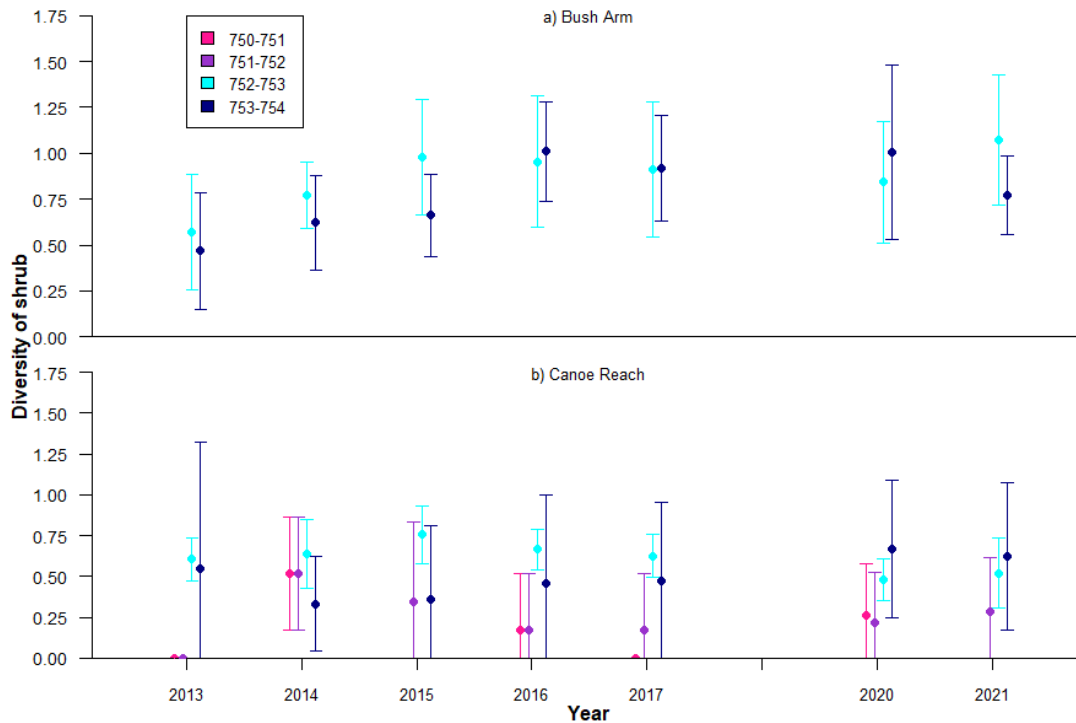
In 2021, shrub diversity within the same transects was not significantly different from previous years, suggesting that most previously documented species were still present in the plots, albeit at reduced densities (Figure 14, ANOVA: $p>0.05$).

Figure 14. Box plots showing the variation in shrub species diversity over time (2013-2021) at different elevations of the drawdown zone, as recorded in sample plots at Bush Causeway (Bush Arm) and Valemount Peatland (Canoe Reach).

As in the case of Bush Causeway, shrub diversity within the same transects did not differ significantly among years, suggesting that most previously documented species were still present in the plots, albeit at reduced densities (Figure 14, ANOVA: $p > 0.05$).

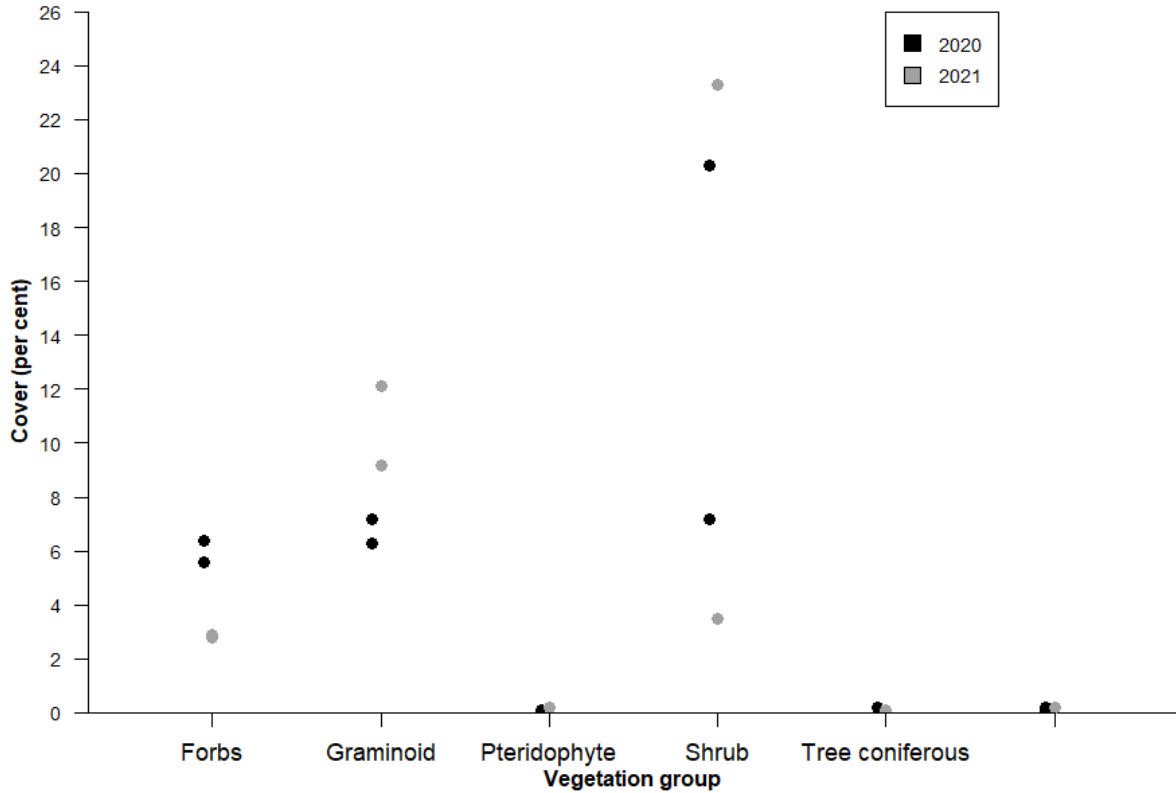
Figure 16. Per cent canopy cover of different plant functional groups on the Bush Causeway (south) windrows in 2020 and 2021. The same-coloured dots within a year correspond to the two different windrows (south windrow and north windrow). In each case, the higher cover value corresponds to the south windrow. For example, shrub cover increased on the south windrow between 2020 and 2021, but decreased over the same period at the north windrow.

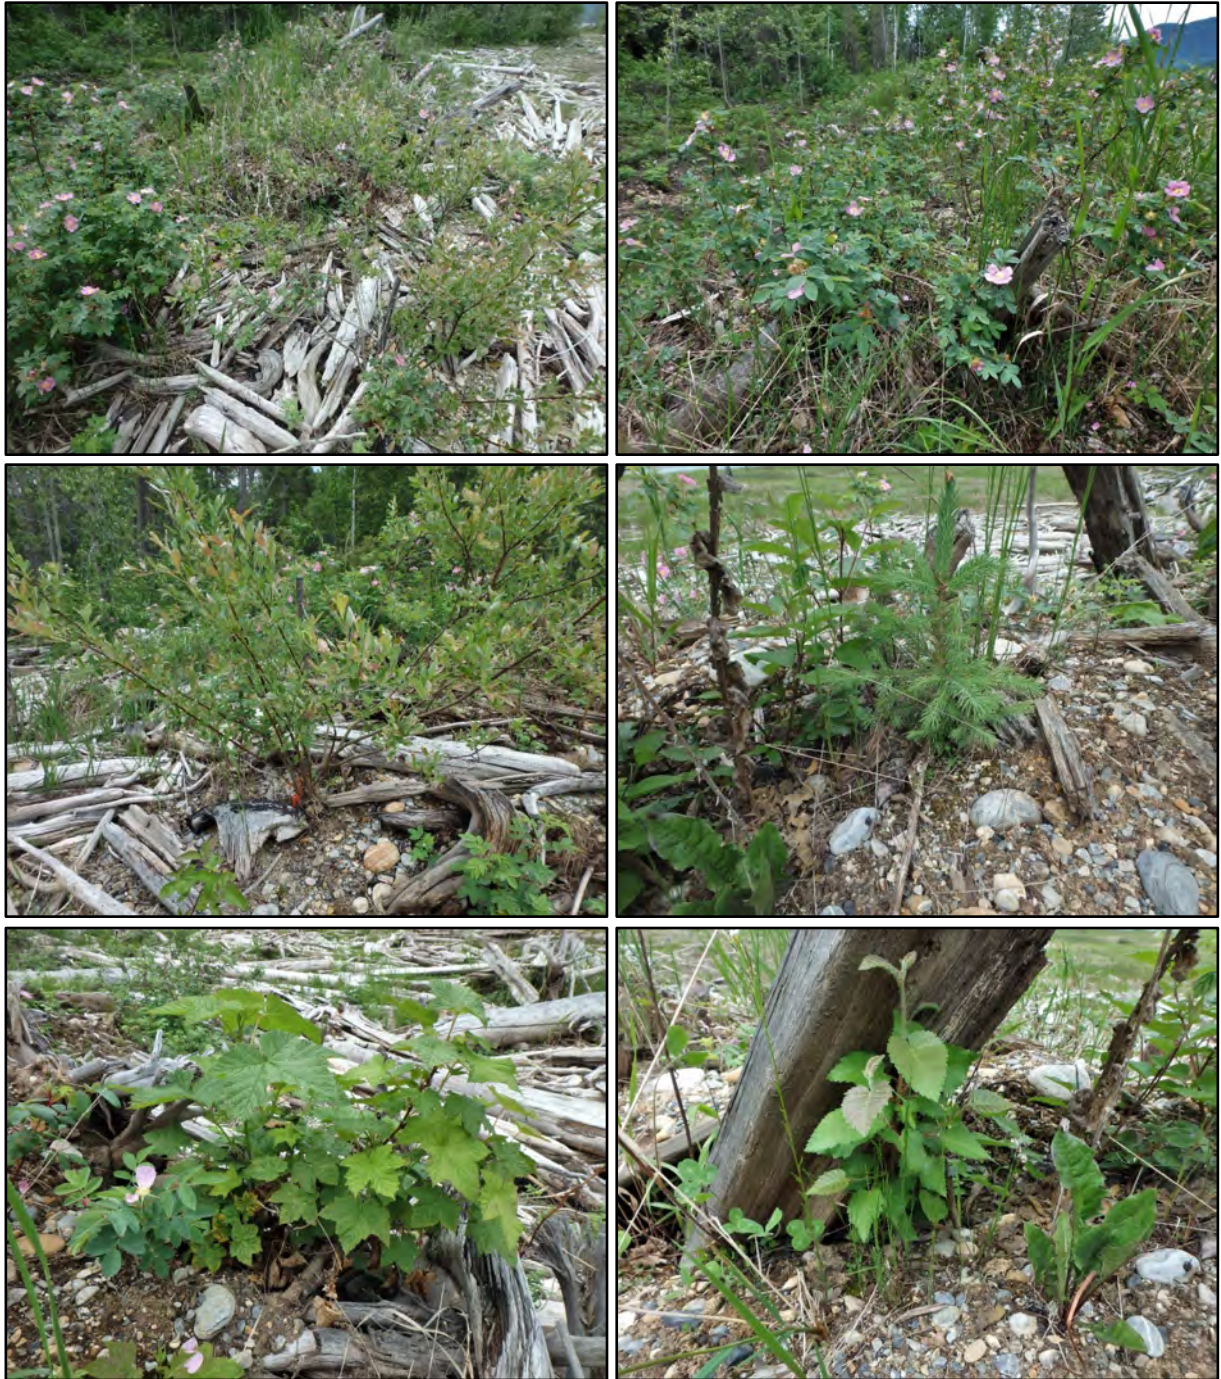
Figure 17. Representative vegetation on the south windrow at Bush Causeway (south) in 2021. Clockwise from top left: general vegetation, prickly rose, Engelmann spruce seedling, paper birch seedling, thimbleberry, planted willow stake.

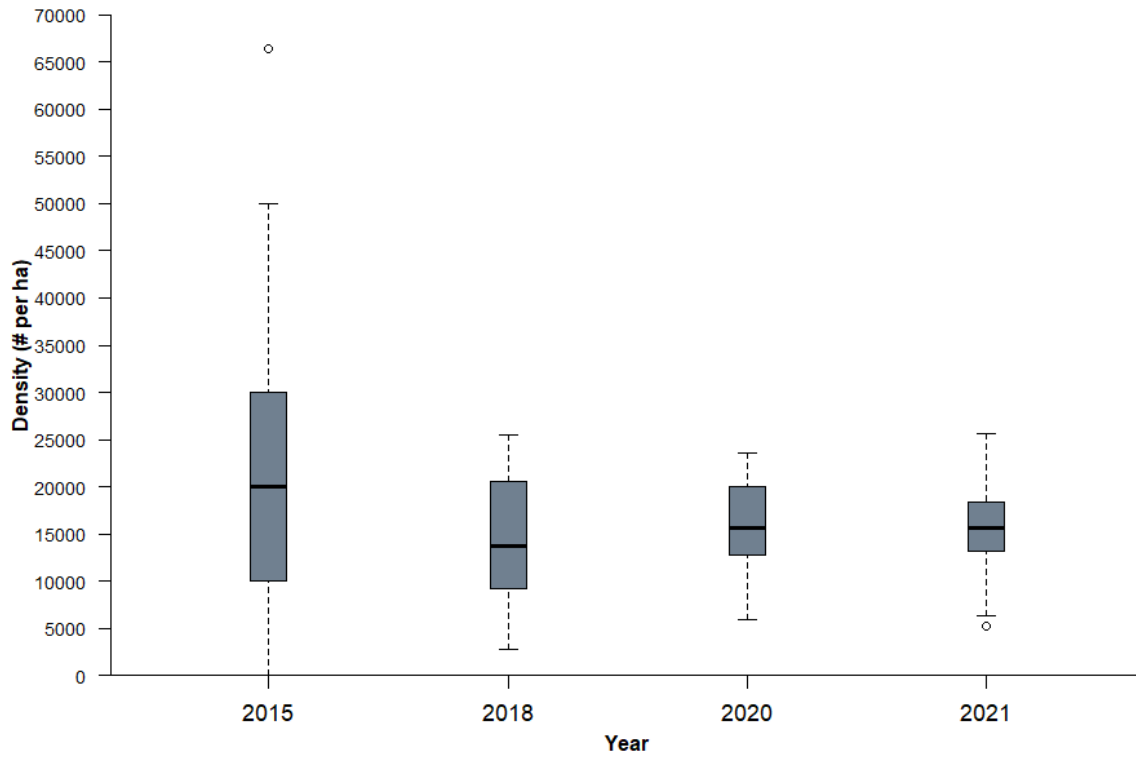
At Km88, plugs of Kellogg's and Columbia sedge continue to grow and seed vigorously eight years post-planting (Figure 19). In 2021, the estimated plug density (treatment units and species combined) was ~15,236 plants/ha. This compared favourably with estimated densities from 2020 (~16,160 plants/ha) and 2018, although, as might be expected, stem numbers appear to have declined somewhat since 2015 (Figure 20). However, the canopy cover provided by sedges has been on a significantly increasing trend since 2015, from ~2% cover in 2015 to ~11% cover in 2021 (Figure 21), reflecting a steady growth in the size of individual clumps as well as, perhaps, the lateral recruitment of new stems through rhizomatous spread or seedling recruitment. (Seedling recruitment was not directly assessed in 2021 but will be studied in more detail in 2022). The change in per cent cover since 2015 was significant (ANOVA: $F=15.9$, $p=0.0001$). A GLM (generalized linear model) fitted on $\log(\text{Cover}) \sim \text{Year}$, with year as a fixed factor, also indicated an increase in cover in 2018 and 2021 relative to 2015 (by a factor of 4.8x and 7.8x, respectively).

Figure 20. Estimated density per hectare of surviving sedge plugs (Kellogg's and Columbia sedge combined) at Km88 in 2015, 2018, 2020, and 2021.

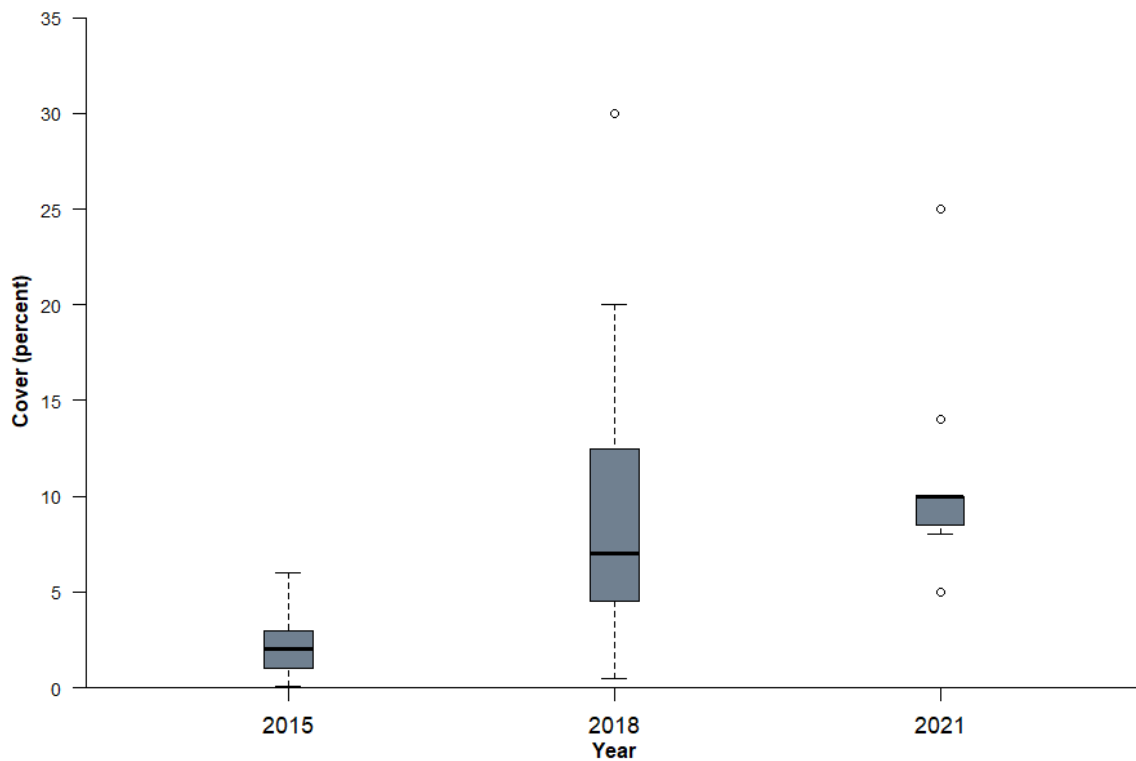
Figure 21. Percent canopy cover of Kellogg's and Columbia sedge at Km88 in 2015, 2018, and 2021 (cover data not recorded in 2020).

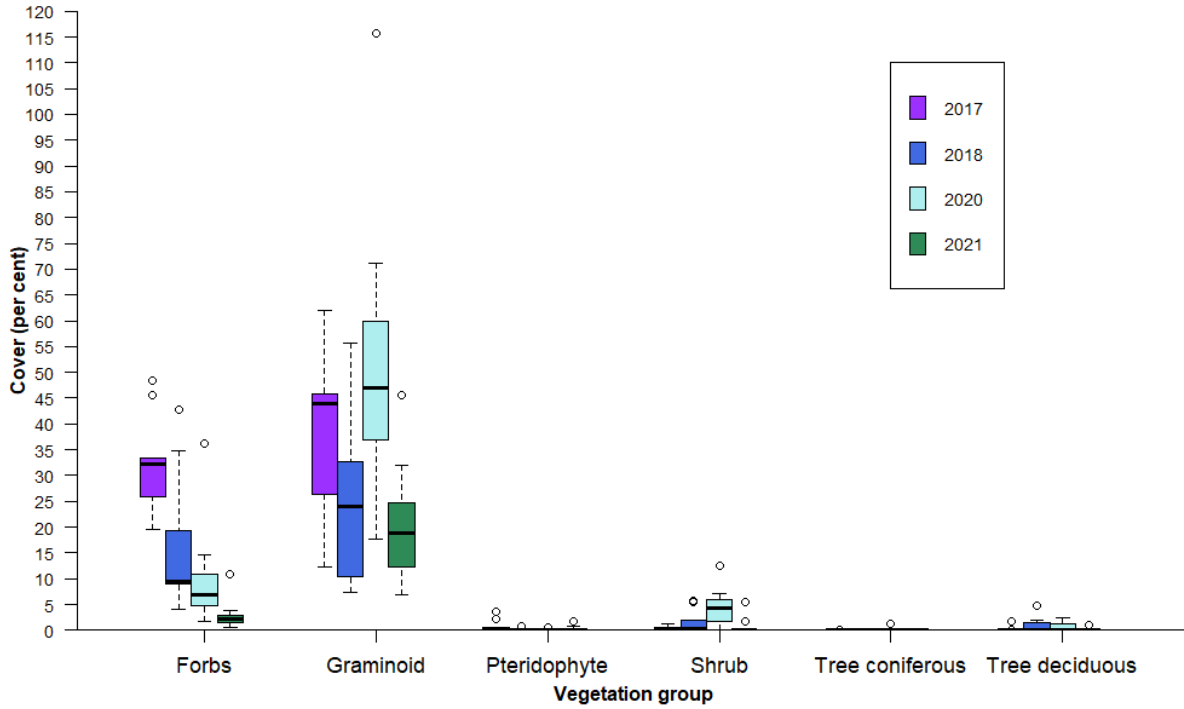
The change in the relative importance of different species groups over time is shown in Figure 23. Of note is the steady decline in native forb cover since 2017, along with the increase between 2017 and 2020 in the cover of graminoids and shrubs. This figure also shows that overall vegetation covers appear to have declined between 2020 and 2021, possibly in response to the 2020 inundation. One-way ANOVA for forbs indicated a significant difference in average cover among years ($F=12.3$, $p=0.0001$), while GLM (fitted on $\log(\text{Cover}) \sim \text{Year}$, with year as a fixed factor) indicated declines of 0.41x, 0.23x, and 0.067x in 2018, 2020, and 2021 (respectively) relative to 2017. For graminoids, one-way ANOVA indicated significant difference in average cover for at least one year ($F=4.03$, $p=0.012$), while GLM indicated that the only significant decline, relative to 2017, occurred in 2021 (0.52x).

Figure 23. Per cent canopy cover of different plant functional groups in the Canoe Reach log-boom exclosure area in 2017, 2018, 2020, and 2021

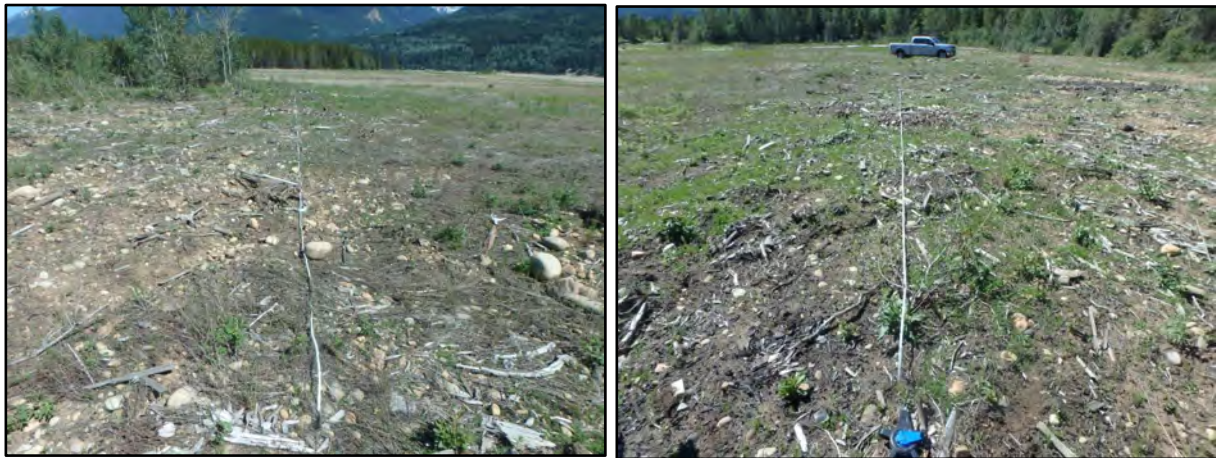
Transects established at the 2021-cleared site upslope of the log-boom exclosure supported minimal cover of regenerating vegetation in June 2021 (Figure 24) and will be reassessed for vegetation development in 2022.

Figure 24. New (2021) woody debris removal monitoring transects adjacent to the Canoe Reach log-boom exclosure.

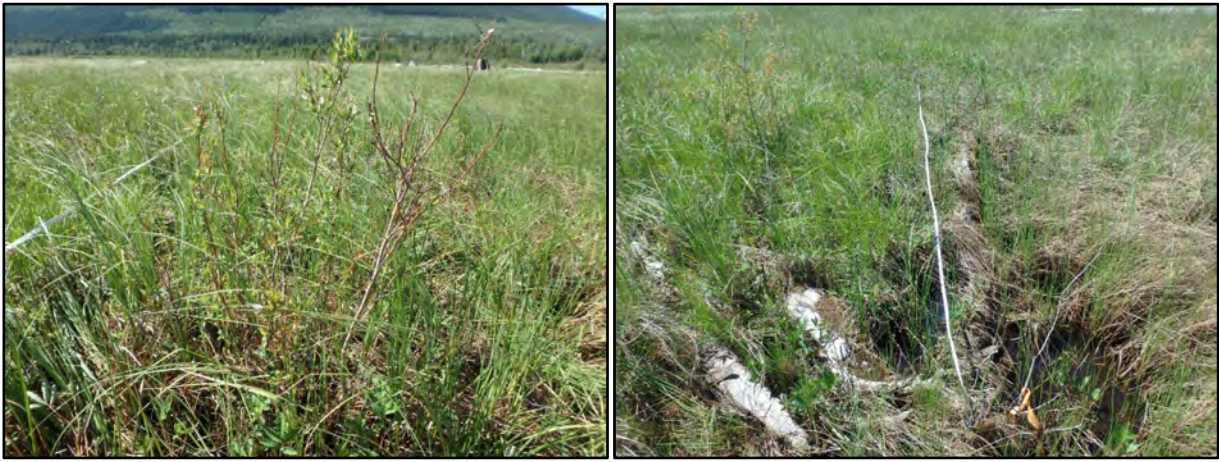
Figure 25. Examples of shrub circular plots at Valemout Peatland first established as part of the CLBMON-61 program and currently being monitored under CLBMON-9.

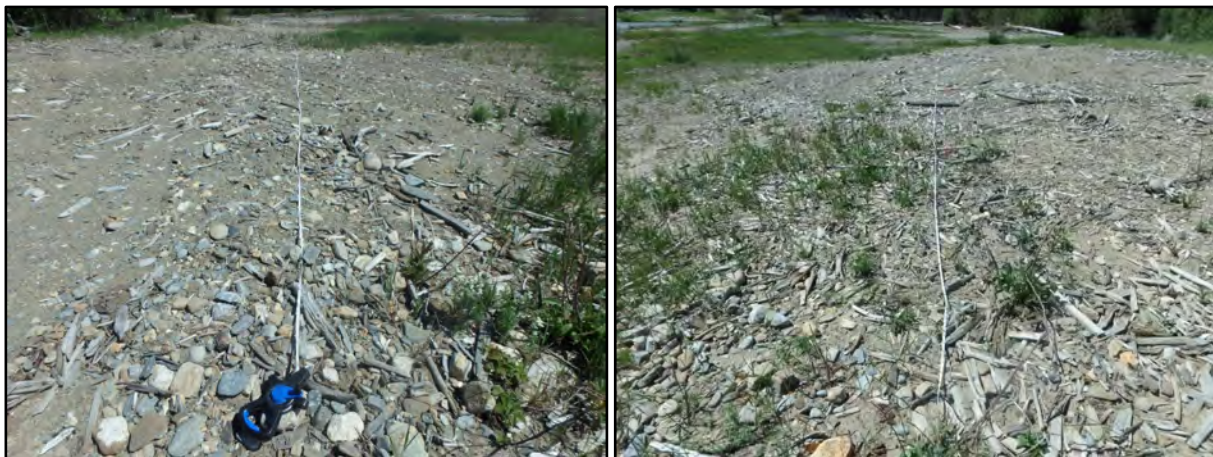
Transects established at the 2021-cleared Packsaddle Creek site supported a modest cover of regenerating vegetation in June 2021 (Figure 29; Appendix: Table 7) and will be reassessed for vegetation development in 2022.

Figure 29. New (2021) woody debris removal monitoring transects at Packsaddle Creek.

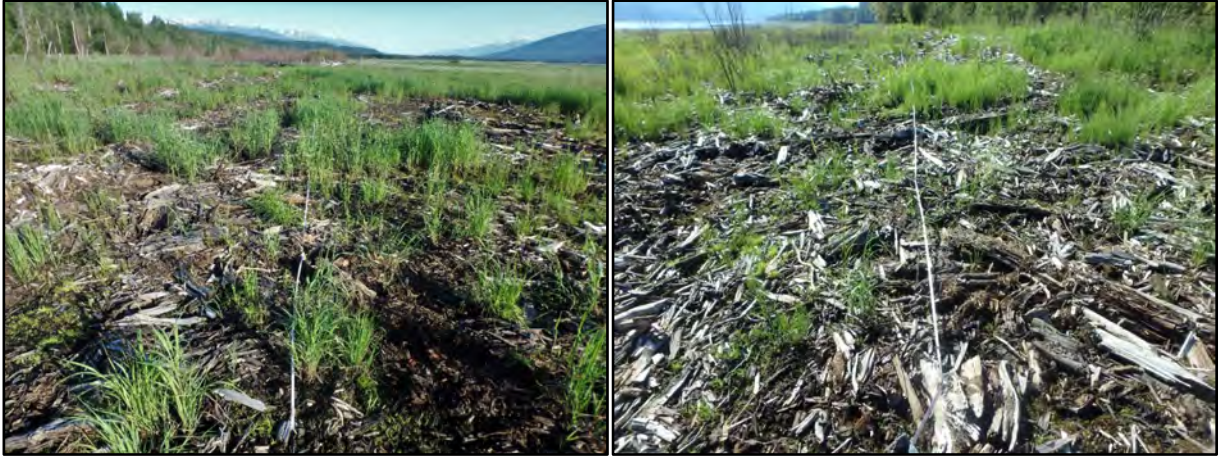
Transects established at the 2021-cleared site south of Pond 12 in Valemount Peatland supported a modest cover of regenerating vegetation in June 2021 (Figure 30; Appendix: Table 8) and will be reassessed for vegetation development in 2022.

Figure 30. New (2021) woody debris removal monitoring transects at south Valemount Peatland.
