## **Columbia River Project Water Use Plan**

**Arrow Lakes Reservoir: Implementation of Wildlife Physical Works –  
Revelstoke Reach**

*Cartier Bay Site 15A Erosion Repair – Detailed Design Report*

# CLBWORKS 30A Cartier Bay Site 15a Engineering Services **Detailed Design Report**

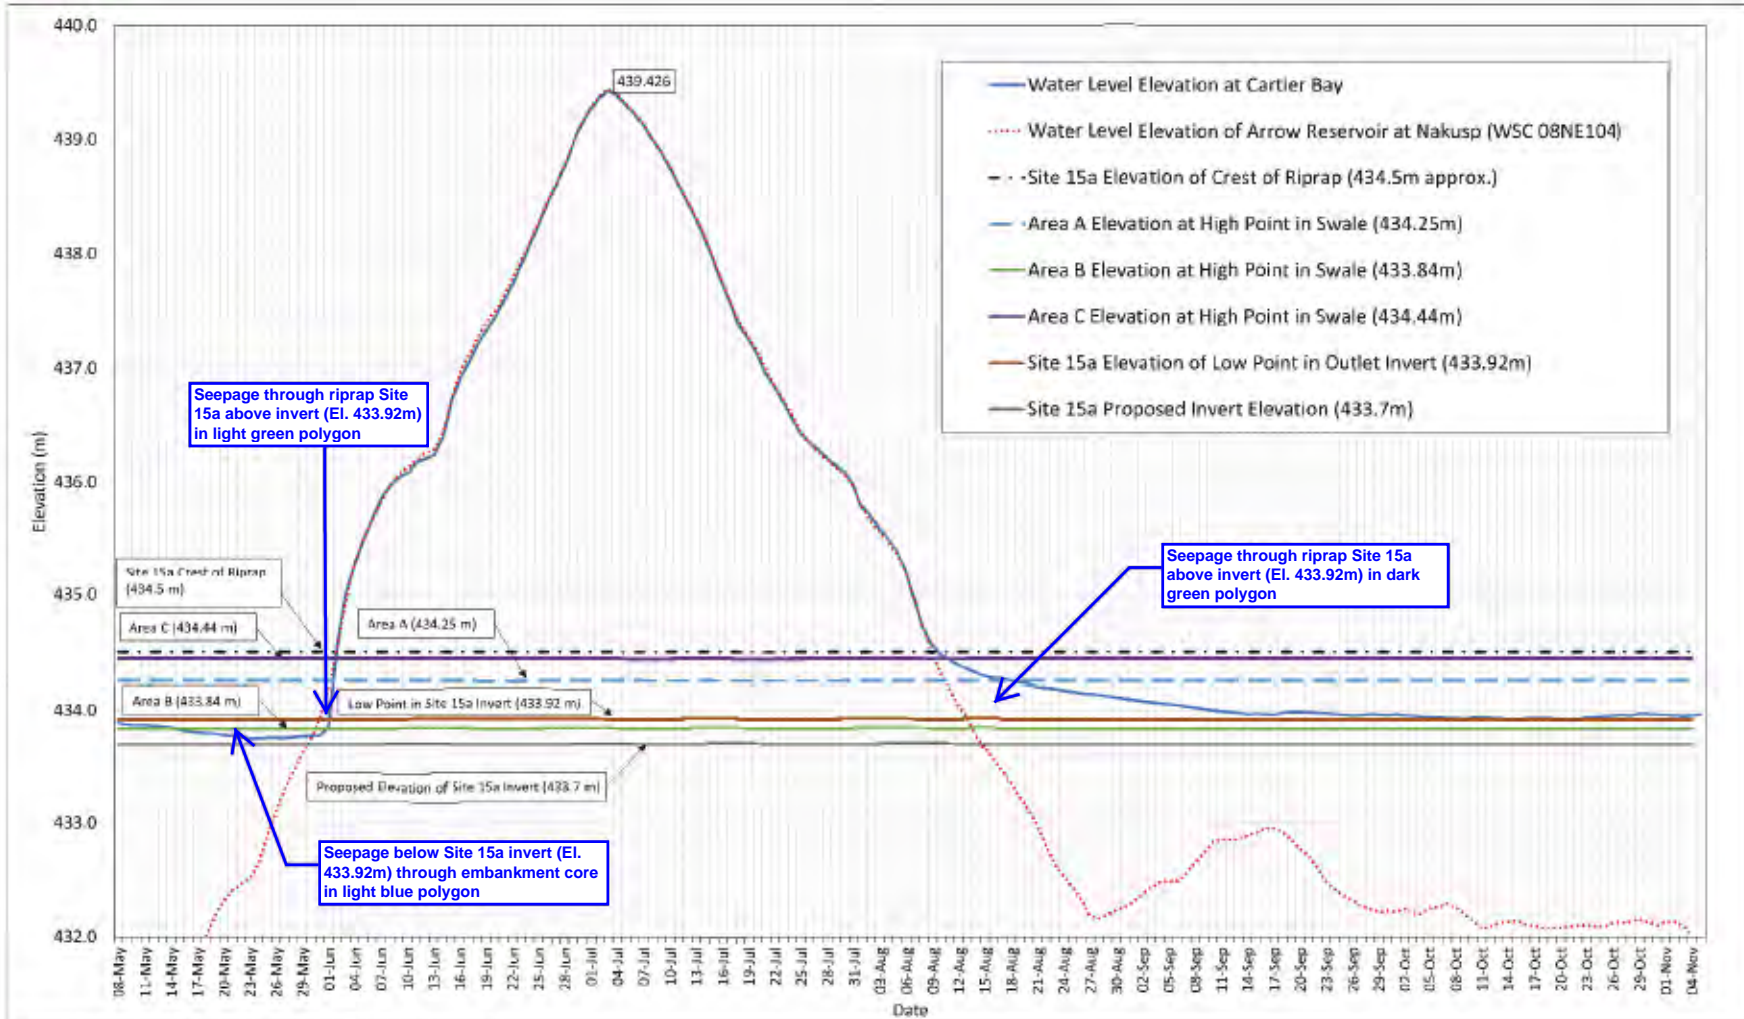
Figure 3: 2021 Cartier Bay Water Levels

A plot of Cartier Bay wetland and Arrow Lakes Reservoir water levels (based on Nakusp) is presented in Figure 3. Wetland water levels are available for the period of from May 8, 2021 to November 5, 2021<sup>1</sup>. This allowed for a review of the water levels and the function of the wetland during reservoir filling and drawdown and a comparison of the elevations of the key wetland features including the swales on the north bank (Areas A, B, and C).

Wetland water levels are expected to normally exceed the Site 15a invert and Area B elevations in early spring freshet and then seep through the permeable Site 15a structure once water levels lower below the Site 15a invert (and Area B) elevation until the reservoir levels become higher than the wetland levels and the reservoir starts to gently reverse the flow back into the wetland as it starts to inundate.

7. Based on the observations from KWL's November 18, 2021 site visit, water was ponded above the Site 15a invert behind the crest of the riprap (See Photo 12), but it had not exceeded the riprap elevation, which is similar to the November 5, 2021 data two weeks earlier as shown in Figure 3.

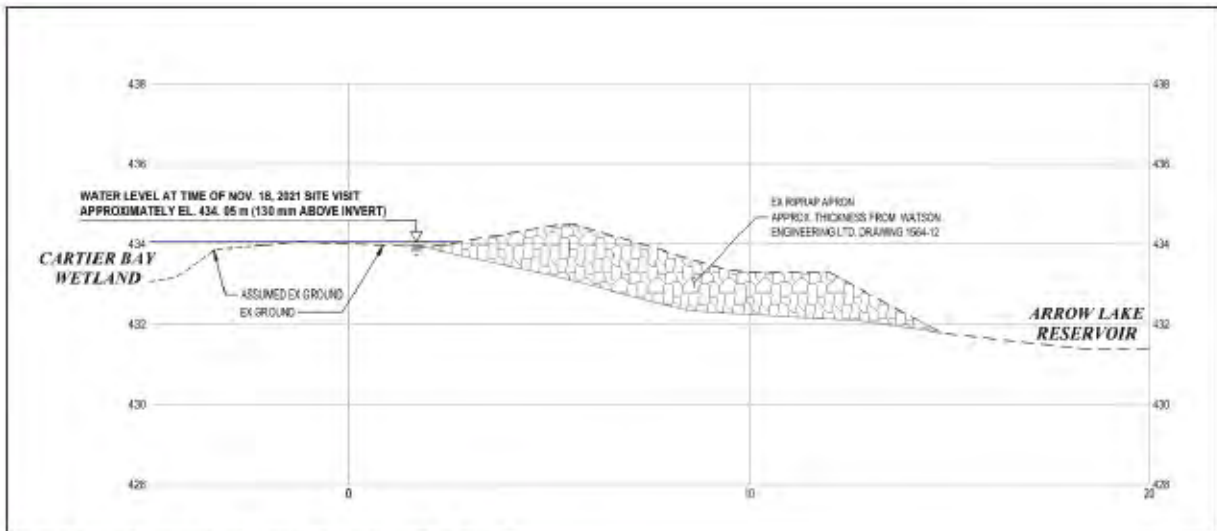
Figure 4: Section Through Site 15a Outlet

The existing riprap crest at the outlet at Site 15a is proud of the invert by 0.4 to 0.5 m, which likely explains the delay in the rising and falling limbs in the hydrograph of the wetland relative to the reservoir. Following the construction of Site 15a in 2016, the riprap voids may have partially filled in with sediment and debris and become less permeable. A transverse section through the Site 15a outlet is provided in Figure 4.

The elevated riprap crest may also be contributing to unwanted wetland discharge at Areas A and B, and erosion at Area B prior to inundation, as the riprap is above the elevations of the swales at Areas A and B and perhaps C.

The existing erosion and headcutting at Area B is thought to be a result of the existing outlet (invert and riprap) elevation at Site 15a allowing the low point at Area B to activate and become a preferential flow path while the wetland is draining and during the early stages of infilling. Lowering the Site 15a invert elevation and raising and/or armouring the swales (particularly at Area B) is expected to significantly reduce the risk of erosion through these alternate flowpaths.

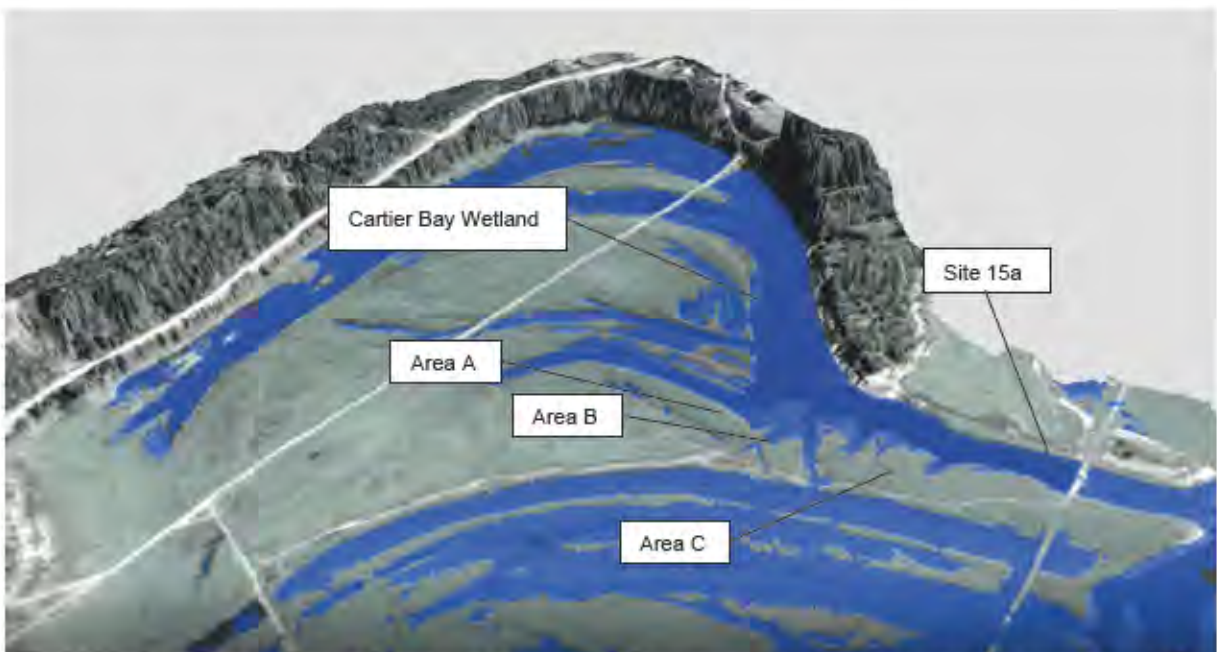
Figure 5: Area B Activation During Reservoir Filling (Reservoir Water Surface Approx. El. 434.1 m)

A spatial visualisation exercise was undertaken using GIS to visualize the interaction of the wetland and the main pool of the reservoir during filling and drawdown operations. Figure 5 presents a view of the water levels reaching sufficient elevation to overtop both Area B and the Site 15a outlet. It also shows that there are no other obvious low points (such as the swales at Areas B and C) that the reservoir would inundate the wetland from at this elevation.

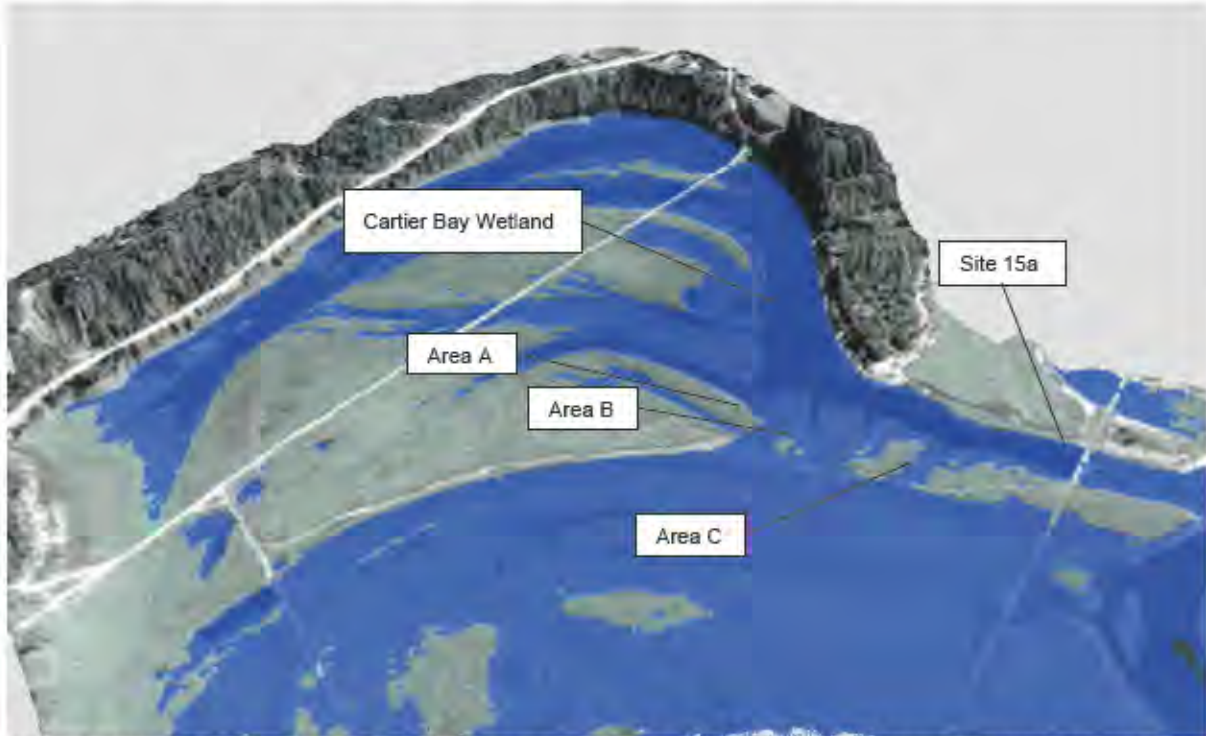
**Figure 6: Wetland and Reservoir Connected at Areas A, B and C (Reservoir Water Surface El. Approx. 434.8 m)**

As the reservoir continues to fill, all identified swales at Areas A, B, and C provide flow connection as shown in Figure 6. As with the previous figure, it also shows that there are no other obvious low points that the reservoir would inundate the wetland from at this higher elevation.

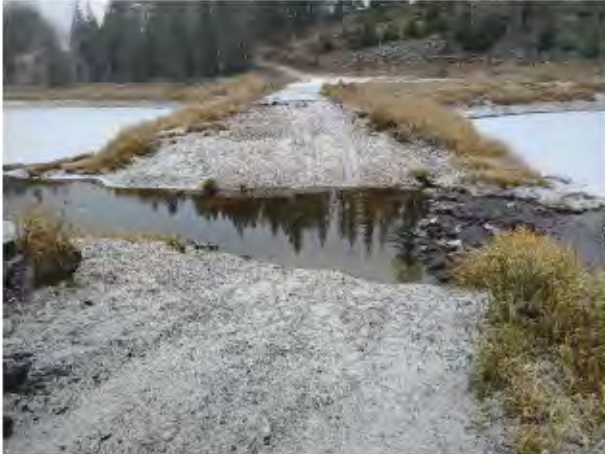
1. The main source of water flowing into the lower compartment comes from the upper compartment where a former paved road embankment separating the upper and lower compartments is breached. This inflow location is shown in Photo 1 of Attachment A. Other inflows to the lower compartment include a small amount of runoff from the surface along the southern wetland margins.

**Photo 1:** Looking south along alignment of decommissioned road separating upper and lower compartments of Cartier Bay. Water flow is from upper into lower compartment (left to right).

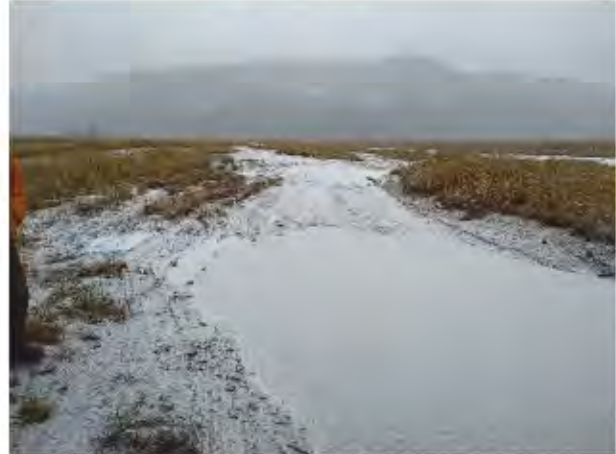
**Photo 2:** Looking west along alignment of unpaved access road north of swales at Areas A, B, and C.

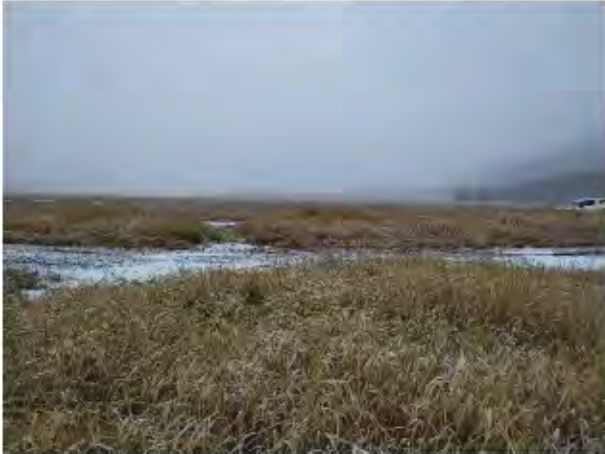
1. There is a noticeable topographic low channel along Area A (Photos 3, 4, and 5).
2. The roads are lower at Area A and had ponded water during the site visit.
3. There was no flowing water along area A at the time of the site visit.
4. The area was generally vegetated with a few bare patches, potentially at low points where water could pool.

Photo 5: Looking north along vegetated swale at Area A. Swale extends to the oxbow channel to the north.

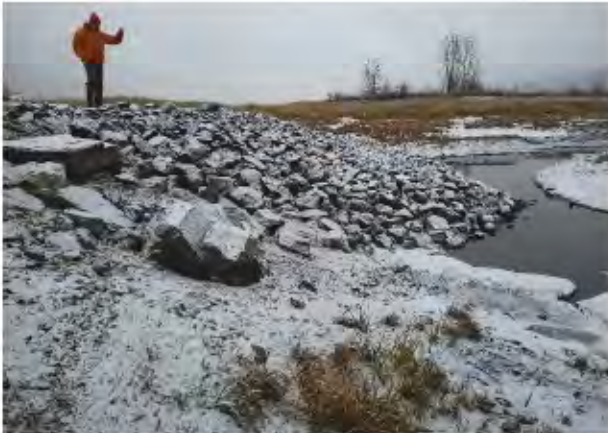
2. Water was flowing through the outlet, by seeping through the riprap and discharging out of the riprap fill on the downstream margin (Photos 13 and 14).

Photo 13: Looking south. Riprap facing on downstream side of Site 15a Dam.

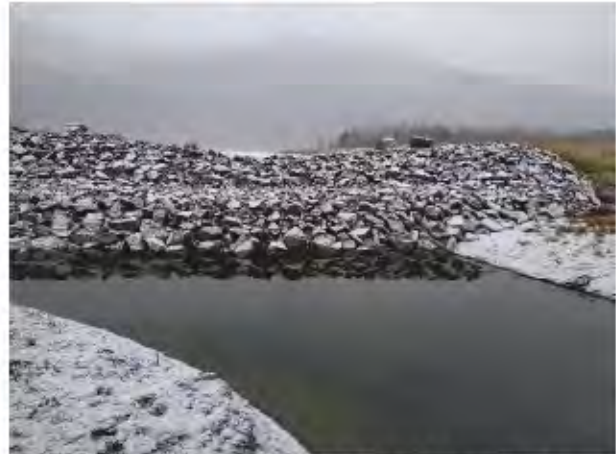
Photo 14: Looking east at Site 15a outlet from downstream side.

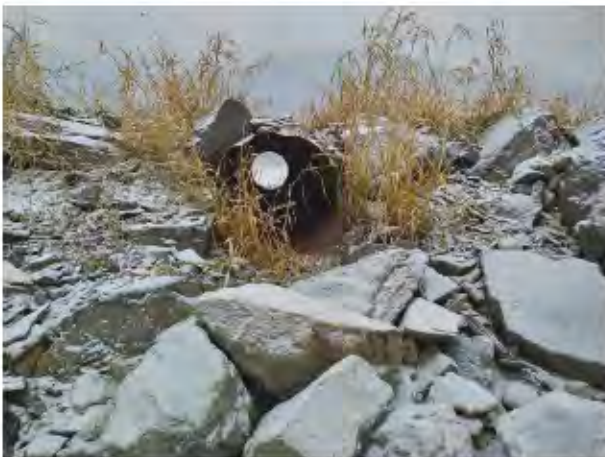
3. There is a 600 mm diameter CSP culvert through the former railway embankment approximately 10 m north of the Site 15a outlet (Photo 15). The crown of the culvert is close to the crest of the former railway embankment above the outlet. The culvert was above the water level at the time of the site visit and was clear and dry.

Photo 15: Looking east. 600 mm diameter CSP culvert approximately 10 m north of Site 15a outlet.
