Columbia River Project Water Use Plan

Mid Columbia River Long Term Erosion Monitoring Program

Final Report

Study Period: 2009 to 2016

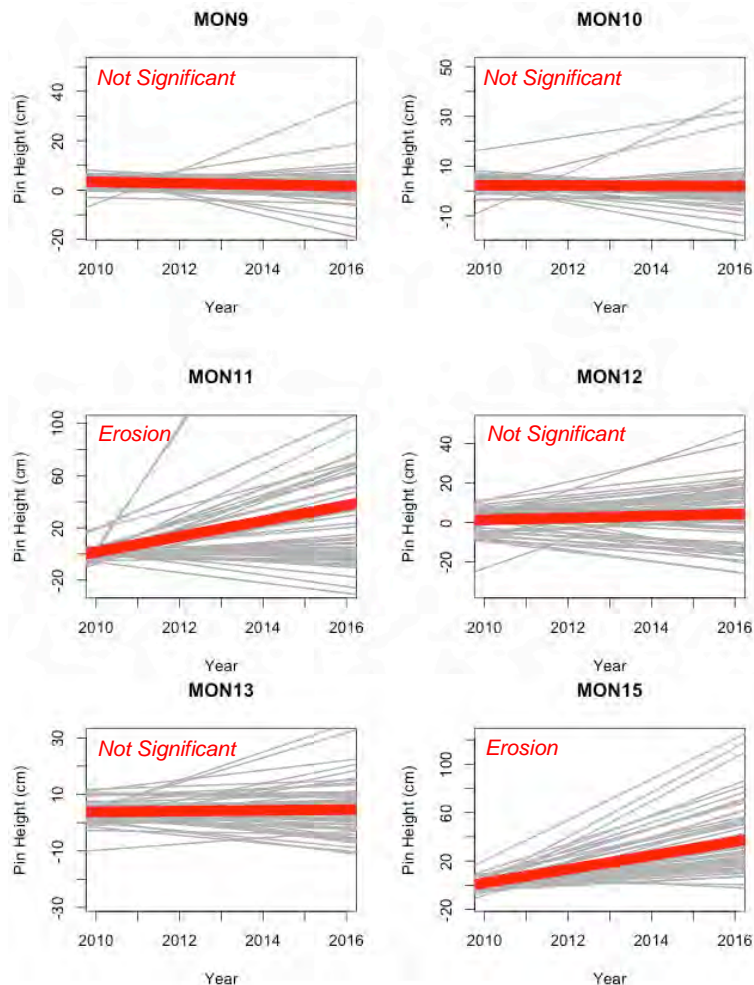
Figure 3-2: Erosion Pin Lengths (cm) Over Time Sites MON 9 through MON 15 for Individual Pins (Grey lines) And Site Average (Red line). Erosion Indicated By Increasing Pin Length, Deposition Indicated By Decreasing Pin Length.

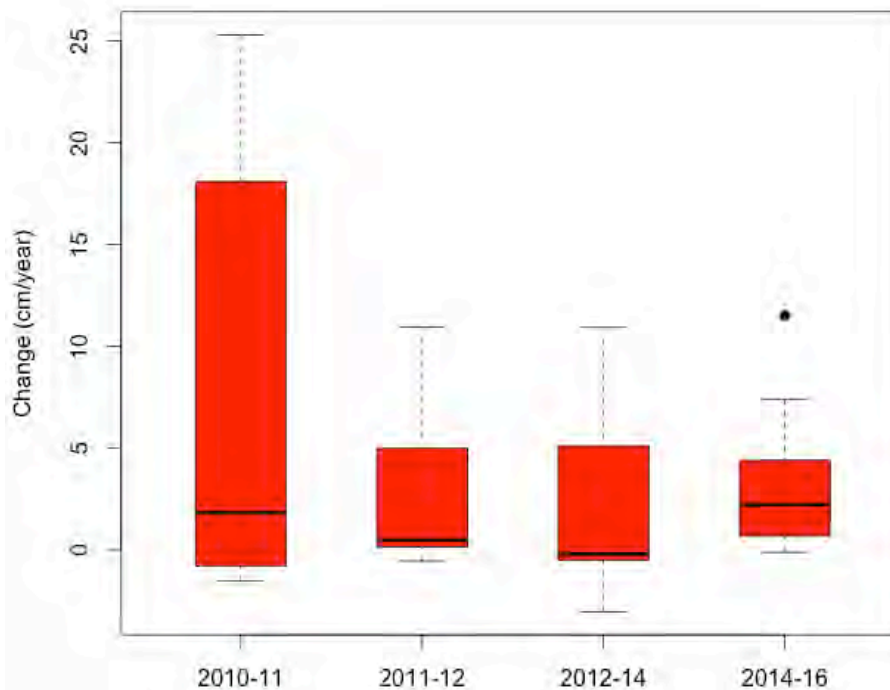
Figure 3-3 displays the erosion pin length change for each time period. The figure highlights three main findings from the pin data:

- Erosion is occurring in all time periods.
- In the year following entry in service of REV5 the erosion was quite variable.
- Since then, the erosion has remained fairly consistent.

Figure 3-3: Pin Length Change (cm/year) For Each Time Period. Positive values indicate erosion, negative values indicate deposition. Shown in box plots are the median (solid line), 25th and 75th percentiles (edges of box), range of values (whiskers) and outlier (dot).

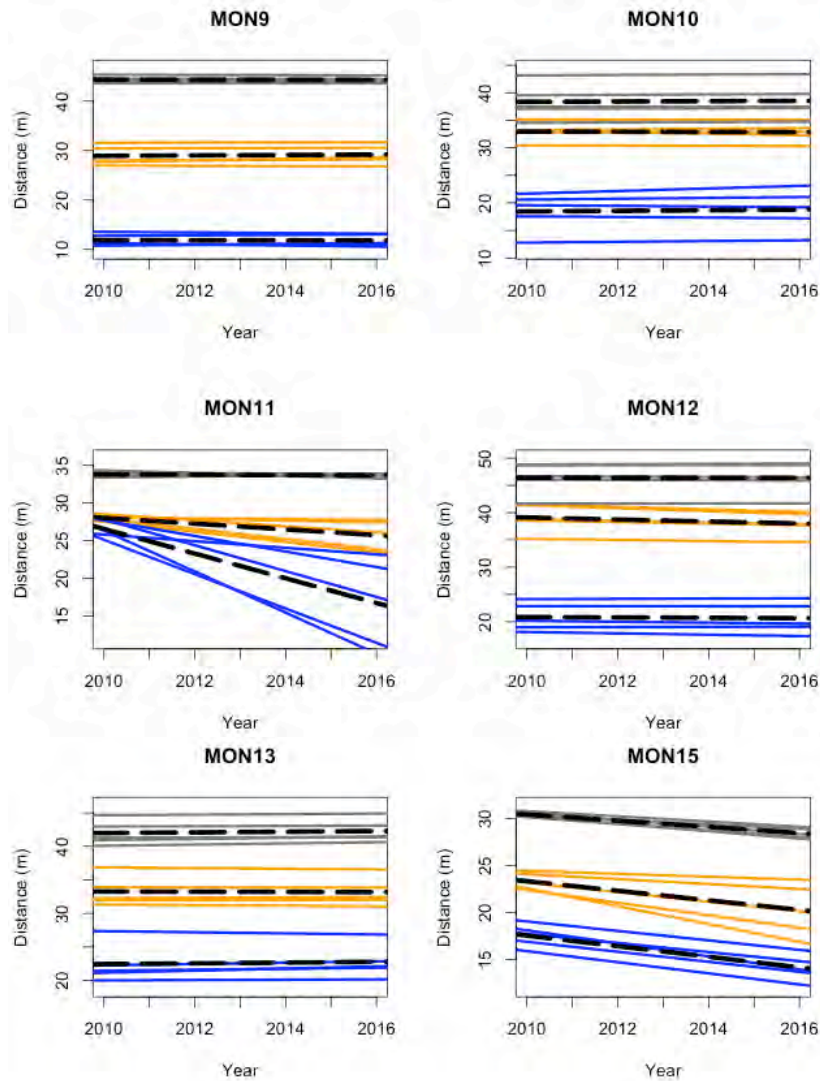
The resulting regression lines are plotted for each site in Figure 3-4 and Figure 3-5. Note that in these figures a consistently decreasing distance (negative slope) would imply consistent erosion over time, while a consistently increasing distance (positive slope) would imply consistent deposition over time (i.e. *opposite* to how the erosion pin data are interpreted).

Figure 3-5: Distance To Cross-section (XS) Line For Individual XS In Elevation Band (Upper: Blue, Middle: Orange, Lower: Grey), And Average (Black Dash), Sites MON 9 Through MON 15. Erosion Indicated By Negative Slope, Deposition Indicated By Positive Slope.

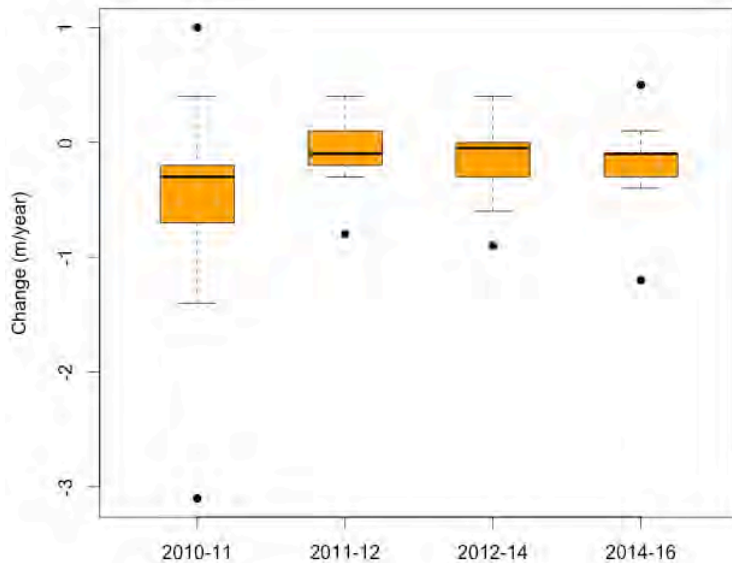
The lack of a consistent trend over time is also evident in Figure 3-6, Figure 3-7, and Figure 3-8, which present the changes over time graphically. As indicated in these figures, the average erosion rate is fairly constant between the different time periods, and erosion occurs in all elevation bands (although it appears to be somewhat less in the lower elevation bands).

Figure 3-7: Change in Distance to Cross-section for Middle Elevation Band For Each Time Period. Negative values indicate erosion, positive values indicate deposition. Shown in box plots are the median (solid line), 25th and 75th percentiles (edges of box), range of values (whiskers) and outlier (dot).

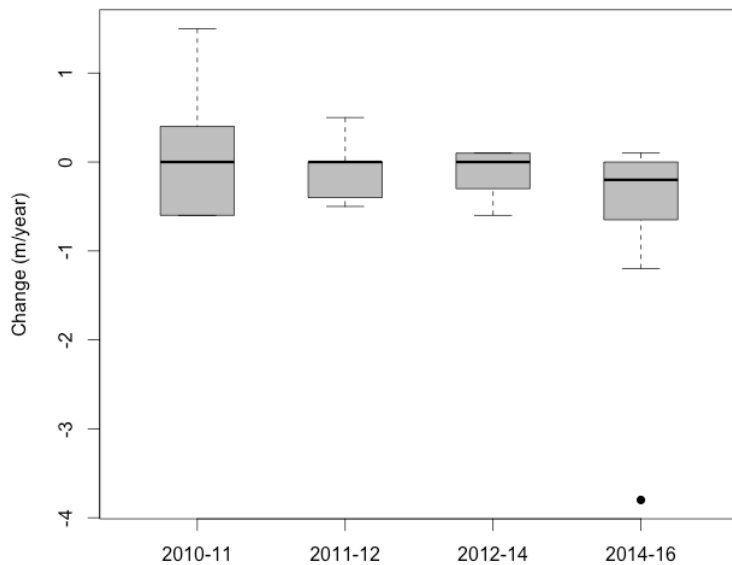
Figure 3-8: Change in Distance to Cross-section for Lower Elevation Band For Each Time Period. Negative values indicate erosion, positive values indicate deposition. Shown in box plots are the median (solid line), 25th and 75th percentiles (edges of box), range of values (whiskers) and outlier (dot).
