Wind & Wave Analysis

Client	BC Hydro
Project name	Columbia River Project Water Use Plan
Document title	CLBWORKS-5A Kinbasket: Valemount Marina Ramp Extension
Document subtitle	Wind & Wave Analysis
Status	Report
Date	September 14, 2018
Project number	9598-01
File reference

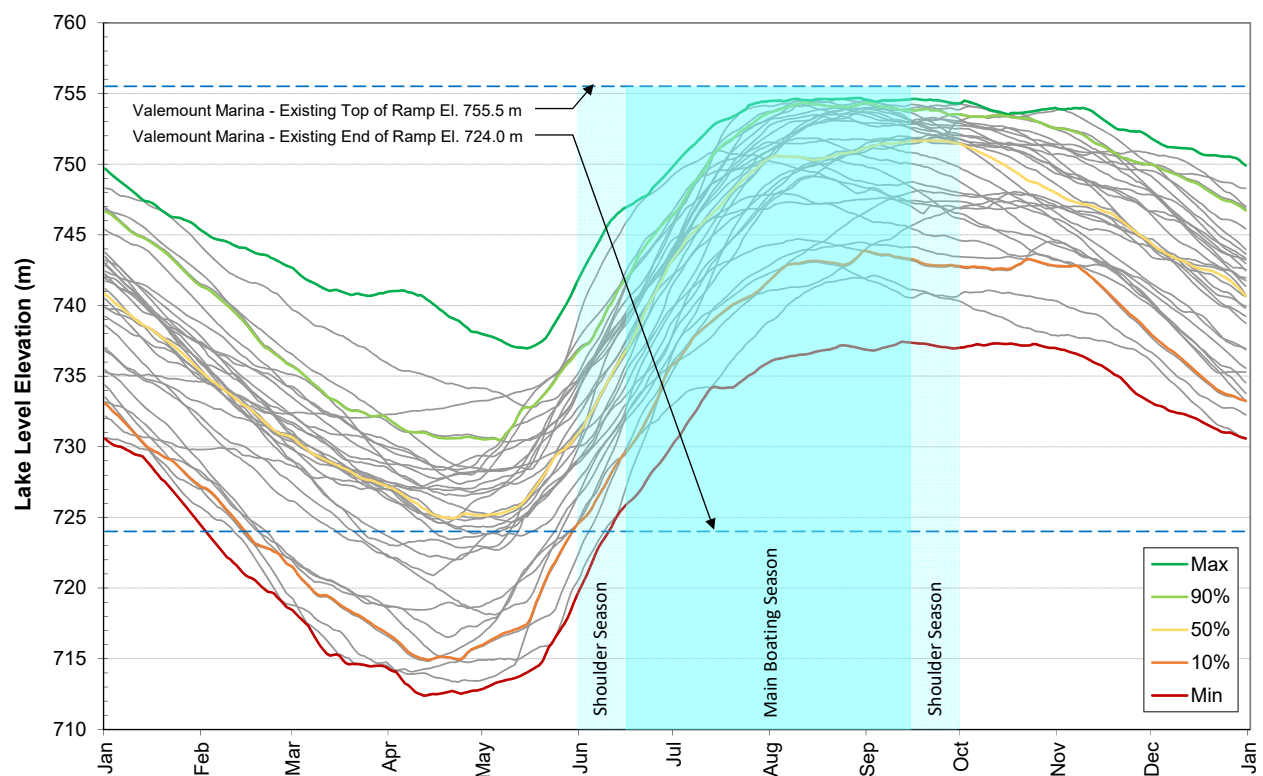
FIGURE 2-3: KINBASKET LAKE HISTORICAL WATER LEVEL ELEVATIONS 1984 – 2015.

The areas where the breakwater profile was affected were all up near the crest of the breakwater around elevation 754.0. If the erosion was wave-related, it means that the damage is likely to have happened within the time span from August to November where the lake level is up around this elevation (ref. Figure 2-3).
