Campbell River Project Water Use Plan

Upper Campbell Reservoir Drawdown Zone

Revegetation Treatment Report – Year 3

Study Period: 2019

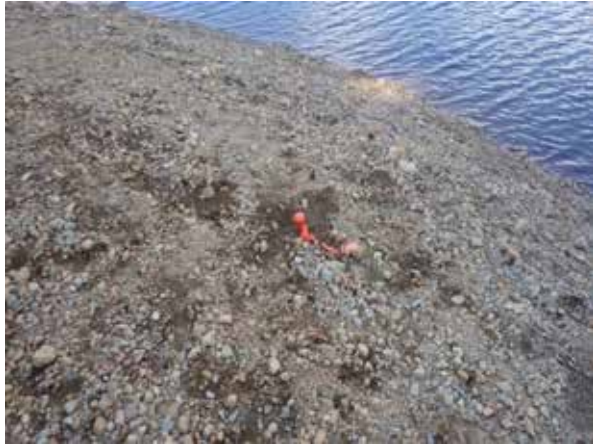
Figure 1. Photopoint monitoring comparison for JHT-PRM06/06a.

a) Looking north through plot centre on 12-Sep-2017 (baseline).

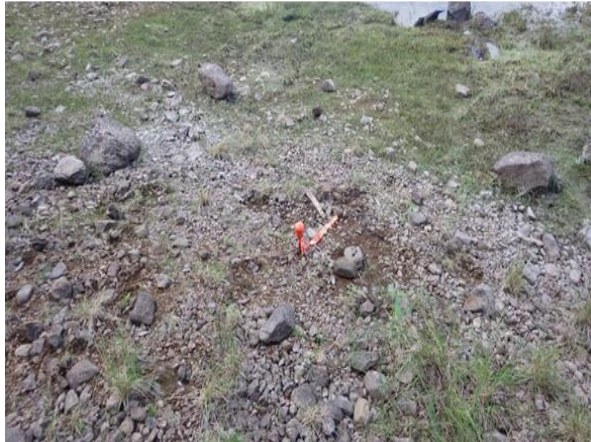
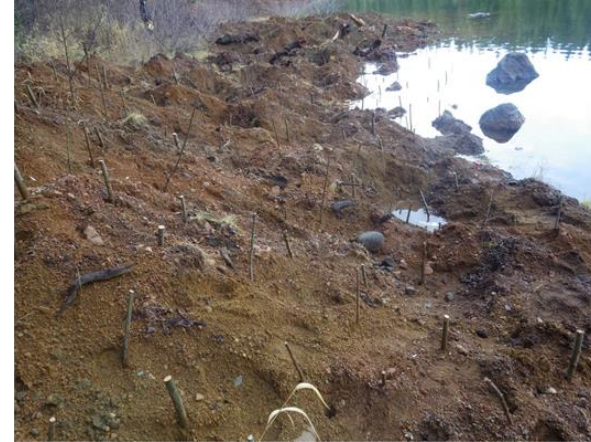
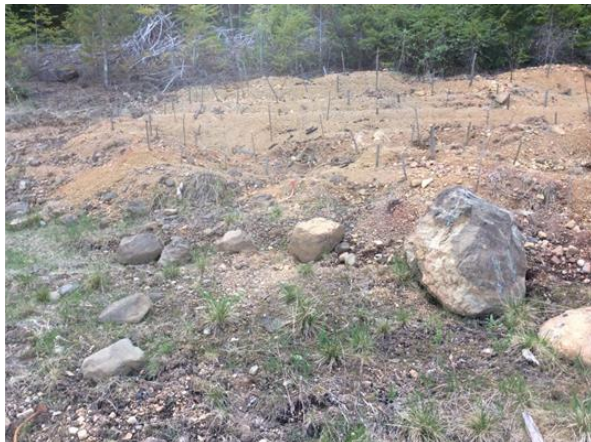
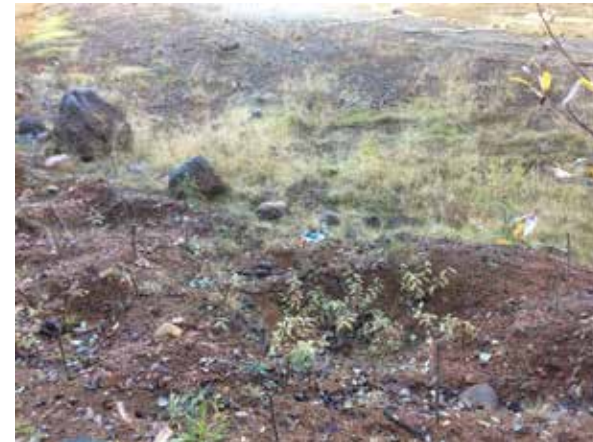
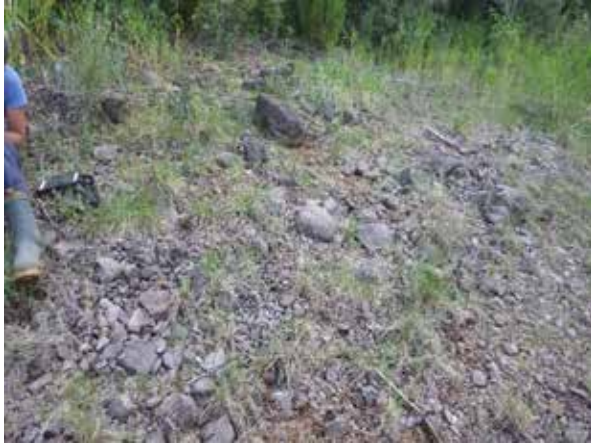
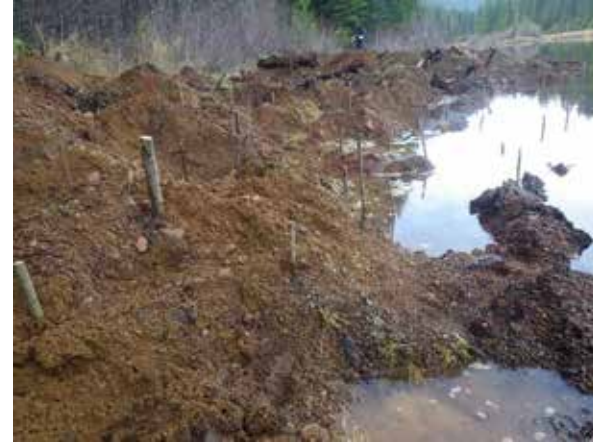
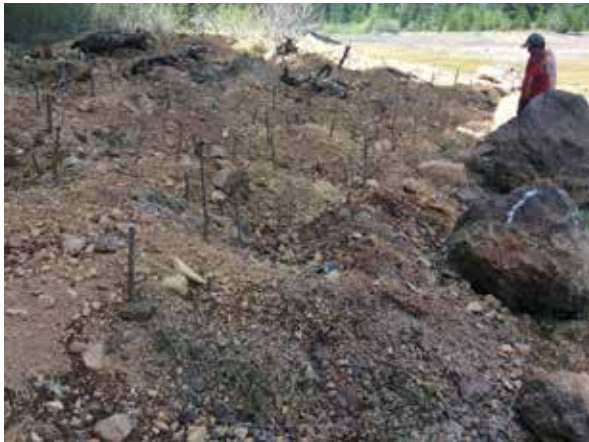
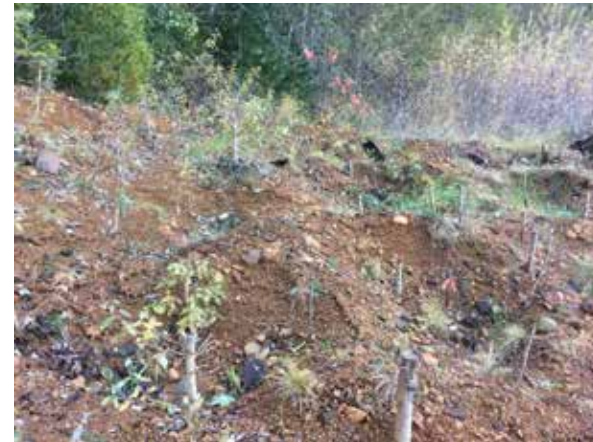
Figure 2. Photopoint monitoring comparison for JHT-PRM07.

Monitoring data recorded within plots representing rough and loose staked treatment (C-1ii, plots JHT-PRM07 and JHT-PRM08) indicated that the success of plants varied by plot within the C-1ii treatment area. An increase in numbers of stems relative to as-built was documented in one of the two monitoring plots (JHT-PRM07) along with high survival (Table 9). In contrast, success at the other plot within the same treatment area was relatively low (57% survival relative to as-built). However, in both treatment areas, the number of stems in monitoring plots had increased substantially relative to baseline (pre-treatment). Stems within the monitoring plots were primarily planted stems; however, naturally regenerating stems were also counted. It was difficult to distinguish between natural regeneration and planted stems for planted species. Photopoint monitoring results (Appendix D) support the increase in growth relative to baseline for treatment C-1ii (i.e., Figures 2 and 3 in Appendix D).

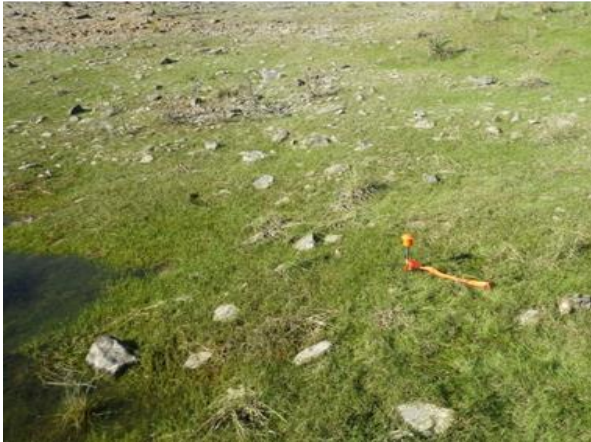
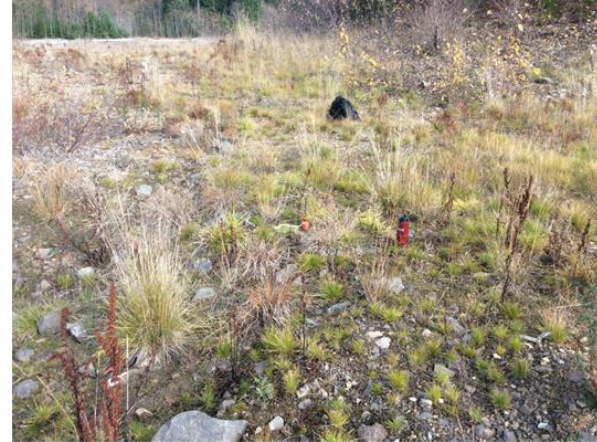
Figure 6. Photopoint monitoring comparison for JHT-PRM26.

the area had been left to regenerate naturally. A decrease in stem numbers since baseline was documented which was likely due to site disturbance incurred during site preparation, and there had been no change since the treatment had been implemented (i.e., no difference in as-built and 2019 stem counts). A reduced stem count relative to baseline was also observed for the control plot (JHT-PRM06/6a); however, this was likely due to high levels of human use or machine damage caused while accessing adjacent areas, although the slight relocation of the plot due to a lost marker made comparison more difficult. Photopoint monitoring results (Appendix D) demonstrate natural regeneration of herbaceous species in the rough and loose treatment (B-1i) monitoring plot (JHT-PRM09) that would have not been captured in the plots that in which only woody vegetation is counted. Photographs also demonstrate the lack of woody vegetation and presence of herbaceous vegetation in the rough and loose treatment (B-1i) polygon (plot JHT-PRM09) (Figure 6 in Appendix D).

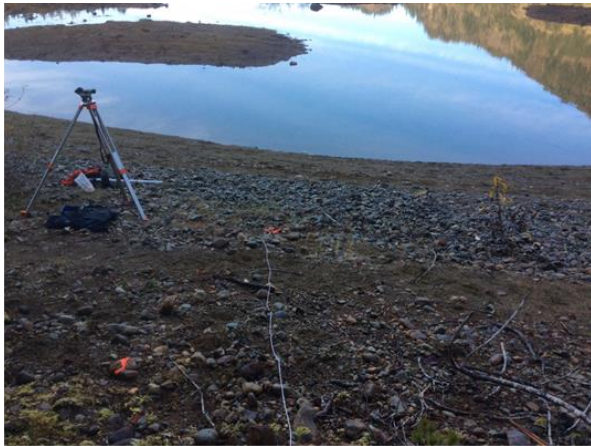
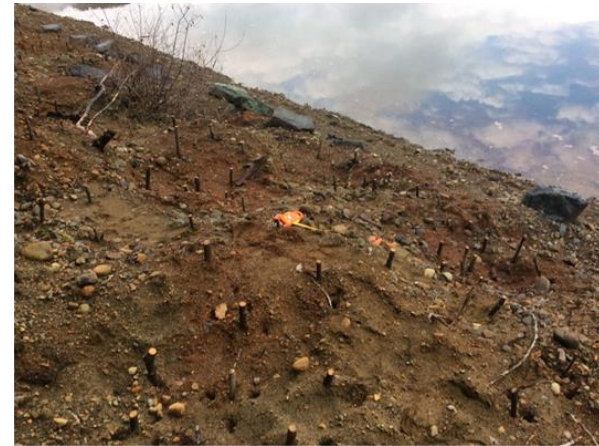
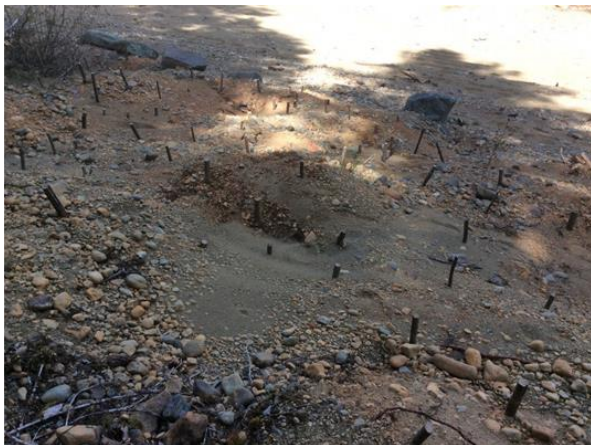
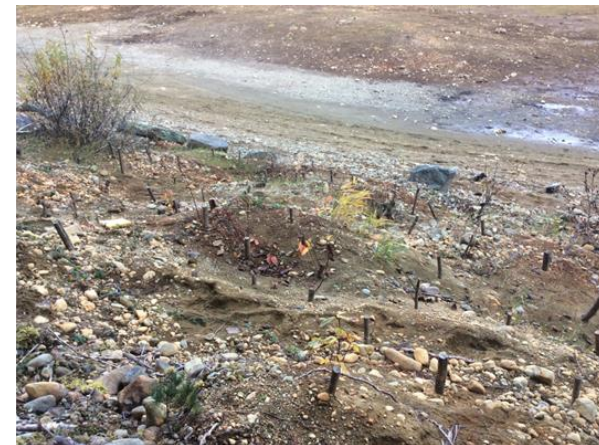
Figure 15. Photopoint monitoring comparison for JHT-PRM51.

Treatments C-1ii and C-2i (JHT- PRM51 and 53) experienced moderate success (numbers of stems in monitoring plots increased since baseline) but had poorest stem survival (~50%) among treatments at this site (Table 10). Photopoint monitoring results (Appendix D) generally support the moderate increase in vegetation cover although stake survival is difficult to discern in the photos (Figures 17 and 19 in Appendix D). A small increase in the number of stems between as-built and 2019 surveys was also documented in the control polygon (treatment C-3; plot JHT-PRM57).

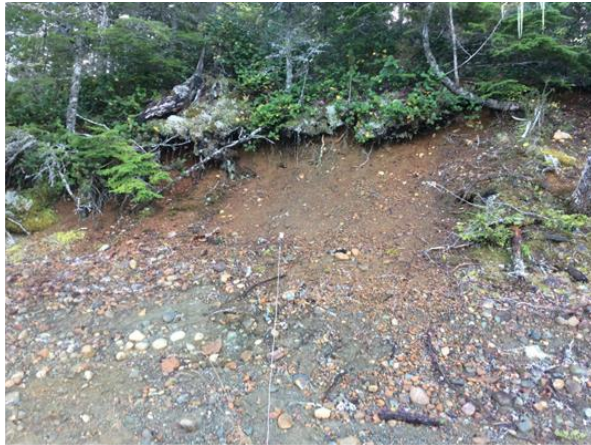
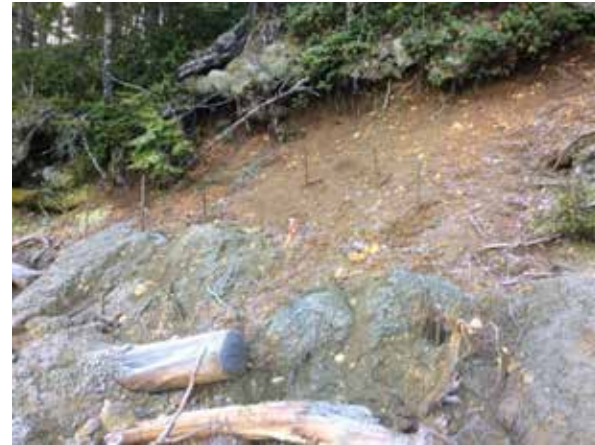
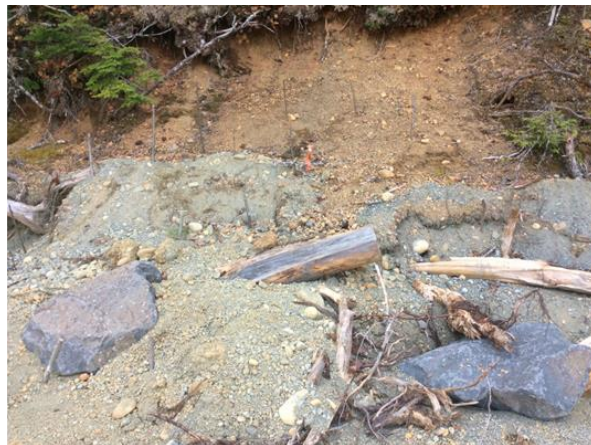
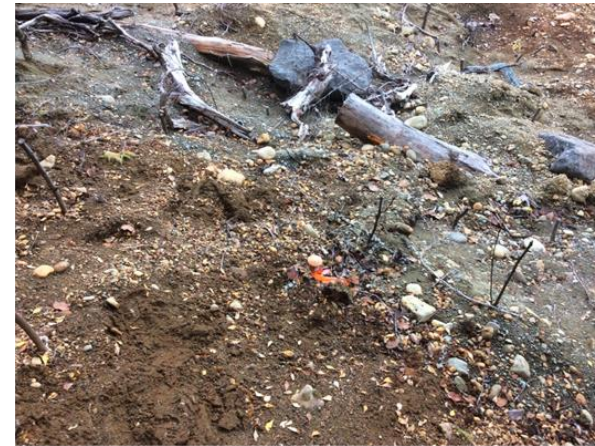
Figure 18. Photopoint monitoring comparison for JHT-PRM54.

The further upland D type treatments had greater success than the slightly lower elevation C type treatments at this site. Stakes planted into terraces prepared with a modified rough and loose treatment (D-3i) had the highest success of all treatments at this site indicating high success in plant establishment. The number of stems in the representative monitoring plot (JHT- PRM54) almost doubled between as-built and 2019 surveys (Table 10). Survival of stakes planted into machine loosened circles (treatment D-2i) was also high (>80% relative to baseline; plot JHT-PRM52). As also noted for the two C type treatments, is difficult to discern stake survival in photographs at this stage in the monitoring program (Figures 18 and 20 in Appendix D).
