**RE: British Columbia Utilities Commission (BCUC or Commission)
British Columbia Hydro and Power Authority (BC Hydro)
Vancouver Power Outage – November 4, 2020
BCUC Staff Questions**

BC Hydro writes to provide its responses to BCUC staff questions regarding a recent power outage on the west side of Vancouver that occurred on November 4, 2020 (**Outage**).

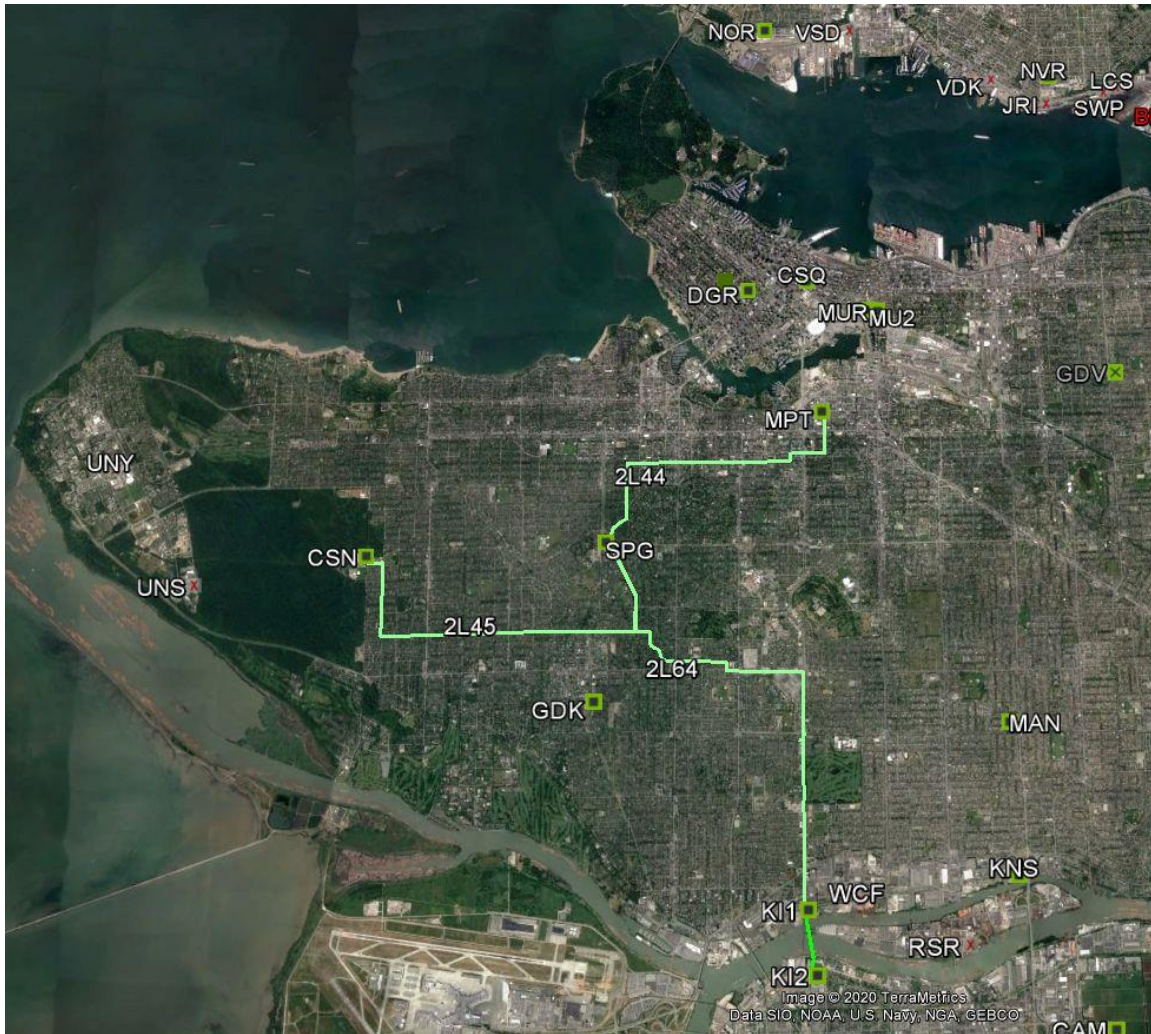
Figure 1 SPG Substation and Associated 230 kV Circuits

Sperling (SPG) substation is a 230 kV/12 kV facility that supplies power to about 62,000 customer accounts in the west-central Vancouver area. It is located at the southwest corner of Arbutus street and King Edward avenue ([Figure 1](#) and [Figure 2](#)). SPG substation also contains a 60 kV switchyard which was not involved in the Outage.

As shown in [Figure 1](#) and [Figure 2](#), the SPG substation is normally connected to the grid by three 230 kV underground circuits, 2L44, 2L45, and 2L64, which tie SPG substation to Mount Pleasant (MPT), Camosun (CSN), and Kidd 2 (KI2) substations respectively.

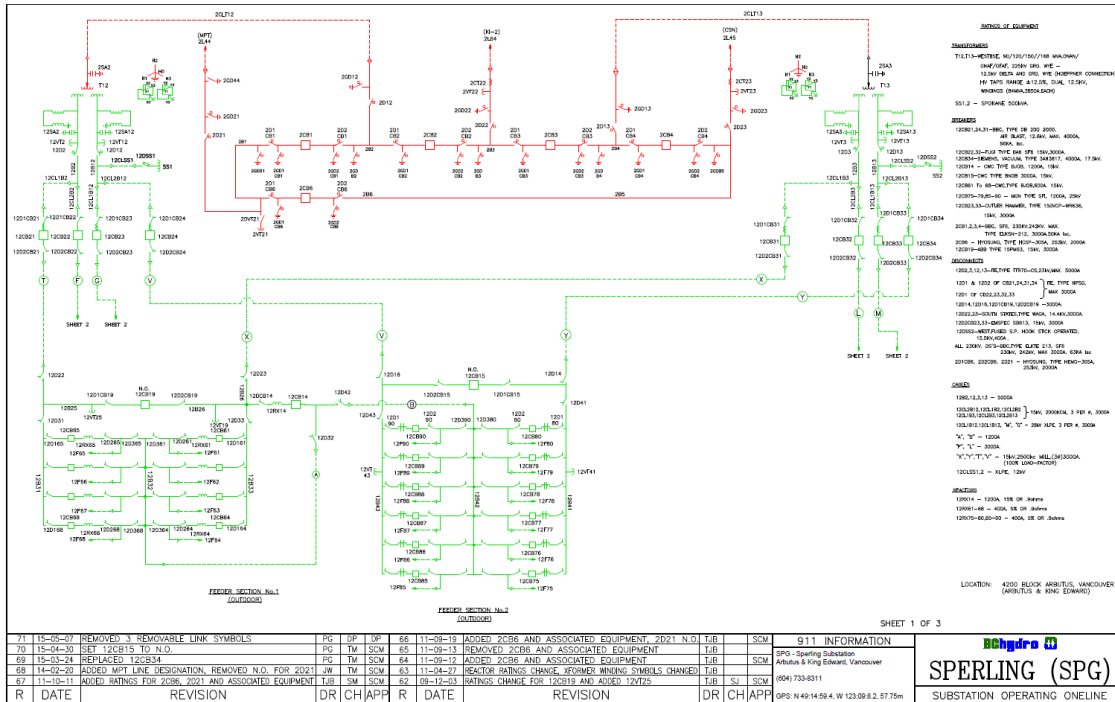
Figure 3a SPG substation Operating One Line Diagram

For safety reasons, and due to the SPG substation configuration, the isolation zone for this work included both circuit 2L64 and transformer T12, which were de-energized. The 230 kV circuit breakers 2CB1 and 2CB3 at SPG substation were also in an open state as part of the planned outage of circuit 2L64. Electricity supply to customers fed from SPG substation was via circuits 2L44 and 2L45 and transformer T13 to the 12 kV distribution network ([Figure 3b](#)).

[Figure 3a](#) shows in part, the substation Operating One Line Diagram of the SPG substation. [Figure 3b](#) shows the Energy Management System operating display just prior to the Outage. The yellow circled area in [Figure 3b](#) represents part of the substation that was out of service for the planned maintenance work.
