**Board briefing – DAM SAFETY QUARTERLY REPORT**
**Executive Summary**

**Risk Profile of BC Hydro's Dam**
**Dam Safety Contribution to Enterprise Risk**

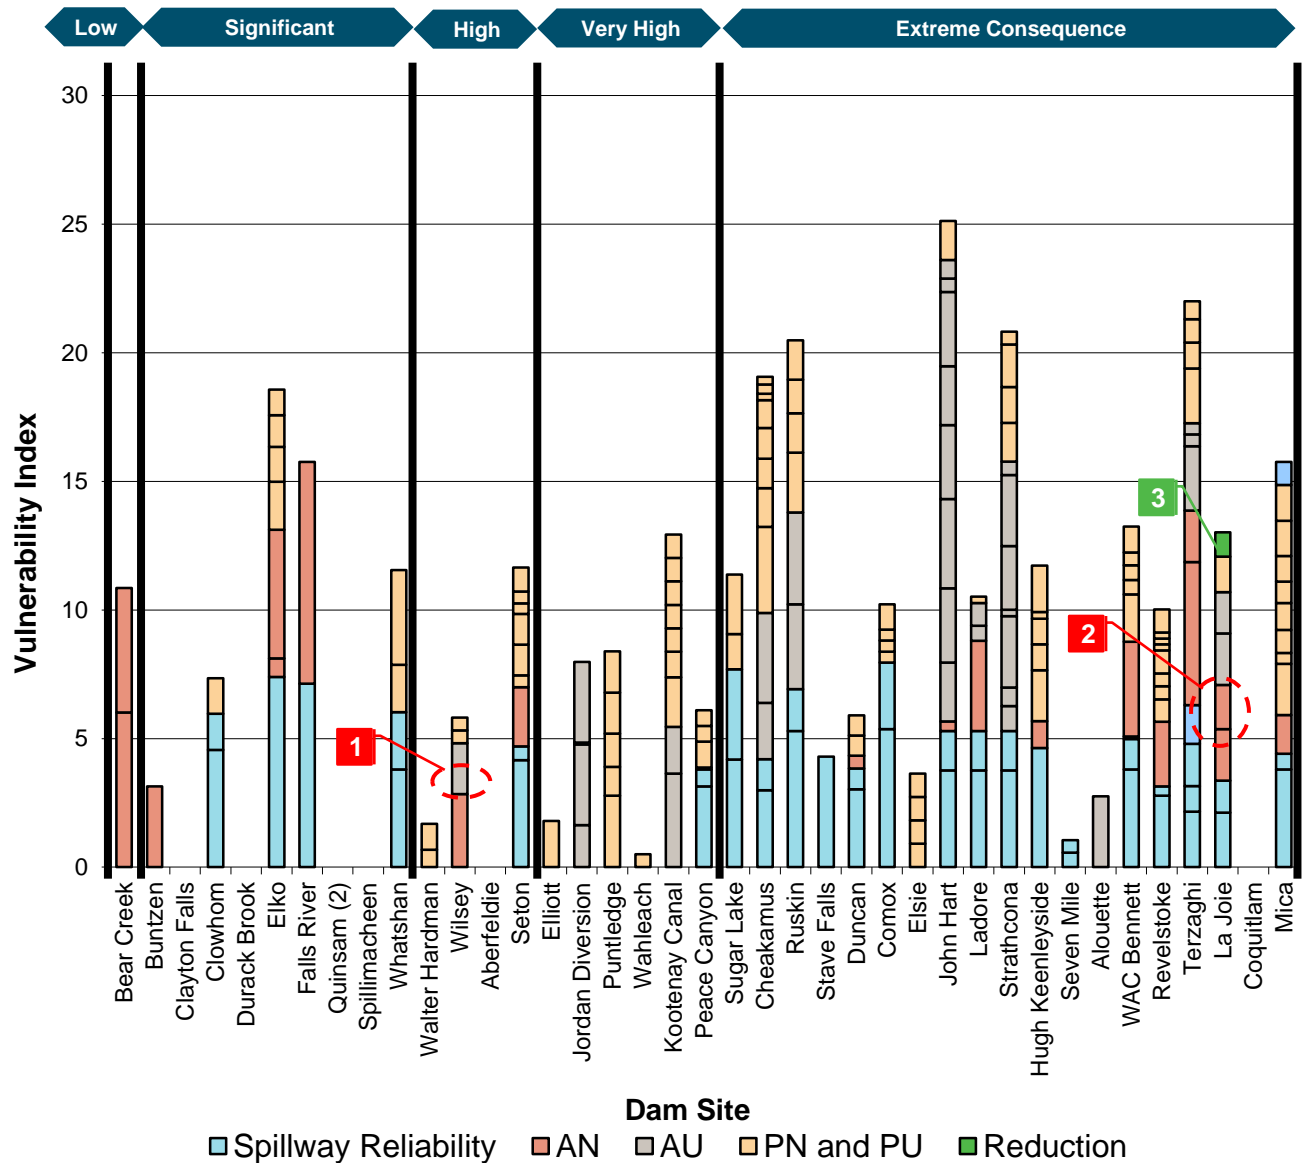
The Dam Safety Program has been executed in a manner that is consistent with its stated objectives throughout the reporting period. The overall Dam Safety risk profile is shown in Figure 1. There has been a slight overall increase in assessed risk this quarter with the re-evaluation and reclassification of pre-existing issues at La Joie and Wilsey Dams.

The Vulnerability Index for each currently identified issue at each dam site is shown in Figure 1. Dams are sequenced from left to right in order of increasing downstream consequences, per the BC Dam Safety Regulation. Notable changes in Vulnerability Index in F2019 Q4 are described below and identified on Figure 1.

**Figure 1** Dam Safety overall risk profile at the end of F2019 Q4, as represented by the Vulnerability Index. Notable changes are identified.

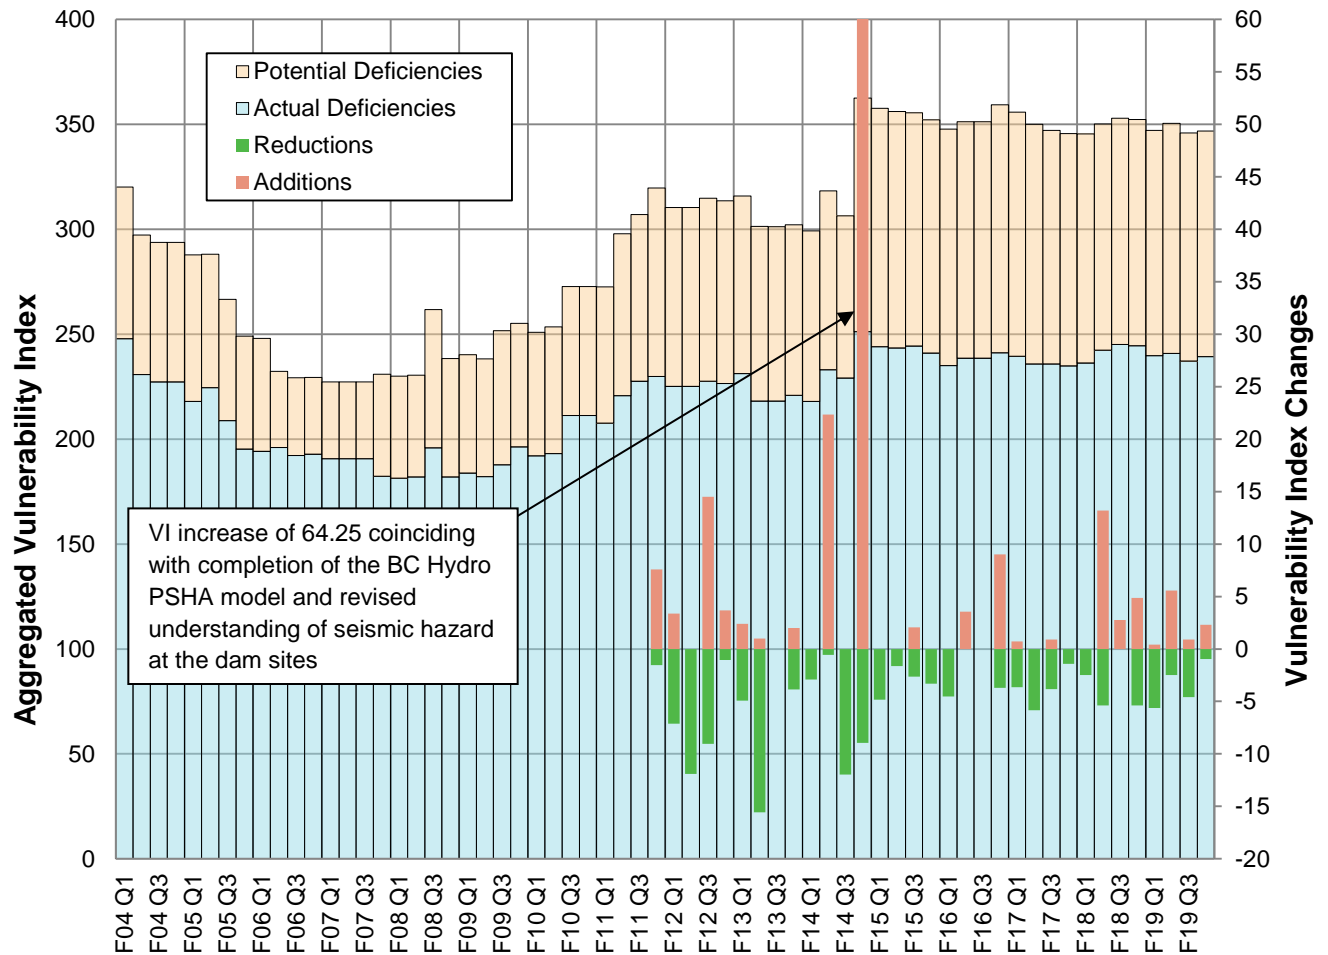
Changes in Vulnerability Index for actual and potential deficiencies—including those related to spillway reliability—aggregated across the entire fleet of dams, are tracked on a quarterly basis and shown in Figure 2. This is an indication of the changes in the understanding of BC Hydro's dam safety risk profile. Additions are due to the development or recognition of new issues. Reductions are due to risk remediation projects delivered through the Capital Plan, completed repairs and corrective maintenance, and resolution of issues via Dam Safety Investigations. Existing issues are re-examined on a regular basis and re-rated as required. These changes—additions and reductions—have been tracked since the end of Fiscal Year F2011.

The red and green bars—additions and reductions in Vulnerability Index, respectively—indicate that in any given quarter there has been activity within the Program to identify new issues, update our understanding of these issues, and actively mitigate or eliminate them. This is one indicator of a healthy Dam Safety Program.

**Figure 2** Changes and trends in the Vulnerability Index aggregated across the BC Hydro system. Note: the bars are “stacked” such that total aggregated Vulnerability Index is given by the top of the Potential Deficiencies bar.

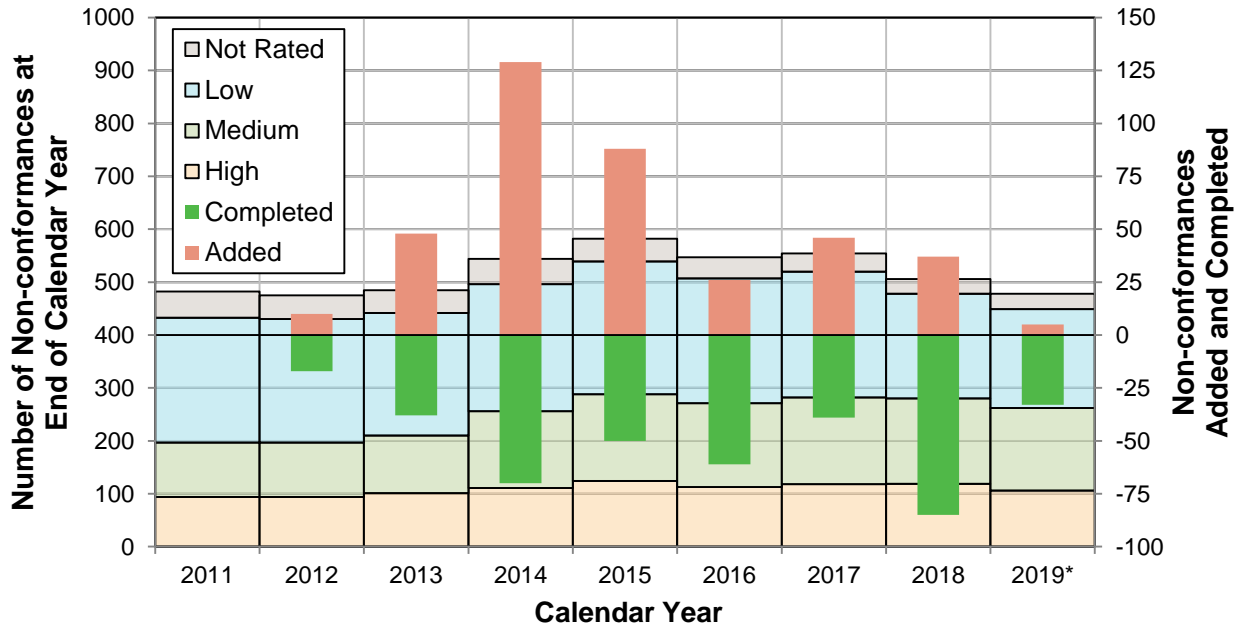
A question that had arisen within Dam Safety is how well these non-conformances have been managed and whether significant additional effort needs to be expended in their correction. We have begun to track and analyze performance in this regard. Figure 3 shows the number of non-conformances in the Dam Safety Database at the end of each calendar year from 2011 onward. The tan, light green, blue and grey bars break them down into High, Moderate, Low and unrated issues, respectively. These are stacked so as to indicate the total number, which is seen to have varied from just under 500 to just under 600 issues at the end of any given year. Roughly 100 of these issues have been considered to be of High priority in any given year. Figure 3 also shows the numbers of non-conformances added and completed (resolved)—in red and green bars, respectively—through the course of each year.

Since the end of 2015, there has been a slightly downward annual trend in the overall number of non-conformances, with a net decrease of just over 100 issues, or 18%, over that period. There has also been substantial activity in identifying and addressing issues, with 25 to 50 added and 40 to 85 completed in each of those years. With specific regard to High priority non-conformances, since the end of 2015 there have in total been 24 new issues added and 39 issues closed. These figures are indicative of a reasonably healthy level of activity in reviewing the Program and, at least to the extent that overall numbers have been contained, in addressing these non-conformances.

**Figure 3** Changes and trends in the total number of non-conformances within the Dam Safety Program. This data is plotted by *calendar year*. (\*2019 reflects only the first three months—January through March—of the year.)

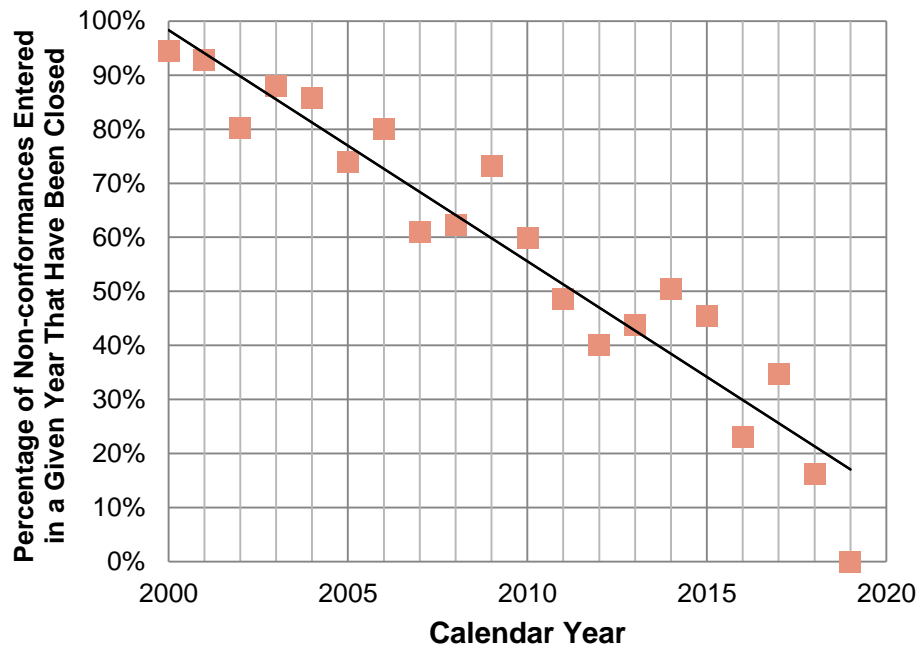
**Figure 4** Percentage of non-conformances entered into the Dam Safety Database in any given year that have since been resolved and completed.

Dam Safety is endeavouring to more closely track non-conformances and to understand and, if warranted, improve their rate of closure. This work is just beginning, but early results are available. Figure 4 plots the percentage of non-conformances that have been closed against the year in which they were first entered into the database. The trend line indicates that about five percent of all the non-conformances that are entered into the system in any one year are resolved and completed in any successive year, *i.e.*, that it's taking approximately 20 years to fully close out all the non-conformances that arise in any one year. We have not yet broken this closure rate out into High, Moderate and Low non-conformances, and will do so as a part of our coming round of assessment.

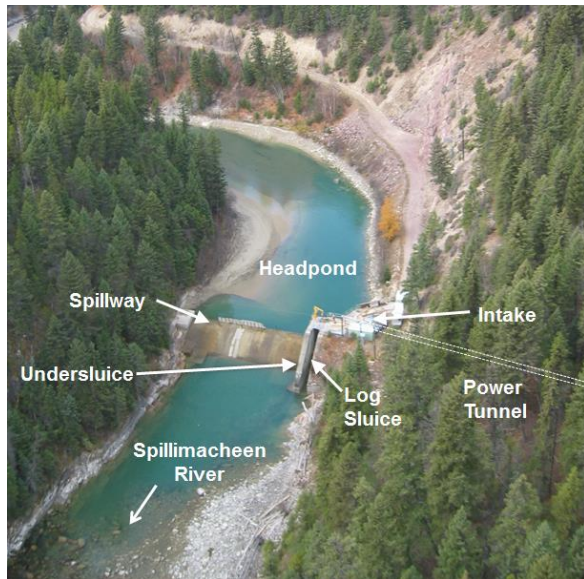
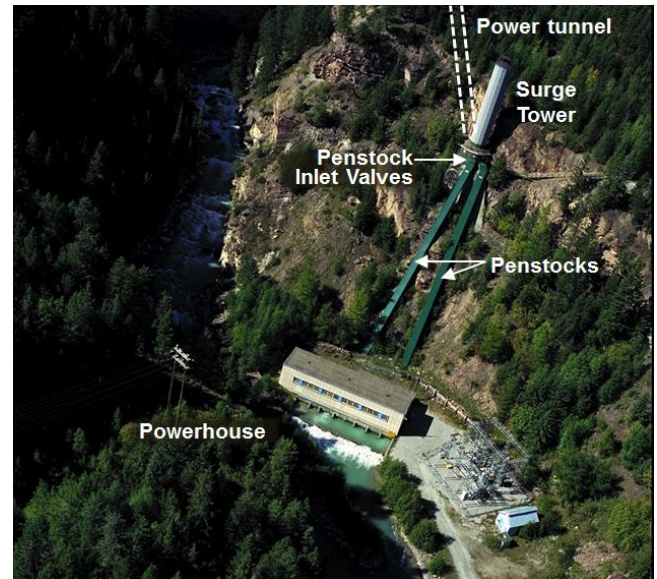
In the very early hours of March 15, 2019, while Spillimacheen was offline for maintenance, Stations Field Operations personnel from Invermere were dispatched to respond to an alarm signalling an overflow condition in the powerhouse sump. Upon arrival, the crew observed the powerhouse to be flooded and water cascading down the penstock slope. The crew determined the source of the leak was Penstock 01/02, near the Penstock Inlet Valve PIV01/02, located as shown in the right hand photo of Figure 5. Photos showing the water leakage later that morning (in daylight) are in Figure 6.

**Figure 5** Spillimacheen Dam (left) and Spillimacheen Generating Station (right).

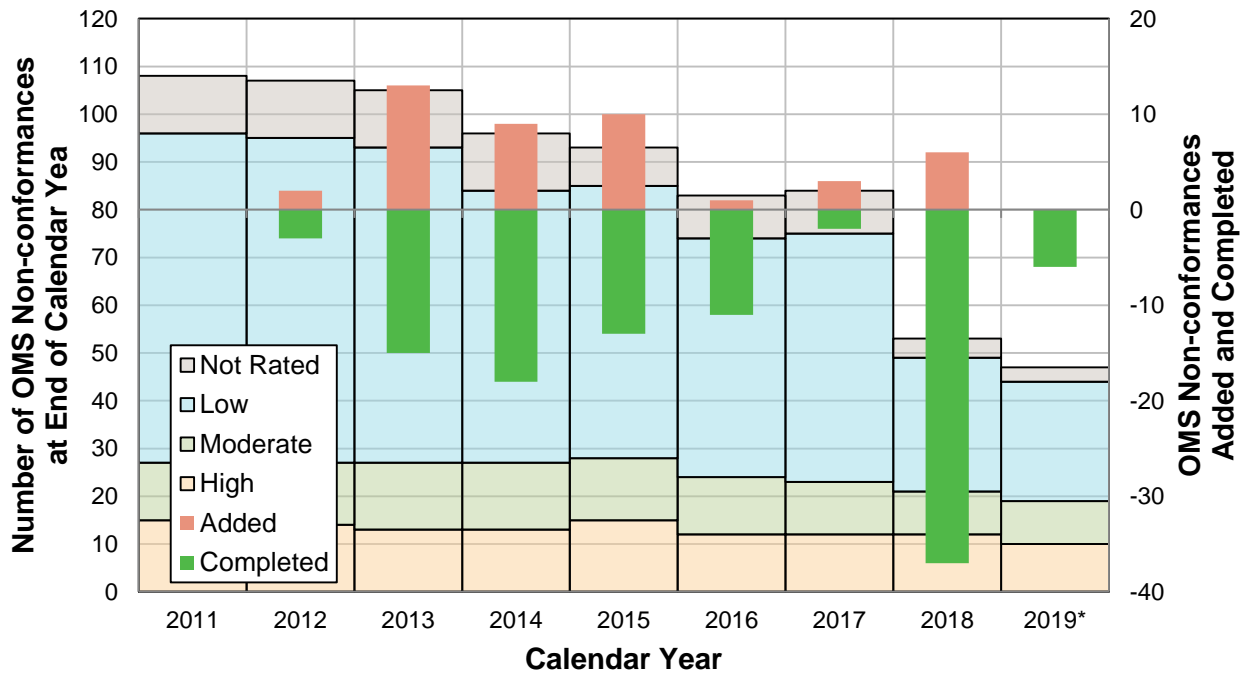
**Figure 8** Changes and trends in the number of OMS non-conformances. This data is plotted by calendar year. (\*2019 reflects only the first three months of the year.)

The significance of the updates to the OMS Manuals is illustrated in Figure 8, which shows the number of OMS non-conformances in the Dam Safety Database at the end of each calendar year from 2011 onward. This figure is similar to Figure 3 which was discussed in some detail earlier in the report. What is notable in Figure 8 is the very great reduction in OMS non-conformances that has been achieved over the past few years. Although the number of updates that were fully completed lagged behind the plan, it can be seen that much progress was made, nevertheless. Through the remainder of 2019 and 2020, the planned OMS Manual updates will close approximately one-half of the remaining non-conformances and 5 of the 10 issues rated as High, at which point the number of OMS non-conformances will be structural. *i.e.*, the number that must naturally arise in accordance with regular reassessments and the regulated and manageable schedule for OMS Manual updates.

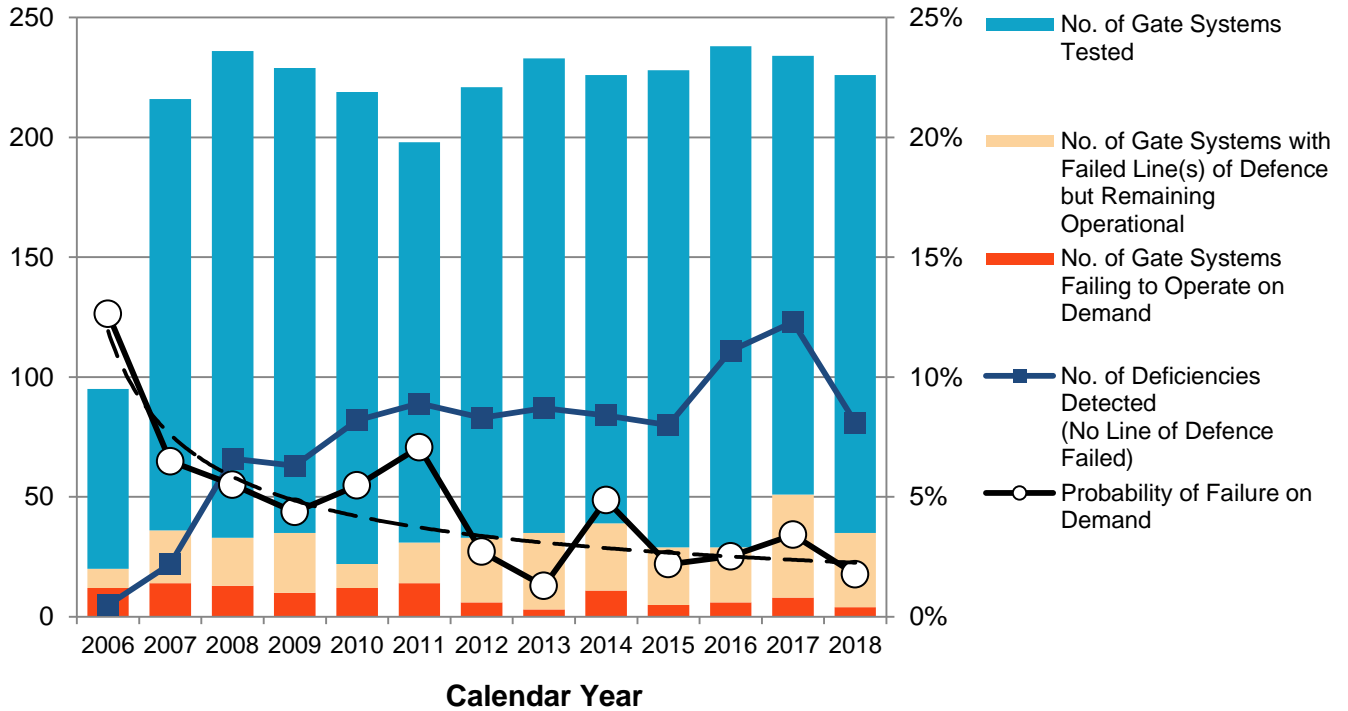
Since 2006, when improved reliability of flood discharge (spillway) gates was identified as a priority in and the Dam Safety Program was adjusted to provide better stewardship of our spillway gates systems through regular maintenance and testing and capital upgrades, there has been a notable improvement in the rates of failure to operate on demand during scheduled tests. As illustrated in Figure 9, rates of failure have decreased by nearly a full order of magnitude.

**Figure 9** Deficiencies detected and rates of failure to operate on demand during flood discharge gate testing.

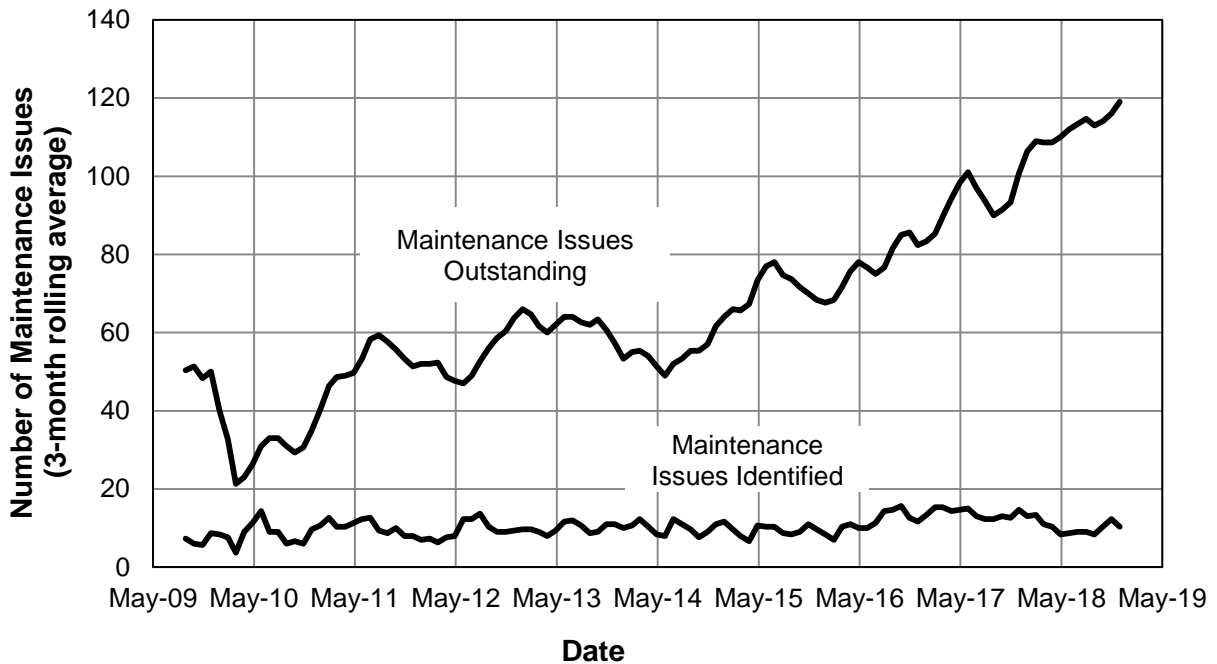
Dam Safety has been monitoring the identification and resolution of these issues. Figure 10 shows the overall number of outstanding maintenance issues related to flood discharge gate systems from 2009 to 2019. It is clear from this figure that there has been a significant increase in the number of outstanding issues since 2016.

**Figure 10** Number of identified and outstanding spillway gate maintenance issues identified and retained on a monthly basis.

Outstanding spillway gate maintenance issues and progress in closing them will be reported regularly to the Capital Project Committee in future quarterly reports.
