DAM SAFETY QUARTERLY REPORT

QUARTERLY FEATURED DAMSITES – KOOTENAY CANAL

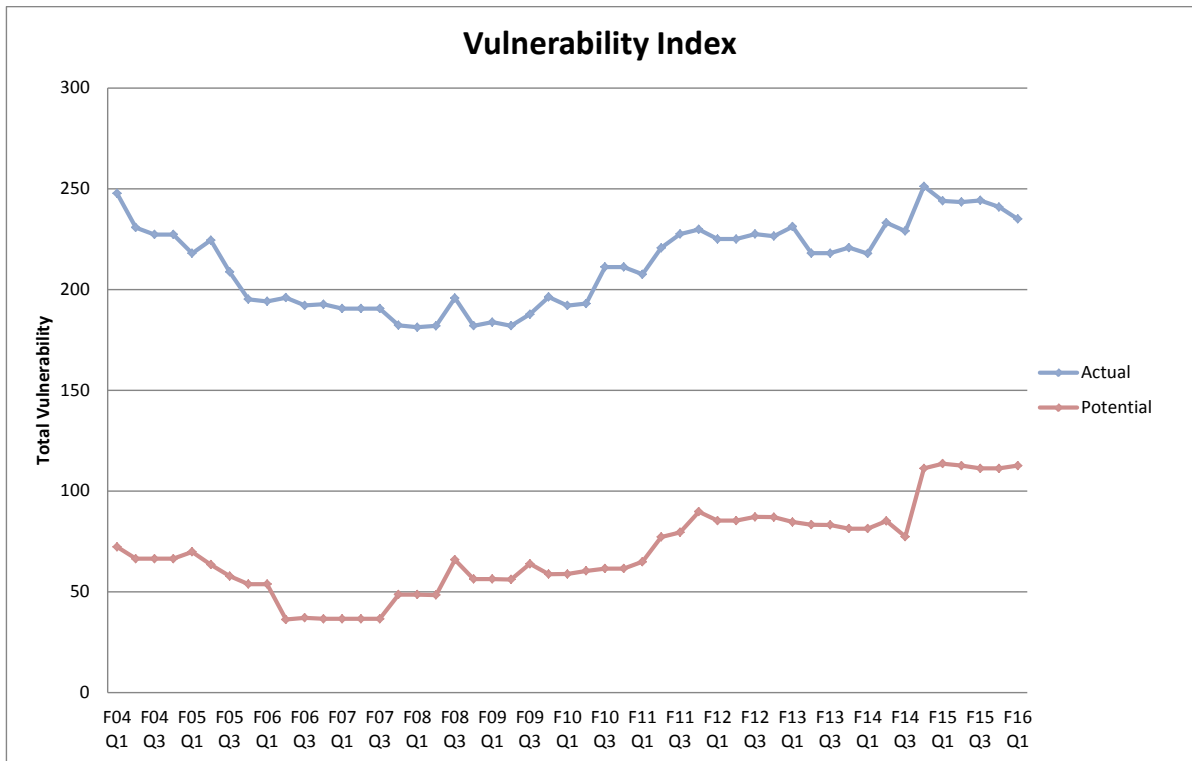
FIGURE 2 – CHANGE IN VULNERABILITY INDEX

Changes in Vulnerability Index for actual and potential deficiencies, as outlined in Figure 1, are tracked on a quarterly basis and shown on Figures 2 and 3. This is an indication of the changes in the understanding of the dam safety risk profile.

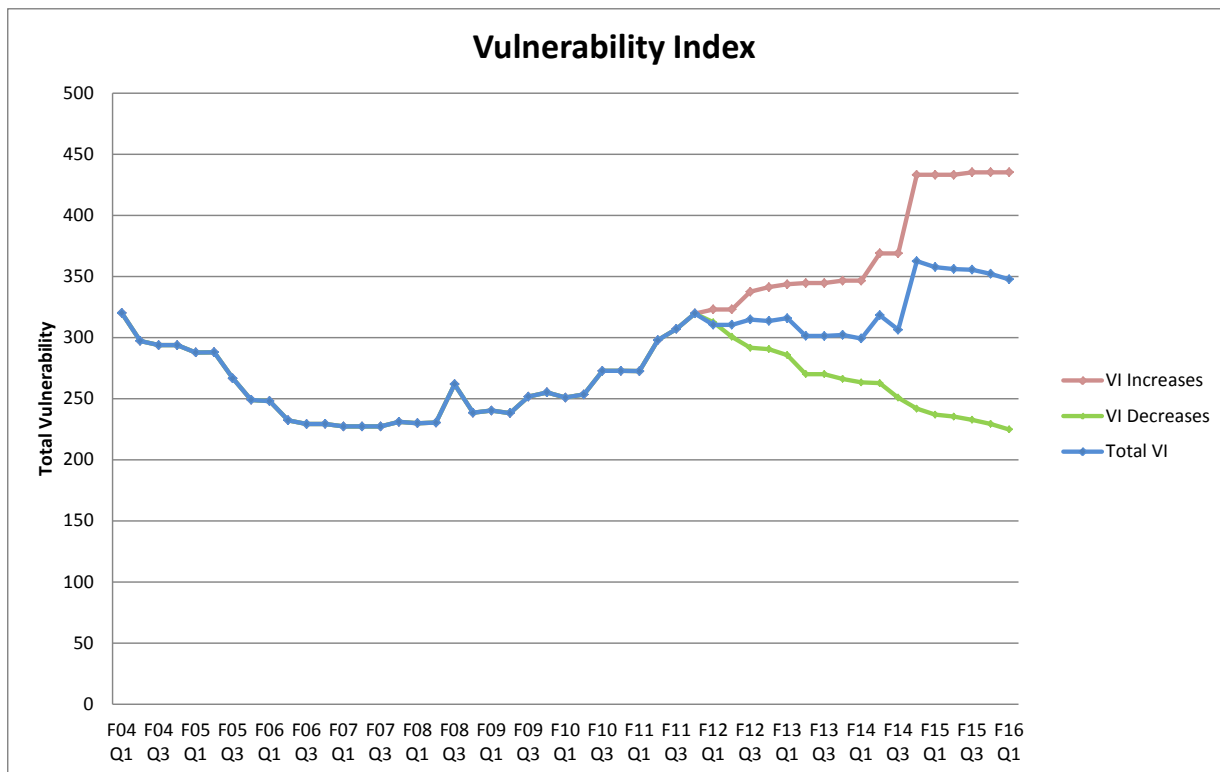
FIGURE 3 – CHANGE IN VULNERABILITY INDEX COMPONENTS

In Figure 3, the total index is shown (sum of actual and potential deficiencies), as well as separate plots for decreases and increases in the total index. Decreases are due to remediation projects as per the Capital Plan and resolution of issues via Performance Investigations. Increases in the index are due to the recognition of new issues. Existing issues are re-examined on a regular basis, and re-rated as required.
