## 13: Quarterly Dam Safety Report

### Executive summary

The purpose of this report is to update the Operations, Planning, Safety and Information Technology Committee of the Board of Directors on key dam risk management activities during the period from July 1 to September 30, 2024 (F2025 Q2) and to provide reasonable assurance that the safety of dams operated by BC Hydro continues to be managed to the established guidelines and criteria of the Dam Safety Program. To keep the Committee as fully abreast of the Dam Safety Program as possible, some notable developments that took place after September 30, 2024, but before the completion of this report have also been included.

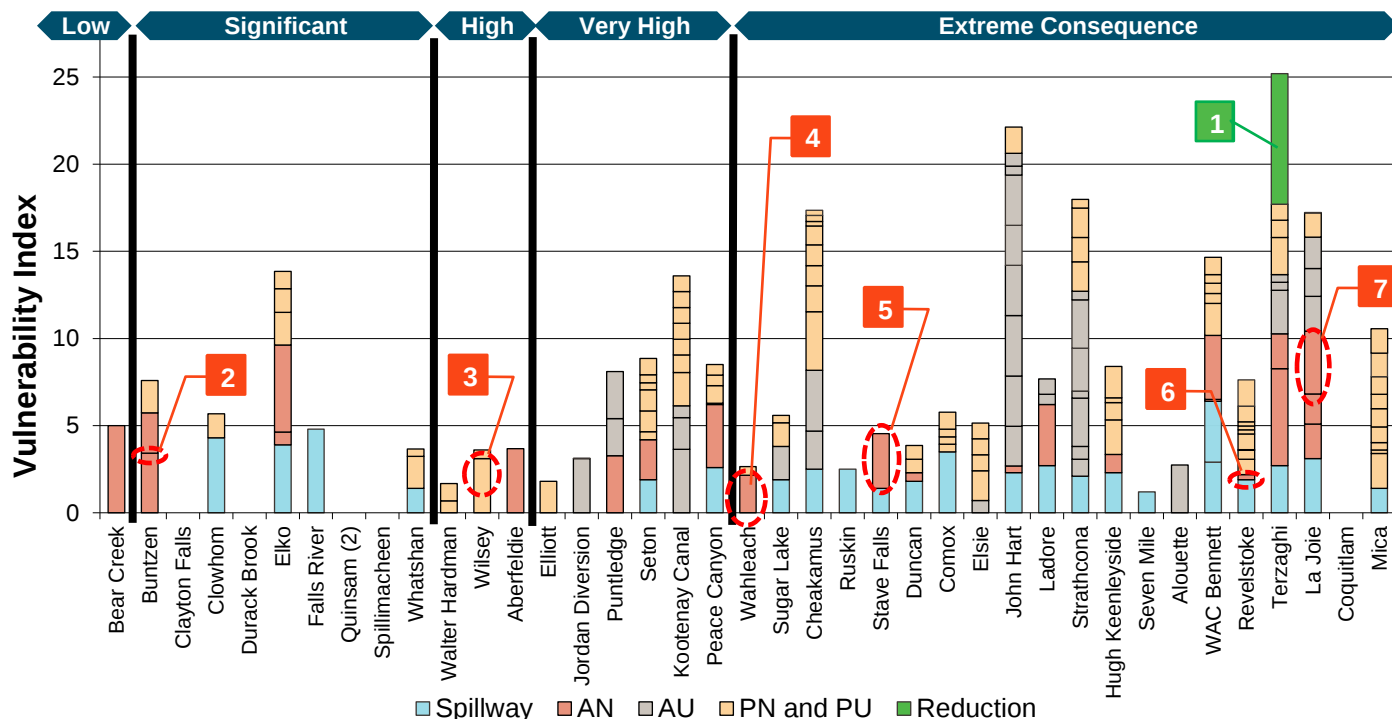
**Figure 1** Dam Safety overall risk profile at the end of F2025 Q2, as represented by the Vulnerability Index. Changes this quarter are indicated by the numbered boxes.

- 1** A **reduction** of 7.5 (Actual Normal deficiency) at **Terzaghi Dam**.  
The rockfall into the Terzaghi Dam spillway reported in F2024 Q4 has been cleared and no significant damage was observed during the recent inspection. See “Update on Existing Issues” on page 6 for additional information.

- 2** An **addition** of 0.29 (Actual Normal deficiency) at **Buntzen Dam**.  
The penstock at Buntzen may be damaged if flood flows enter the penstock corridor from either a spillway breach or overtopping of the dam. This issue is not new but has been reassessed and rerated as part of an annual review of database issues.

- 3** An **addition** of 2.85 (Potential Normal deficiency) at **Wilsey Dam**.  
Dredging to remove sediments from headpond and upstream face of Wilsey Dam was performed in August 2019. (See the F2020 Q2 Quarterly Dam Safety Report.) During the most recent formal inspection, however, it was observed that sediments had again accumulated on the dam face to an elevation that now exceeds the level for adequate sliding stability (*i.e.*, with a desired factor of safety) of the so-called “plug dam” at the arch dam’s base. This elevation was calculated by a simplified analysis that neglects some stabilizing features for the plug dam. Due to the expected conservatism of the calculations, this deficiency is characterized as a potential rather than an actual deficiency.

- 4** An **addition** of 2.15 (Actual Normal deficiency) at **Wahleach Dam**.  
Ongoing, slow displacements of the slope above the Wahleach powerhouse have been monitored and recorded since construction of the power tunnel through the slope in 1952. This issue has been newly entered as part of an annual review of database issues.

- 5** An **addition** of 3.15 (Actual Normal deficiency) at **Blind Slough Dam (Stave Falls)**.  
The spillway boom has deteriorated to the point where it would not be expected to effectively prevent debris from blocking the spillway during a large inflow event. While it performed satisfactorily during the atmospheric river event of November 2021 (about a one-in 30-year event), it might not withstand a larger event with higher debris load. The boom is scheduled to be replaced under the GM-0344 Reservoir Booms Replacement project, with a target in-service date in the spring of 2025.

- 6** An **addition** of 0.3 (Actual Normal deficiency) at **Revelstoke Dam**.  
The facility is currently operated using the Outlet Works Maintenance Gates as the normal water barrier, degrading gate reliability since both the Maintenance Gates and Operating Gates must be operated to discharge flow. This issue is not new but has been reassessed and rerated as part of a review of spillway gate database issues.

- 7** An **addition** of 3.6 (Actual Normal deficiency) at **La Joie Dam**.  
Intake Operating Gates 3 and 4 are in poor condition, are not able to be used as Single Device Isolation equipment and are unable to close under flow. Their condition has been previously noted in several Quarterly Dam Safety Reports, beginning in F2022 Q1. Replacement of these gates is planned to be completed in F2026 under the La Joie Dam Intake Operating Gate and Follower Replacement project.
