Executive summary

The purpose of this report is to update the Operations, Planning, Safety and Information Technology Committee of the Board of Directors on key dam risk management activities during the period from July 1 to Sept 30, 2025 (F2026 Q2) and to provide reasonable assurance that the safety of dams operated by BC Hydro continues to be managed to the established guidelines and criteria of the Dam Safety Program. To keep the Committee as fully abreast of the Dam Safety Program as possible, some notable developments that took place after Sept 30, 2025, but before the completion of this report have also been included.

10 Quarterly Dam Safety Report

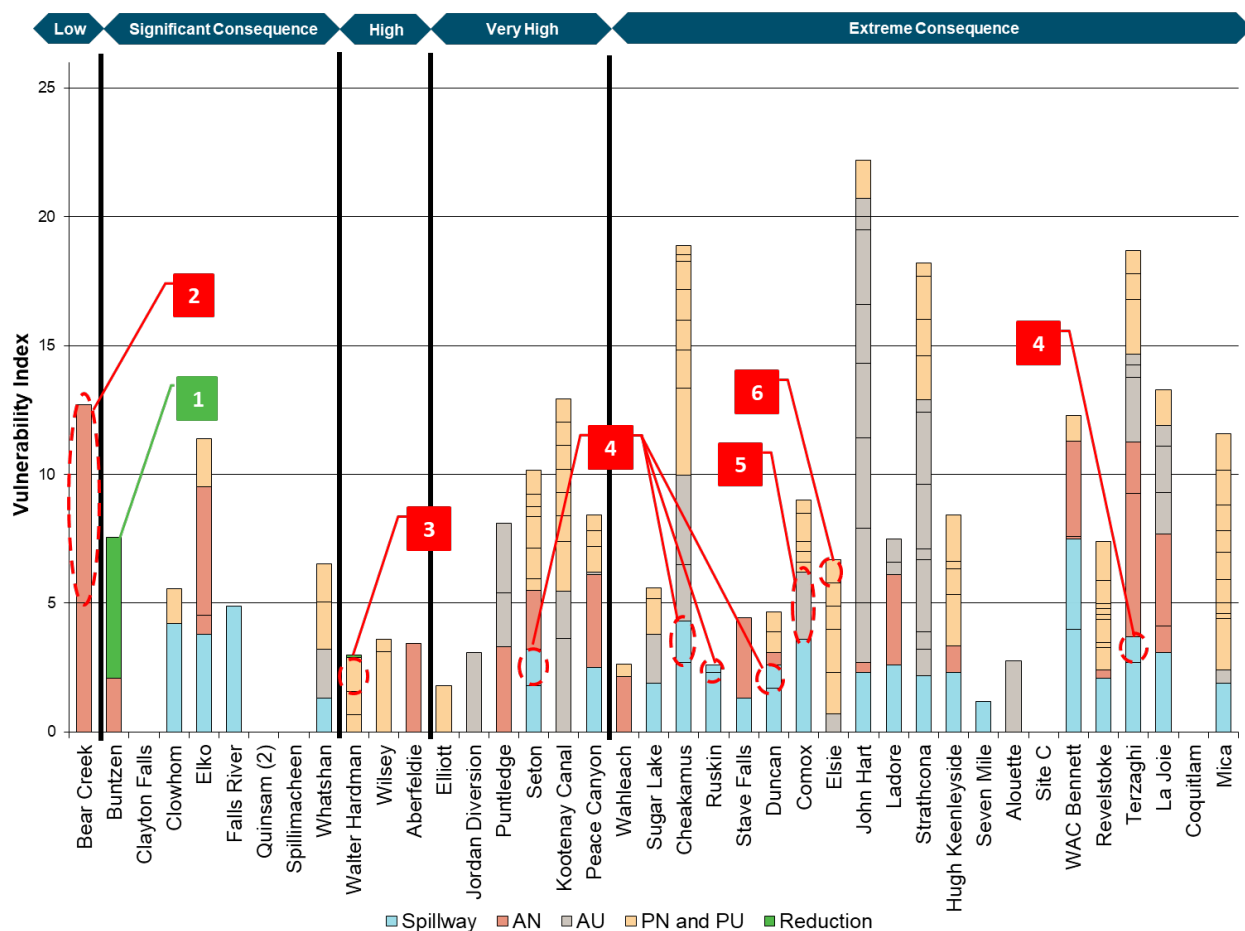
Figure 1 Dam Safety overall risk profile at the end of F2026 Q2, as represented by the Vulnerability Index. Changes this quarter are indicated by the numbered boxes.

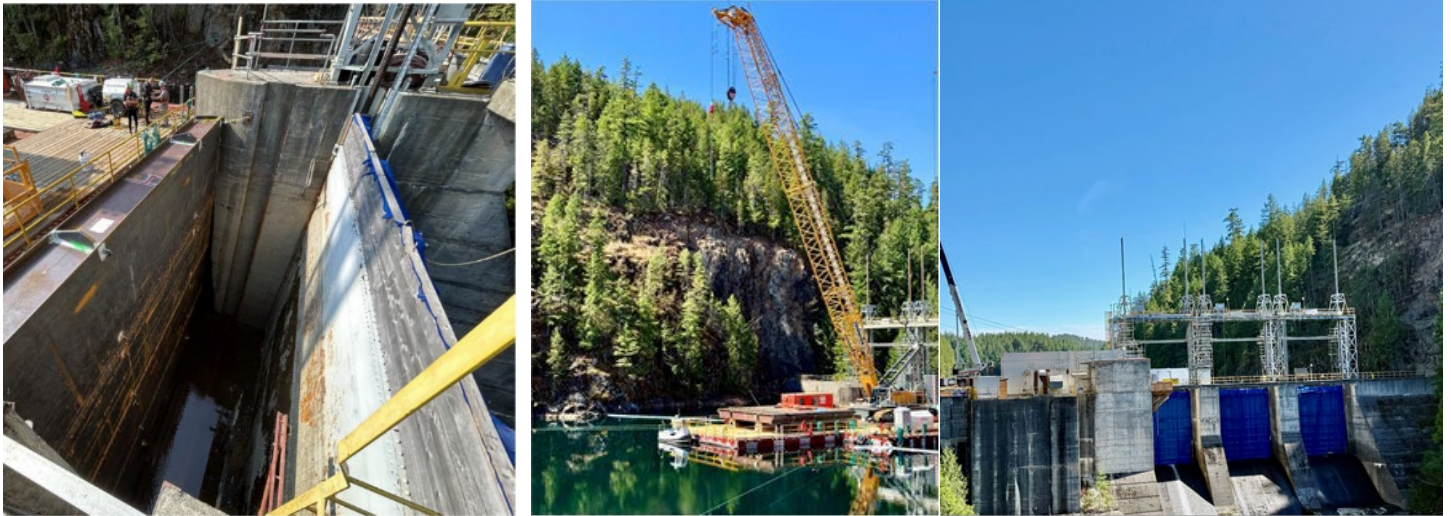
Figure 8 Ladore Dam. Left: Installation of Gate 3 bulkhead, Middle: Upstream view, Right: Downstream view

In fall of 2025, upgrade work on Spillway Gate 3 will begin, and replacement of that spillway gate and its hoist system is planned for completion in 2026. Spillway Gate 2 will be replaced in 2027, and Spillway Gate 1 will be placed in 2028.

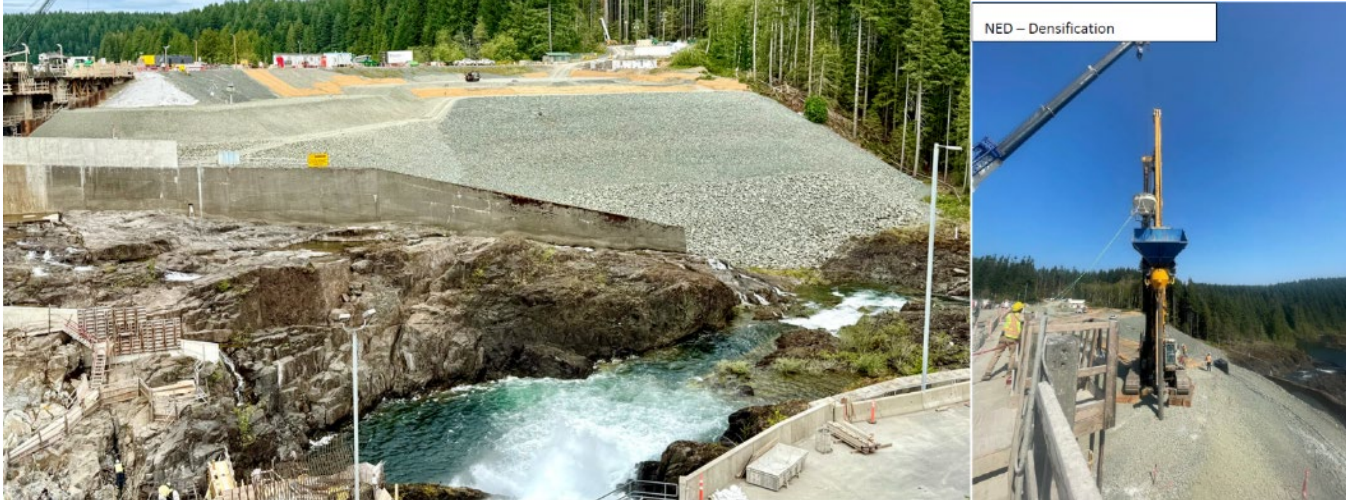
Figure 9 Downstream side of the John Hart North Earthfill Dam and the downstream berm and ground improvements

The hydromechanical request for proposal is scheduled for release in fall 2025. The approximate three years of hydromechanical work is planned to begin in summer 2027, immediately following the completion of the current civil work upgrades in spring 2027.
