### Executive summary

The purpose of this report is to update the Operations, Planning, Safety and Information Technology Committee of the Board of Directors on key dam risk management activities during the period from Oct 1 to Dec 31, 2025 (F2026 Q3) and to provide reasonable assurance that the safety of dams operated by BC Hydro continues to be managed to the established guidelines and criteria of the Dam Safety Program. To keep the Committee as fully abreast of the Dam Safety Program as possible, some notable developments that took place after Dec 31, 2025, but before the completion of this report have also been included.

## 6 Quarterly Dam Safety Report

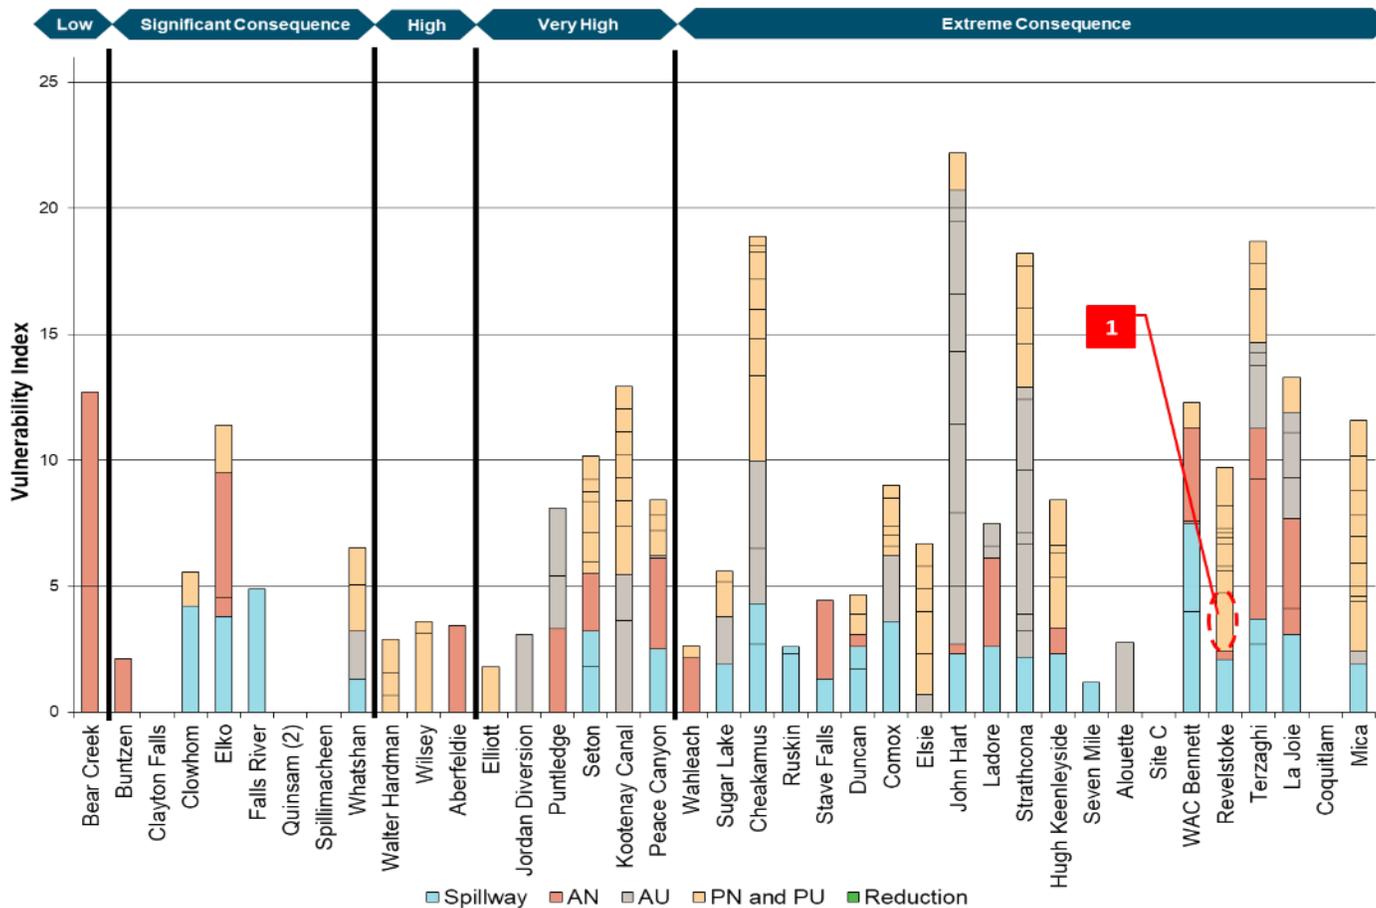
**Figure 1** Dam Safety overall risk profile at the end of F2026 Q3, as represented by the Vulnerability Index. Changes this quarter are indicated by the numbered boxes.

The Revelstoke Dam Safety Review identified that the spillway chute can only pass about 36% of the design flow before overtopping of the chute walls due to bulking of the flows caused by aeration slots. The aeration slots were added to the design of the spillway late in the process to reduce the risk of cavitation. An external review by Peter Mason has confirmed BC Hydro's earlier findings that the risk of cavitation is low and that the aeration slots are likely not required. Plans to restore the spillway chute to its design capacity are being explored.

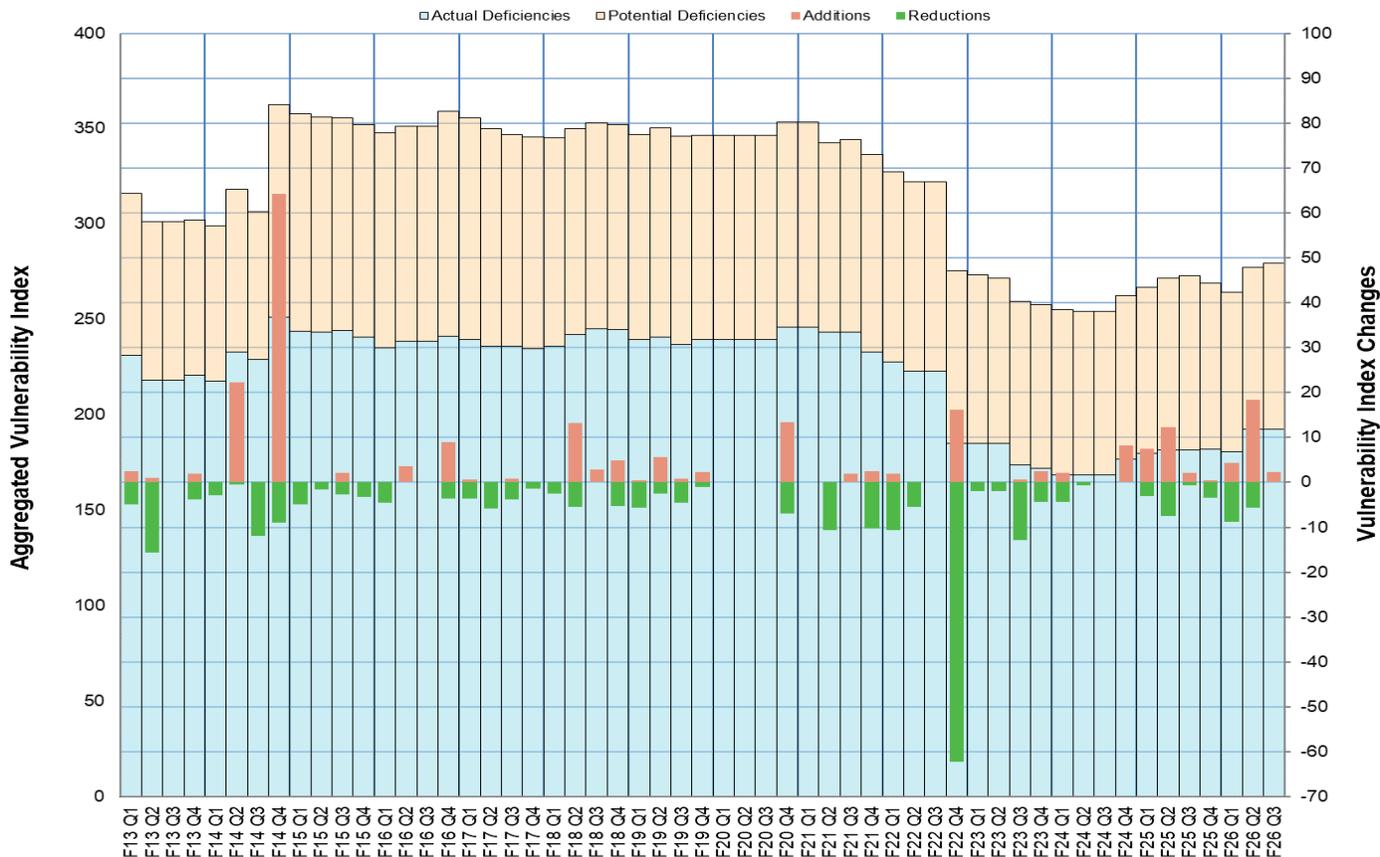
**Figure 2** Historical and forecast changes and trends in the Vulnerability Index aggregated across the BC Hydro system. Note: In this chart, Spillway deficiencies are included as Actual deficiencies.

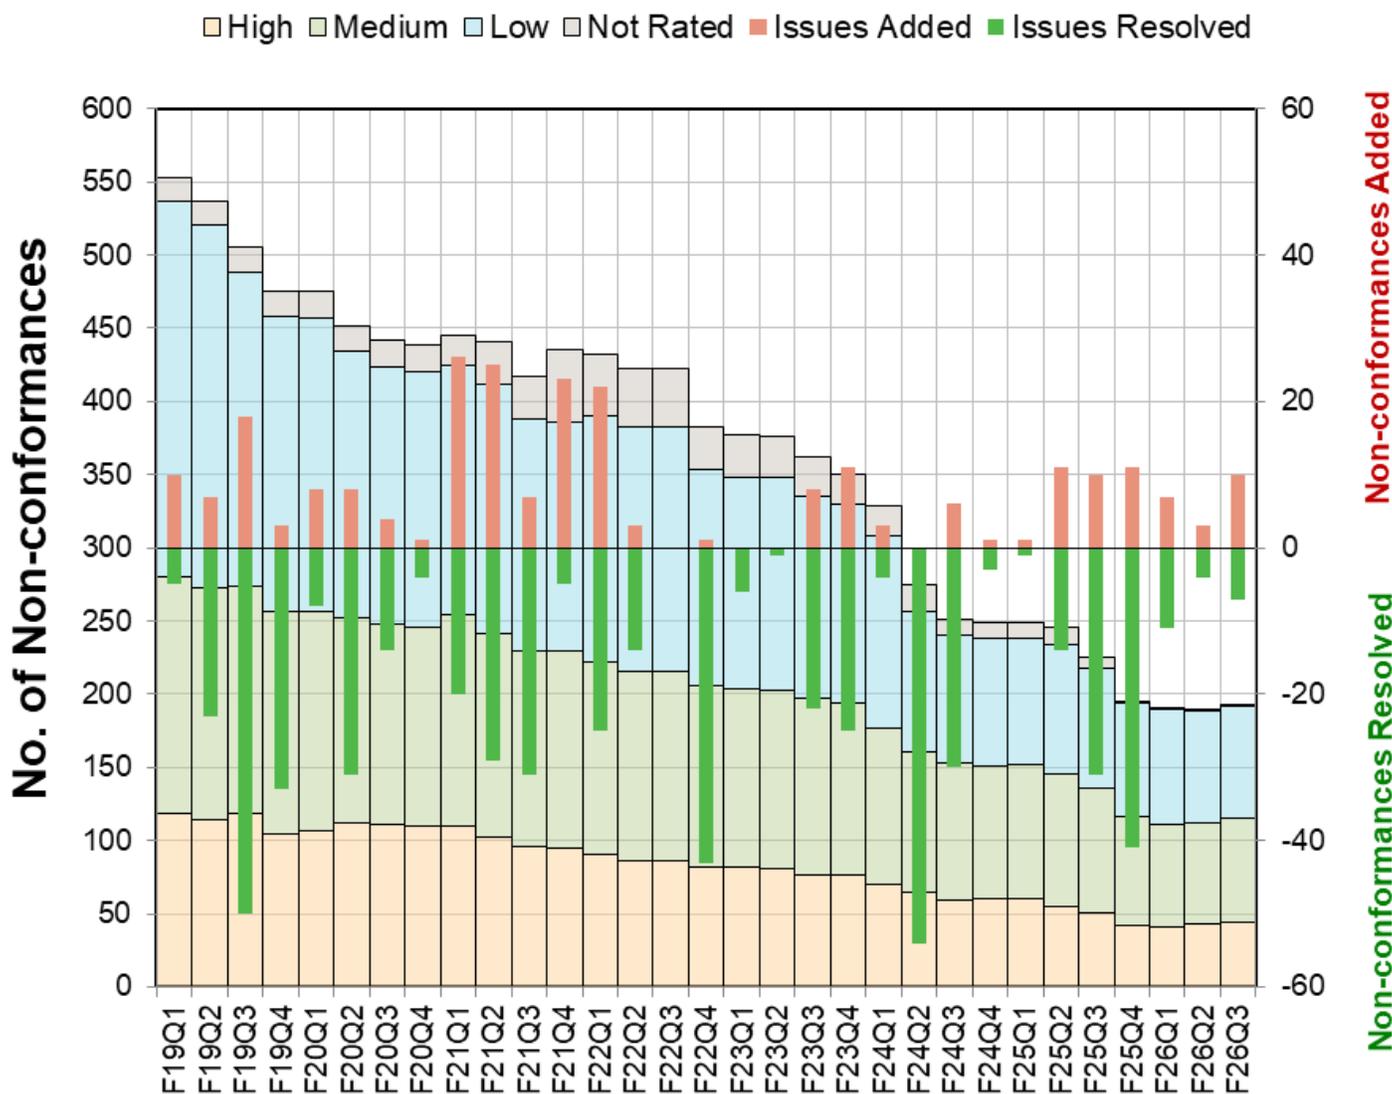
Activities to identify, review, resolve and close Non-Conformance issues continued through F2026 Q3. As a result, seven Non-Conformance issues were resolved and ten new issues were identified in Q3, resulting in 193 outstanding issues. Figure 3, below, shows the continuing progress in reducing the number of Non-Conformance issues.

**Figure 3** Changes and trends in the total number of Non-Conformance issues (characterized by level of importance).

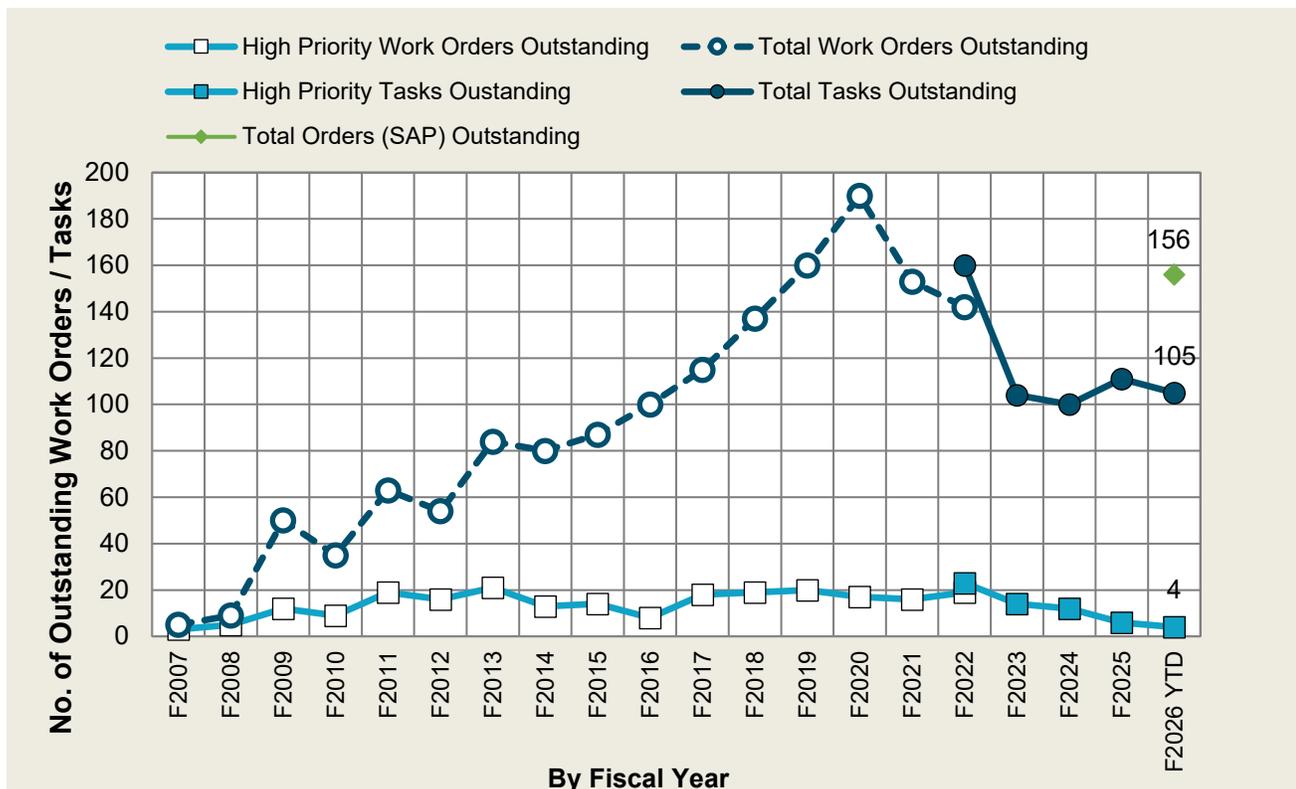
Due to the SAP transition (as described in the Civil Maintenance section), the maintenance completions for F2026 Q3 are not available, so they not been included. Inclusion of these results will be evaluated as the changes in business processes are aligned with the enhanced capabilities of SSAP. The number of outstanding flood discharge gate reactive operations is shown in the chart in Figure 6. As a process improvement, the transition to SAP is allowing the inventory of work to be determined based on equipment rather than manual tagging. The SAP orders are shown in a new data series and an accompanying step change in the chart. The approach is being refined and further changes may be implemented next quarter.

**Figure 6** Outstanding reactive work on flood discharge devices
