**RE: British Columbia Utilities Commission (BCUC or Commission)
British Columbia Hydro and Power Authority (BC Hydro)
Electrical Explosion Incident – Marine Building, Downtown Vancouver**

I am writing to provide the results of BC Hydro's investigation into the explosion and fire that occurred in one of BC Hydro's underground vaults (Vault No. 73) on the 300 block of Burrard Street in Vancouver at approximately 6:00 pm on February 24, 2023. Two members of the public were injured, and several businesses were damaged.

12. The scope of this report is to document the investigation of the cause of the explosion and fire that occurred on February 24, 2023 (collectively, the “Incident”).

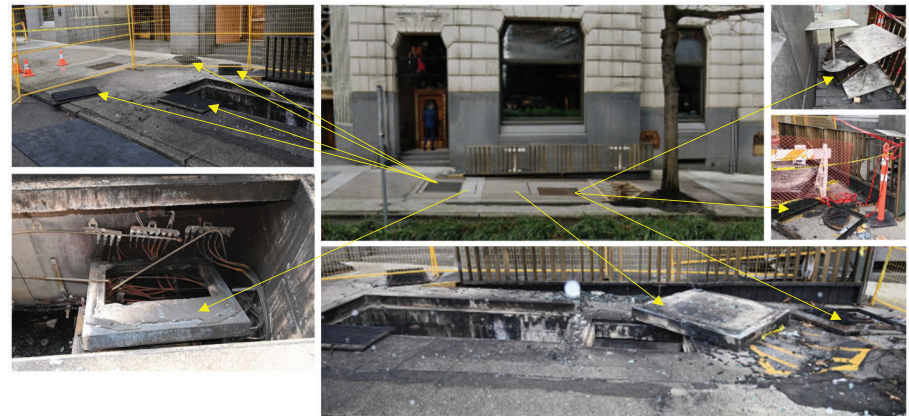
Figure 4: Photo array showing vault debris displacement.

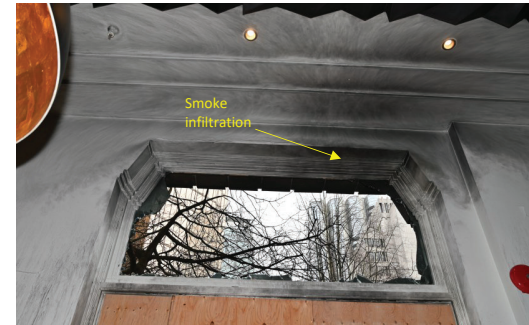
Figure 10: JJBean interior smoke extension dominant through south end of window.

- 43. Based on the above, the post-fire burning was dominant to the west-center of the vault, around and below SW2019 wholly, and SW2018 partially. This also aligns with the soot demarcation in the JJBear store where smoke dominantly entered the premises through the south end of the upper window and the area of hardness testing of SW2019 (as documented in the Powertech Report).

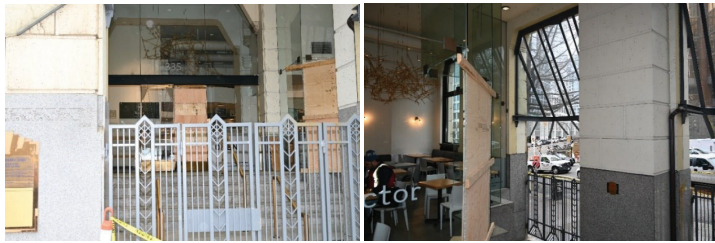
Figure 12: Images showing Tractor restaurant damage.

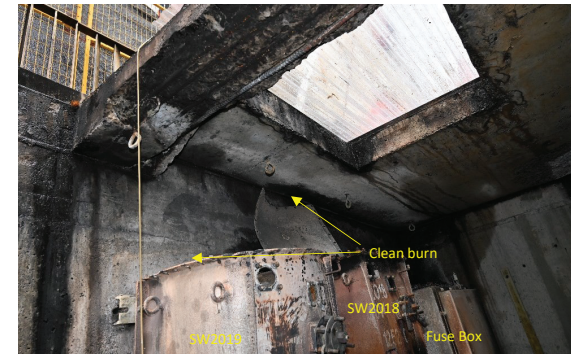
Figure 14: Ceiling on the west side at the north end of V73.

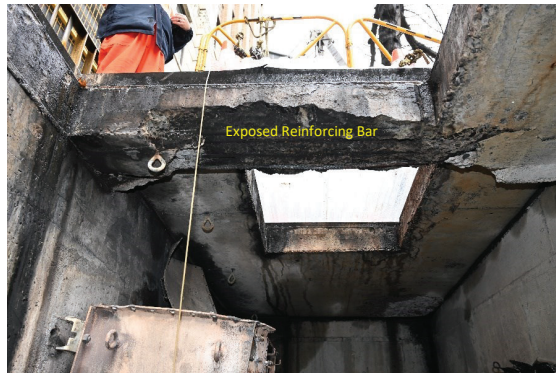
- 40. Although there was some minor spalling in the northeast corner, the greatest damage to the vault concrete enclosure was to the midsection where large portions of concrete had spalled, exposing the reinforcing bar [Figure 16].

Figure 16: Vault structural damage.

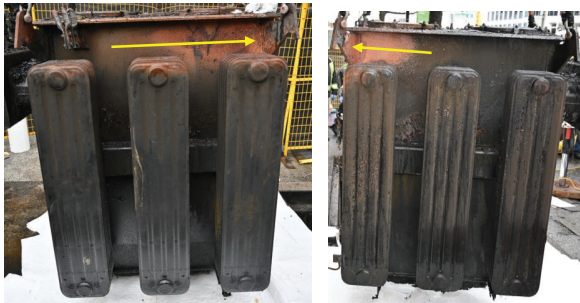
Figure 21: Sides of transformer (a) Left - east side (b) Right - west side.

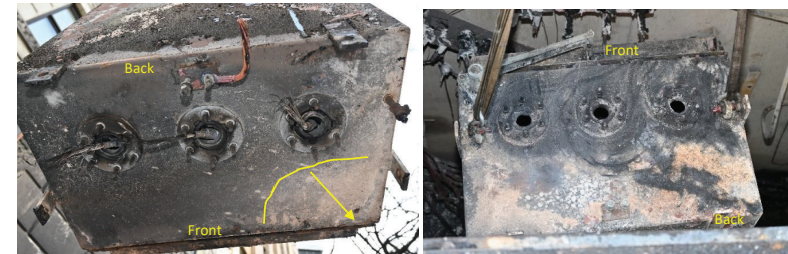
Figure 26: Bottom of CLF cabinet showing broken cables (left); top of CLF cabinet (right).

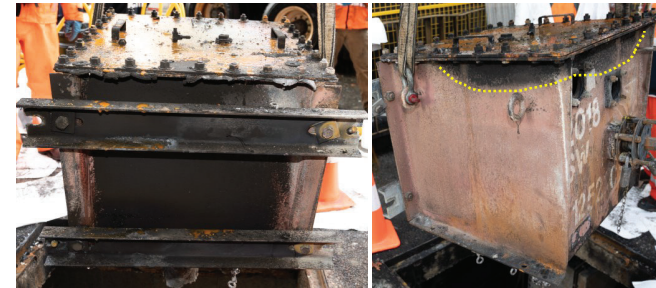
- 65. In summary, the physical damage to SW2018 is consistent with fire exposure. No indications of failure were identified that are indicative of it being the cause of this Incident.

Figure 30: SW2018 back of housing - west side against the wall (left); left side and front (right).

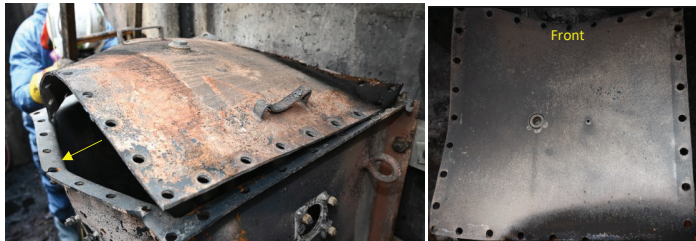
Figure 36: Lid of SW2019 in its original position (left); underside of the lid (right).

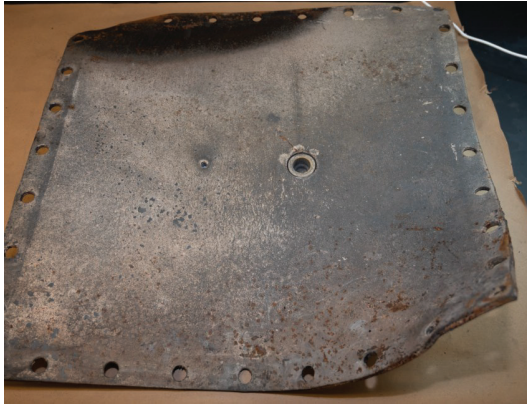
Figure 52: Underside of the lid from SW2019.

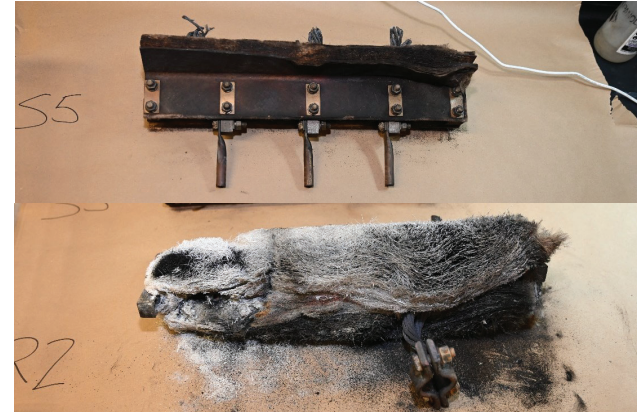
Figure 54: Insulation for Switch Hinge Pins (a) Switch 2018 (Sample S5); (b) Switch 2019 (Sample R2).

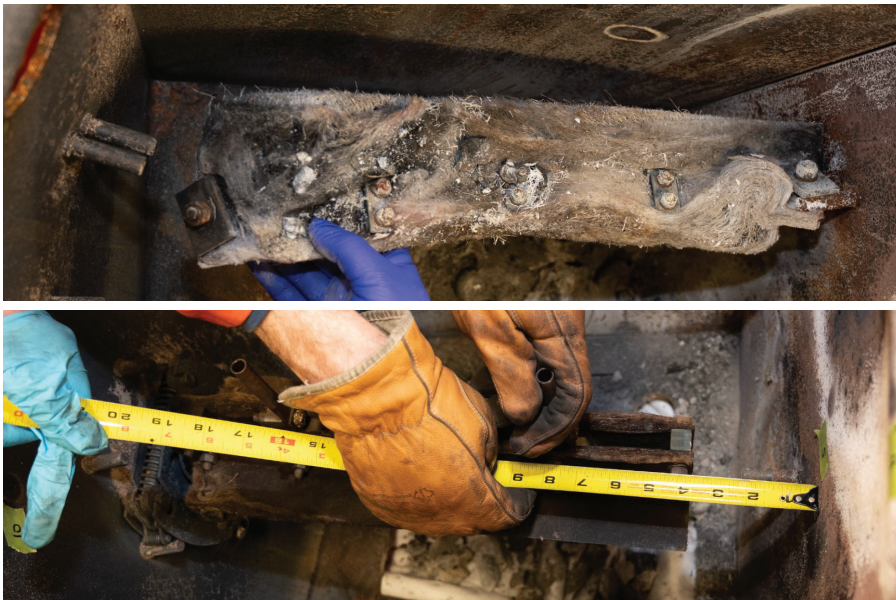
Figure 53: Service insulating board assembly showing gap at left side (top); supply insulating board from SW2018 positioned in SW2019 showing gap due to deformation of the SW2019 housing.

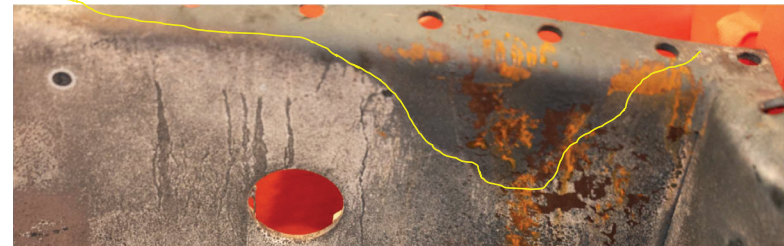
- Acetic acid from silicone could cause cracks in the paint, the paint lifting, or minor electrolytic corrosion as well as react with the Nebar seal causing a seal failure, water to leak into the tank, the paint to lift, and initiate the corrosion process.

- Collection of degraded enamel just outside the no-paint region had a different spectral pattern than other paint areas in the tank indicating a chemical degradation by more than just thermal exposure from the fire.

Figure 58: Region where no epoxy-enameled paint remained post-Incident.

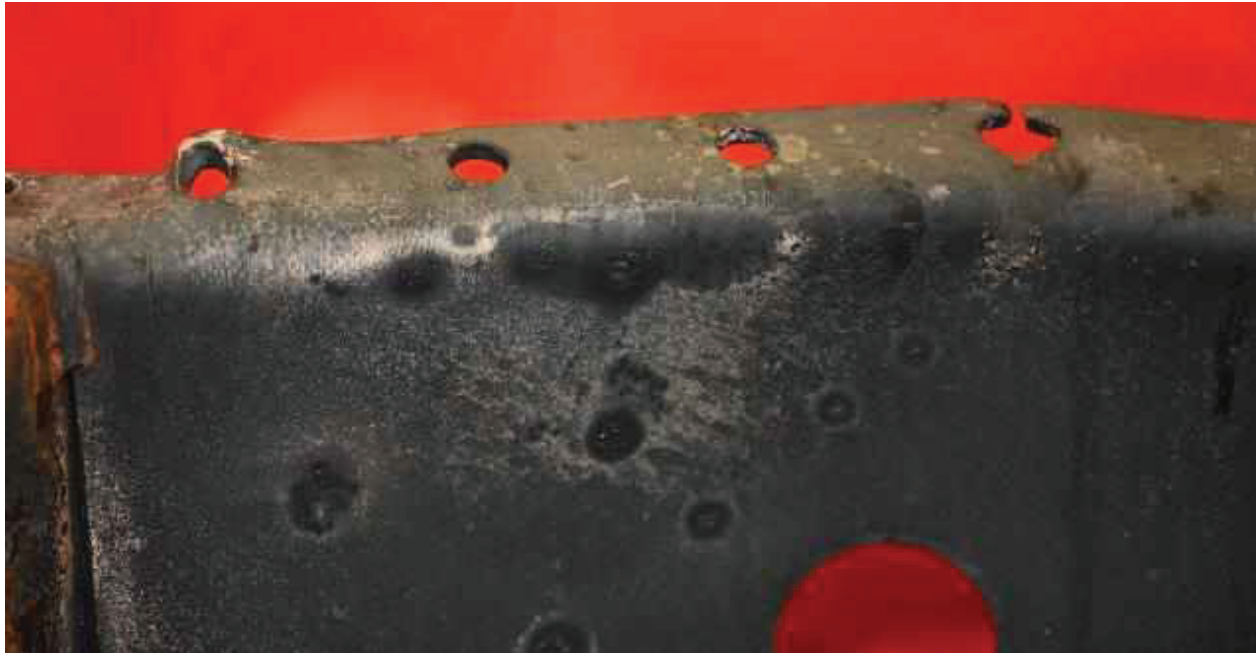
Figure 3. Close up of bolt holes on front right of switch 2019 (view from inside of tank)

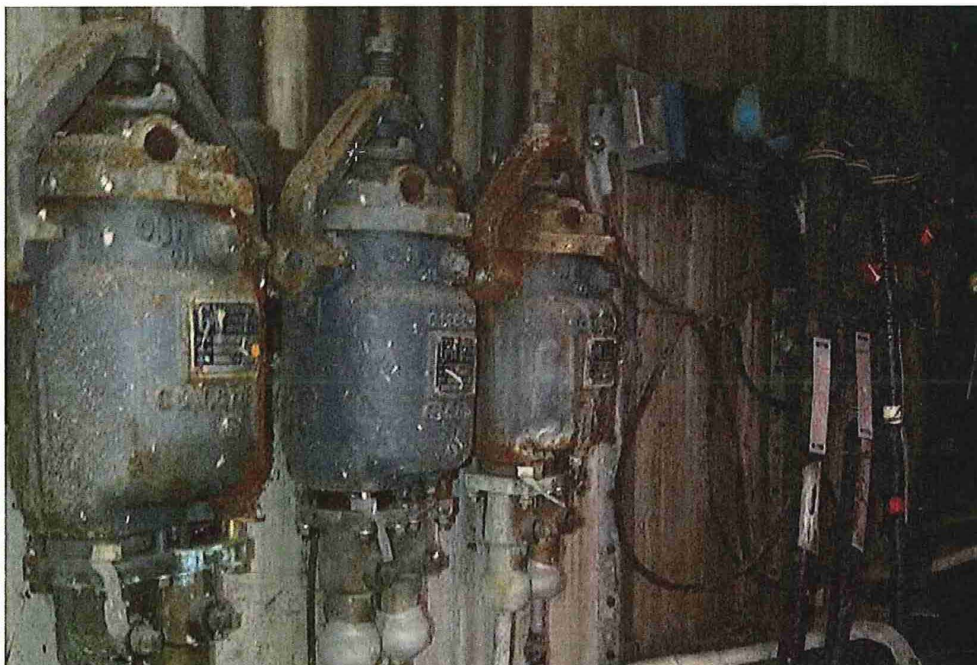
Figure 10 - Open loop vault 1, Oil fuse cutout and junction bar shown
