## Explosion & Fire on Burrard Street at BCH V73

### Explosion & Fire Analysis Reconstruction

**Our File Number:** 2300129  
**Date of Report:** June 7, 2023  
**Revision:** 0  
**Report #:** 001  
**Date of Incident:** February 24, 2023

**Prepared for:** Ms. Nicole Prior  
Senior Manager, Legal Services  
BC Hydro  
6911 Southpoint Drive, Podium A03  
Burnaby, BC V3N 4X8

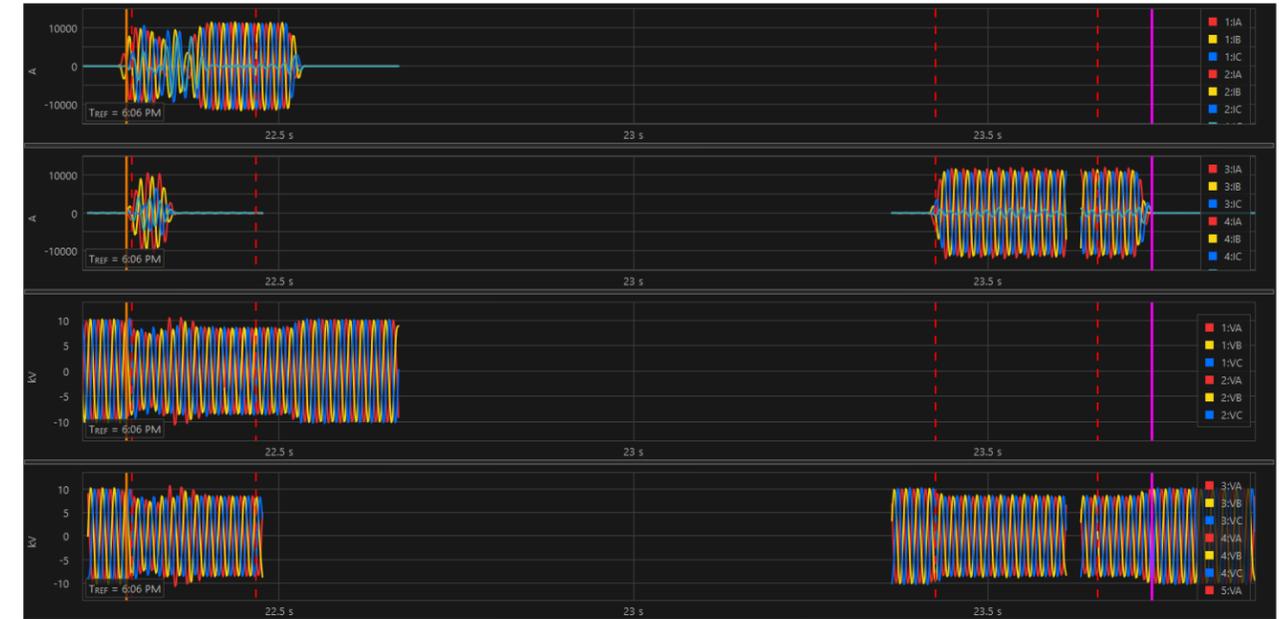
Figure 3: Oscillography of circuits connecting to V73.

- BCH Engineering Report (the “BCH” Report), included as **Appendix C**, which describes the electrical configuration and system protection and includes oscillography of the circuits involved and the corresponding interpretation of the results. The oscillography is illustrated in **Figure 3**.

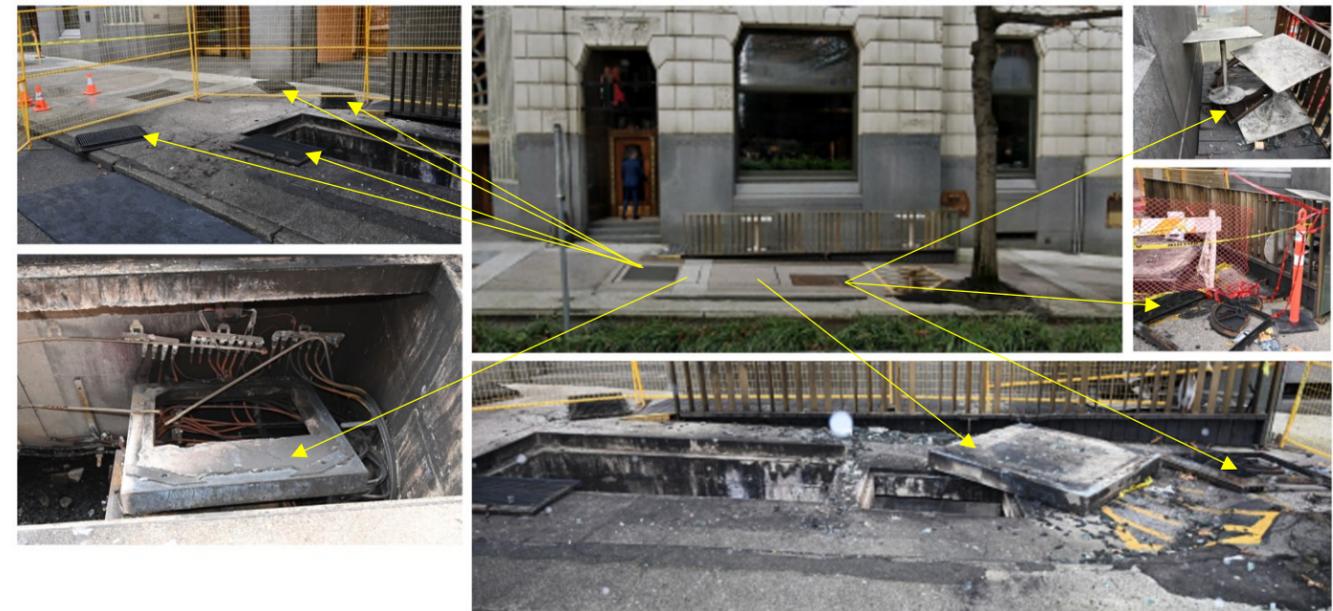
Figure 4: Photo array showing vault debris displacement.

16. The force of the explosion raised the covers on V73. The 5 ft by 5 ft concrete sidewalk inserts had been lifted and displaced, as shown in **Figure 4**.

18. The utility grate and opening were lifted and displaced to the northwest landing on the sidewalk and the storefront patio, shown in the top right corner of **Figure 4**.

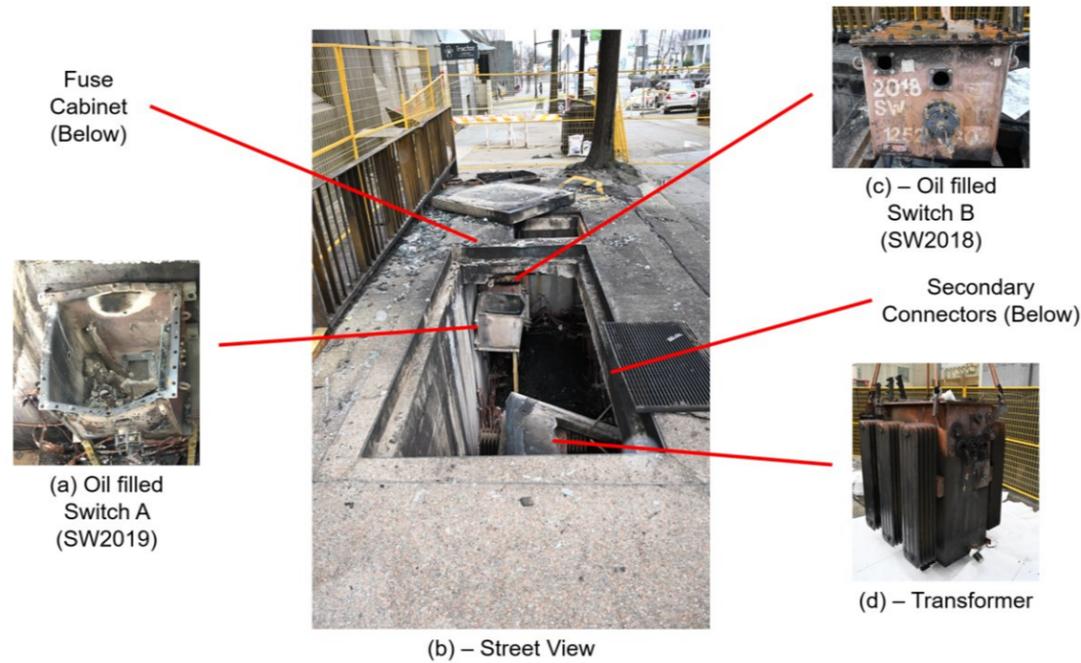
Figure 5: Vault V0073 Layout after the explosion.

19. The approximate layout of the electrical equipment in the vault, post event, is shown in **Figure 5**.
- #### 3.2 Relay and Sensor Data
20. Electrical relays and sensors connected to the circuits were able to record data up to the event. Switch 2018 and Switch 2019 were connected to Circuit CSQ 125F21 and CSQ 12F511 respectively.

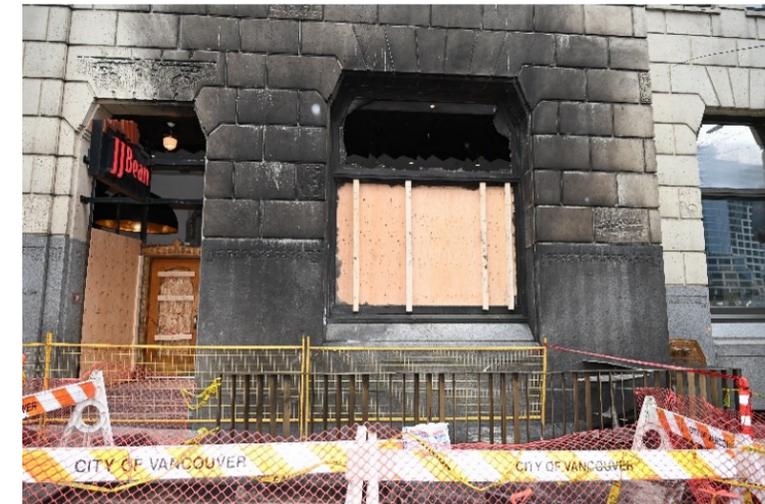
33. The façade configuration meant that the predominant heat and fire damage was localized to a portion of the east façade of the building around the JJBean tenant space. Smoke damage was visible on the lower five storeys of the building façade, dominantly in front of the JJBean tenant and opposite V73 [Figure 8 and Figure 9].

34. The glass windows and door of JJBean were broken from the Incident, as seen in Figure 9. This likely occurred in combination with the initial explosion and the subsequent heat exposure from the fire. The glass above the doorway to JJBean had one pane broken, but two remained intact.

Figure 9: JJBean café east façade.

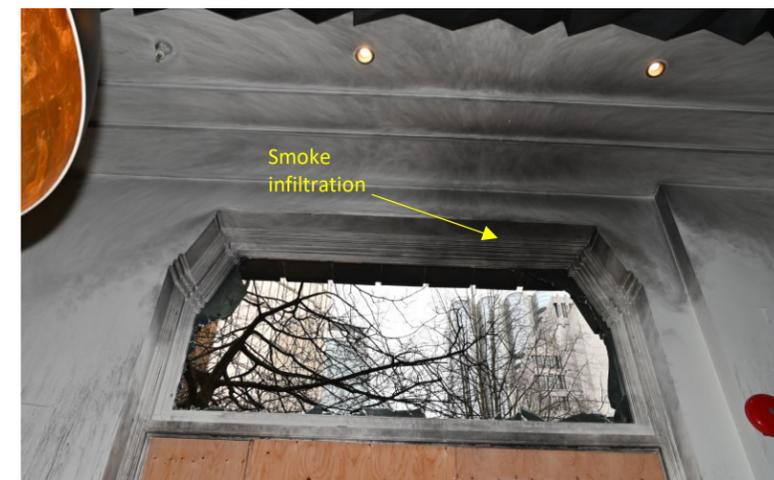
35. Inside JJBean, there was heat damage along the interior walls and ceiling surrounding the damaged window [Figure 10], and smoke damage throughout the space [Figure 11]. The automatic sprinklers were all intact at the time of the initial site inspection meaning the smoke and heat from the fire in the vault was insufficient to fuse the sprinkler heads and cause water to flow. This aligns with the absence of water patterns on the walls around the sprinkler heads suggesting no sprinkler heads had been replaced. A dominant smoke pattern was observed at the south end of the upper windowpane immediately opposite V73 [Figure 10].

Figure 10: JJBean interior smoke extension dominant through south end of window.

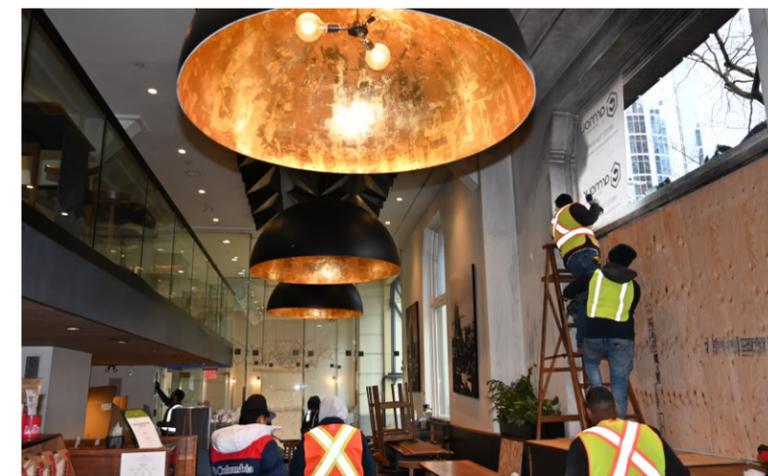
Figure 11: JJBean interior looking north.

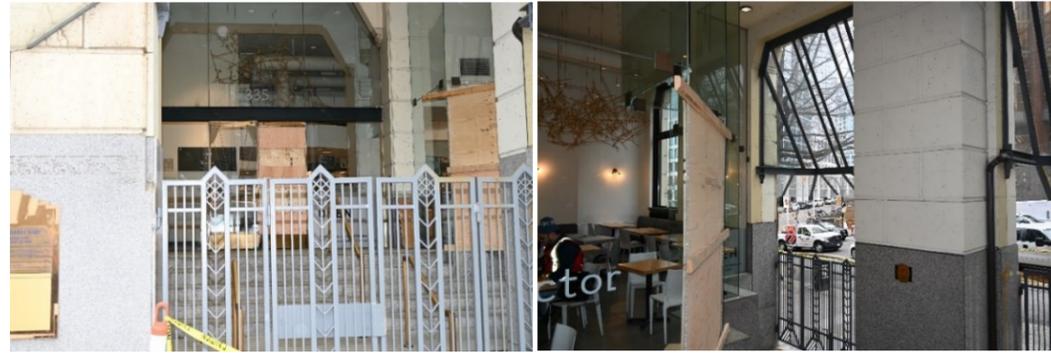
36. Tractor, the neighbouring restaurant to the north, had a recessed entranceway with multiple glass panels and doors and a glass awning. A glass door and a window panel of the restaurant were broken, as shown in Figure 12. There was no evidence of significant heat and smoke damage within the restaurant. The glass awning (closer to the explosion) did not fail, and no sprinklers fused within the covered awning area or the restaurant.

Figure 12: Images showing Tractor restaurant damage.

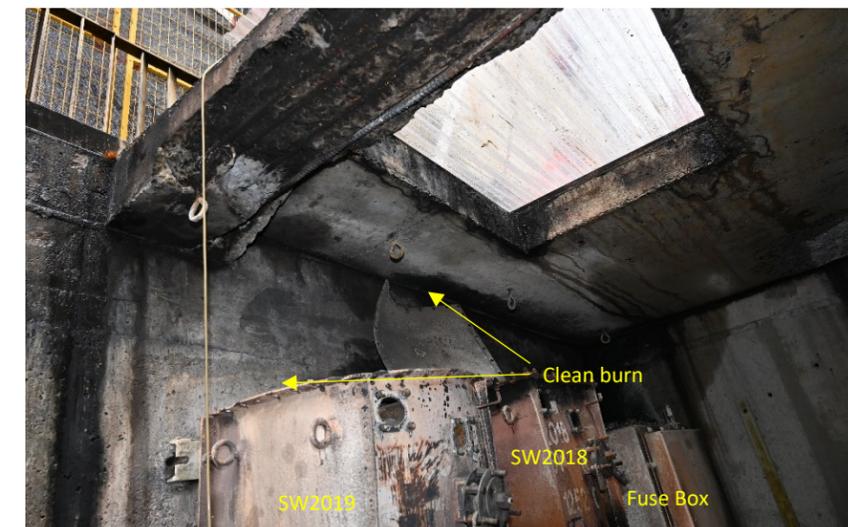
Figure 14: Ceiling on the west side at the north end of V73.

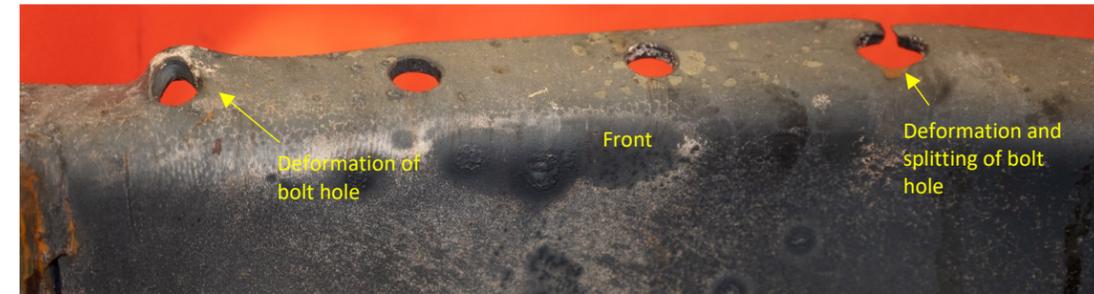
Figure 38: Deformation of bolt holes in front wall of SW2019.

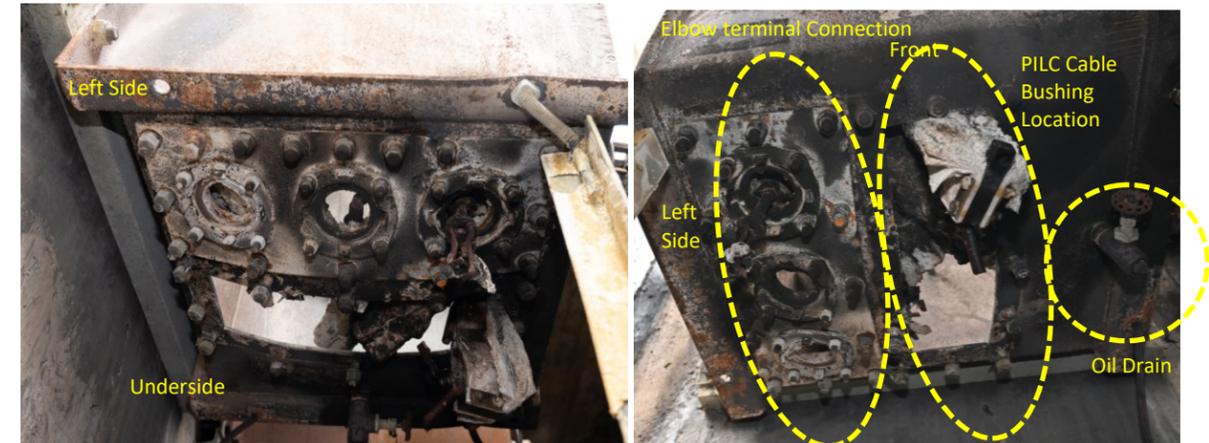
- The bottom of the housing was also bowed outwards [Figure 39 - left], and the PILC termination and connectors were no longer in place, nor were the elbows or the exiting service cable [Figure 39 - right].

Figure 39: SW2019 underside of housing showing bowing (left), and absence of service connections (right).

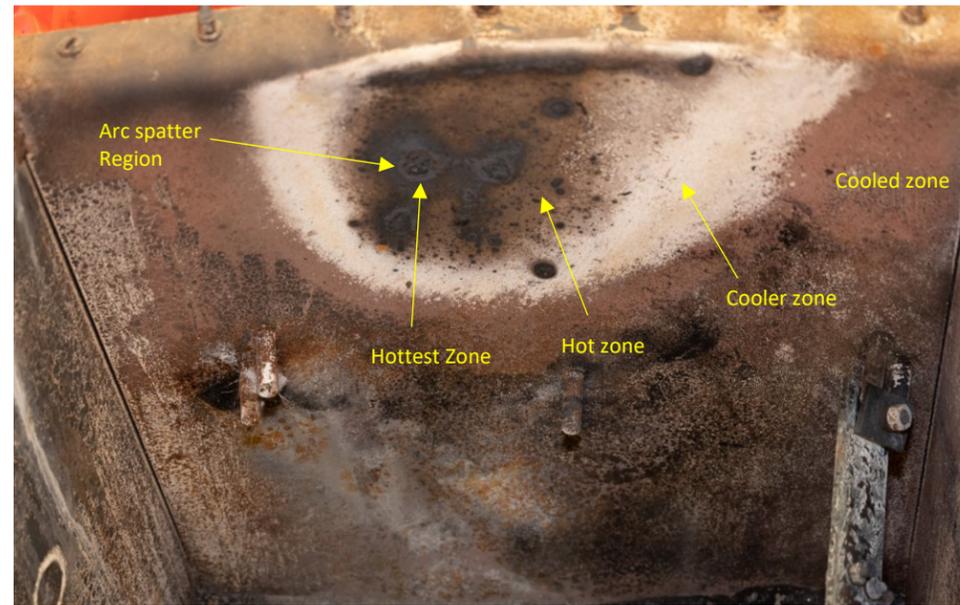
Figure 48: Arc spatter zone on interior back wall of SW2019.

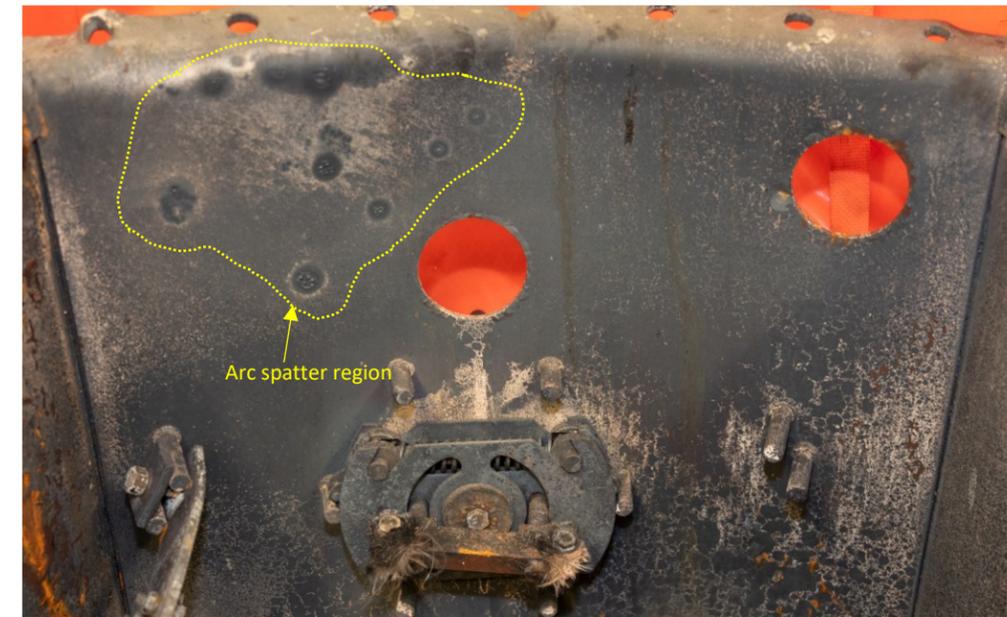
Figure 50: Arc spatter zone on interior front wall of SW2019.

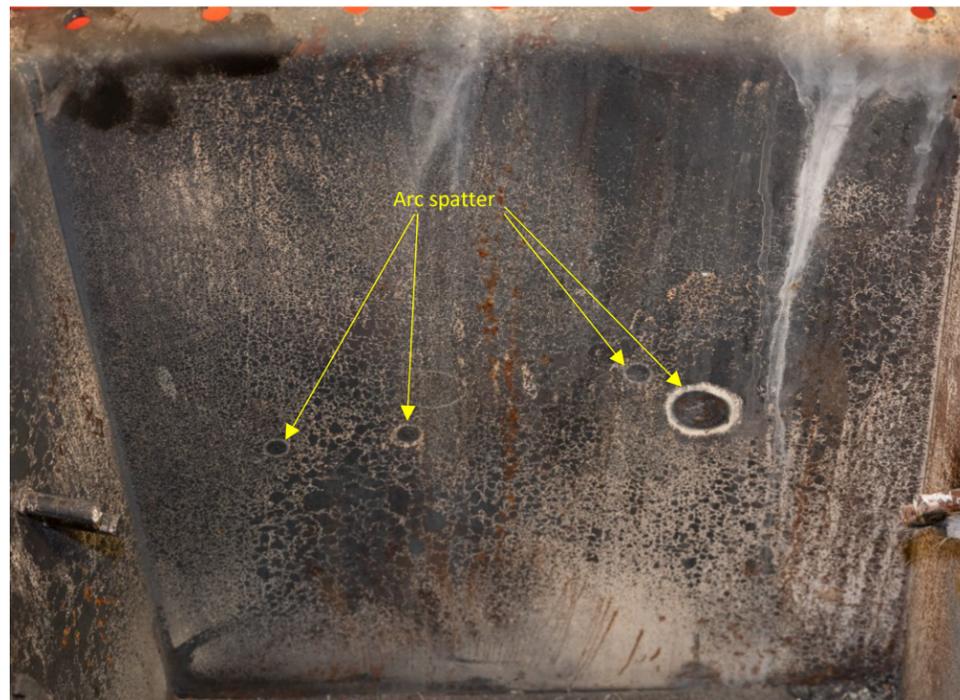
Figure 49: Arc spatter zone on interior left wall of SW2019.

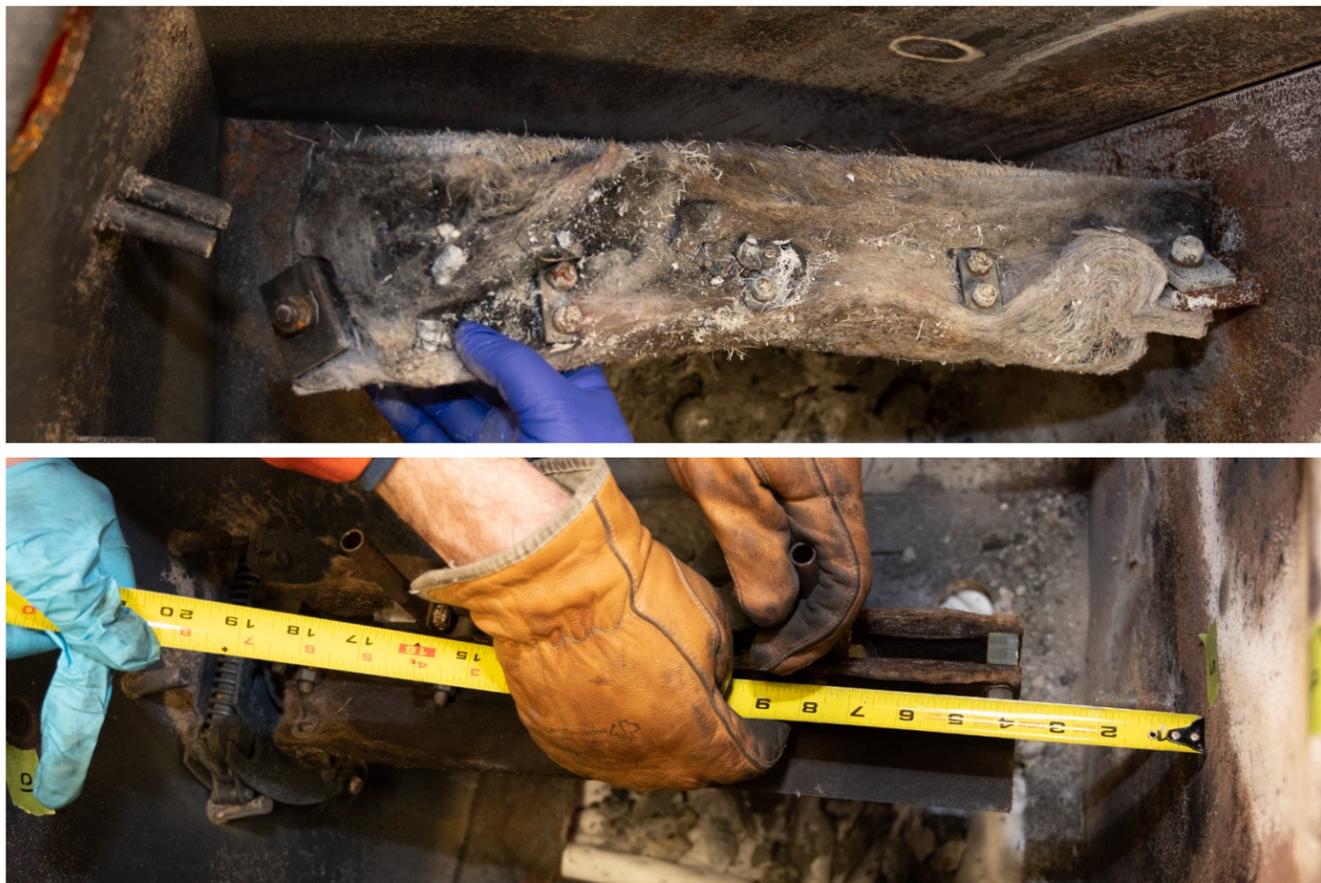
Figure 53: Service insulating board assembly showing gap at left side (top); supply insulating board from SW2018 positioned in SW2019 showing gap due to deformation of the SW2019 housing.

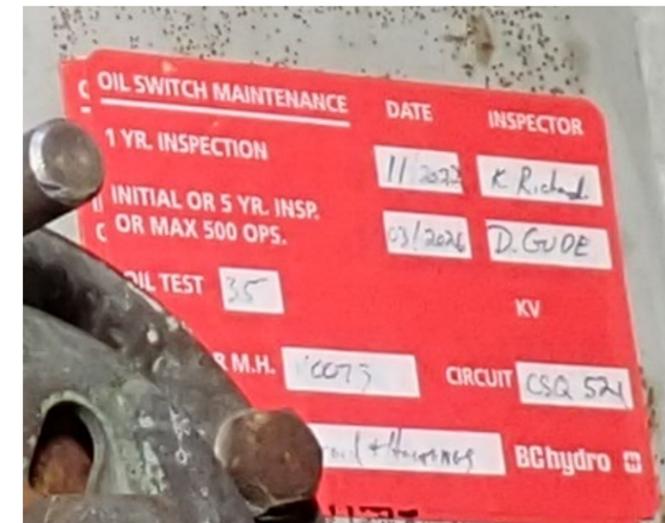
102. With respect to the Incident, the service tag for SW2019 was captured in a photograph on November 24, 2021 and shows an oil test of 35 kV completed in March 2021 [Figure 55], which aligns with the new test method and IEEE Guide.

Figure 55: 5-year Oil Switch inspection tag on SW2019 taken from Street Vault Inspection November 24, 2021.

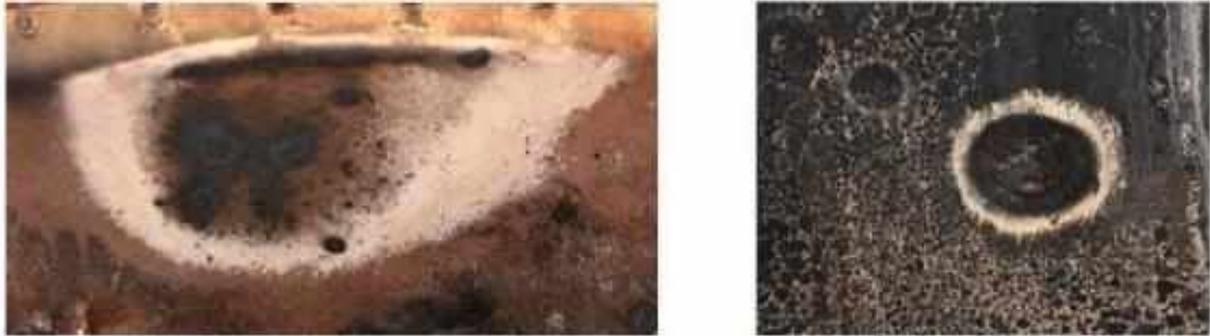
At the back of the switch 2019 tank, a large, dark, discoloured patch with a white ring was observed (Figure 5). A similar small, dark patch with a white ring was also observed approximately halfway up on the left inside the tank. In both cases, small metallic-appearing deposits were in the middle of the dark patches/rings. These observations are consistent with a hot material contacting the wall, transferring heat outwards, damaging the paint on the inside of the tank in a radial fashion.

**Figure 5. Close up of white rings on inside of the switch 2019 tank**

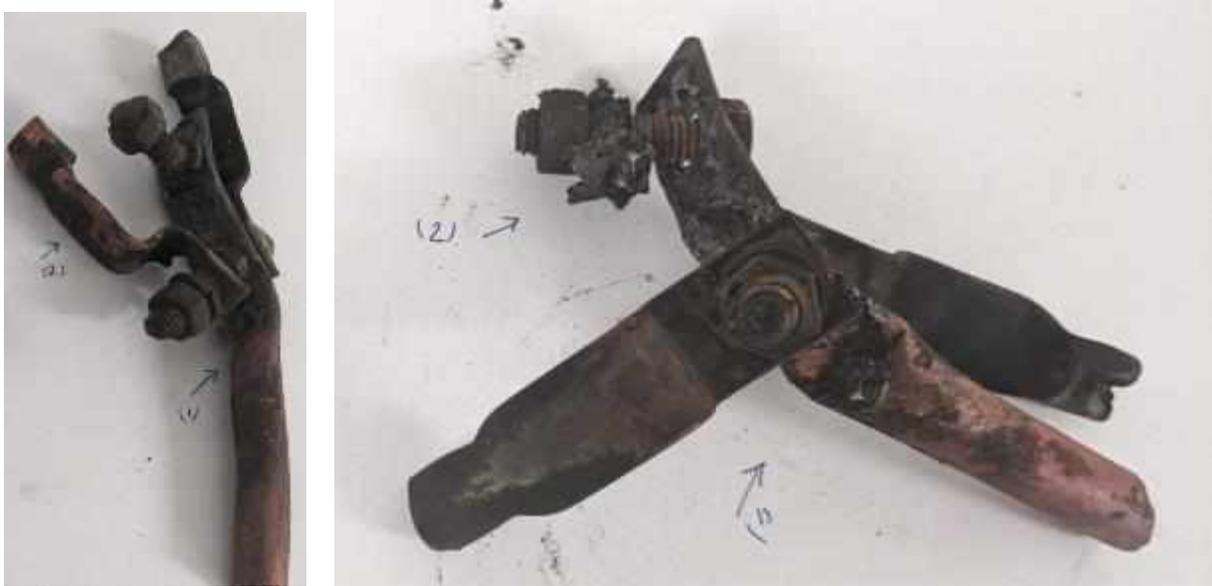
To try to determine the source of the metallic-like globule splatters, SEM-EDS analysis of two contacts from switch 2019 were performed (Figure 14). The bulk of the blades were determined to be almost exclusively copper, with minor amounts of aluminum, tin, and zinc on their surfaces. However, at the connection point of the blade to the switching device, the o-rings and bolts were observed to have similar presence of aluminum and copper, with minor amounts of iron, magnesium, and tin.

**Figure 14. Blade assemblies analyzed from switch 2019**

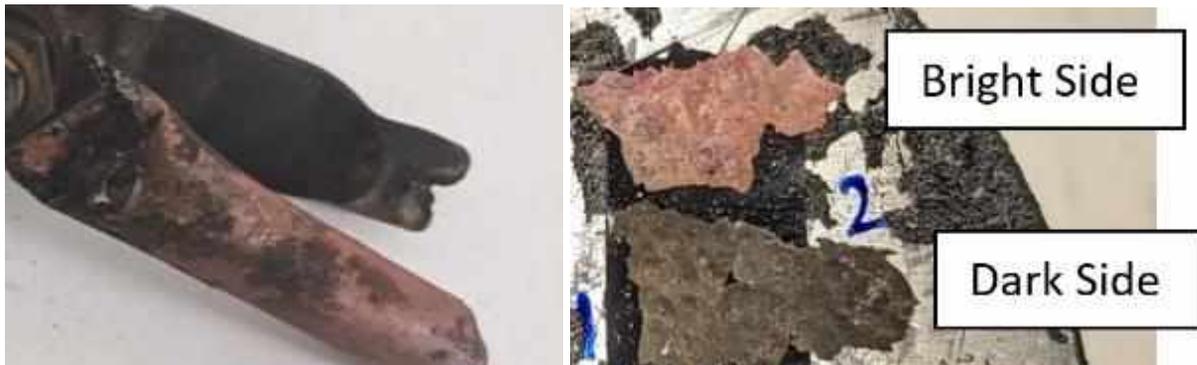
On the surface of the bulk of the blades were darker regions (Figure 15). When analyzed by SEM-EDS for their elemental composition, it showed the dark material to contain copper, but aluminum, tin, calcium, and carbon were the predominant elements. Zinc was also present in minor amounts. When scraped with a blade or abrasive disc, the black region would be removed, exposing a copper surface. This indicates the aluminum on the actual blades was a result of a deposition and not an intrinsic part of the blades.

**Figure 15. Dark side/section of switch 2019 blade analyzed**

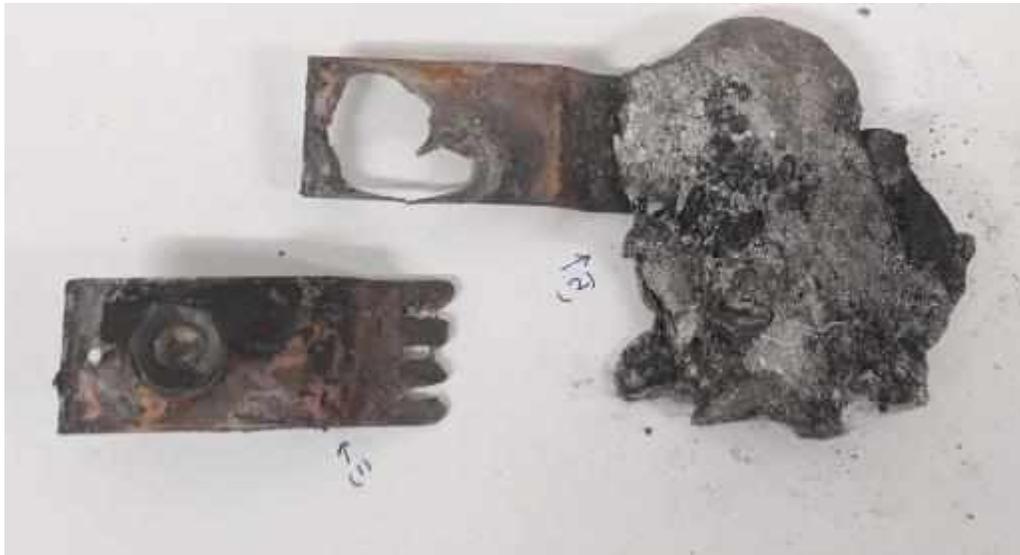
**Figure 16. Selected contacts analyzed by SEM-EDS for elemental analysis  
Left: Bare Contact; Right: Contact with metallic mass at the end**

In addition to analyzing the blades for elemental composition in switch 2019, two selected contacts were analyzed. As shown in Figure 16, both contacts showed damage.

The bare contact showed the bulk material of the blade to be copper. Lesser amounts of aluminum, carbon, chlorine and cobalt were also observed in the blade material sample. Meanwhile, the large globular mass enveloping the prongs of one of the contacts was identified as being almost exclusively aluminum, with minor amounts of carbon, chlorine, magnesium, tin, and zinc. Copper was observed in sub-trace concentrations in the large globular mass. These observations indicate that the aluminum observed on the walls of the tank were not from the blades or contacts of the switch, but instead from an alternate source.

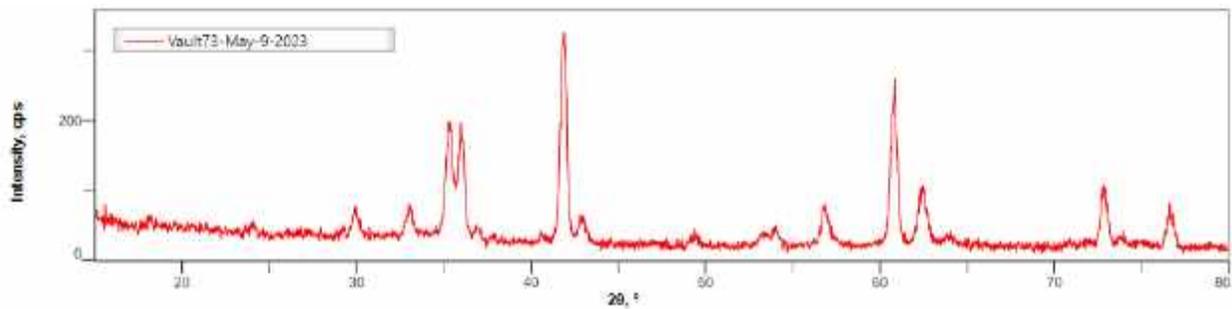
Figure 17. XRD pattern of the collected rust sample from switch 2019

To provide insight in the form of rust, a sample of the residue was collected from the defined section of deterioration at the right front wall of switch 2019 by physically scraping it, and the sample was analyzed by x-ray diffraction analysis (XRD). The XRD pattern of the rust sample, along with a reference analysis pattern of magnetite and hematite (forms of iron oxide) are provided in Figure 17 and Figure 18.

When compared to the reference libraries and XRD patterns for hematite and magnetite, the sample was observed to contain both forms of iron oxide, as well as trace amounts of other compounds. The presence of magnetite indicates the formation of some of the sample under an oxygen-starved environment (i.e., under nitrogen blanket, moisture trapped under a surface by the wall).<sup>1-5</sup>

With the observation of magnetite, and knowing that the formation of magnetite is also slow compared to hematite, it indicates moisture was in contact with the steel for several weeks or longer. This signifies that the rust observed at the right front of the tank had been present in the system before the explosion, and not a result of being exposed to damage and water after the explosion. This finding is also supported by the observations of the investigative personnel, who saw rust at the same location inside the tank when on-site, the day after the explosion. By hematite also being observed in a significant amount, with flaking and

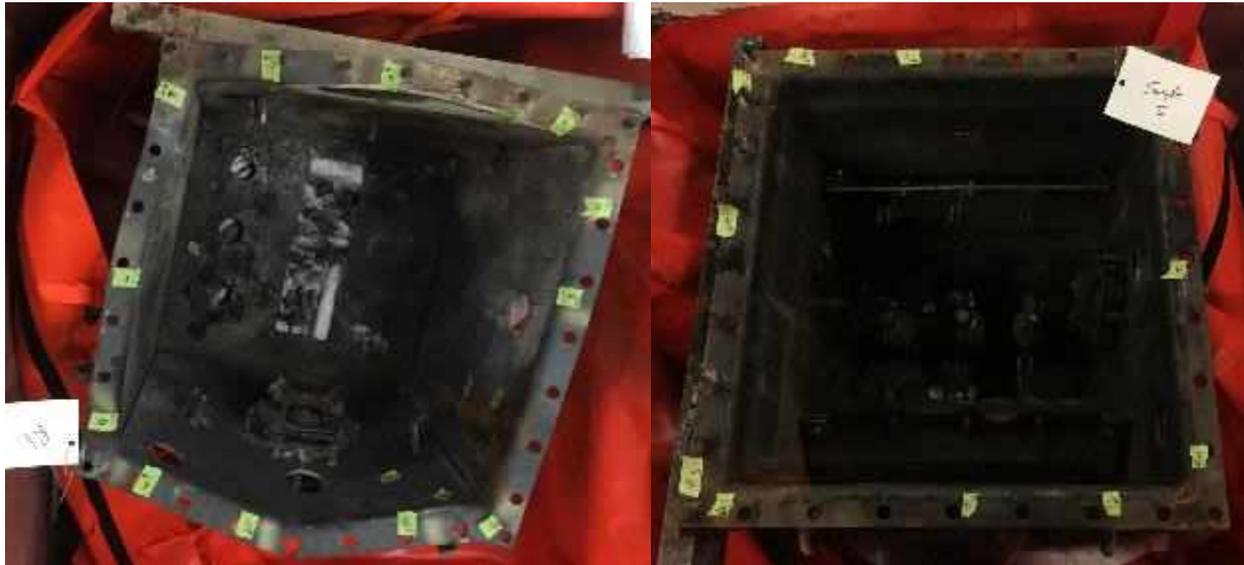
**Figure 19. Locations on Switch 2019 and Switch 2018 subjected to Leeb hardness testing**

To explore the possibility that the metal of the rim of switch 2019 may have been compromised before the explosion in vault 073, hardness measurements around the rims of switch 2018 and switch 2019 were performed. Using a portable Leeb Hardness tester, multiple points around the rim of each switch was tested three times and the average value was reported for a testing point (Figure 19).

The average values observed for within the typical ranges (343 to 383). Switch 2019 had many readings of less than 300, showing softer areas near the back and side of the switch closest to the transformer. However, these readings may have been due to softening from the deforming and heating of the metal from the explosion and resulting fire. The data for the hardness of the rims of the two switches did not indicate a potential issue with the hardness of the metal before the explosion.

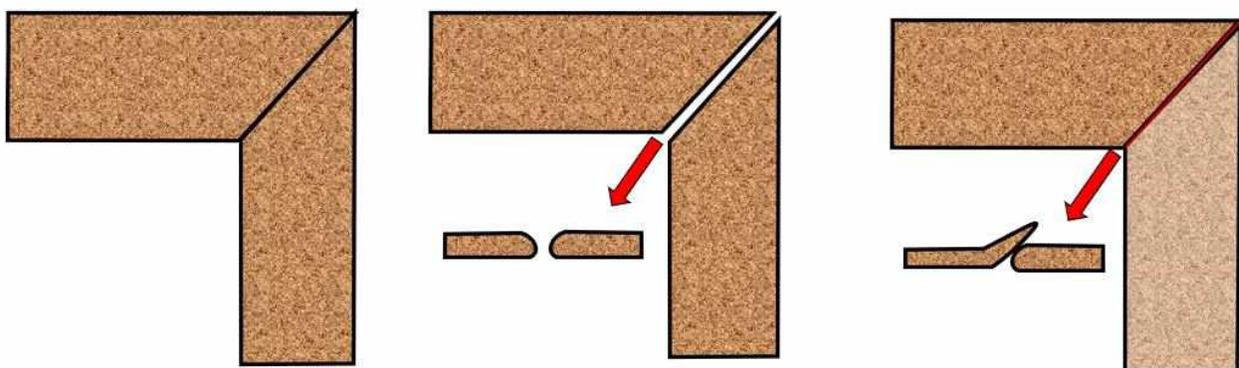
**Figure 21. Depictions of effects of shrinking or swelling of gasket material**  
**Left: A good corner interface of a gasket; Middle: Effect of shrinking; Right: Effect of swelling**

By Nebar utilizing natural cork as part of its composition, it needs to stay in contact with a liquid to keep it moist and free of shrinking, cracking, and losing elasticity. On the vault side of the gaskets, the vaults are typically humid. However, during summer months of lower precipitation, or winter months of higher precipitation, the humidity of the vaults can fluctuate. In either case, the change in humidity can cause swelling or shrinking of exposed Nebar, both cork and rubber (Figure 21). By the gaskets in the switches being composed of 4 separate pieces, by shrinking or swelling there is the increased risk of leaks forming at the interfaces of two sides. For example, if the gaskets shrunk or dried out at the interface of two sides, the seal could be lost. Similarly, if the gasket overlapped or significantly swelled at a corner, gaps could be formed to break the seal and cause a leak, or the material itself may start to mechanically crumble. Even if gasket was one piece, similar effects could be observed.

Once the cork and/or rubber have deteriorated, they are compromised and do not self-repair. Additionally, if the vault becomes warmer from outdoor climate temperature, or from increased loading of the transformer also contained in the vault, the water in a vault can start to react with the Nebar (given high enough temperature and/or exposure time), causing degradation. At some point of deterioration, the Nebar will form microcracks, voids, etc. Some of these defects will not become apparent until the gasket is physically disturbed (i.e., opening the lid or vibrations are experienced), or when a change in pressure is experienced (i.e., quick release of nitrogen headspace, overfill of nitrogen, generation of gases from switch). As a result, the defects can be missed with just performing a visual inspection. Additionally, the leaks generated may be slow, taking hours or days to register a detectable reading on an analogue gauge. The ability to detect possible leaks is also made challenging by using a traditional low precision gauge. Additionally, as part of the 5-year maintenance procedure, the system is pressurized and depressurized by nitrogen before filling with oil. Although this provides a sealing check, it also creates additional stresses on the seal that could create a small, undetectable leak, when subsequently filled with oil.

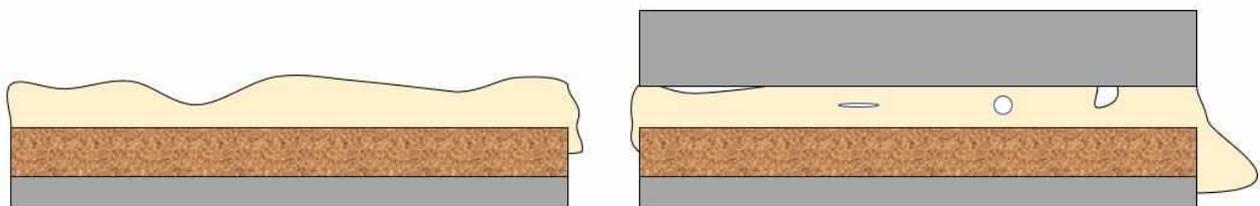
**Figure 23. Sketch of uneven RTV application to switch at lid**

**Left: Uneven RTV silicon application to gasket;  
Right: Possible holes/channels formed when lid placed on**

Tack-free times of most RTV silicones are normally on the order 30 to 120 minutes and full cure times being many hours or days. To help reduce the curing time of many RTV silicones, acetic acid is added. Depending on how high in concentration the acetic acid is included in the RTV silicone, it can heavily influence the cure times by a couple of hours, requiring 12 to 72 hours for a full cure. As mentioned previously, acidic molecules are detrimental to cork – causing it to degrade and weaken (section 2.5.1). If RTV silicon that contained acetic acid was used on or around the Nebar gasket, it would promote a region of leaking or damage to the cork in the gasket. Additionally, depending on the type of rubber component contained in the gasket, it may not have good compatibility with the acetic acid, and may not bond well with the silicone. If an RTV silicone was used that were “quick-cure”, a higher amount of acetic acid would be contained and a greater probability of causing damage to the gasket, or even degrading the coatings and metals of the switch.

Independent of the gasket type used, it should be noted that most home, commercial, and industrial applications of self-curing RTV silicones are not intended for pressurized applications. Instead, they are to simply act as a water barrier in stationary applications (i.e., bathtubs, flashing on houses, windows, holes in siding or decking, etc.). The reason for this is RTV silicones do not typically have a roughening or etching agent that allow for good adhesion of the silicon to different surfaces. This is why applied silicones are relatively easy to remove with a flat rigid edged tool such as a putty knife or piece of plastic when needing replacement every 5 to 15 years. As a result, when pressurized with nitrogen, there is the potential that the silicon could release from smooth surfaces to create small channels for leaks to form. If the nitrogen is applied before fully curing, micro cracks could be formed and go unnoticed right from application. Alternatively, if the oil volatilizes or gases are generated in the tank from different processes, the pressure could also increase, promoting release of the silicone from the different surfaces. Even when cured, the structural morphology of the silicone may not be as strong as if left to cure with no backpressure, allowing for the possibility of voids and leaks occurring as the silicone is left on the active unit.

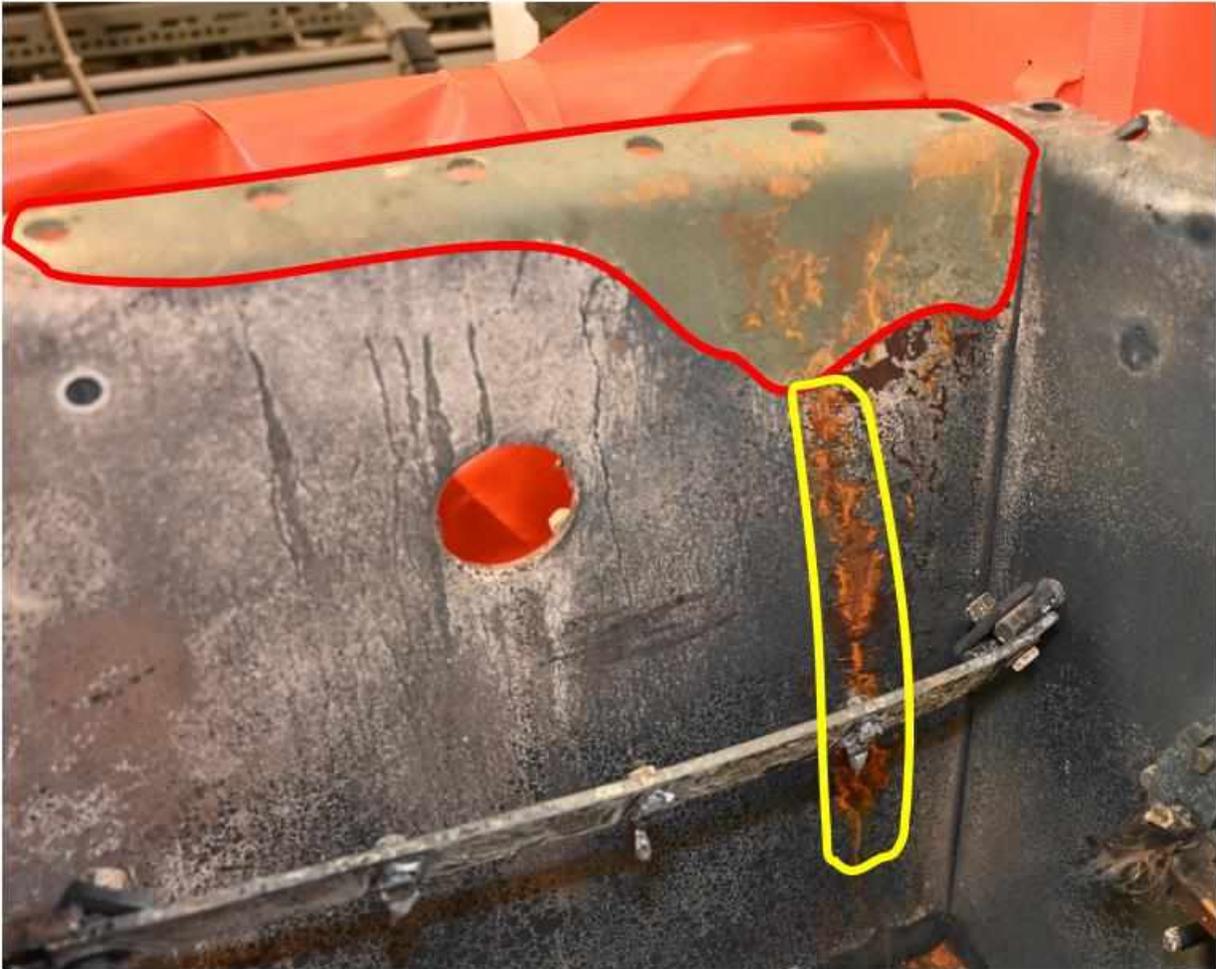
**Figure 25. Depiction of silicon on tank wall for switch**  
**Red: Area of application and possible overflow of silicon on tank edge and upper wall**  
**Yellow: Possible drip channel of silicone or path of water, oxygen, etc. at wall**

Additionally, as discussed previously, one-part RTV silicones use moisture in order to cure. Although initially low (part-per-million levels), the moisture in the oil and on the walls of the tank could be drawn to the silicone and concentrate at the wall (Figure 25). Acetic acid would significantly enhance the degradation of any coating (including enamels); however, the heat generated by the silicone curing and localized high moisture content with other conductive filler components could cause cracks in the paint, the paint lifting, or minor electrolytic corrosion. In turn, the tank iron could be exposed, and small iron and oxidized iron (rust) particles could diffuse into the bulk oil of the tank. This would reduce the dielectric of the oil or generate locations of reduced insulation, promoting electrical potential, oxidation, and other detrimental events in the oil.

Analysis of the upper edge on the right side of the tank of switch 2019 (red section of Figure 25) for traces of an enamel coating, another organic coating, and silicon was performed. Samples of possible organic materials were collected both by collection with a specialized abrasive disc and chemical extraction in sections of the defined area. Analysis by FT-IR did not show the detectable presence of organic materials. This indicates that region was free of coatings or deposits as visual observation suggested. By comparison, areas on the side of the tank that had white residues/deposits were identified as having the presence of organic material (identified as a degraded enamel coating). These analyses indicate this area of the tank had a compromised coating in the identified region of Figure 25. As the other regions of the top of the tank did not have the same appearance (i.e., free of white and deepened rust), it indicates that the coating was degraded by not just the fire. Instead it is suggestive that the breakdown of the coating had undergone a chemical degradation. Collecting a surface sample from below the bare section (slightly white) and analyzing by

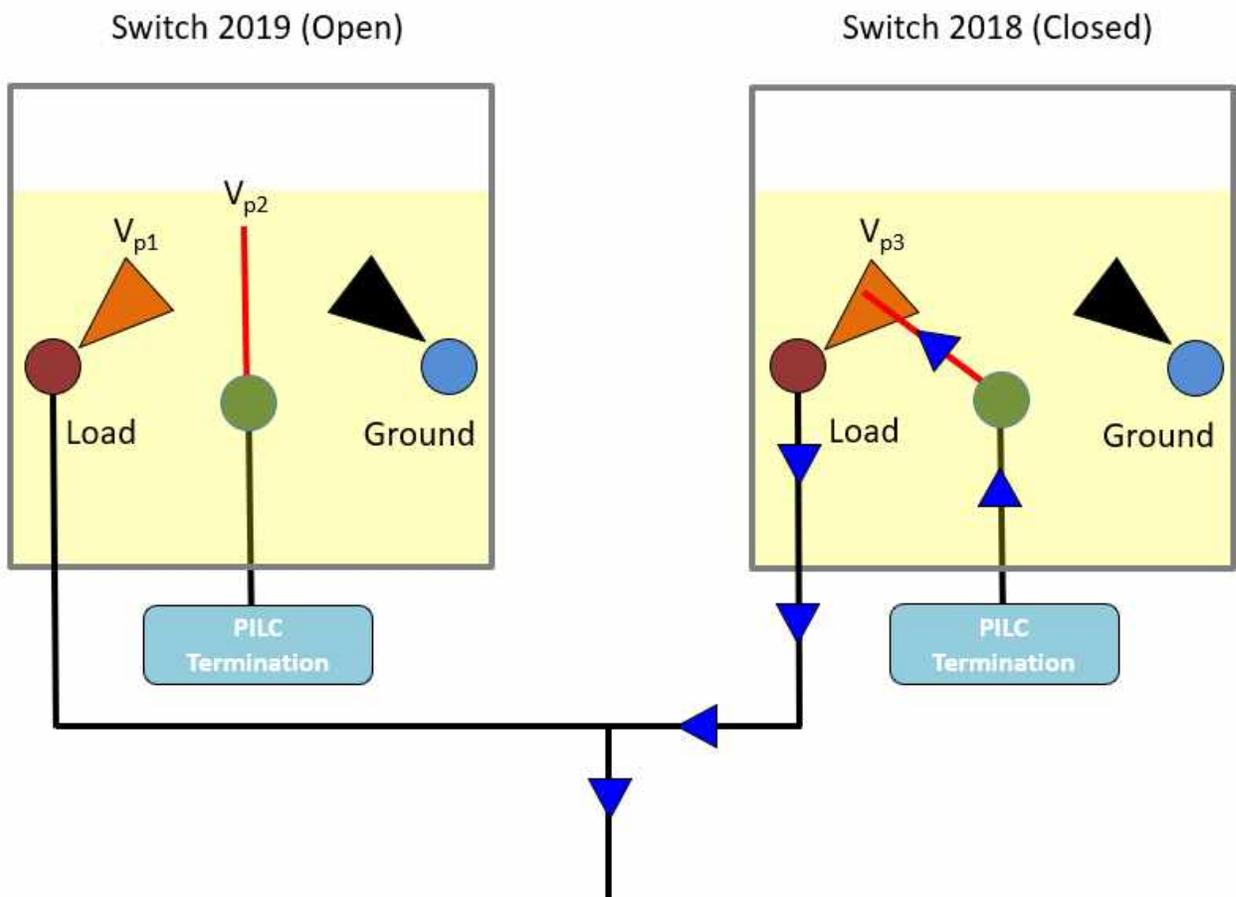
**Figure 29. Arrangement of switches in vault 073 (Blue arrows indicate current flow)**

The two switches (2018 and 2019) were in a dual-radial arrangement. Switch 2018 was the primary switch (i.e., in the closed position), while switch 2019 was the auxiliary switch (i.e., in the open position). By being in a dual-radial arrangement, even though switch 2019 is not load carrying, it would still have electric potential contained within the switch. Figure 29 presents a diagram of the setup of the switch in vault 073.

Although switch 2019 does not have current flow, it does have potential at both the load (contacts,  $V_{p1}$ ) and source (blades,  $V_{p2}$ ) when in the central position of the switch. Electrical discharge does not happen at the end of the central switch contacts due to the insulating characteristics of the oil. However, if the oil becomes contaminated due to a leak of water and/or air into the system, the dielectric would be reduced. From the observation of the

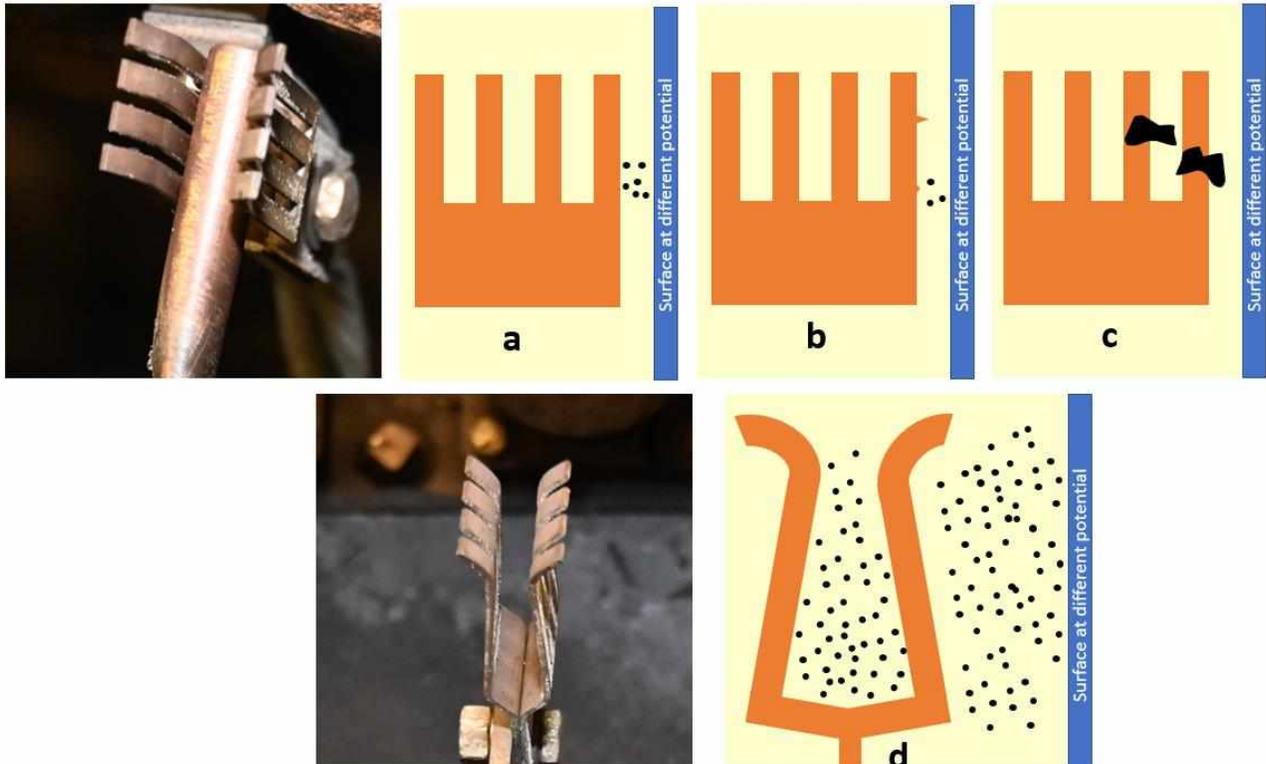
Although the distances between the conductive components in the auxiliary switch may have been far enough away not to cause PD and arcing with new oil. As degradation produces build up dielectric is reduced from the contamination, and the system becomes set up to allow PD (Figure 30). If the dielectric is reduced enough, an arc will be produced. Depending on the dielectric between the blades and contacts themselves, the blades and the tank walls, the blades and the air, the blades and wall of the tank, etc. they all have the ability to generate PD. PD does create conductive particles in mineral oil and degradation products, but it also generates several combustible gases such as hydrogen and methane. When a system is closed and free of oxygen, even though combustible gases as generated, they will not ignite even when subjected to an electrical discharge or heat, since oxygen is required to burn. However, if the switch had leaks into the tank (as was indicated from the presence of the rust) oxygen would enter the system. Depending on the size of the leak and the amount of time allowed to leak, an explosive mixture could be produced. Depending on the diffusion and dispersion of the degradation products and conductive particles, there

can be regions or pathways of reduced dielectric breakdown. When the dielectric pathway becomes enough of a conductor, a point of electrical discharge can be extended and, in an extreme case, an arc can be generated.
