## Explosion & Fire on Burrard Street at BCH V73

### Explosion & Fire Analysis Reconstruction

**Our File Number:** 2300129  
**Date of Report:** June 7, 2023  
**Revision:** 0  
**Report #:** 001  
**Date of Incident:** February 24, 2023

**Prepared for:** Ms. Nicole Prior  
Senior Manager, Legal Services  
BC Hydro  
6911 Southpoint Drive, Podium A03  
Burnaby, BC V3N 4X8

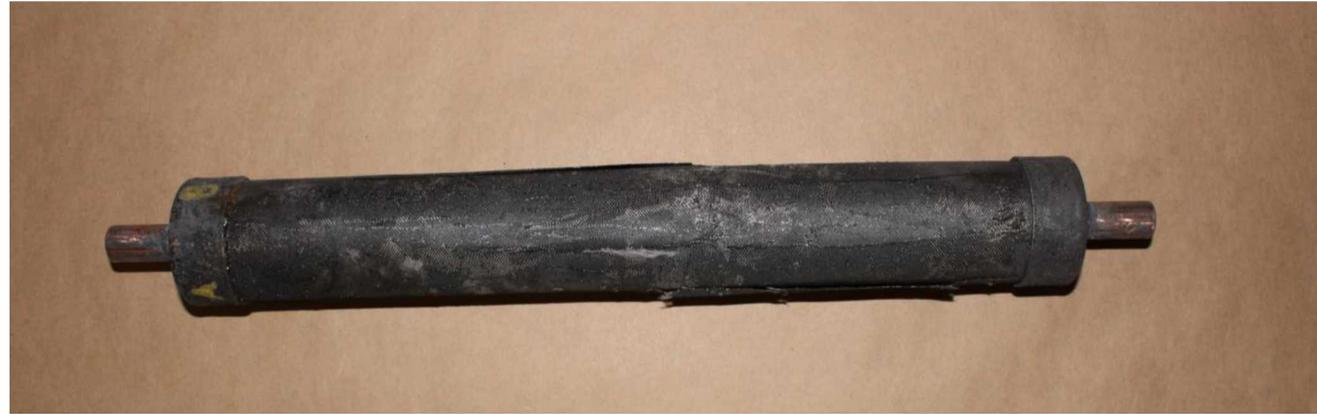
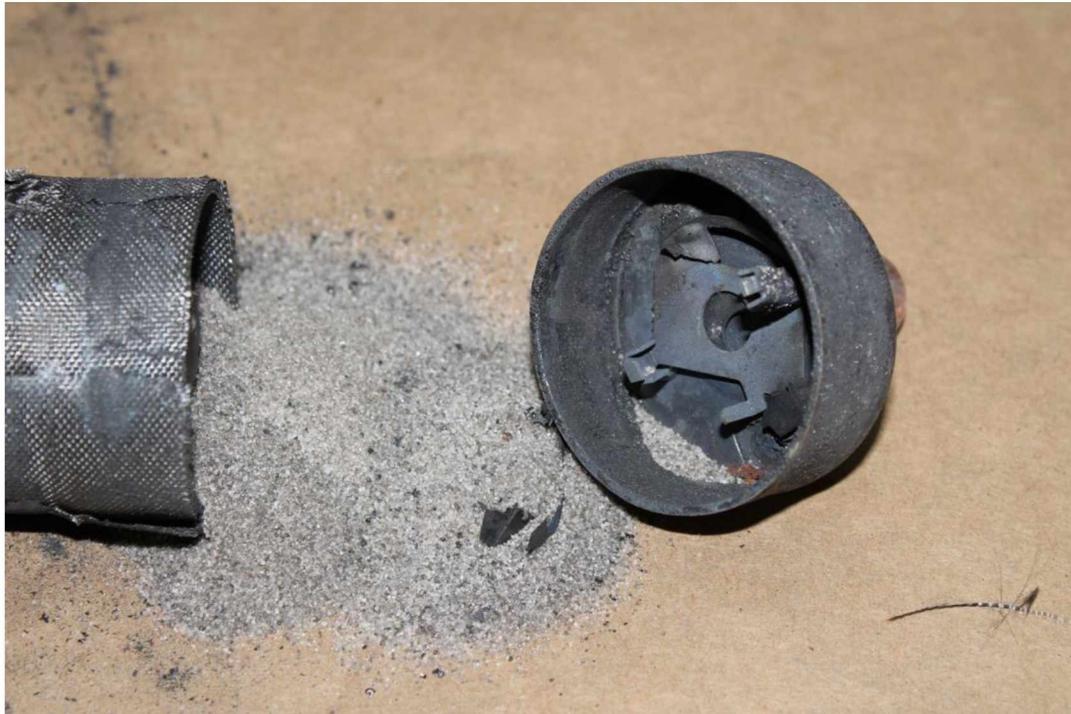
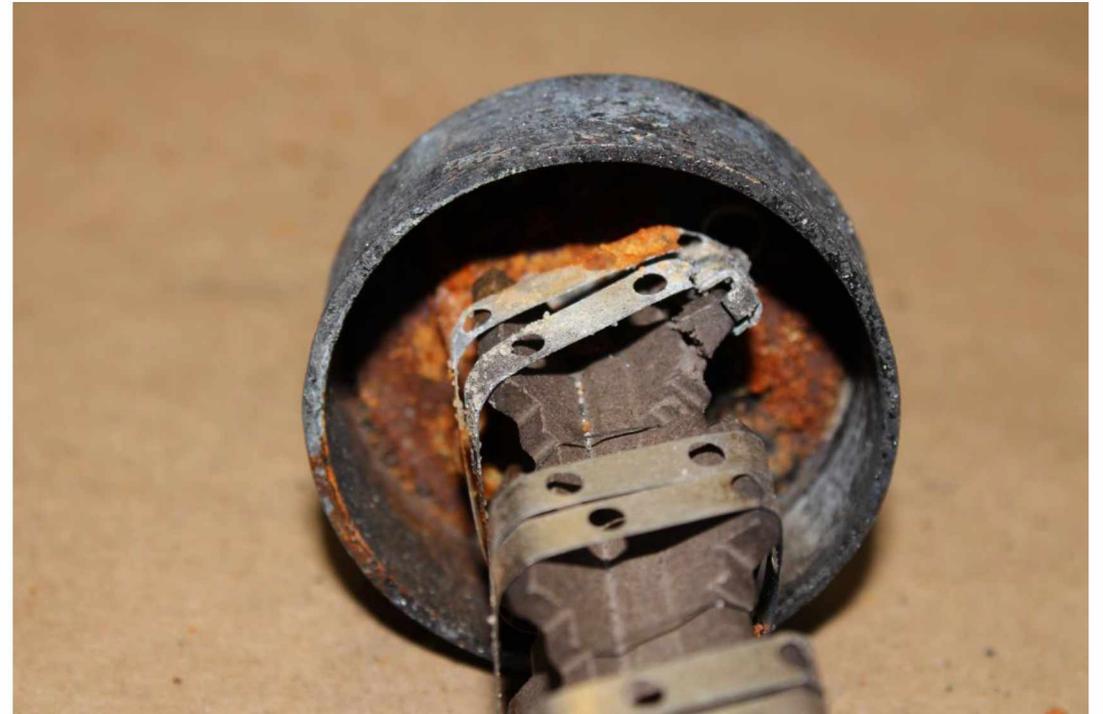
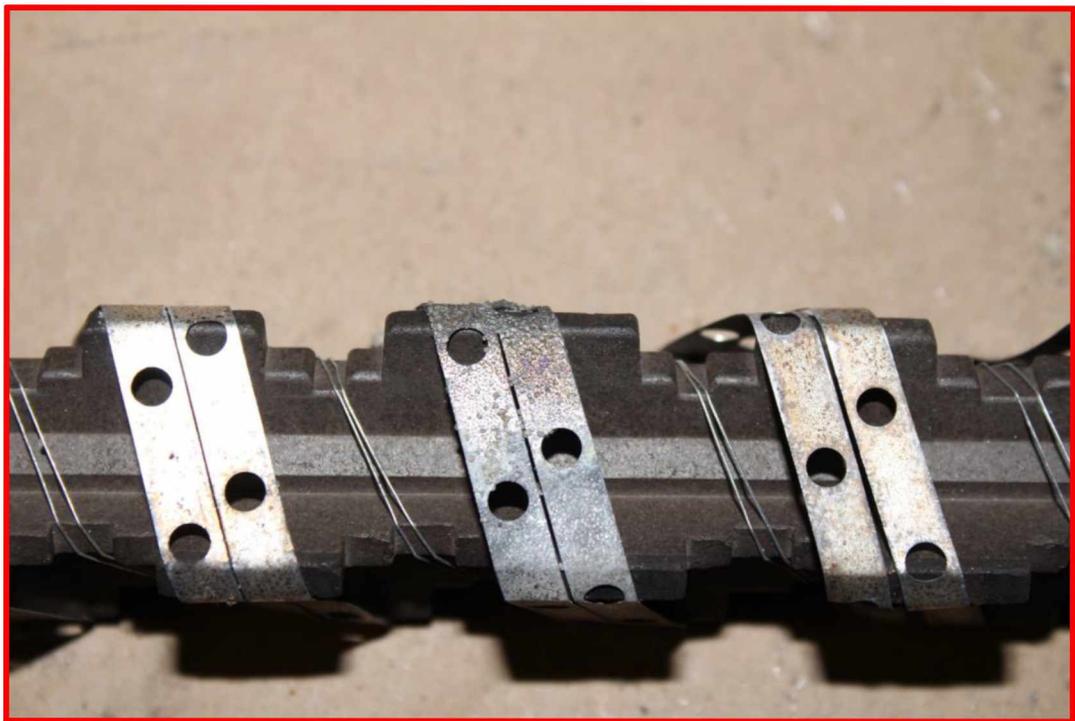
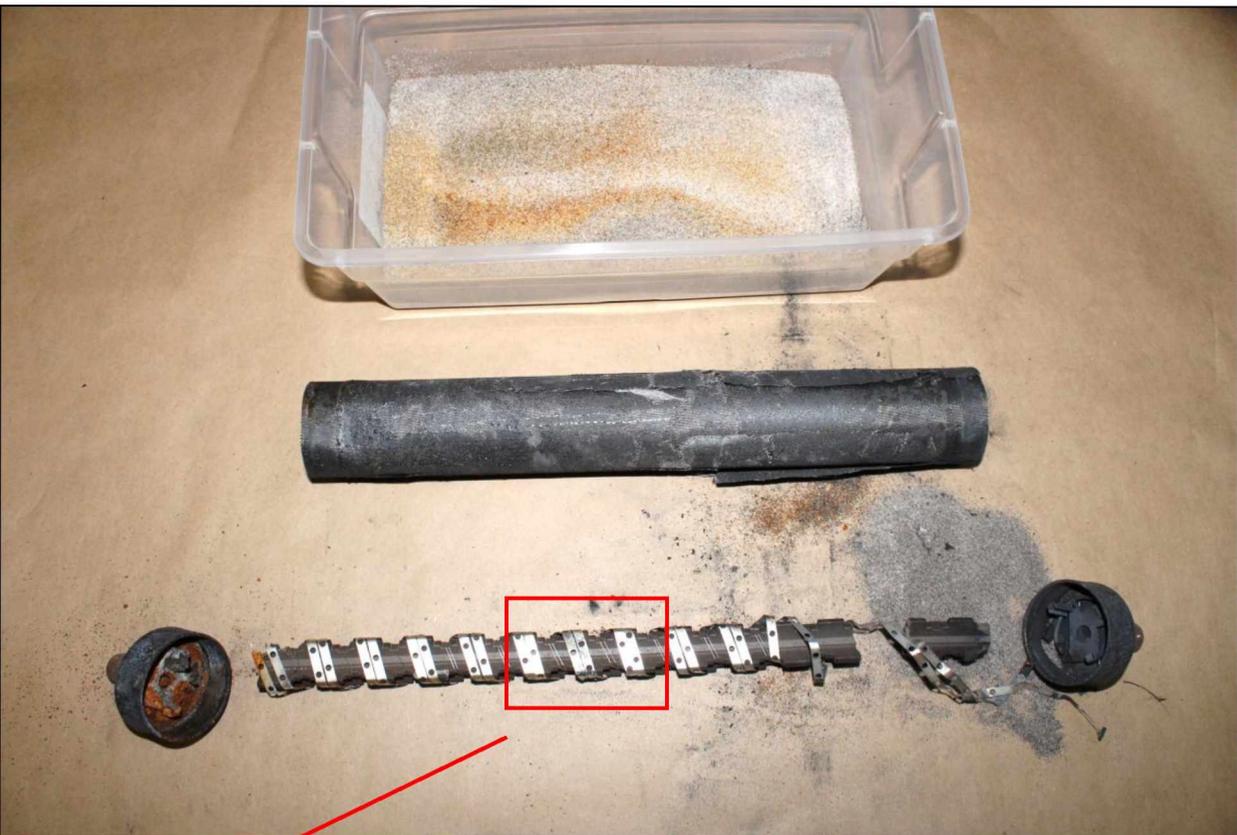
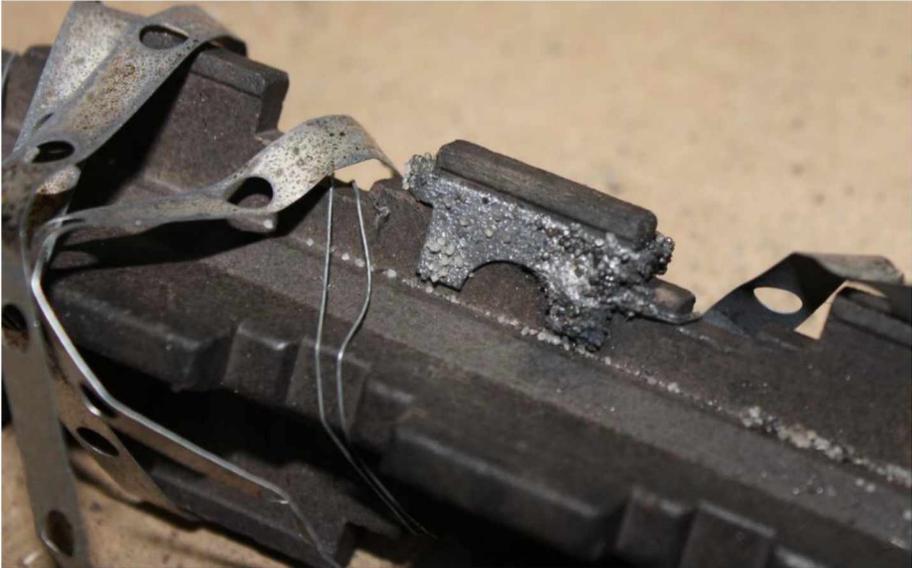
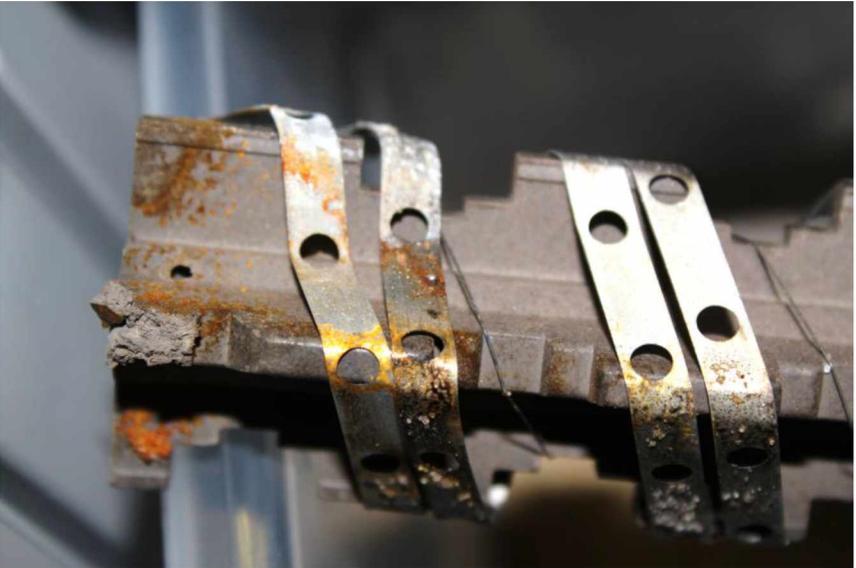
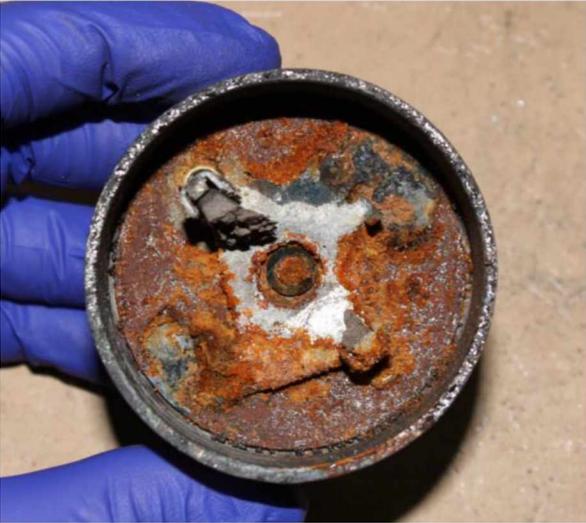
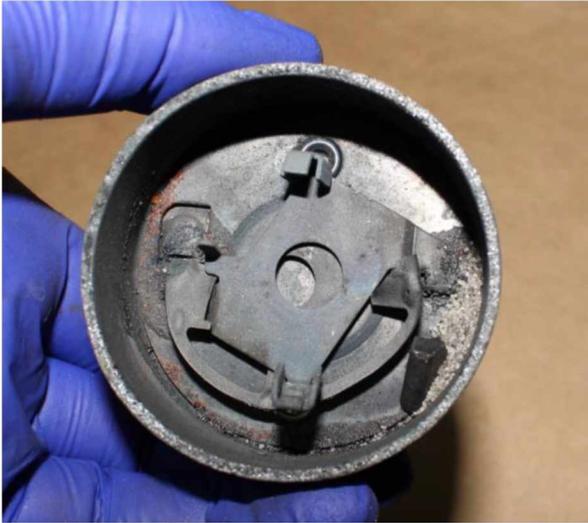
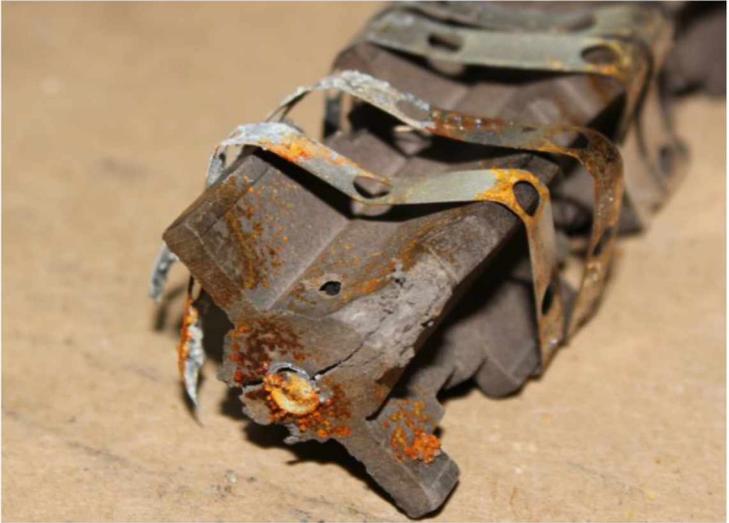
Sample B – Fuse 1

- Fuses were filled with sand.
- Outer shell was a wrap of several layers of (metal?) fiber mesh.
- Sample C - Fuse two had the most visible damage. The outer case was hardened on one end and frayed on the other. Inner beam was broken into several pieces.
- All fuses appear to have some rust on the inside.

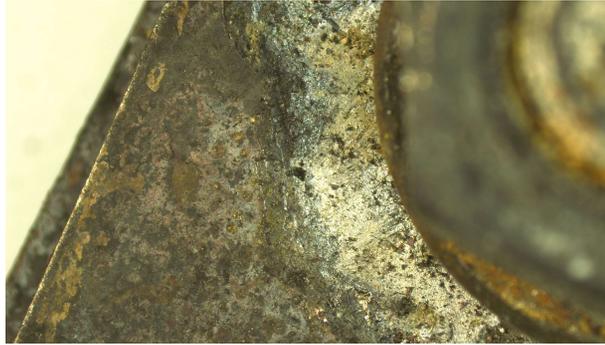
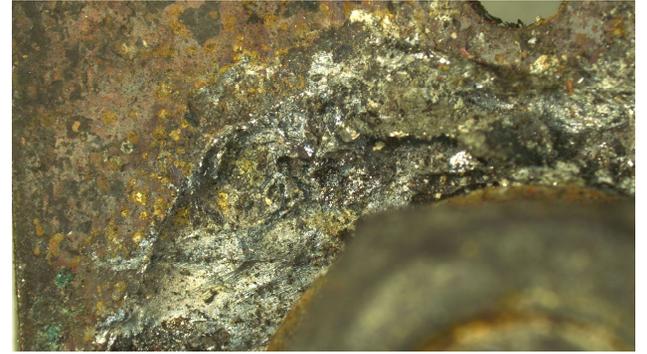
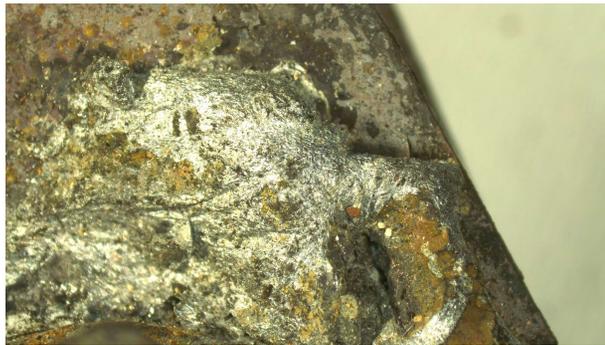
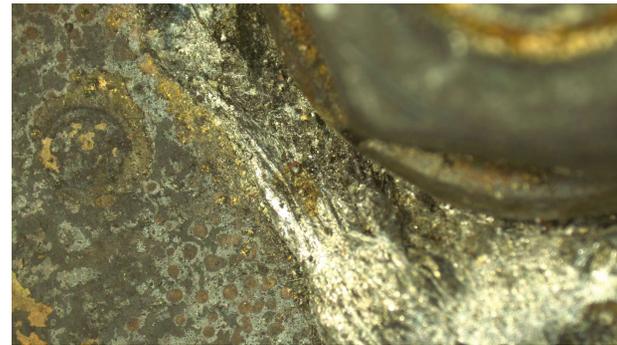
E9 Damage  
around Nut
