### Board briefing – DAM SAFETY QUARTERLY REPORT

#### Quarterly Featured Damsite – Walter Hardman Dam

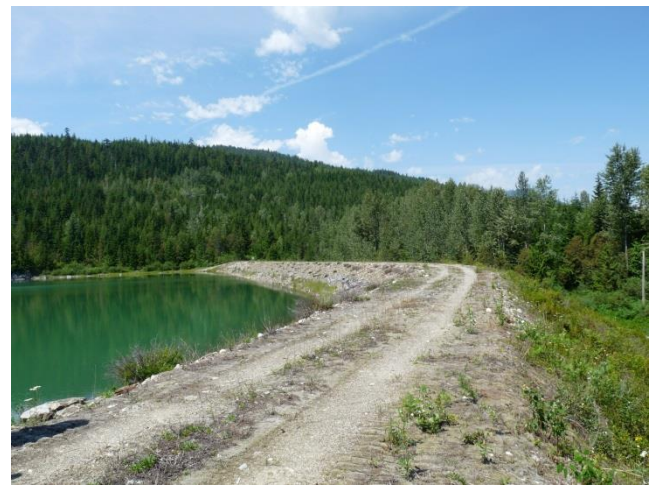
*Walter Hardman Headpond Dam*

The Walter Hardman Headpond Dam was constructed in 1961 and is a 381 metre long earthfill dam with a maximum height of approximately 12 metres. Two through-going conduits encased in concrete (the Discharge and Penstock Conduits) pass through the base of the dam. Drawings indicate that the dam is zoned earthfill constructed of rolled compacted earth fill with a glacial till core, fine gravel transitions on either side of the core, and sand and gravel shells. Original drawings also indicate that the upstream slope was to be protected by 0.9 metres of riprap but this was apparently not completed during construction. Riprap was placed on the upstream face in 1988 to address this omission.

The Walter Hardman Headpond Dam was constructed to a design elevation of 704.1 metres. However, during inspections completed as part of the 1985 CIR, the crest was found to be up to 0.44 metres below the design elevation. This difference is believed to have been a result of construction error rather than excessive settlement. In 1988, rehabilitation work included raising the dam crest to its design elevation of 704.1 metres, although survey data indicates the dam crest was raised higher than this. This is typical of the discrepancies that have been identified between the information provided on the Record Issue drawings and what is observed at site, leading to large uncertainties about what was actually constructed.

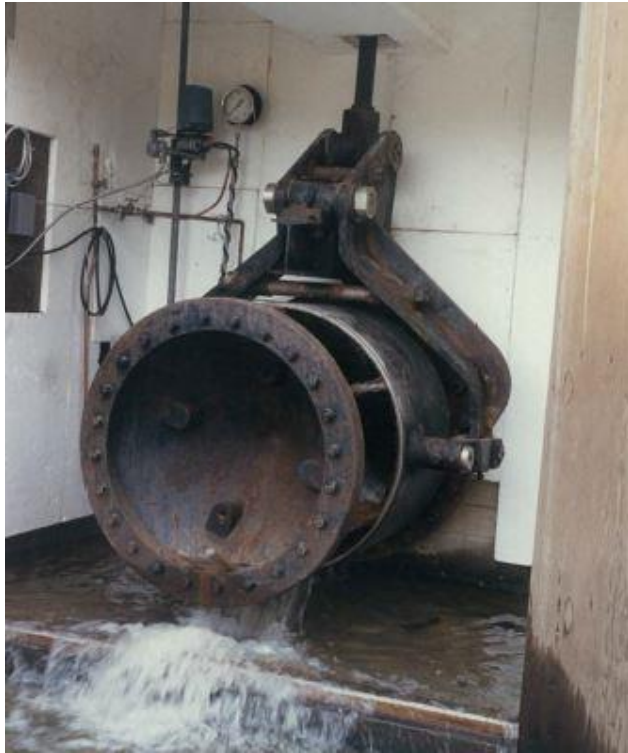
*Hollowcone Valve, 1986*

The ungated power intake structure is located at the upstream toe of the Headpond Dam. The intake structure leads to a discharge conduit and a penstock conduit located in the base of the dam. The discharge conduit has a hollow cone valve at the downstream end which has not been used since 1986. Flow from the discharge conduit passes under Highway 23 into a steep gully which discharges into Arrow Lake adjacent to the powerhouse. The penstock conduit has a valve house at the downstream end containing a butterfly valve. From the valve house, a steel penstock continues down the hillside to the 8 MW powerhouse.

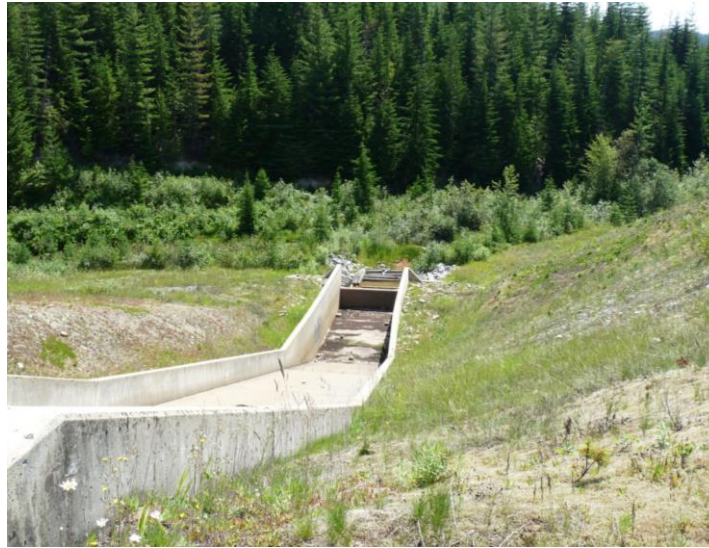
*Walter Hardman Spillway*

In the fall of 1979, a third Spillway was constructed to replace the failed Spillway. This is the Spillway present at the Walter Hardman Project today. The Spillway is located between the Cut-off Dam and the previous (1974) Spillway. A Closure Dam was constructed in the location of the 1974 Spillway and connects the present Spillway to natural high ground to the south.

Until 1996, the spillway was regularly used for four to five months every year during seasonal high flows from Cranberry Creek. In May 1996, during high water releases, rock-filled gabions and riprap at the toe of the spillway were washed away and erosion in the discharge channel occurred. The erosion caused concern about the environmental impacts of spilling through the discharge channel and as a result, the operating level of the headpond was permanently reduced by 0.9 metres to avoid spilling. The reduced operating level was embedded in the Water Use Plan in 2006.
