**02SH36**  
**THE PROCTER CHANNEL**  
**FINAL REPORT**

Submitted by: Gay Jewitt, Administrator  
Whitevalley Community Resource Centre  
Prepared by: Thomas Minor, BSc, CET  
Date: April 12, 2003

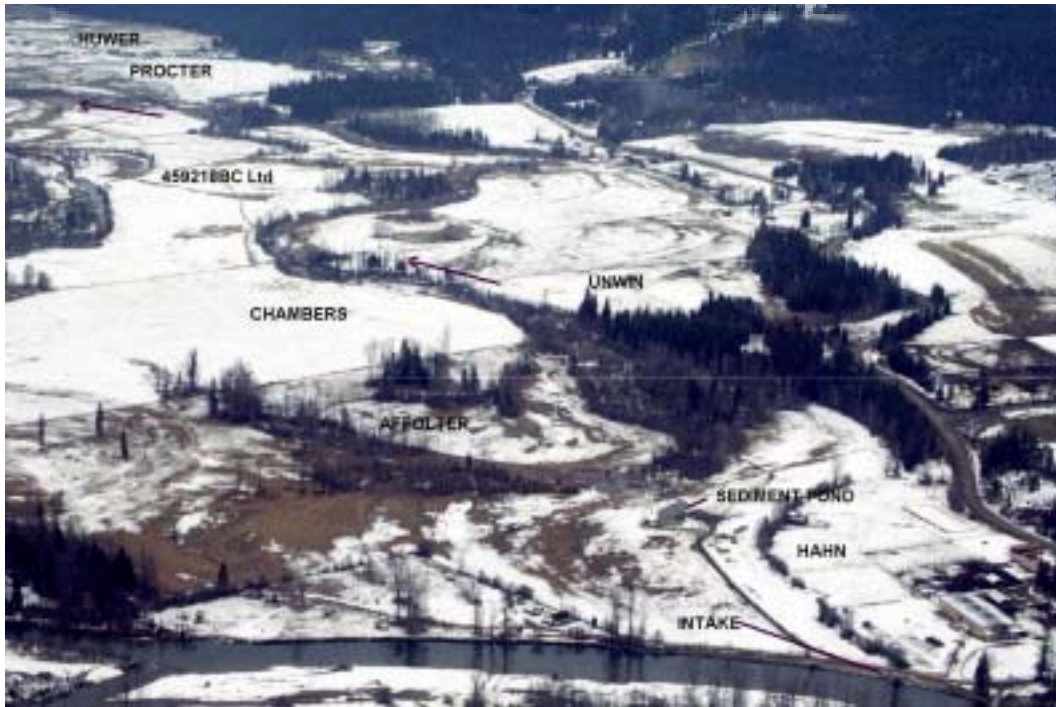
Figure 1: The photo shows an overview of the Procter channel looking north. From the intake on the Shuswap River (bottom right) there is 300 m of buried pipe diverting water to the sediment pond. From the sediment pond, the water flows into existing channels and wetlands. Photo taken Feb 2003.

The intake for the Procter Channel site is located on the Middle Shuswap River approximately 8.5 km downstream of the Wilsey Dam (BCGS map 82L037). This is immediately downstream of the most heavily utilized spawning area in the Middle Shuswap (Arc Environmental 2001). It is about 5 km downstream of the Bessette Creek confluence, the largest tributary to Middle Shuswap. The Procter Channel consists of remnant channels that have been cut off from the Shuswap River at the upstream end. It flowed intermittently from groundwater contributions and surfacial runoff from the adjacent hillsides. The remnant channels contain approximately 13 hectares of ponds and cattail marches (Figure 1).

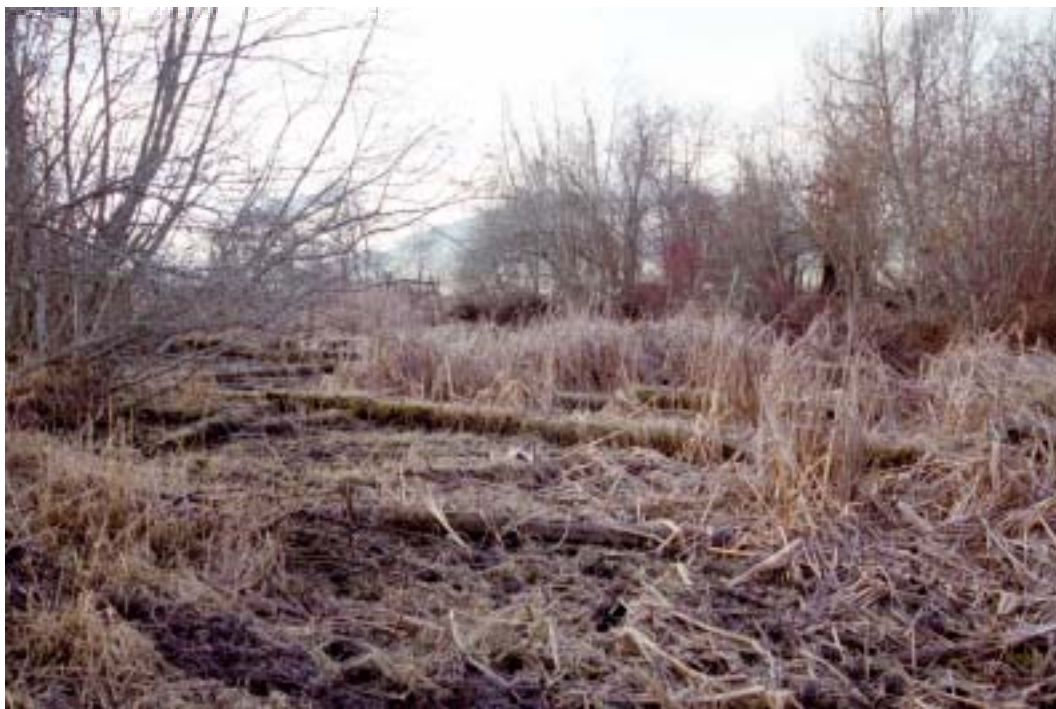
Figures 2a: Trees and roots were often pushed into sloughs when the land was cleared. Photo taken in November 2002

The land adjacent to these channels is largely agricultural, being used for pasture and hay production. The existing riparian width along the old channel varies from 20 m to over 120 m. The riparian is largely deciduous, the merchantable timber having been removed. The old channels are richly complexed with woody debris due to the old clearing practices. When the adjacent fields were being cleared, the stumps and unusable logs were pushed into the old channels both to dispose of the waste and create fill to enlarge the fields. Much of the cedar roots and logs still are present and provide in-stream cover (Figures 2a & b).

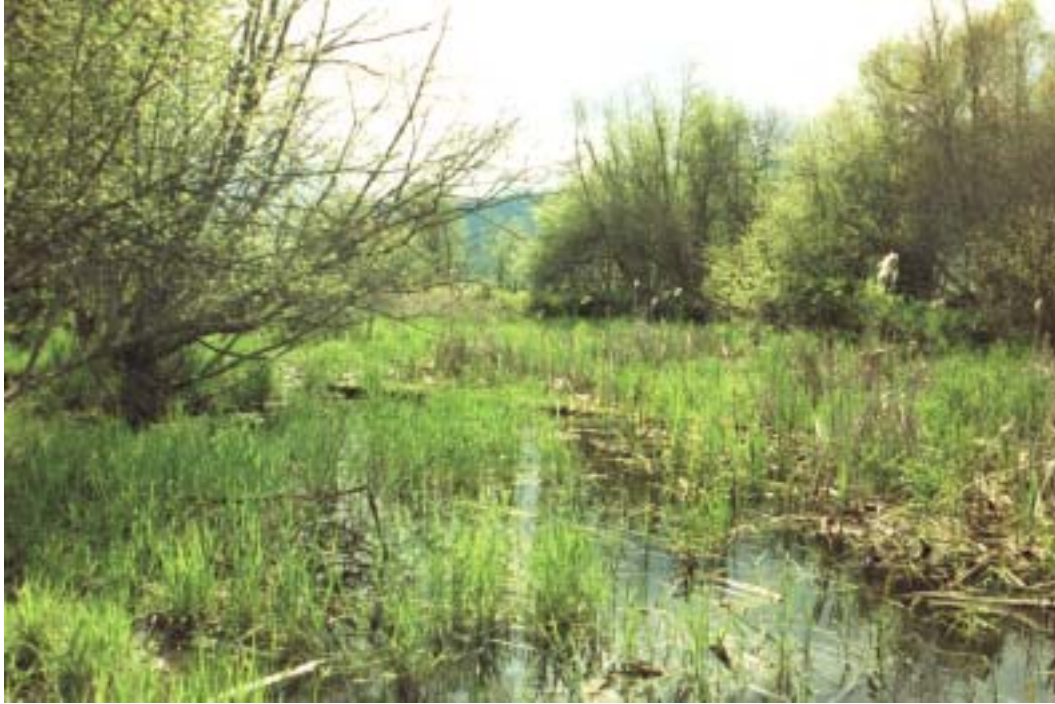
Figure 2b: The wood debris left from land clearing becomes fish habitat when water is added to the remnant channel. Photo taken in May 2003.

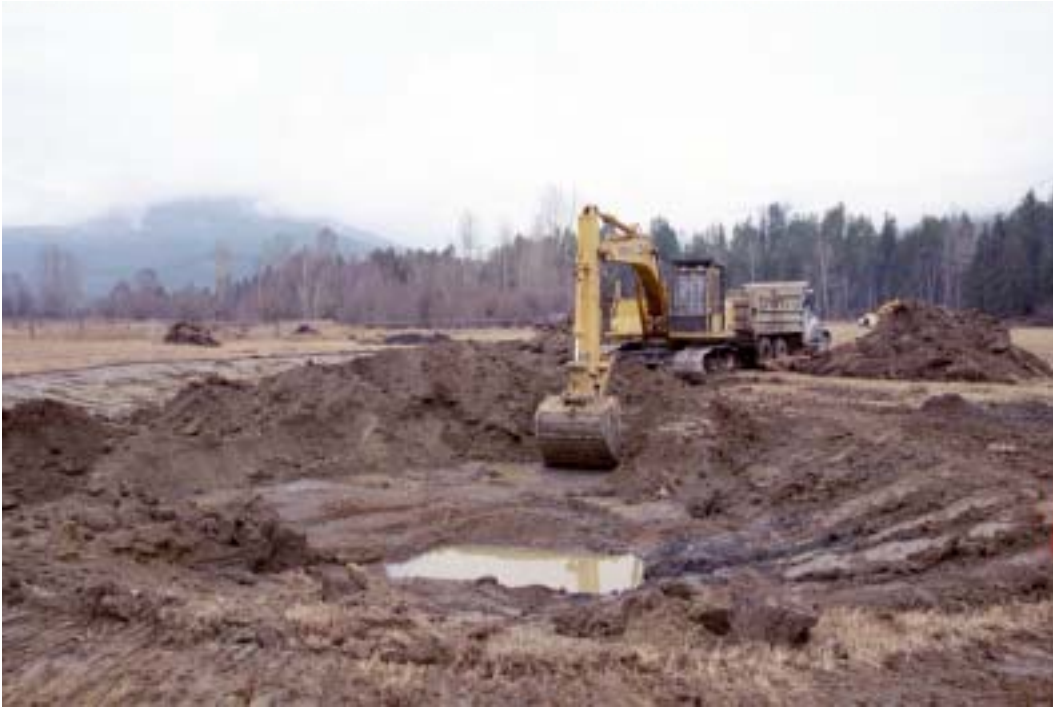
Figure 3: The settling pond located on the Hahn Property. Waste material was used to fill low spots on the adjacent fields while gravel was used for spawning areas.

Excavation began December 2 on the Hahn property. Two excavators, a John Deere 790 @ \$105/hr and a John Deere 690 @ \$100/hr were hired to dig the sediment pond and to dispose of the waste material. The sediment pond is located on the Hahn property 300 m north of the Shuswap River. It is kidney shaped approximately 50 m long and 15 m wide

(Figure 3). Because of the fine material at the ground water level, the depth of the pond was limited to about 2 m at the widest sections. Trying to dig deeper just resulted in the sides sloughing in and the pond widening. The intake is at the south end and the outlet on the north end. Spawning gravel has been placed at the inlet, the narrow center and the outlet.

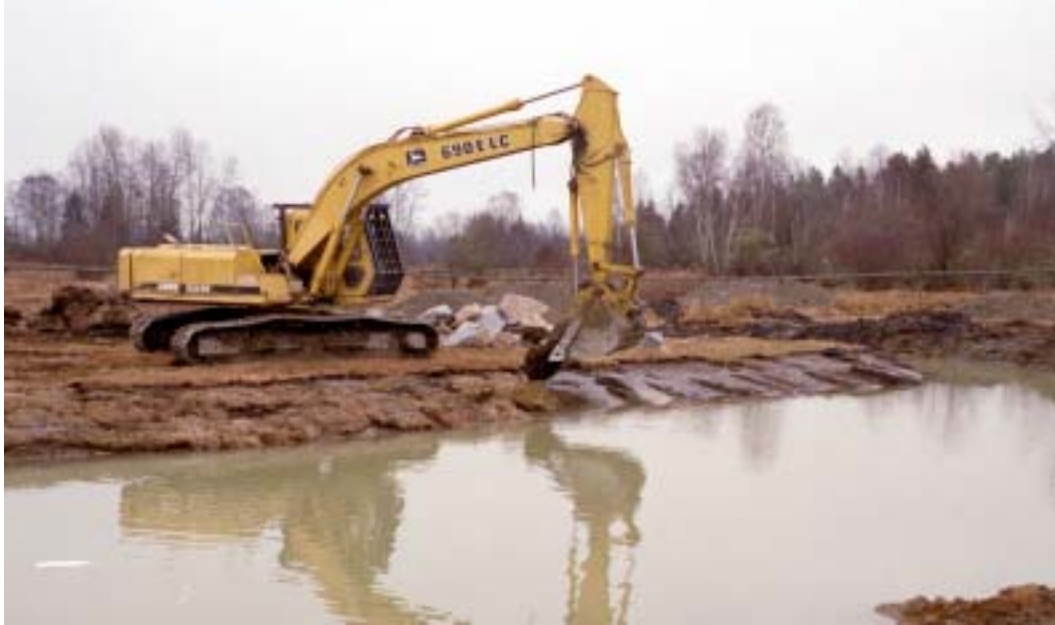
Figure 4: The sod was replaced along the sloped edges of the settling pond. Shrubs and trees were planted in the spring.

The sod that was removed from the pond area was piled to the side and replaced along the sloped banks above the water line (Figure 4). The majority of the material excavated from the pond area was silt or clay and was taken to a low spot in the Hahn's field approximately 200 m away. Two dump trucks @ \$60/hr each, were hired to move the waste material from the pond area to the waste site. One excavator was used to excavate the pond and load the trucks while the second was used to lift the sod from the waste site, spread the waste material and scatter the sod on top. Some gravel material suitable for spawning gravel was found at the north end of the pond. This was put to the side and later spread at the center and outlet of the pond. The pond took two days to rough out.

Replacing the sod around the edges of the pond during excavation worked well. This is a practice that WCRC commonly used when doing stream stabilization work. The old sod quickly re-roots and prevents the banks from washing in during high flows or heavy rain. With the sediment pond there is the additional inflow of water from the high springtime water table. With the silty soil and low surface water level due to the closed intake, the pond is highly susceptible to erosion from groundwater flow (Figure 18). Without the sod placement, erosion would have been extensive.

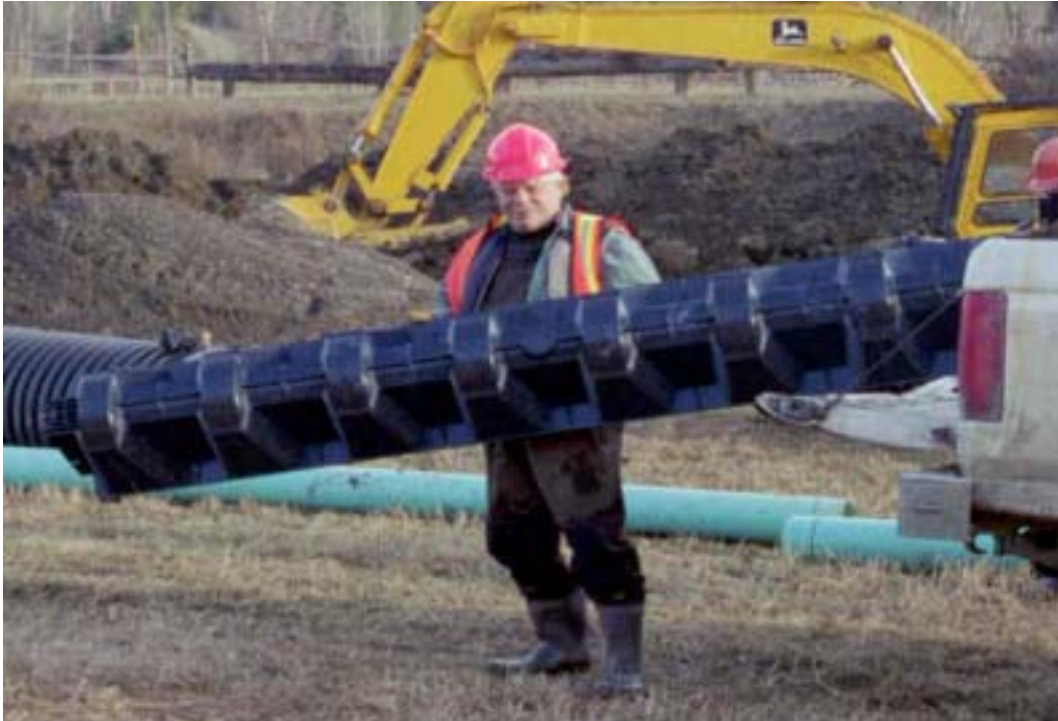
Figure 5: Larry McGregor holds up a section of the intake gallery. The sides have slots that angle downwards. Water is able to flow in, but sand and gravel is kept out. This type of gallery has a larger exchange area than standard perforated pipe.

An infiltration gallery (Figure 5) was placed along side the 600 mm pipe to collect groundwater. The gallery was placed where the material below the water table consisted of coarse sand and/or gravel to collect ground water (Figure 6).

The gallery is made up of 2 m sections of arch-shaped plastic that is open on the bottom and solid on the top. The sides have louvered slots that slant downwards. This allows water to flow in without sand falling in. The cross sectional area of the gallery is about 320 cm<sup>2</sup>. In areas where the material below the water table contained fines, a solid 25 cm diameter plastic sewer pipe was used to connect the infiltration galleries.

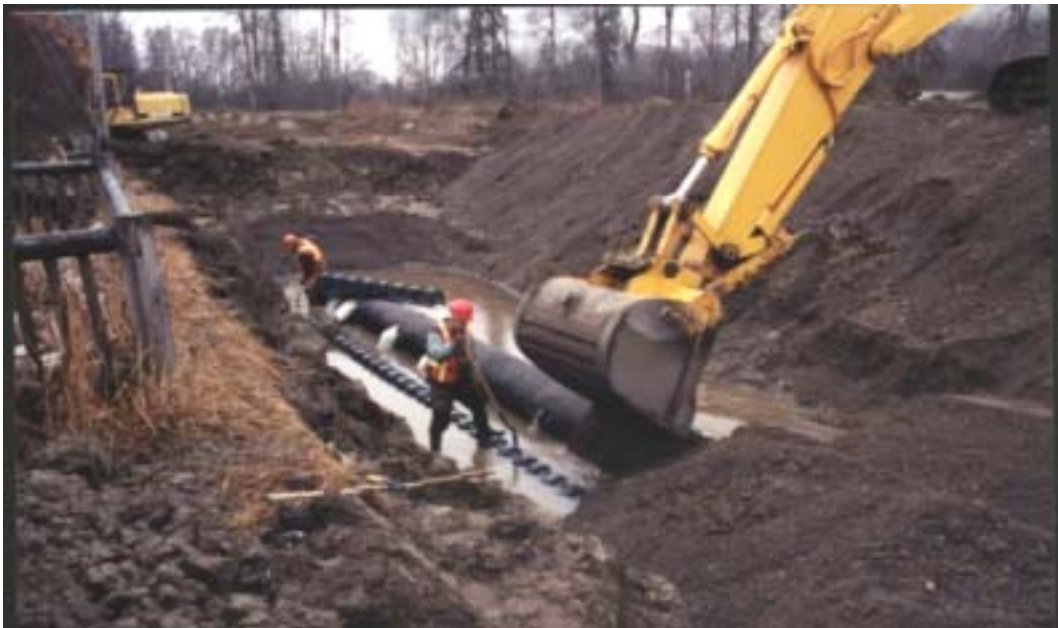
Figure 6: An infiltration gallery was placed beside the 600 mm pipe to collect groundwater. This will allow a flow of water even when the intake is closed. Sandbags were used to counter the buoyancy of the pipe.

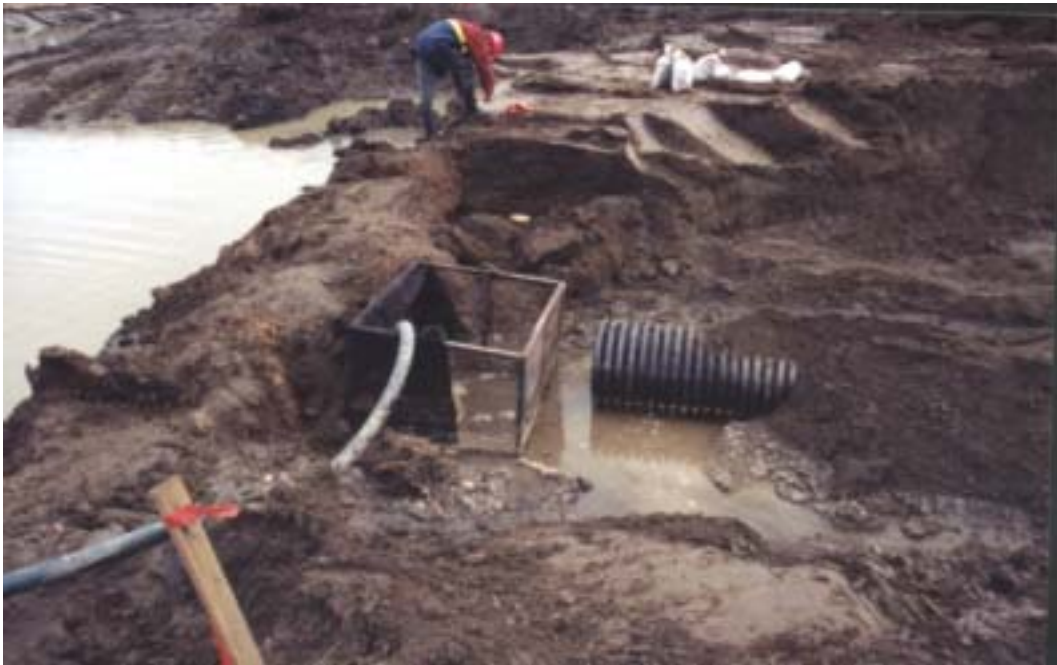
Figure 7: A pump was placed behind a berm on the downstream end of the intake pipe. This allowed the ditch to be drained for ease of pipe placement and minimum sedimentation.

The outlet of the pipe was kept separate from the rest of the sediment pond with a berm (Figure 7). A sump hole was dug at the downstream end of the pipe, separated from the pond by a berm. A wire cage was placed in the sump hole and water pumped from the caged area to the sediment pond, keeping the ditch line water level to a below 30 cm. The cage kept the pumps from being clogged from wood debris flushed out while excavating. While the pumps were running, the ditch water 0.6 to 1 m below the pond water level. Over night, the pumps would be shut off and the berm breached slightly. By morning, the ditch water would have risen and would be flowing into the pond through the breach. An hour before work was to begin, the breach would be filled and the pumps started.

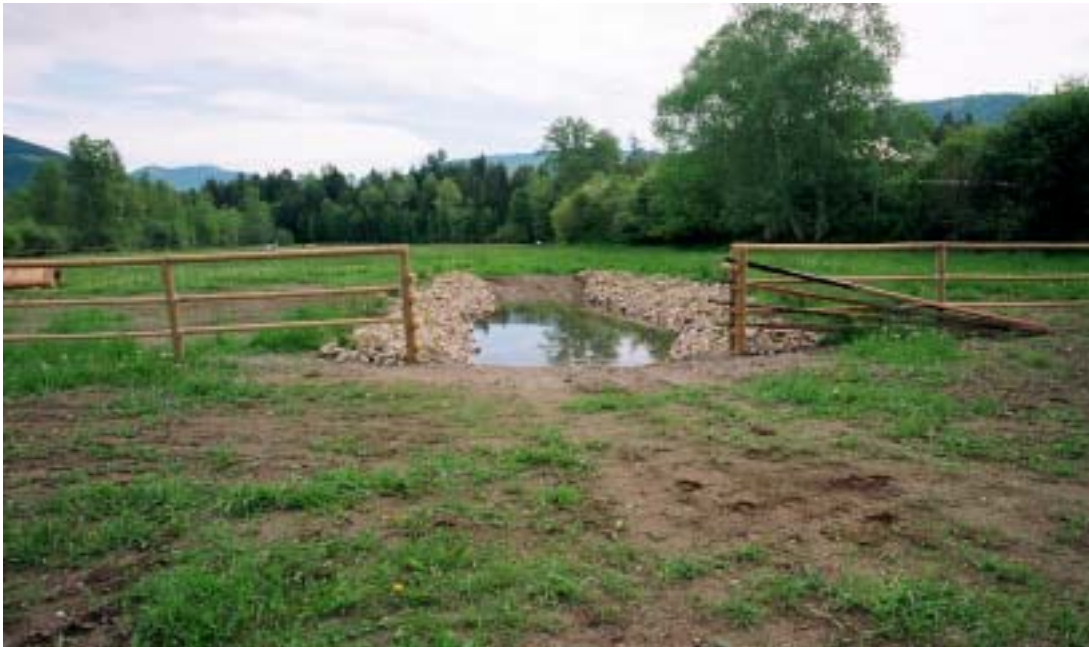
Figure 8: This water jump was dug 30m from the pond. It is connected to the pond by a 20 cm pipe that supplies water to the jump.

The Hahn property is an equestrian center and the pipeline and pond are located in fields used for jumping. The landowner had hoped that he would be able to use the open channel in the original plans in his jumping course. This wasn't possible with the buried pipeline. To allow him a water jump, a 25 cm pipe was connected to the 600 mm pipe that diverts water to a water jump and then back to the sediment pond. The jump area is a 5 m x 15 m trench 1.5 m deep at the center tapering to ground level at the ends. Two sides are steeply slope and rocked while the north and south ends are low gradient to allow the horses to run through (Figure 8). There is 30 cm of water on the graveled bottom. The jump is located 30 m up the pipeline from sediment pond.

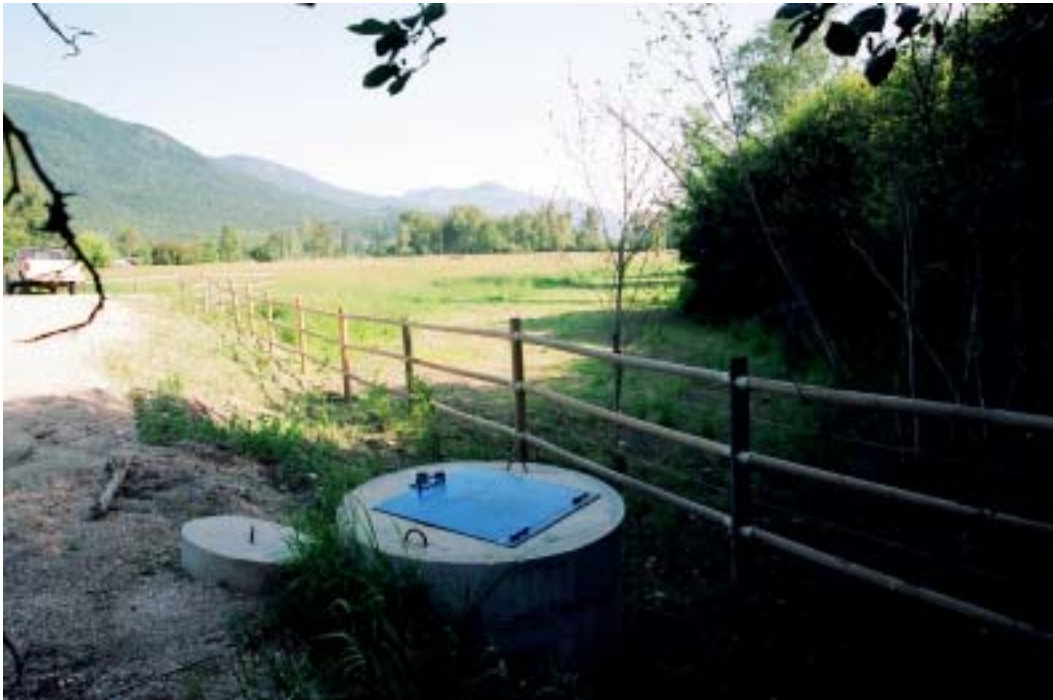
Figure 9: The manhole housing the control valve is located on the north shoulder of Lawrence Road. The metal door is locked.

The control valve is located in a manhole on the north shoulder of Lawrence Road across from the intake structure (Figure 9).

The manhole consists of 3 – 1 m high concrete rings 107 cm (42”) in diameter. The bottom ring has an 8 cm concrete slab at the bottom. The top ring has a concrete lid with a lockable metal hatch. The valve is a simple steel plate with sides that allow it to slide over the last rib of the pipe (Figure 10). It is lifted and lowered manually with a handle welded to the back of the plate. It can be held open by a chain at 5 cm intervals (the length of a link). The concrete rings are fitted with rungs for access to the bottom of the manhole. If work has do be done on the valve, the water can be shut off at the intake structure by sliding a half sheet of plywood between the concrete and the grill.

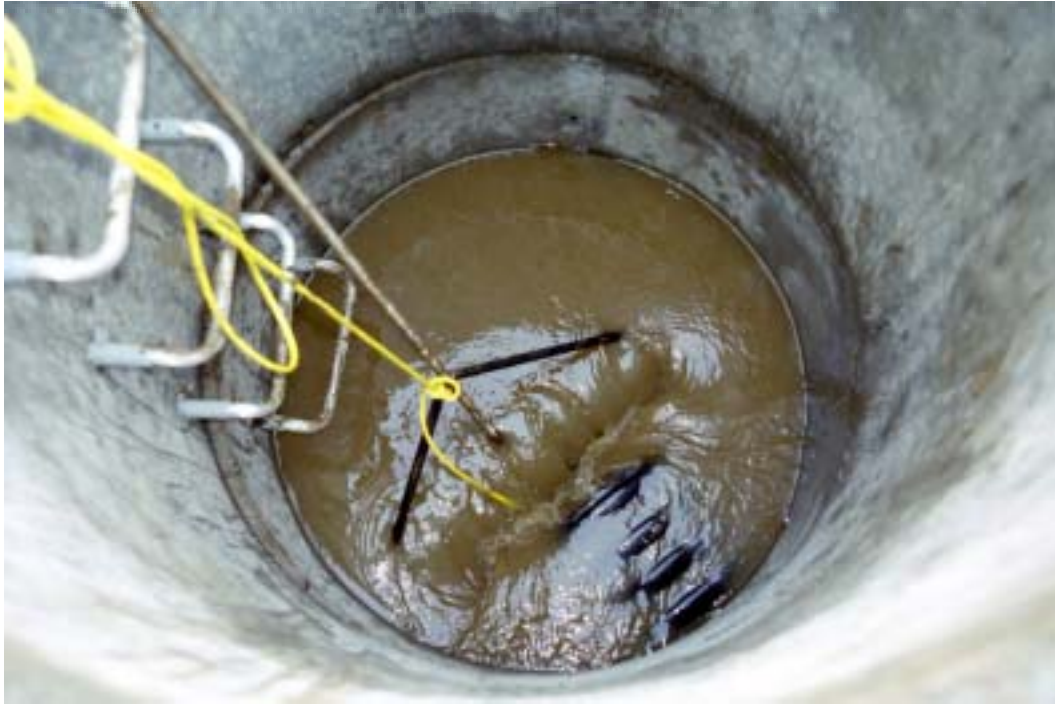
Figure10: The control valve being lowered over the end of the pipe during construction.

held in place by grooves that slide over the end rib of the pipe (Figure 10). The valve is controlled from the top of the manhole by a pulley that lifts or lowers the plate. It is not necessary to climb into the manhole for setting the valve. The manhole is access by a padlocked metal door.

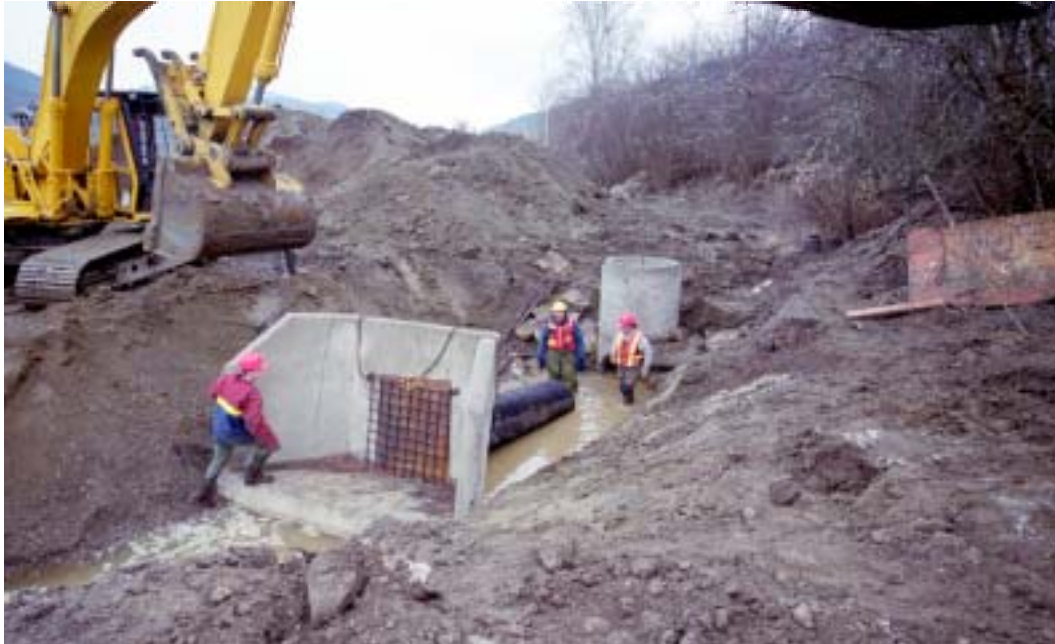
Figure 12: The inside grill of the intake structure is fixed to the concrete for safety reasons it can only be removed with a cutting torch. A piece of plywood is blocking the pipe.

The intake structure is a three-sided concrete structure with a bottom approximately 1.2 m high, 1.5 m wide and 1.5 m deep (Figure 11). There are two grills. One is placed on the back wall immediately in front of the pipe inlet that covers just the pipe (Figure 12).

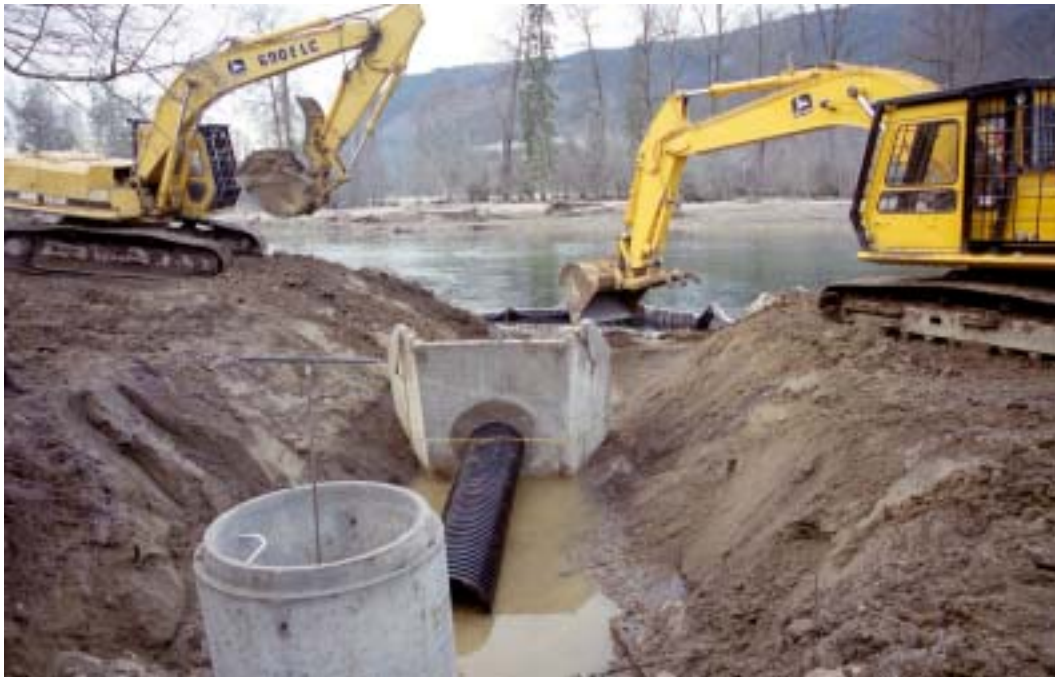
Figure 13: A silt fence was placed in the river. The intake structure had a 3 m piece of pipe attached to it. The last section pipe to be installed connected the intake structure pipe to the manhole. This allowed about 30 cm of leeway.

The pipe had previously been laid up to the manhole and backfilled before the road was breached. A 3 m piece of pipe had been fitted to the intake structure (Figure 13), so that once the structure was in place, only one section of pipe placed to complete the line.

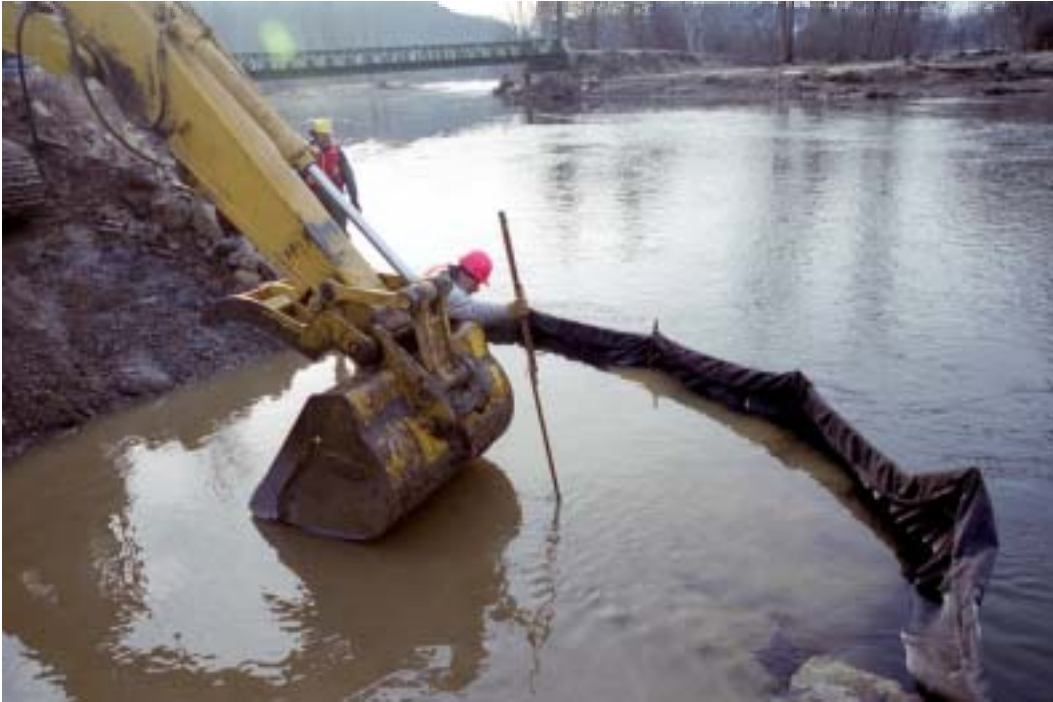
Figure 14: The elevation is checked for the placement of the intake structure. Note the silty water on the inside of the curtain compared to the clear river water. The dirty water was drained down the pipeline during construction. Because the cold water would quickly incapacitate anyone who fell in, all the workers wore floatation jackets.

The intake was placed after the trench was dug to the proper elevation (Figure 14). Two chains attached to the intake allowed the two excavators to level the intake with a great deal more ease than if only one excavator had been used. With the intake leveled, the berm between the river and the ditch could be restored and armoured. The final section of pipe was then attached and the trench backfilled.

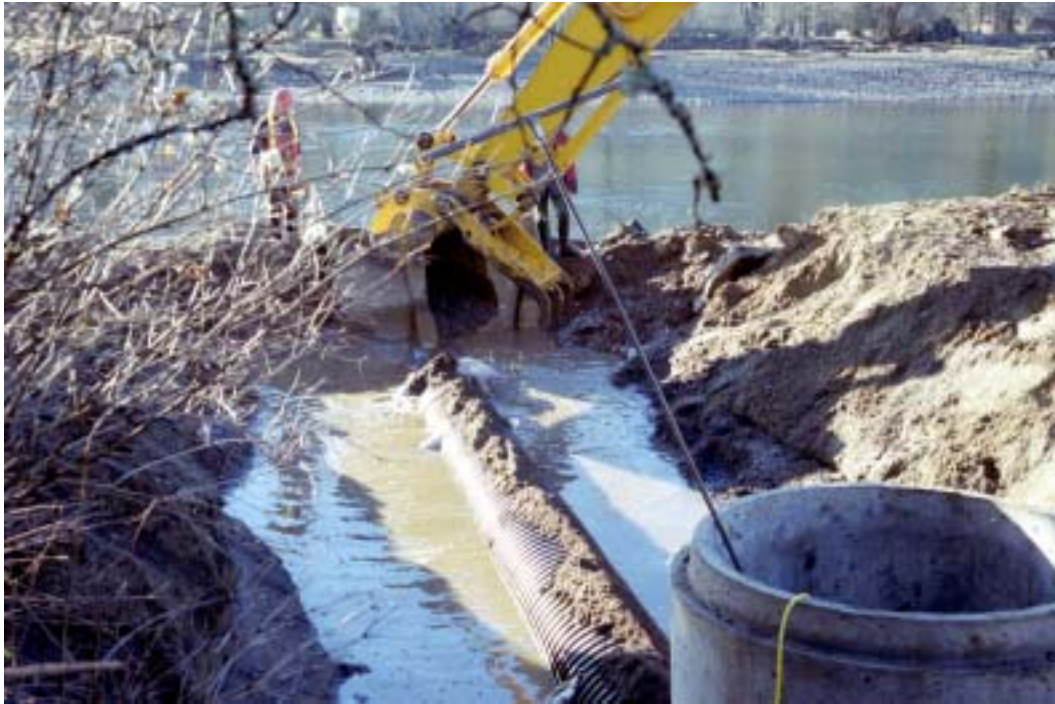
Figure 15: With the last section of pipe in place, the water was not able to drain down the pipeline to the sediment pond. Much of the water could be bailed from the ditch to the field side of the road, but there still remained enough moisture in the backfill to make vibration ineffective. A load of rock was added to the fill to give support until the material was able to drain.

The road was backfilled and vibrated in 1 m lifts. The vibration did not significantly help with compaction. The trench through the road was backfilled with dry material but there was enough water in the trench to over-moisten the soil for good compaction (Figure 15). With the last section of pipe in place, the water couldn't drain down the line as the trench was filled. To give this section of the road support under these wet conditions, a load of

rock had to be added to the road prism. The road was topped with a layer of crush material and compacted.

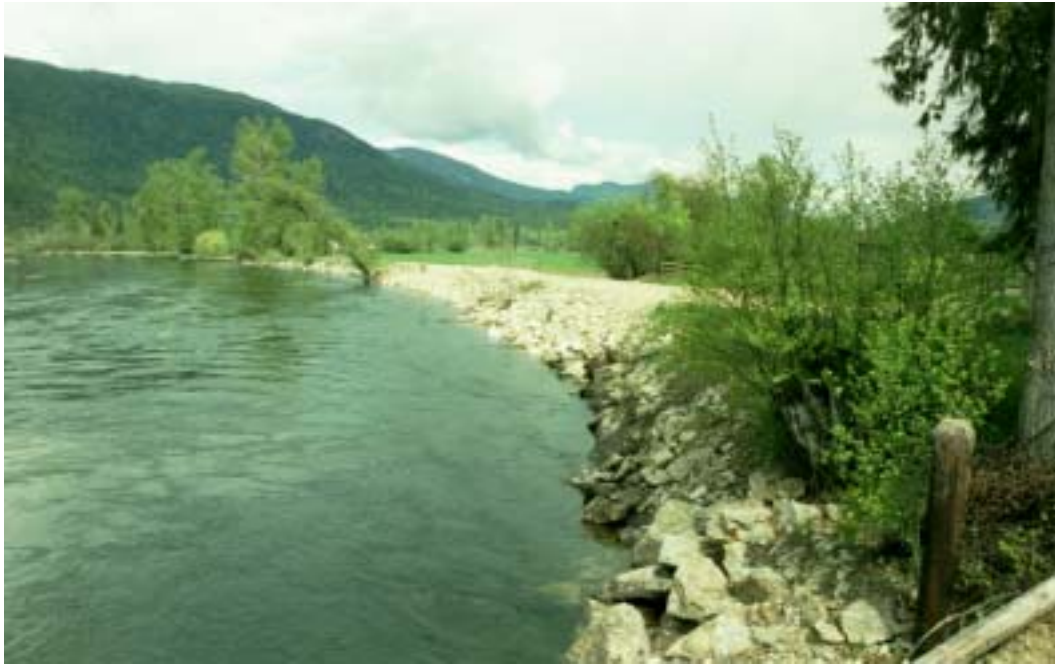
Figure 16: The existing riprap along Lawrence Road had been placed at a steep angle and had been deteriorating. Sixty meters of the road was pulled back 2m from the river to allow new rock to be placed at a more stable angle. Willow stakes were planted in with the rock. Work was done outside the window and without working in the water.

The fence on the Hahn's property had to be moved back as well. Thirty loads of rock were placed along the newly sloped road (Figure 16). Twelve loads of pit run were used

to widen the road prism and eight loads of crushed gravel were used to surface the road. Willow cuttings were planted during the placement of the riprap.

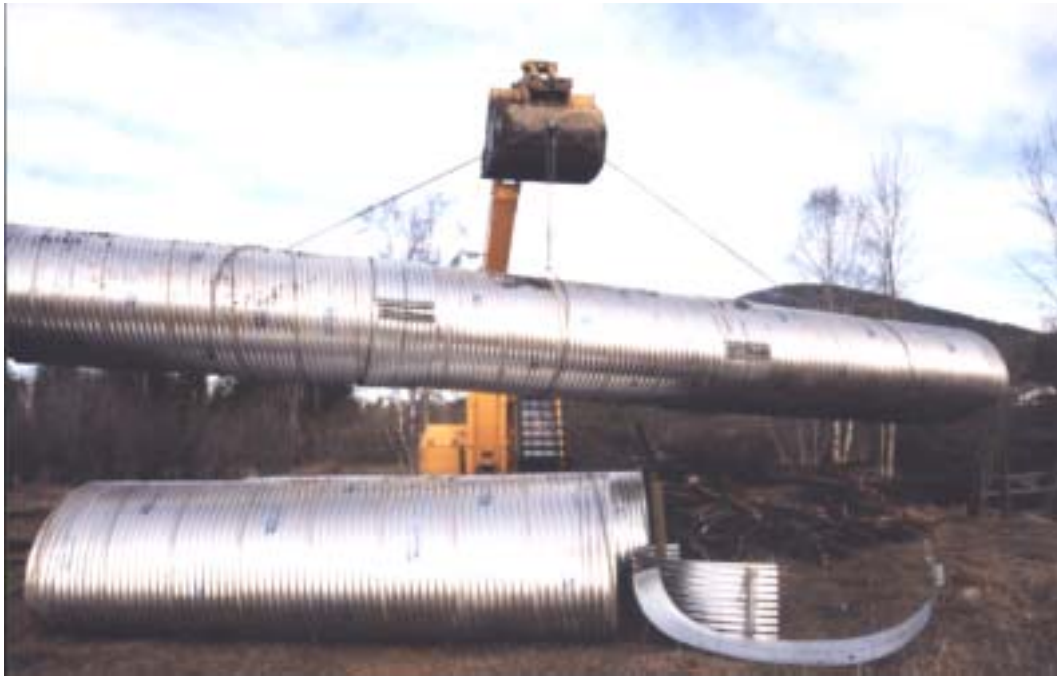
Figure 17: The JD 790 lifts a 2130mm x 1400mm x 12m steel pipe arch to placed it at a channel crossing. The culverts were assembled on the flat and lowered into place. The unseasonably dry weather allowed this work to be done in the dry.

WCRC upgraded these crossings with steel pipe arches (Figure 17). An additional crossing was also put in at the end of the sediment pond on the Hahn/Affolter property line. This crossing provided access across the channel for both properties. A 12 m 1390

mm x 970 mm pipe was used at the uppermost crossing. For crossing farther downstream on the channel either two 1390 mm x 970 mm pipes or a single 2130 x 1400 mm was used to accommodate the additional groundwater flow. The single larger pipe arch would be preferable because there is less chance of plugging with debris or being dammed by beaver. However, on some crossings the surrounding fields are only slightly higher than the water level. To build the road high enough to accommodate the larger culvert would make the crossing higher than the adjoining fields. During flood periods this would force the water to flow through the fields instead of over the armoured crossing.

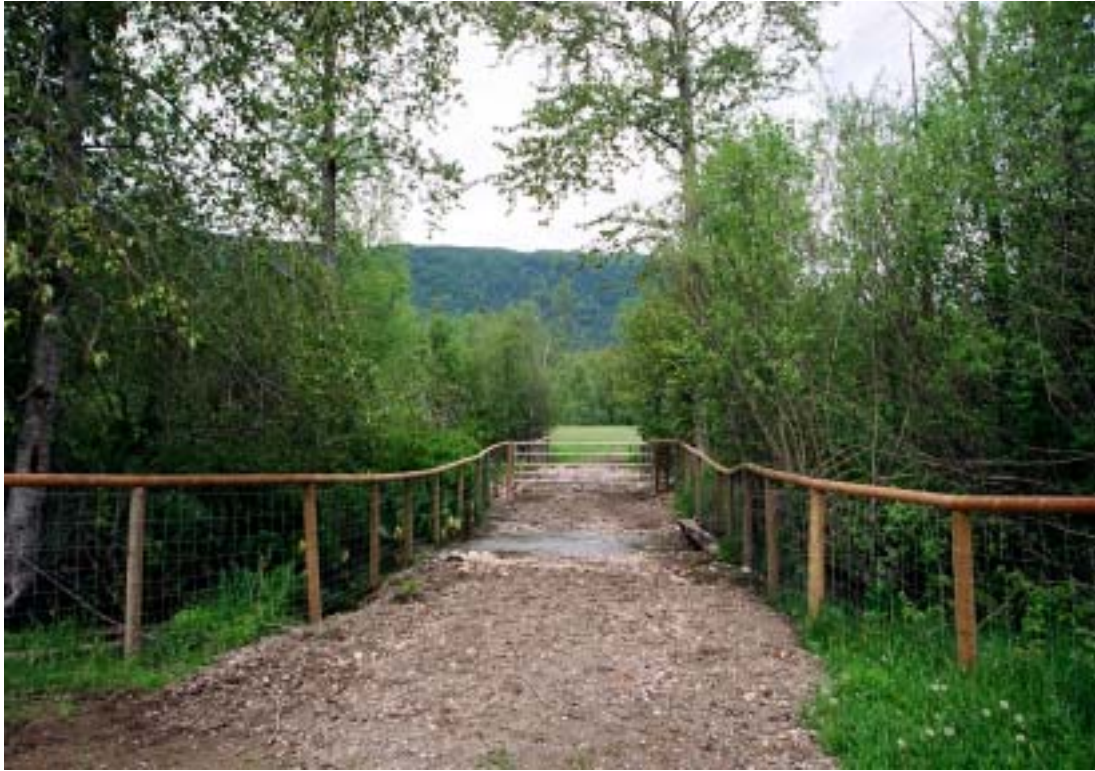
Figure 18: The middle crossing on the Affolter property doubles as an armoured watering site. With the gate in the center closed, animals can access the water from either side of the crossing. With the gate open, the channel can be crossed. A layer of rock was topped with a layer of gravel to prevent sedimentation of the channel.

On one of the crossing on the Affolter property, no culvert was used. The original crossing here was made from log corduroy. At this site the adjoining fields were less than 30 cm above the new water level. If a pipe arch had been placed here the road would either have to be built up over a meter or the pipe buried a meter below the channel bottom. If the road way were to be built up higher than the surrounding fields, floodwater would be forced through the fields rather than over the crossing. If the pipe were buried low enough so the roadway was not built above the fields, it would gradually fill in with sediment and the water simply flow over the road. Instead of placing culverts, the corduroy was removed and the crossing armoured. First a 30 cm layer of 8-inch minus was laid down followed by 1-inch gravel. This was vibrated in using the vibrating head on the John Deere 670 in such a way that the water flows in two separate streams on either side of the crossing. The metal pipe gate was placed in the middle of the crossing. The gate would normally remain closed allowing animals to water from either side of the channel. If the gate is opened, the channel can be crossed (Figure 18).

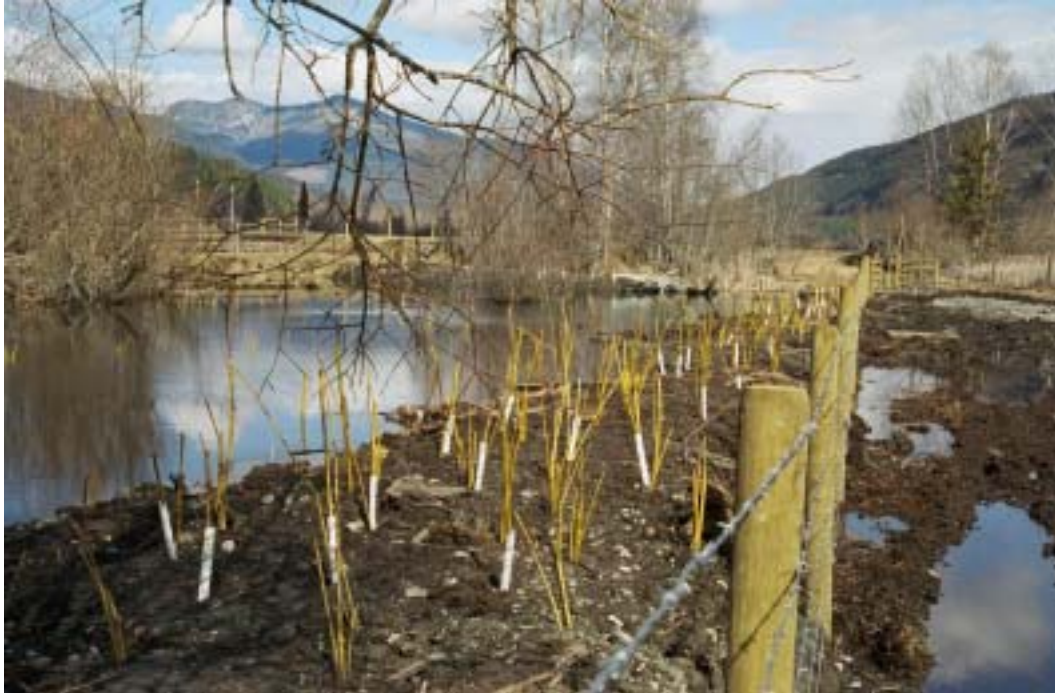
Figure 19: When the above refuge pond was dug, the soil was placed along side the channel and heavily planted with Pacific willow before the soil froze. Later in the spring rooted stock was also planted.

Several thousand Pacific willow cuttings were made. Disturbed areas were planted heavily as the excavation work was being done (Figure 19). The willow was collected locally in February.

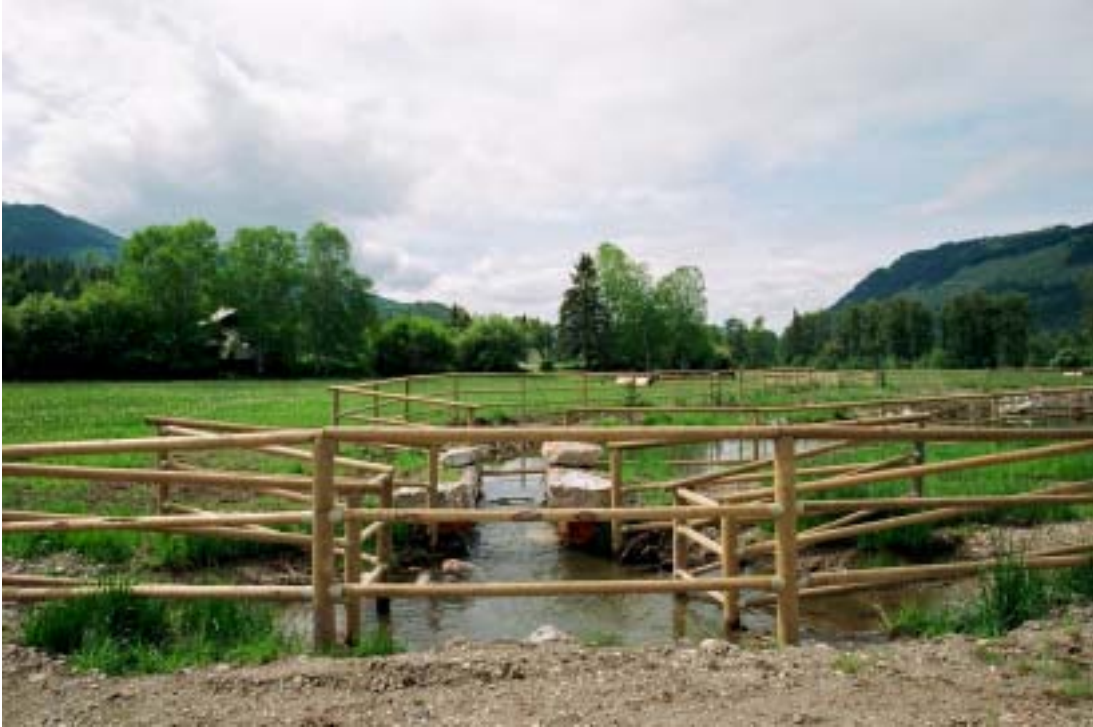
Figure 20: A rail fence was built on the Hahn property to match the existing fence. Plastic cups are used to attach the rail to the post to lessen the chance of injury to the horse or rider. Holes are drilled through the post and electric wires are run between the rails.

The Hahn property is used for cross-country horse riding with the owner holding clinics for different levels of expertise as well as competitions. The rail fence was constructed using plastic cups to hold the rails to the posts (Figure 20). If a horse or rider were to fall onto a rail, the rail would pull out of the cup, reducing the chance of injury.

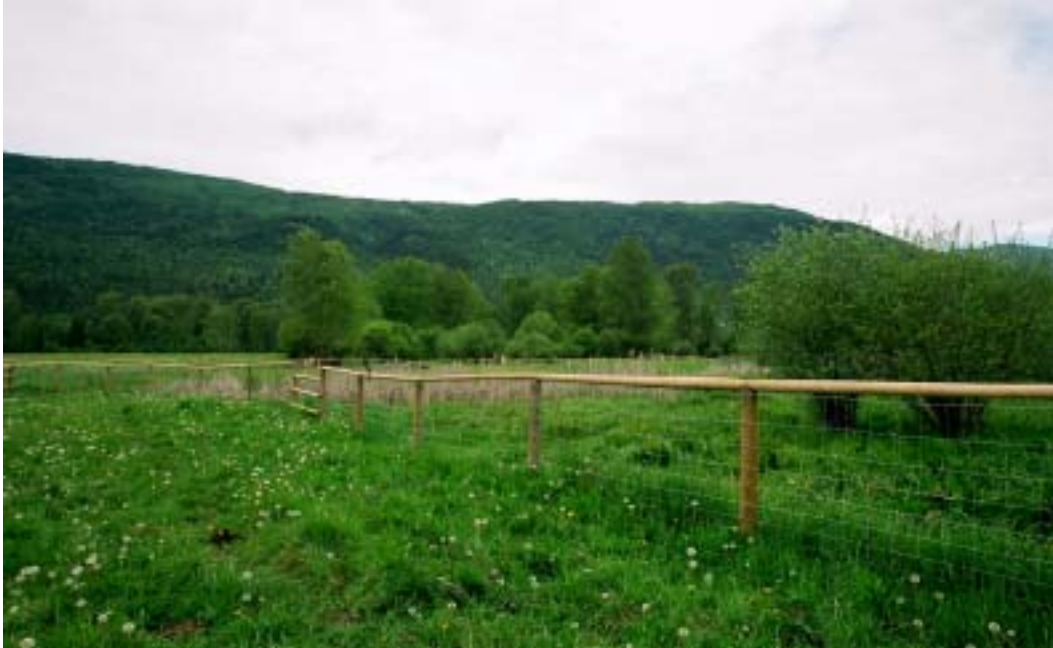
Figure 21: On some sections of the page wire fence, rails were added. The top of the wire was lowered and the bottom of the wire was raised to allow passage of wildlife such as fawns and bears.

Both the Affolter and Unwin properties were fenced with page wire with a top rail. Page wire was requested because the landowners anticipated keeping sheep in the fields adjoining the channel. One of the difficulties using page wire is that it acts as a barrier to most wildlife. Larger deer can jump the fence but fawns will look for a way under the fence often making them susceptible to predation. Bear will struggle with the fence, eventually pulling it down trying to get through or over it. In an attempt to remedy this, rails located 35 cm and 90 cm above the ground were placed on some sections of the fence. The bottom of the page wire was cut and lifted to the bottom rail and the top of the page wire was cut and lowered to the top rail to allow limited passage under and over the fence at these sections (Figure 21). These sections were placed where game trails were evident during the winter. An additional one was added in June where there were signs of animals trying to pass through the unaltered fence. These railed sections double as climb-overs for human access into the riparian area as well.

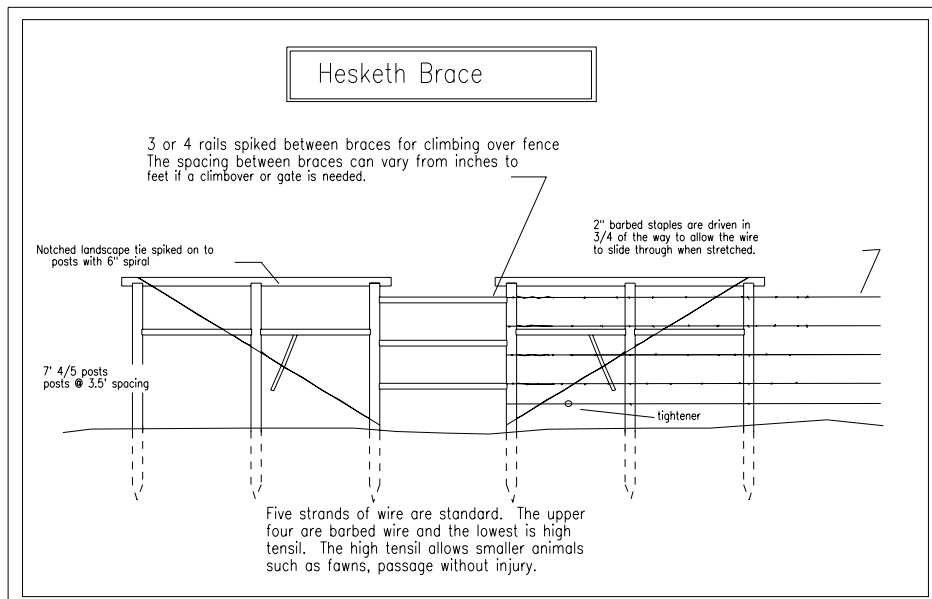
Figure 22: The Hesketh brace used on barbed and high tensile wire fences.

The Chambers and limited company properties both are used for pasturing cattle and barbed wire was used. On both properties the Hesketh method of bracing was used. This is a 3-post brace with a brace placed at the end of every section of wire (Figure 22).

Whenever there is a change in direction of the fence line, a new section of wire is started. At any change in the fence direction therefore, there are two braces with a gap in between the braces. By using this method, the wire is only stretched in one direction. When a continuous fence is tightened any bend in the fence line creates a sideways pull on the fence posts at the bend. Because the fence is not braced against lateral tension, the posts are eventually pulled over and the fence slackens.

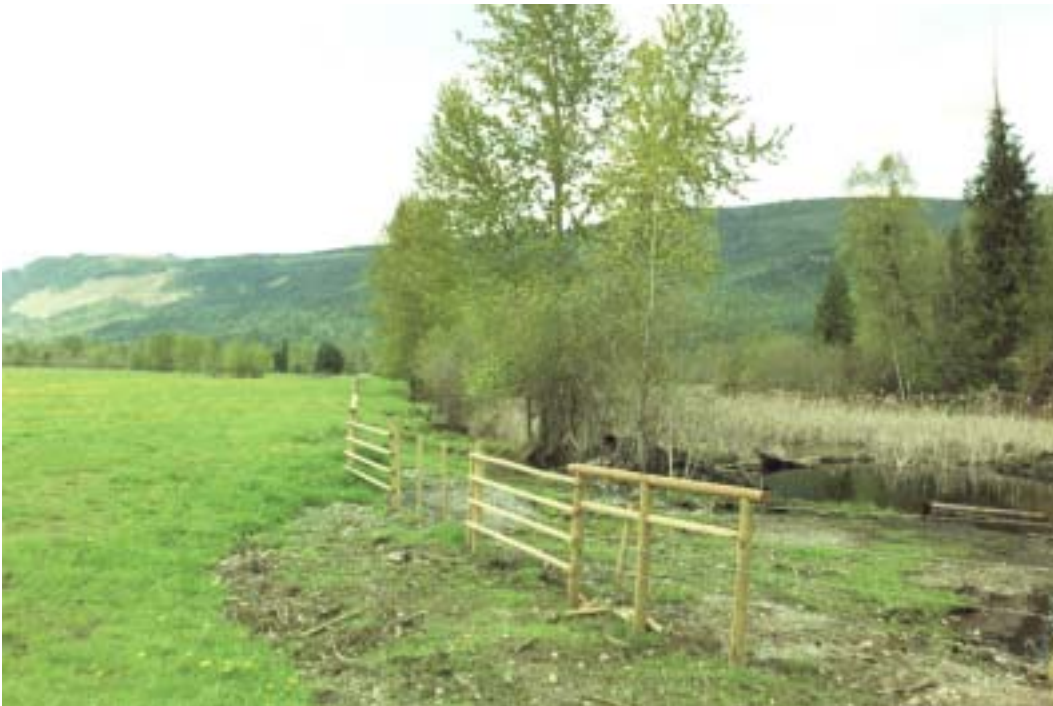
Figure 23: The braces shown above were placed wide enough apart to allow a wire gate to be placed in between. In addition to the gate, sections of rails were also used. The rails offer strength at a point of concentration if cattle have to be moved through and a climb-over for quick access into the riparian enclosure.

The gap between the two braces is most often spaced about a meter with three or four rails joining the two braces. The rails make a convenient climb-over and don't translate lateral tension. In some cases, a larger gap is left and a gate place between the braces (Figure 23).

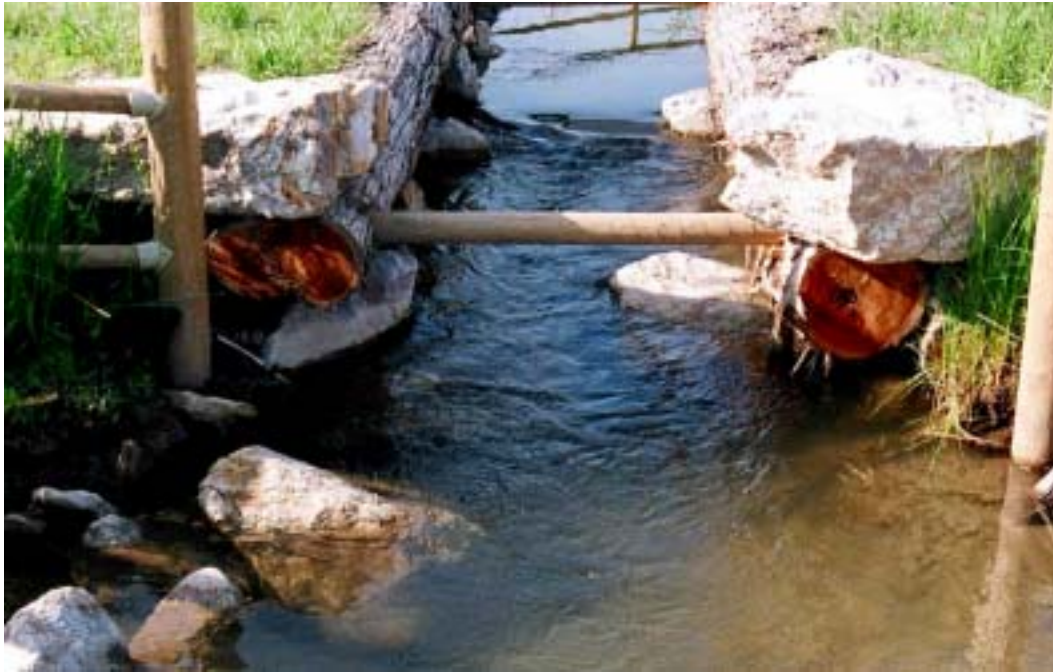
Figure 24: This photo taken in mid-June shows the water flowing out of the sediment pond on the Hahn property. At the time, the river was high and the water turbid, with visibility to a depth of 30 cm. The intake valve is closed. The water flowing out of the pond is largely groundwater and clear with the infiltration gallery accounts for most of the flow. There is also infiltration from the sides of the pond.

The placement of the infiltration gallery worked well. When the river gets turbid the intake valve can be closed. The pond level drops about 10 cm from the reduced flow

depending on the groundwater level. When river water is shut off, the infiltration gallery still supplies a clean flow, approximately 2 ft<sup>3</sup>/s (Figure 24).
