**02SH36**  
**THE PROCTER CHANNEL**  
**FINAL REPORT**

Submitted by: Gay Jewitt, Administrator  
Whitevalley Community Resource Centre  
Prepared by: Thomas Minor, BSc, CET  
Date: April 12, 2003

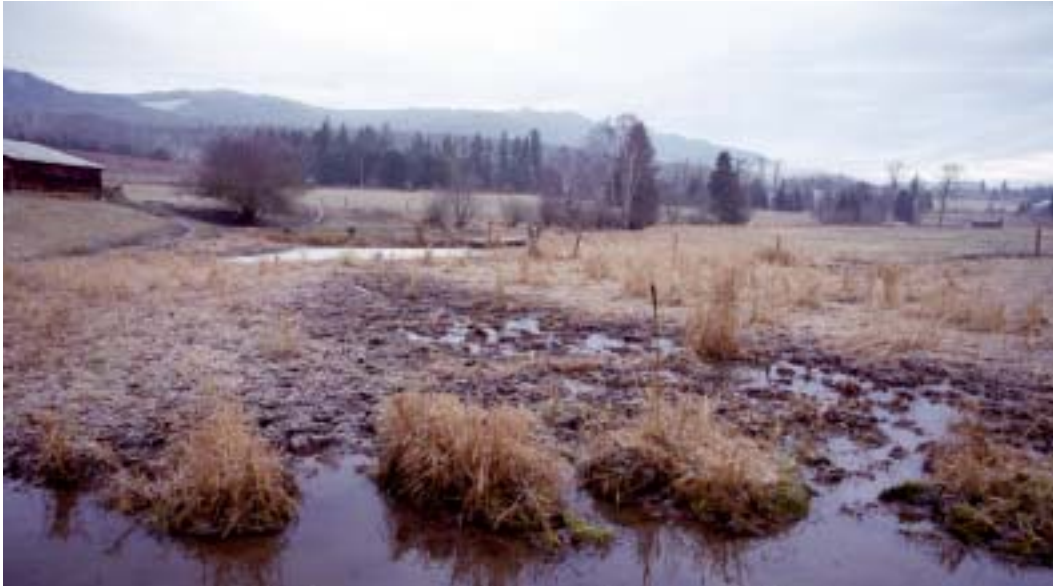
Figure 26a: Cattle have trampled this feeder creek to the Procter Channel to the point that there was no defined channel and vehicle access to the field was not possible except in very dry weather.

crossings and around the barnyard. The combination of the new fence and restricting the cattle from trampling a small intermittent stream that flows through the yard, greatly improved the appearance of the property (Figures 26 a & b).

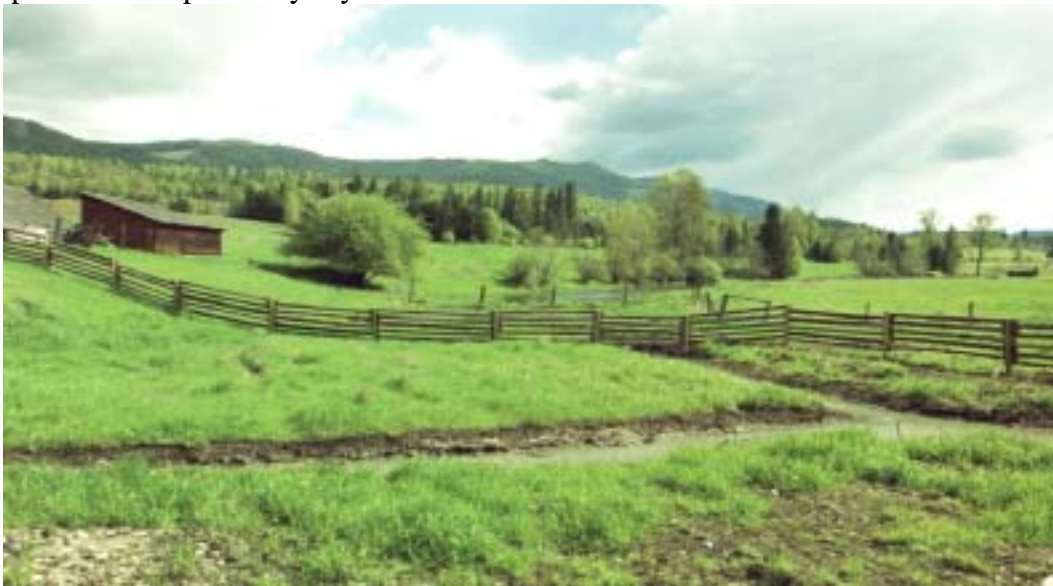
Figure 26b: The creek has been redefined, a culvert placed and an enclosure fence of salvaged cedar rails has greatly improved the appearance of this property.
