BC HYDRO
WAC BENNETT DAM
EXPERT ENGINEERING PANEL
REPORT - VOLUME 1

13 August 2012

Report No. N3405

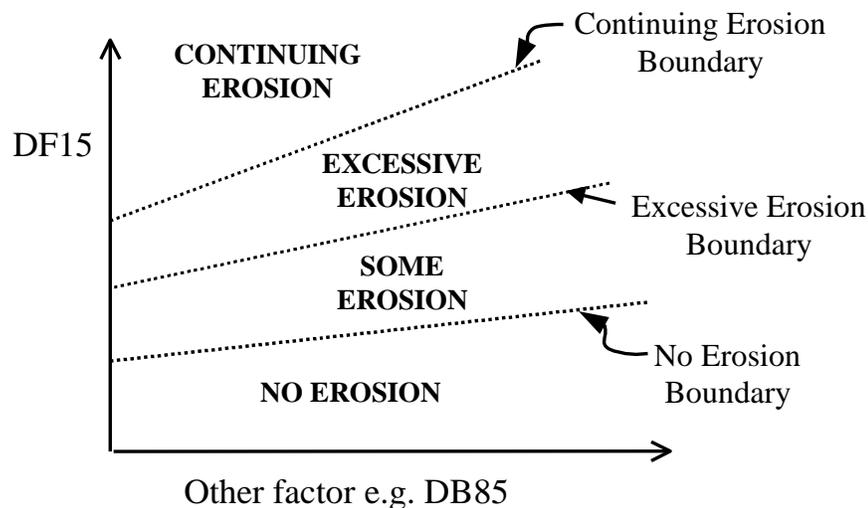
Conceptual filter erosion boundaries (Foster, 1999), Foster & Fell (2001)

Continuation (filtration). Continuation is the phase where the relationship of the particle size distribution between the base (core) material and the filter controls whether or not erosion will continue. Foster and Fell (2001) and Foster (1999) define four levels of severity of continuation; no erosion, some erosion, excessive erosion and continuing erosion. These are shown conceptually in Figure A1 and defined individually below.

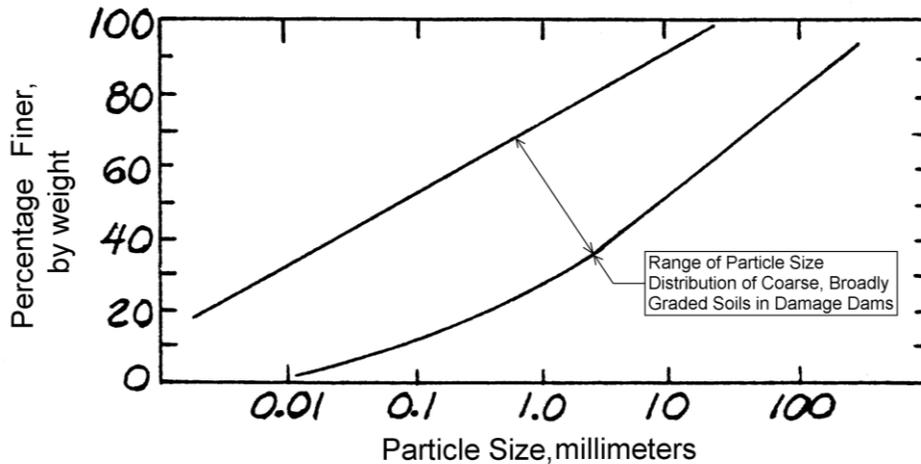
Examples of grading envelopes of some broadly graded soils which did not self filter (Sherard, 1979)

Self-filtering. In soils which self-filter, the coarse particles prevent the internal erosion of the medium particles, which in turn prevent erosion of the fine particles. Soils which potentially will not self-filter include those which are susceptible to suffusion, and very broadly graded soils such as those which fall into the grading envelope shown in Figure A2.
