BRITISH COLUMBIA HYDRO AND POWER AUTHORITY
TERRACE – KITIMAT TRANSMISSION PROJECT
ENVIRONMENTAL AND SOCIO-ECONOMIC EFFECTS REPORT

Fisheries and Aquatic Habitat

Appendix B.1

Aquatic Catalogue

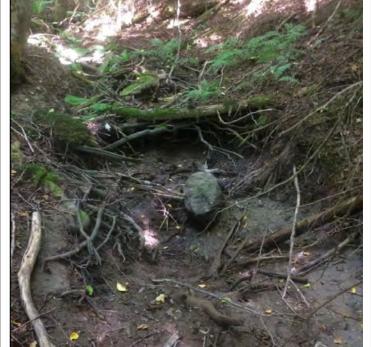
Downstream extent of transects.

Dry channel, only potential for fish habitat during high flow periods. Fish may access site from downstream fish-bearing creek when water present, no barriers present. Downstream channel is well defined with alluvial materials present. Upstream of culvert, drainage becomes undefined, broad and damp area, with abundant skunk cabbage, poor to nil fish habitat. Culvert is wood log culvert, appears to allow water through. Potentially fish bearing during high flows.

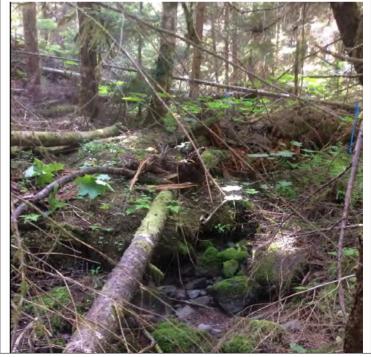
Ephemeral, defined channel was dry during time of survey. Drainage likely has flow conenctivity only during meltwater/runoff periods. Site is upstream of perched culvert barrier at the downstream railroad crossing.

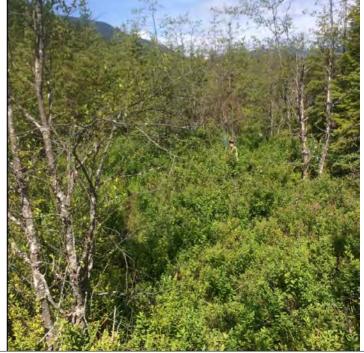
Site consists of a series of open water wetland pools, separated by beaver dams and vegetated marsh sections. No channelization or scour observed. No flowing water, pools are connected by groundwater seep only. No overland flow. Organic substrates only, no alluvial material present. Abundant algal mats. Drainage offers no fish habitat.

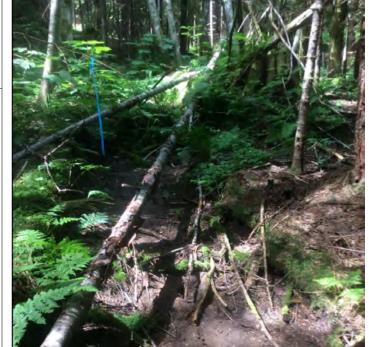
Intermittent channel definition present, fine substrates with few sections of gravel. Some isolated shallow pools present with depth <10 cm. Fish access restricted due to subsurface flow and lack of connection between any visible surface water. Non-fish bearing. No obvious barriers observed downstream where stream crosses track.

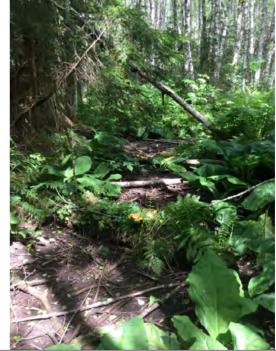
View of dry channel at upper limit of survey.

Low energy stream, fine bed material with diverse cover. Moderate coho juvenile habitat. Cool water although shallow. No spawning or overwintering habitat. A trace of small gravels at the lower end of site. Coho juveniles viewed in pools, 2 captured.

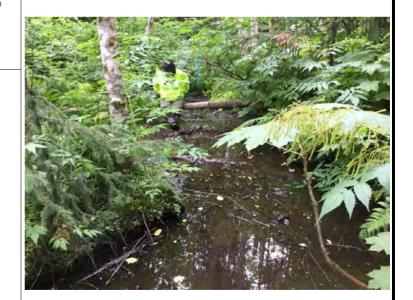
Photos of shallow standing water with coho fry observed near confluence with 44C.

Small channel that is connected to 44C. Coho observed downstream in 44C drainage.

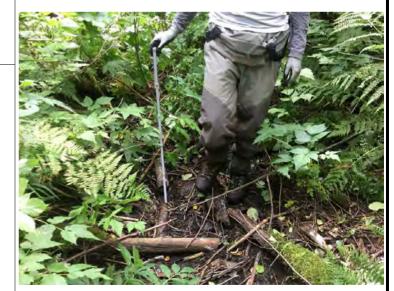
Dry channel, habitat poor to moderate in the rainy season or spring snow melt.

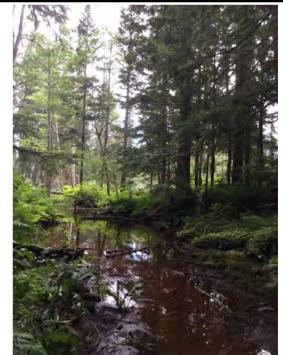
At downstream extent of survey area the channel is choked in algae and the bed material is predominantly fine and organic materials. Further upstream the channel becomes dry with areas of isolated pools. Coarse substrate is more common further upstream. Fish observed at the downstream extent of the site.

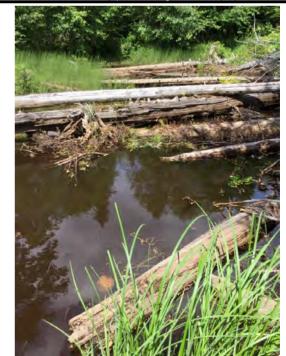
Reach 2 is defined by beaver activity creating a series of dams and impoundments. Cover is abundant from depth and woody debris that has entered the impoundments. One small beaver impoundment is in the transmission line right of way and a second, larger beaver is just upstream of the proposed transmission line right of way.

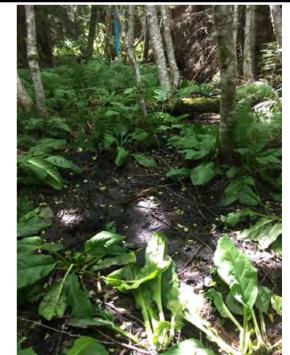
Limited channel development at upstream end of the proposed transmission line right of way. Channel dry at time of survey. Bed material predominantly fine and organic materials however some cobble and gravel observed in downstream portion. Ferns and other shrubs growing along stream margins provide cover. Woody debris common in study area.

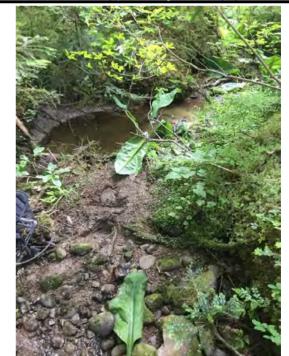
Watercourse is a well-defined, intermittently wet stream. The upstream section is dominated by fine substrates and mostly dry at the time of survey. Some isolated pools are present. Near the downstream extent, the substrate has a greater proportion of gravel/cobble and more of the channel is wetted. Creek is confined by steep valley walls. Mature forest on top of valley. Stream may provide rearing and migration habitat during high-water periods. No barriers observed between survey site and downstream watercourses.

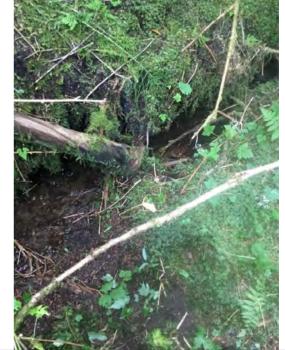
View of channel near downstream end of site.

Some subsurface flow and small drops about 50 cm high. Becomes spread out in places upstream with some overland flow. Flow disappears downstream and goes subsurface for at least 30 m.

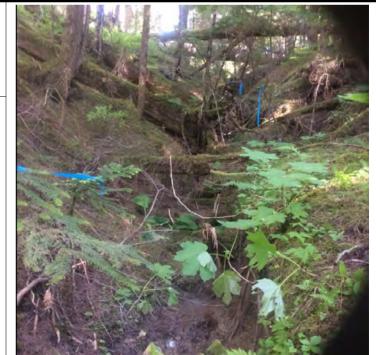
Incised drainage with little to no surface water present at crossing location or surveyed reach. Approx 30 m upstream of crossing drainage channel disappears and ends at a pool of groundwater seep. No alluvial substrate materials present. High gradient. No fisheries access above crossing location and below crossing slumping banks nearly close channel and flow becomes subsurface. Very small drainage area and flows are likely minimal even during freshet. Small residual pools present and less than 5cm depth.

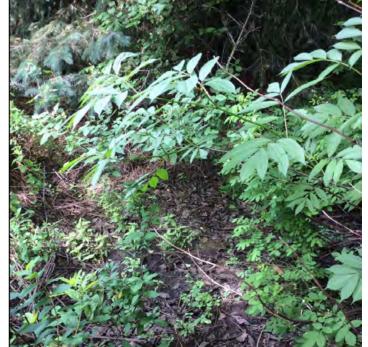
No scour or substrate present. No water.

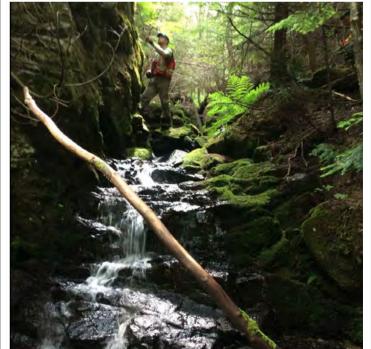
There are two bedrock chute/cascades upstream of the transmission line crossing towards site RD114 / Bridge Site 38. Gradient in the chutes is high (>20%) with two cascade drops of approximately 2 m and is a barrier to fish passage. Morphology at the TL10 crossing is bedrock chute habitat for about 40 meters before flowing in a cobble gravel stream. Electrofishing and minnow trapping upstream habitat did not capture any fish in 2015 or 2016. Electrofishing was conducted in the pool immediately below the barrier in 2016 and a cutthroat trout was captured quickly. The stream is therefore rated as fish-bearing up to the barrier and at the TL10 crossing site.

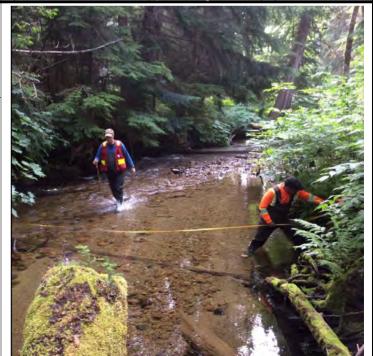
Overall excellent stream for all life stages, excellent diversity of habitats, good substrate variety, abundant refugia, high cover, deep pools abundant. Abundant young of the year coho observed.

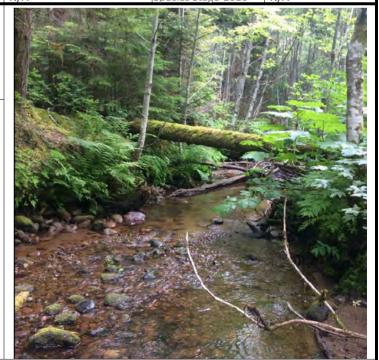
Good-quality salmon and trout stream. Well defined channel with diverse habitat types and abundant cover. Good spawning habitat on gravel side-channel bars. Salmon fry visible in pools and along margins.

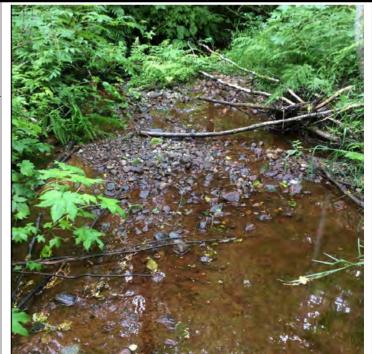
TL12 site was assessed downstream of actual crossing site. Channel characteristics are the same at the crossing site and the assessed site. Channel meanders significantly more than is marked on the FWA 20k map. Red algae present throughout site, coating channel substrates.

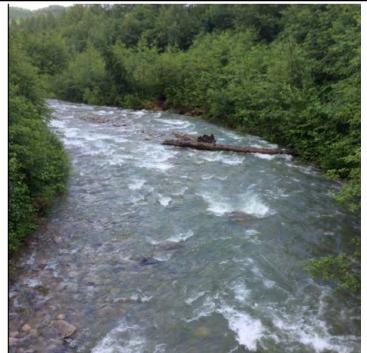
Deep fast-flowing creek.

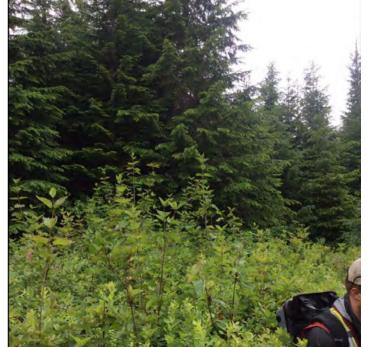
No channel present at crossing location.

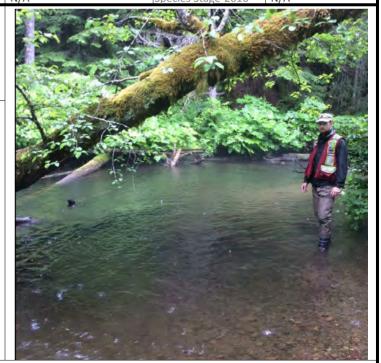
Beautiful trout and salmon stream. Excellent spawning habitat and lots of cover for fry and juveniles. Observed schools of salmon parr along the margins and in the pools behind large woody debris.

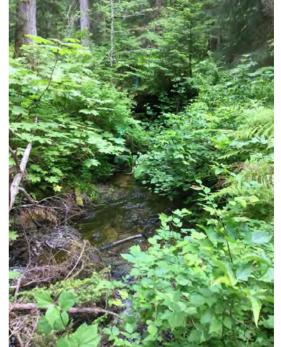
Abundant cover and moderate flows with cool water make this an excellent rearing stream for young salmonids. Mature forest with canopy gaps. Some areas are more shaded than others. Good large woody debris recruitment here.

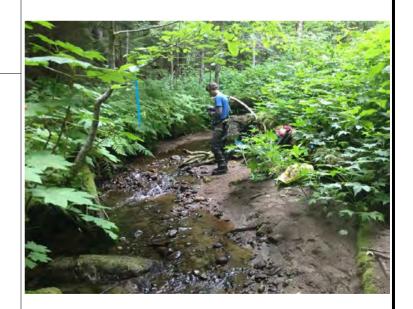
This is a good quality stream with consistent cool water flow. Diverse channel with all cover types for trout and salmon.

Sampling conducted in 2015 captured coho salmon, Dolly Varden and coastal cutthroat trout. Juveniles observed during 2016 assessment.

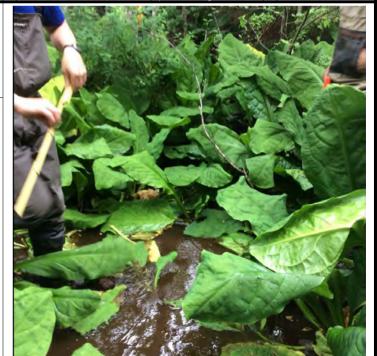
Crossing site.

No fish habitat, no fish access. Stagnant, disconnected pools. Likely low dissolved oxygen. No observed flow rate. Not fished.

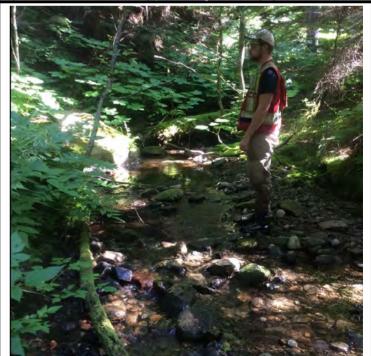
Stream is excellent trout and coho salmon rearing and spawning habitat. $\ensuremath{\mathsf{Good}}$ habitat variety, pools, riffles, steps. Presence of coho salmon parr indicates no barrier further downstream to Wedeene River. Many fry observed in pools.

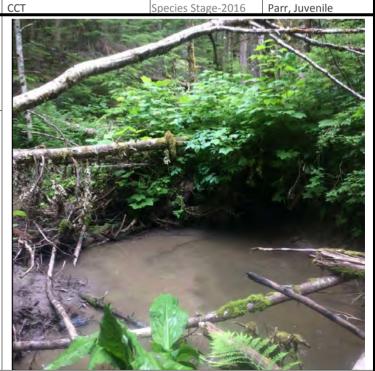
Crossing site looking downstream.

Good fish stream, high diversity in cover and habitat units. Lots of cover. Salmonid rearing and spawning habitat.

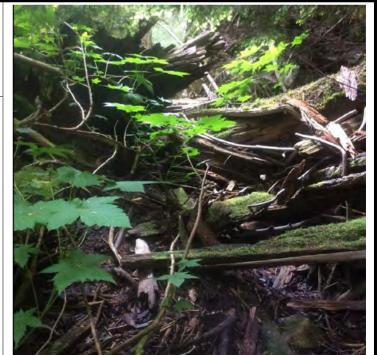
Very steep mountain stream. Water is flowing, small pools present, many cascades. At survey point downstream of transmission line crossing site, stream is very steep, average of 40% gradient. Channel jammed with woody debris, abundant small and large wood in channel, boulder/bedrock substrates. No fish access potential, no fish.

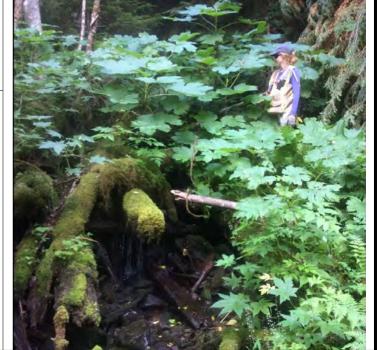
Very steep mountain stream. Water is flowing, small pools present, many cascades. Large cascade barrier at survey point downstream of transmission crossing site. 50 m long cascade jammed with woody debris, measured 42 %gradient. Abundant wood in channel, large cobble/boulder substrates. No fish access potential, no fish.

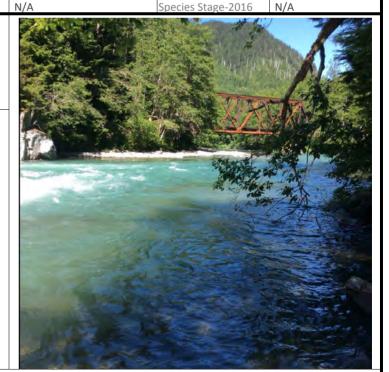
Good to excellent quality habitat for all life stages of salmon and trout.

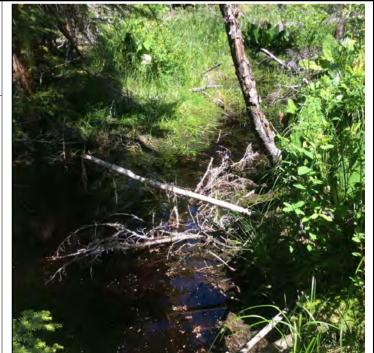
No fish habitat. Abundant beaver dams with stagnant disconnected pools. Pools are filled with algae and are not flowing. Amphibian habitat, poor quality fish habitat. Likely low dissolved oxygen year round. No fish caught.

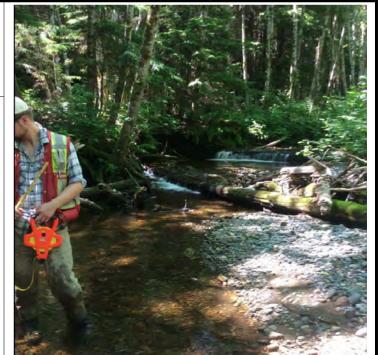
Excellent creek for salmon and trout. Rearing and spawning excellent, embedded logs offer abundant pools and diversity.

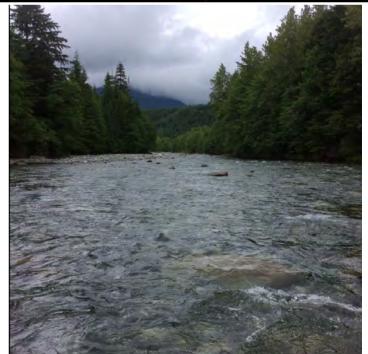
Good quality salmon river. No migration barriers, good overwintering potential in pools and margins. Larger substrates are good spawning for chinook. Patches of smaller gravel are moderate for smaller salmon or trout. Excellent rearing for juveniles. Abundant fry observed along banks in back eddies and under large woody debris. Good micro habitat variety, riffles, small pools, runs. River forks around island downstream of crossing site.

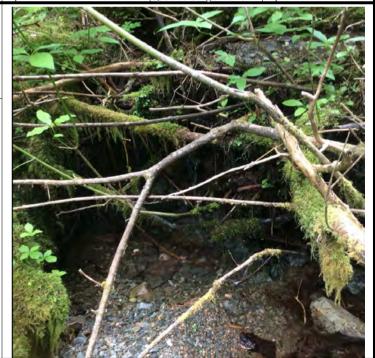
$\label{eq:moderate} \mbox{Moderate quality habitat for young trout. Some pools offer good cover with}$ undercuts woody debris and overhanging vegetation. Some steps down to pools, poor migration potential at time of survey.

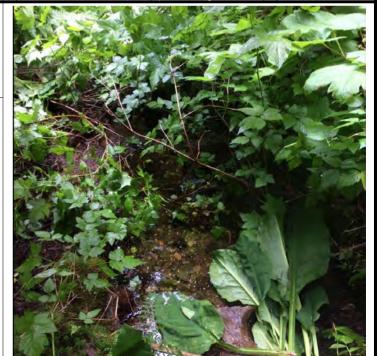
Some subsurface intermittent flows and channel. High cover available. Some isolated pools - these are the only areas that provide habitat at time of survey. Majority of creek too shallow for rearing.

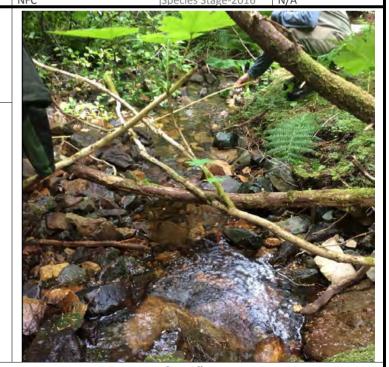
Low flows and small pools. Barrier found to fish passage downstream of site. Series of steep cascades and falls. Section is approximately 16 m long with large elevation drop, estimated to be 10 m. No fish passage possible up cascades. Juvenile coastal cutthroat trout captured downstream of cascades.

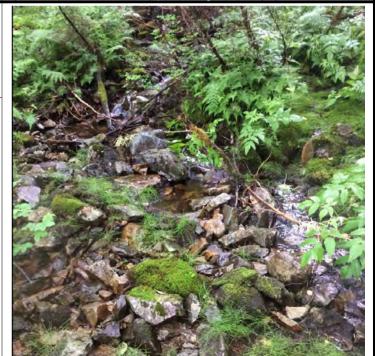
Moderate rearing for small juvenile trout. Pools support trout with good cover. Large bodied fish habitat is absent. Step pool morphology throughout with low flows.

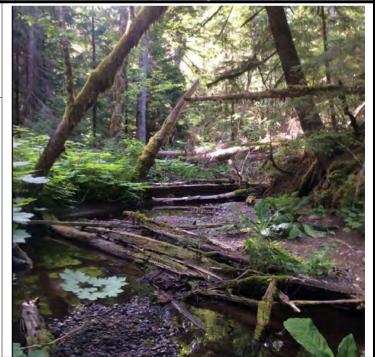
Looking upstream at the top of site.

Good fish species diversity for such a small stream with low summer flow. Habitat is very diverse with lots of cover but is flow limited in summer.

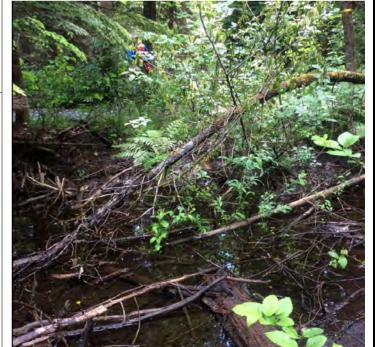
Upstream of site. Upstream of existing road (RD165)

No visible channel upstream of road. Small pool upstream of road, no flowing water. Mud and vegetation including skunk cabbage.

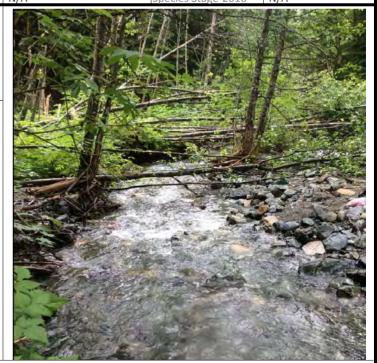
Large series of falls downstream of site, 3 falls, 4 to 6 m tall. No access for fish up falls. Braided channel at crossing site. Good rearing trout habitat. RB captured, likely resident population upstream of falls barriers. Cascade at upstream end of site acts as partial barrier for small fish. Adults may pass during high flows.

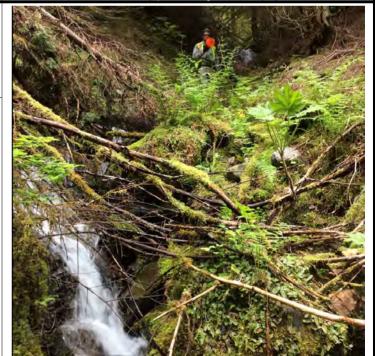
Channel too steep to support fish habitat at crossing location. Crossing site was electrofished in 2016, no fish were captured. Stream was electrofished approximately 300 m downstream and captured juvenile rainbow trout.

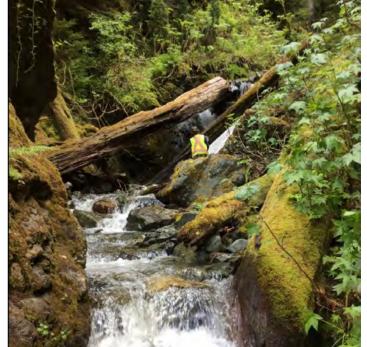
Barrier site downstream of TL33. Cascade pools downstream for ~200 m, with increasing gradient towards barrier: 100 m at 20%, 100 m at 25%. Immediately downstream of barrier, gradient is 30%. Barrier consists of a series of cascades and shallow pools. First downstream cascades is 2 m high, with 0.5 m plunge pool, 2nd cascade is 1.5 m with 0.75 m pool, third cascade is 6 m with 0.80 m pool. Downstream of barrier, habitat for fish is limited by high gradients and high velocity water flows. Excellent spawning and rearing habitat for salmonids present further down stream, closer to valley bottom.

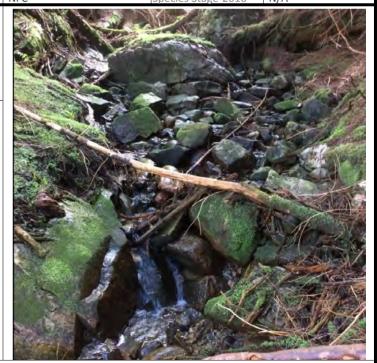
Narrow small stream in steep rocky gully. Boulders, cobbles, present throughout, possibly indicating high flows that would remove fine particles. Upper reach is flatter and slower moving, gradient increases towards downstream end of reach. Fish access is dependent on fish access to lake outlet upstream. Habitat generally moderate to poor for small juvenile salmonids. Large fish would have trouble accessing site due to limited water depth. Downstream of site there is a short section of channel with a gradient of 37%. This steep section may be a barrier to fish passsage. Downstream fish access should be re-evaluated at a different time of year to confirm fish-bearing status.

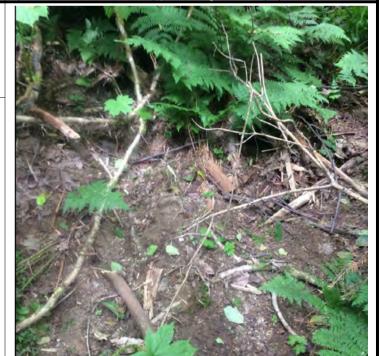
No visible channel downstream of crossing site. No water, no flow, and no fish

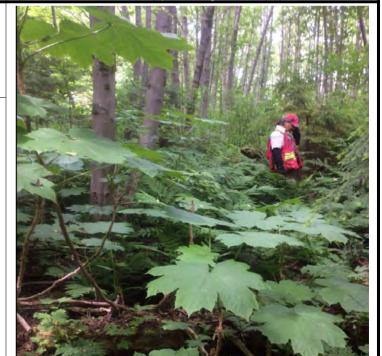
No visible channel downstream of crossing site. No water, no flow and no fish

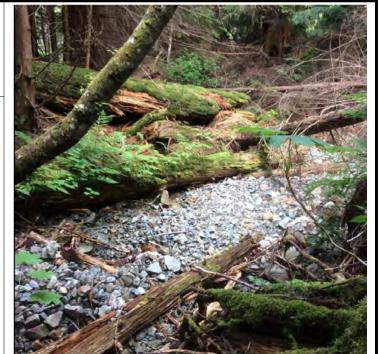
Dry channel. Stream is highly disturbed by flashy water flows. Large substrate and debris piles are present throughout. Large trees and boulders are piled throughout the channel. No passage for fish during dry periods. Flows during floods are likely too high to allow fish passage. Gradient below crossing site is high, approx 30%. Groundwater flows are likely present below large debris bed. Groundwater flows become surface flows at one 10 m long section. Channel is approx 7 m wide, deeply entrenched. Banks are steep, eroded by high flows.

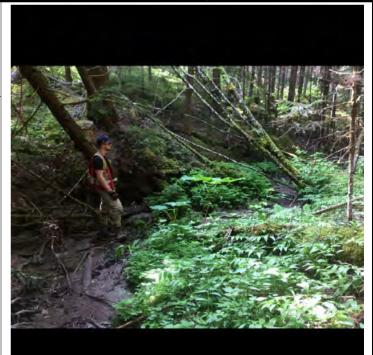
View of dry channel looking downstream.

Dry channel. Seasonally flowing stream likely provides only occasional rearing and holding habitat for fish in lower reaches during wet periods. Evidence of significant water flow and scour was observed, but no water was found in the channel.

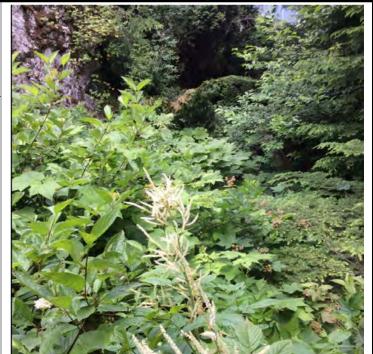
Small, defined stream channel with some poor-quality rearing and migrating habitat. Low water depths limit access for fish and habitat area in the channel. Abundant woody debris and overhanging vegetation enclose the stream, offering high levels of cover. Small gravel for spawning and deep pools for overwintering are absent.

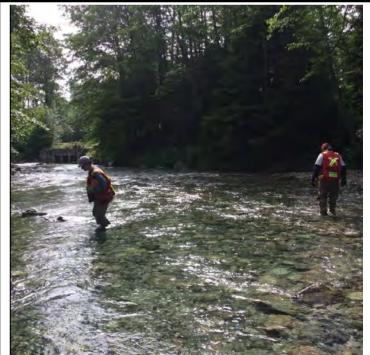
Good quality habitat for salmonids. Variety of habitats, including pools, riffles, back eddies. Gravel suitable for spawning throughout reach. Impassable falls upstream of site. Fish ladder located 150 m downstream of crossing site. Armored bank on left bank, some pieces of concrete slab throughout channel. Power line crosses above creek.

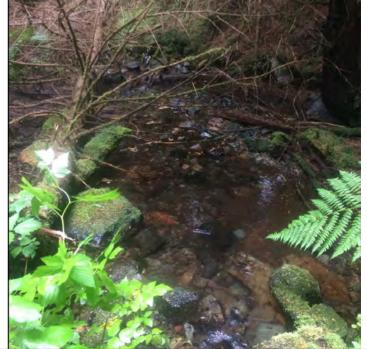
Stream is very nice, well defined channel. However, barrier to fish passage was identified downstream. Fishing done at crossing sites and immediately upstream of barrier, no fish captured. Fishing for 55 seconds below barrier captured 2 coastal cutthroat trout parr. No fish access above barrier site. Crossing sites upstream are non-fish bearing.

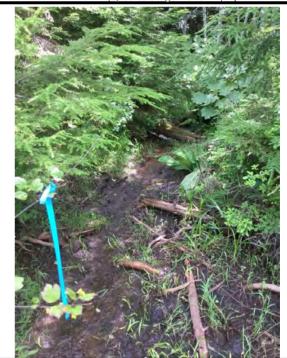
Watercourse converges with another tributary at a beaver impoundment. The first ten meters are wetted however the majority of the watercourse is dry. Some small isolated pools exist further upstream. The channel extends approximately 70 m upstream of the crossing site before becoming non-classified drainage. No coarse substrate found within the study area. Bed substrate comprised of organic and fine materials.

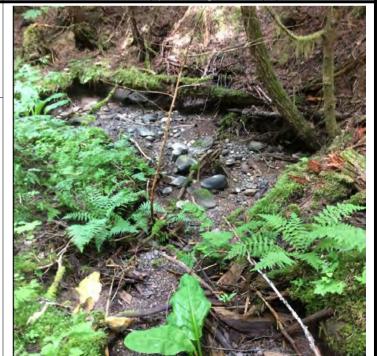
Dry channel facing downstream looking towards crossing.

Mostly dry channel, small, shallow residual pools present approx every 10 m. Low flow during summer, only seasonal use during high flow periods.

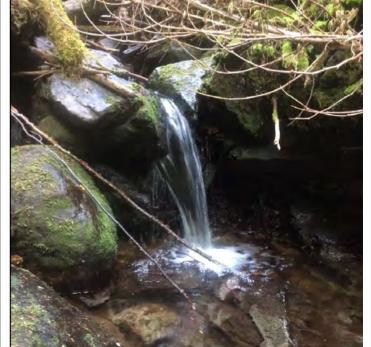
Assessment done at barrier site downstream of crossing site, so no channel dimensions for the actual crossing site are available. Barrier site is long (60 m) cascade pool section, with several small falls. Channel is narrow boulder bedrock chute, with an average 30% gradient. Short ~5 m sections with gradient of >50%. Falls at upstream end is 0.9 m tall, with a 0.1 m plunge pool. Not passable by juveniles or adults at any conditions. No plunge pool for adults to jump barrier falls. Juveniles not able to jump this height. Cascades section downstream is also too steep and shallow for passage. No fish potential at crossing site.

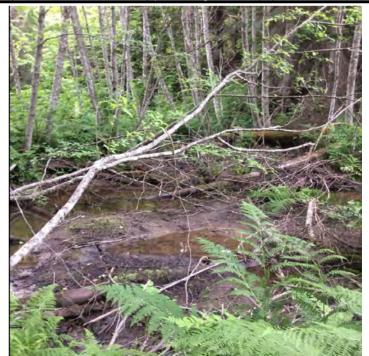
Large beaver dam located downstream of the crossing site. Large open water backflooded area upstream of dam, large sedge-dominated wetland located upstream of open water area. Short section (approx 50 m long) of defined channel was visible approximately 75 m upstream of the dam at the crossing site. Channel was shallow, with low flows and some deeper residual pools. Fish were captured in these deeper pools. Above the defined channel, another beaver dam and backflooded pool (24 m across) were present. Migration is likely limited in this system, with only small fish able to pass the beaver dams and shallow streams.

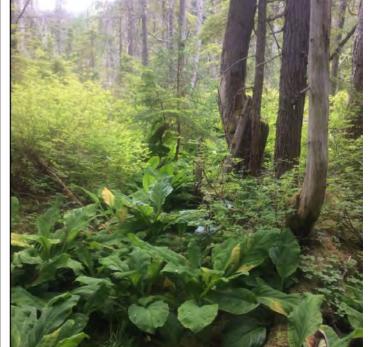
No visible channel. This is a bog drainage, with damp sphagnum moss and skunk $% \left(1\right) =\left(1\right) \left(1\right) \left($ cabbage with few intermittent pools of 0.05 m depth. Downstream of crossing drainage is through forested habitat with no evidence of overland flow, connection with downstream appears subsurface through a 2 m high valley wall. Non-fish bearing.

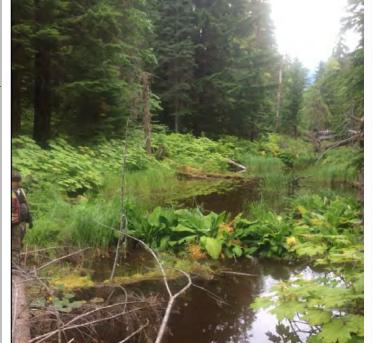
Wetland system, with wetted width of 15 m at crossing and composed of organic substrates. Beaver dams observed approximately 10 m upstream towards Bridge site 52, with flow cutting channel through. Old growth hemlock dominant forest along riparian edge with skunk cabbage, Devils club and emergent reed grasses. Yellow water lily present as in-stream vegetation. Large woody debris, water depths combined with high tannin content and undercut banks providing cover. Downstream extent of site wetland area approaches 30 m in diameter between valley walls, with large portion of wetted width hidden by emergent grasses. Fish observed feeding on surface near crossing location. No spawning due to organic substrates, poor overwintering (adequate depth, potential for low dissolved $% \left\{ 1,2,\ldots,n\right\} =0$ oxygen), moderate rearing, moderate migration. Habitat 400 m downstream becomes more channelized and contains coarse substrates covered in a thick layer of rust colored algae. Many beaver dams >5 were observed some without flow over top, however can not be ruled a permanent barrier. One coho captured $400\,$ m downstream. No permanent gradient barriers observed between fish capture and crossing site. Fish bearing stream.

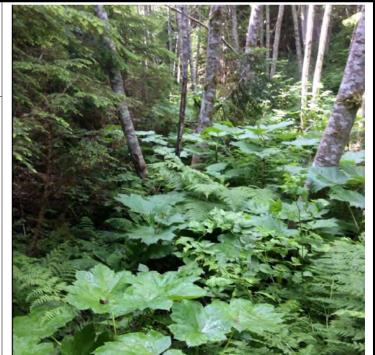
Small channel, with low flow rate and depth. Heavily vegetated, abundant overhanging vegetation provides high cover levels. Small channel only capable of providing temporary rearing habitat for juvenile fish, no access for large-bodied fish, no overwintering, no spawning habitat.

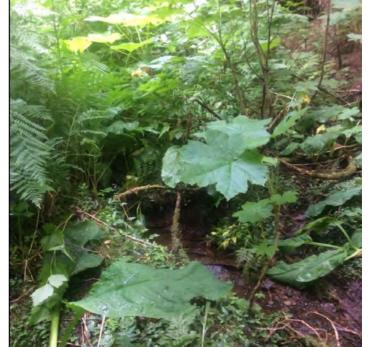
Intermittent channel development, separated by sections of subsurface flow. Organic dominant substrates with small amounts of gravels and small amounts of water in isolated pools and little flow. When valley width increases drainage only visible due to wetland vegetation. Drainage often choked with ferns, Devils club and salmon berry. Access to fish limited due to sections of subsurface flow downstream, no drainage visible until 20 m downstream of crossing, upstream only subsurface flow with 38% gradient. Non-fish bearing.

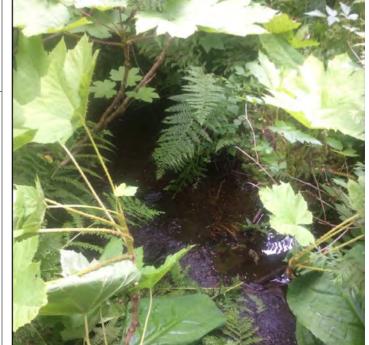
No channel development, small sections of overland flow through wetland vegetation separated by sections of subsurface flow. Organic dominant substrates with very small amounts of gravels and small amounts of water in isolated pools and little flow. When valley width increases drainage only visible due to wetland vegetation. Drainage choked with ferns, Devils club and skunk cabbage. No access for fish due to subsurface flow and lack of channel development 26% gradient. Non-fish bearing.

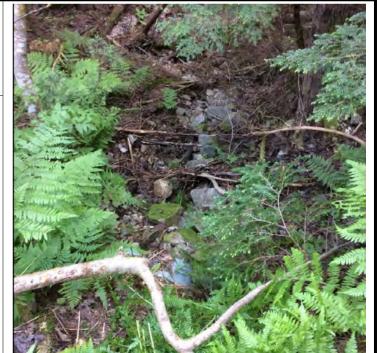
Dry channel present downstream of crossing and in upstream ditch. Channel extends approximately 80 m downstream of crossing, then becomes broad and poorly defined NVC. Gradient is high (18%) downstream of culvert, then lower (10%) 30 m downstream, then nearly flat (2%) beyond 60 m downstream. Scoured channel is likely a result of high energy water flowing down steep slope from ditch and perched crossing and scouring until energy is dissipated. One small pool of standing water was observed in scoured channel, approx 65 m downstream. Downstream NVC is damp and muddy, with no standing water.

Site is located approximately 1 km upstream of a known fish passage barrier. No fish access to site currently possible. Non-fish-bearing.

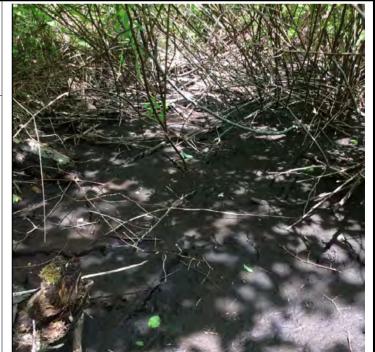
Culvert crossing carries ditch drainage from steep upslope area across road and drains into broad, undefined wetland area. Wetland consists of discontinuous shallow pools with abundant Instream and overhanging vegetation. 50 m downstream, the wetland joins a small scoured channel. Channel is 2 m wide, standing water depth of 20 to 50 cm, with organic substrates and very slow flow. No alluvial substrates observed. Evidence of beaver damming on small channel. Channel is very marginal fish habitat. Appears to be upper headwater drainage for tributary stream to RD115/Site 13 stream several km downstream. There is no visible channel drainage downslope of the culvert. The channel is not fish passable due to discontinuous stagnant pools with no evidence of scouring higher flows. No fish habitat present upslope of crossing, ditch flows only. Non-fish bearing at crossing site.

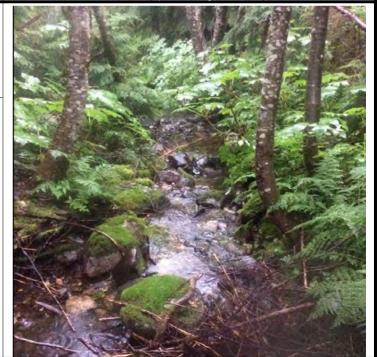
Stream is flowing in a defined channel with alternating riffle-pool and cascadepool morphologies. Gradients are moderate (approx 5-10%), with steeper sections with short cascades. Cascades range from 0.5 m to 1.0 m in height. Fish habitat for salmonids is generally poor-moderate. Fish captured by dip netting, other juveniles observed in adjacent pools. Three coastal cutthroat trout caught during electrofishing survey immediately downstream of crossing. Fish-bearing site.

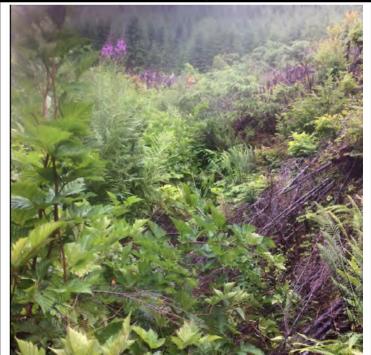
Stream channel heavily influence by recent clear cutting from current road crossing to approximately 50 m downstream, with limited definition and overgrown by vegetation and choked its woody debris likely from mulching activities. Channel then is defined (where measurements taken) for 30 m until confluence with known fish bearing stream of site 1062AR_2954. Fish presence is possible due to lack of barriers observed in this reach, however would likely be limited to periods of high flows during freshet.

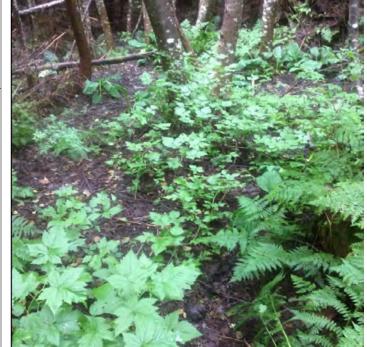
Site consists of cross-road overland flow from upslope ditch to undefined, organic dominated, disconnected pools in the forest downslope. Seepage through the road is likely responsible for the majority of cross road flows. Downstream drainage with isolated pools has no channelization, but some evidence of flooding and temporary overland flow between pools. No defined channel visible at site, no fish habitat, non-fish bearing.

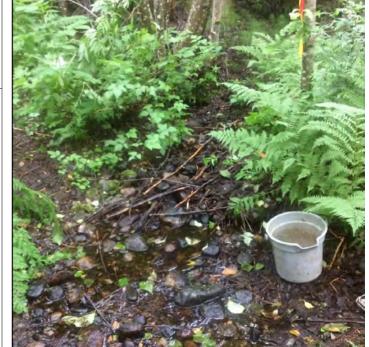
Stream has small, defined channel, and is fed by ditch flow from upstream roadside ditch and upstream groundwater seep. Groundwater seeps likely provide majority of ditch flow, as several were observed flowing into the ditch upslope. No barriers to fish passage were observed downstream. One 20 m long steep (28%) section 20 m downstream of the crossing may limit fish access, but it may not be a complete barrier to passage. Stream may provide rearing, spawning and migration potential. Deep pools for overwintering are absent. Electrofished downstream of crossing in limit pool habitat, no fish captured. Potential fish habitat during higher flow periods, habitat potential limited during current low flow period.

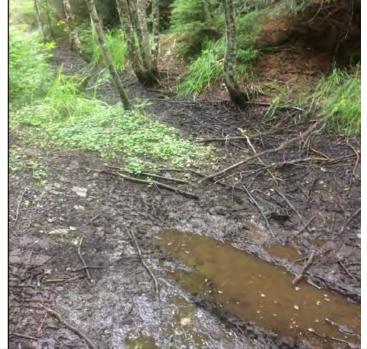
Marked crossing site on 1064 road connects roadside ditch from west to roadside ditch of east side of 1064 via cross ditch. Drainage is artificial ditch, with abundant organic materials. No channel measurements recorded. Ditch flow then drains south across Br13 road. Downstream of culvert on Br13, drainage is broad, undefined wetland area with no fish potential. Drainage is approx 15 m wide, with abundant skunk cabbage, ferns, and red alder. Fish habitat is absent downstream of Br13 road, so the marked crossing site on 1064 is non-fish bearing.

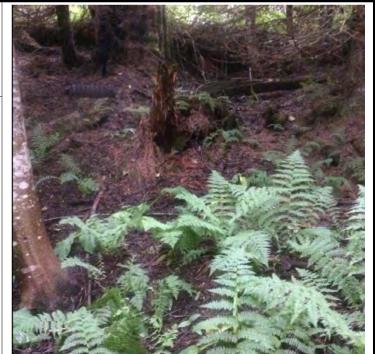
Downstream of crossing.

Crossing site has no overland flow or culvert crossing. Some subsurface water may seep through the road. Downstream is damp, undefined, unscoured wetland area. Upstream, roadside ditch carries water away from site to crossing site to south. No fish habitat, no fish.

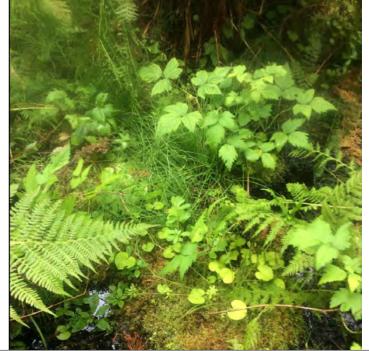
Stream has intermittent channel development downstream of road crossing and flows subsurface for a section of approx 20 m then surfaces again. Temperature of 6 degrees and groundwater seeps near upstream reach suggests groundwater fed drainage. All organic substrates throughout with exception of road surface. No spawning potential. No fish access due to undefined drainage and sections of subsurface flow.

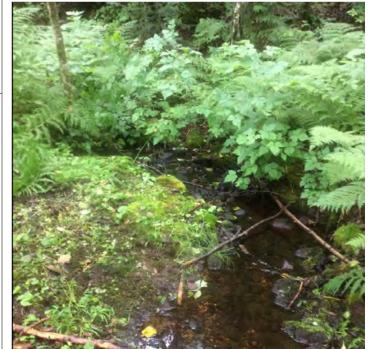
Ditch channel (mostly fed by ditch upstream) crosses road, flows downstream 20 m through overhanging vegetation then into a 14 m 600 mm culvert, which spans an additional abandoned road. Pond present where flow enters culvert inlet. After culvert outlet stream flows for approx 30 m under clumped large woody debris leaving stream fully covered. After woody debris pile, water flows in a step pool morphology with little cover other than tree canopy. Substrates are dominated by gravels and provide suitable spawning habitat. No barriers to fish migration observed. No fish captured during electrofishing however potential for fish presence.

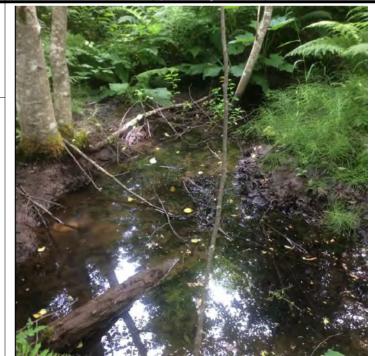
Stream is dominated by multiple small beaver dams. Upstream fish passage is currently limited up dams. No evidence of high flows that may dislodge a barrier. Habitat in pools is limited, as water is stagnant, with shallow depths (0.5 m) and likely low dissolved oxygen. Larger beaver dam 30 m upstream of crossing, 1.5 m high. Coastal cutthroat trout captured at crossing at downstream end of existing wood culvert. No fish observed or captured upstream, but no permanent barriers to fish passage were observed.

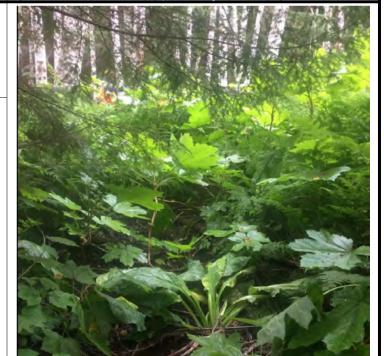
Most defined channel exists at road crossing. Downstream of road intermittent channel development for 30 m then wetland habitat dominated by organic substrates starts and continues for 20 m. Drainage appears to end 20 m $\,$ downstream of wetland in a mud bottomed forest. Upstream of crossing no channel development, fine and organic substrates with vegetation growing throughout damp drainage area with a few isolated pools.

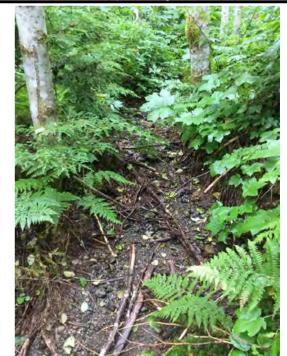
Substrate upstream of culvert is primarily fines with some gravels. Downstream of the culvert substrate is predominantly gravels and cobbles. Some boulder downstream of the culvert. Gradient increases approximately 100 m downstream of culvert. Channel becomes more confined with more woody debris cover.

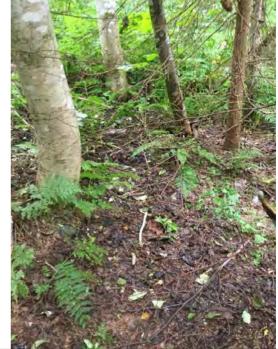
A larger creek parallels the road on the upstream side. A culvert allows some water to pass underneath however the majority stays on the upstream side. Water likely only enters the culvert during high flows. A discernible channel is visible for approximately 30 m downstream of the culvert before becoming undefined. Gravel and some cobble is present near the culvert outlet.

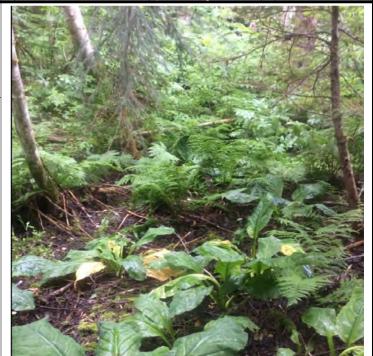
Ditch drainage. No channel development upstream or downstream of road. Drainage ditches meet, flow across road through 400 mm 8 m long culvert then into undefined, unscoured wetland and forested area. No fish access or habitat. Non-fish bearing.

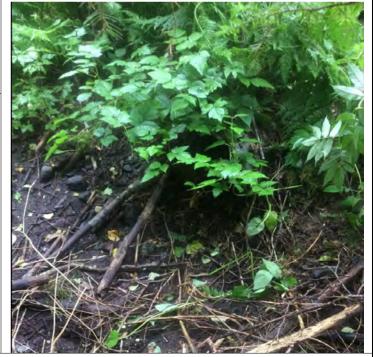
Ditch drainage. No channel development upstream or downstream of road. Drainage ditches meet, flow across road through 400 mm 8 m long culvert then down a 10 m long steep road embankment then undefined, unscoured wetland area. No fish access. Non-fish bearing.

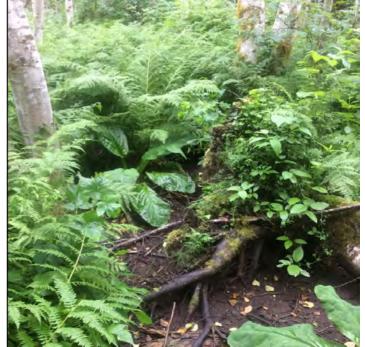
Ditch drainage site. Upstream area is roadside ditch. Dry at time of survey. Crossing site is 400 mm 8 m culvert. Downstream, short channelized section due to concentrated ditch flow. Drainage spreads out and becomes undefined wetland area 30 m downstream. Wetland has organic mud substrates, skunk cabbage, ferns. No fish access or habitat. Non-fish bearing.

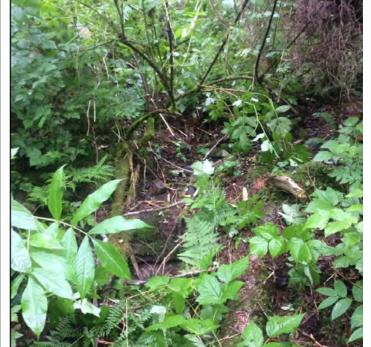
Site is cross road drainage culvert, carrying water from upslope ditch across road. Culvert is 500 mm 8 m corrugated steel pipe. Ditch is fed by road runoff and any upslope overland flows. No stream channel exists upstream. Downstream of crossing, drainage consists of undefined overland flow route. Flow route only visible by deposited road material and organic mud deposition. Gradient 24% downslope. No fish habitat, no fish potential.

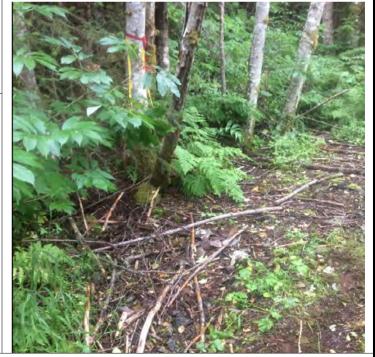
Ditch drainage. No channel development upstream or downstream of road. Drainage ditches meet, flow across road via cross ditch then down a 10 m long steep road embankment then undefined, unscoured wetland area. No fish access. Non-fish bearing.

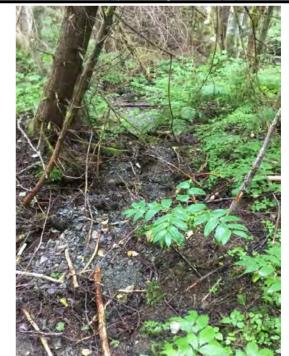
Downstream of the road crossing showing shallow banks and gravel substrate.

Approximately 150 m downstream from the road crossing the channel becomes NCD creating a fish barrier. Confirmed non-fish bearing.

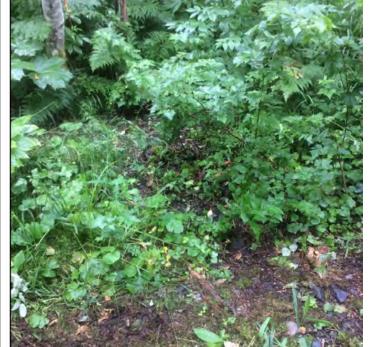
Ditch drainage. No channel development upstream or downstream of road. Drainage ditches meet, flow across road via cross ditch, then into a landscape depression in the forest downslope. No evidence of channelization or wetland area. No fish access. Non-fish bearing.

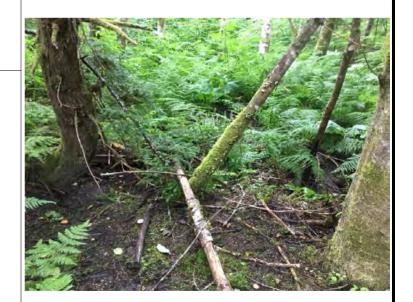
Downstream of the road crossing showing NCD section.

Drainage crosses over road creating a 1 m wide channel approximately 10 m $\,$ downstream from the crossing. The drainage then becomes NCD.

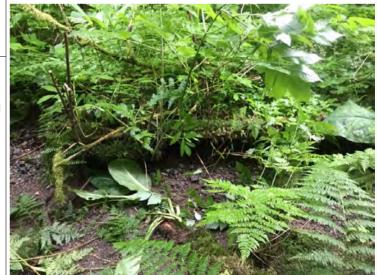
Site assessed up to 200 m downstream looking for fish barriers. Channel becomes overgrown by thick vegetation and in some areas has very shallow banks. No barriers were observed. All measurements were recorded within 50 m of the road crossing. Creek flows over top of road, no culvert. Substrate downstream of the culvert is primarily fine materials with some gravels. Upstream of the culvert substrate is gravel and cobble. Creek parallels the road on the upstream side. Eroding banks observed near road.

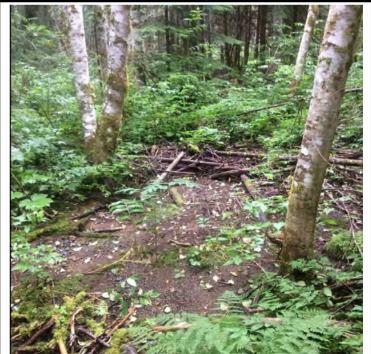
Crossing site is ditch to convey flow across road. No culvert present. Stream is intermittently scoured non-classified drainage. Upstream section has short scoured sections in steeper areas, with broad, undefined areas between scoured areas. Downstream has short scoured section for 30 m, before gradient lowers to 2% and drainage becomes broad, undefined damp forested area. Channel measurements are for short scoured sections only. No fish habitat or potential. No fish.

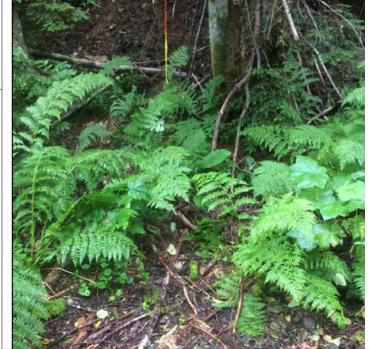
Crossing site is cross-road drainage. No culvert exists. Ditch drainage crosses road in shallow drainage ditch. Upslope, ditch drainage is only water source. Slope above ditch is steep forest, with small cliffs. Downstream of crossing, road fill drops off down steep slope 52% gradient. No channelization downslope, only road fill downslope of ditch crossing. Dry forest downslope with no channel. No fish habitat, no fish potential.

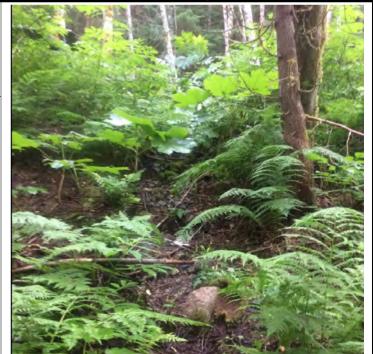
Ditch drainage. No channel development upstream or downstream of road. Drainage ditches meet, flow across road then down a 10 m long steep road embankment then undefined, unscoured forested area. No fish access. Non-fish bearing.

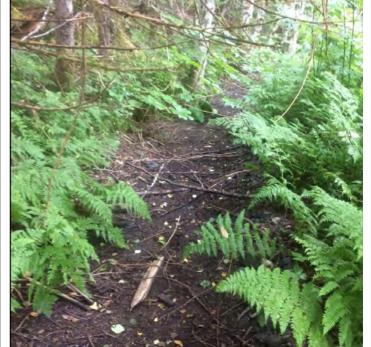
Ditch drainage. No channel development upstream or downstream of road. Drainage ditches meet, flow across road down a 10 m long steep road embankment then no drainage visible. No fish access. Non-fish bearing. No fisheries potential.

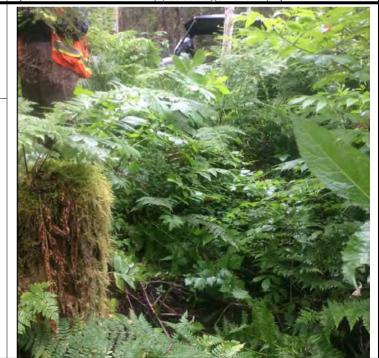
Ditch drainage. No channel development upstream or downstream of road. Drainage ditches meet, flow across road via cross ditch, then into a landscape depression in the forest downslope. No evidence of channelization or wetland area. No fish access. Non-fish bearing.

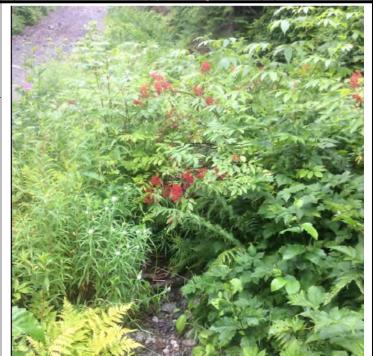
Drainage ditch from road flows through 500 mm culvert. No defined channel downstream of culvert. Drains into steep 25% gradient forested area. Only ditch drainage channel upstream of culvert inlet. Non-fish bearing.

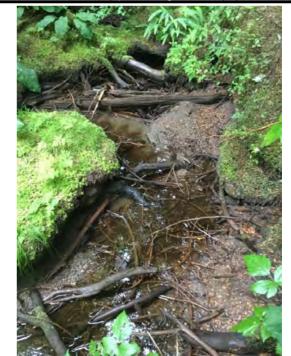
Upstream of the culvert a small stagnant pond without flow extends approximately 15 m. Channel is dry above the pond. Substrate in the upstream section is fine and organic materials. No gravel or cobble. The channel has cobble and gravel substrate from the culvert to approximately 25 m downstream. Some side bars and one mid gravel bar were observed in this section may provide spawning opportunities. Further downstream the channel returns to fine material substrate. A small amount of flow downstream of the culvert connects pools and provides connectivity.

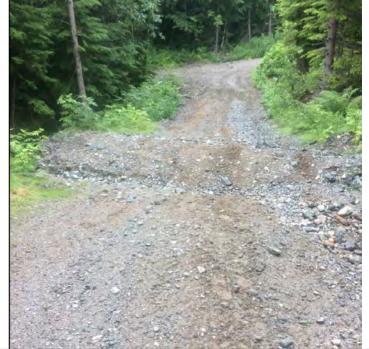
Ditch drainage. Crossing is cross road drainage ditch, conveying road flow and any runoff from steep upslope areas across road. No channelization upstream or downstream. Downstream of crossing, 65% gradient slope with no channelization. Road material deposited on slope. Forested area downslope. No fish access or

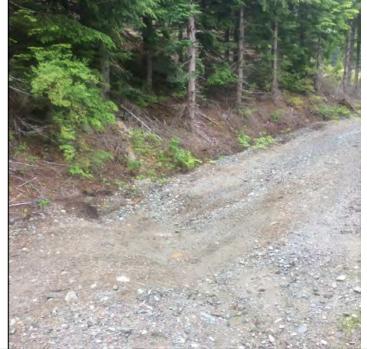
Ditch drainage. Crossing is cross road drainage ditch, conveying road flow and any runoff from steep upslope areas across road. No channelization upstream or downstream. Downstream of crossing, 44% gradient slope with no channelization. Road material deposited on slope. Forested area downslope. No fish access or habitat.

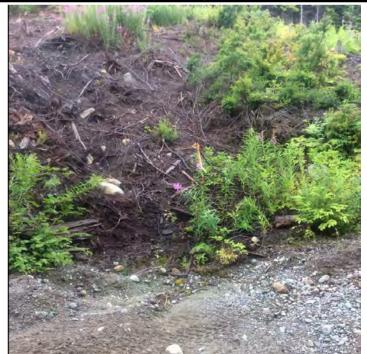
Ditch drainage. Crossing is cross road drainage ditch, conveying road flow and any runoff from steep upslope areas across road. Logged upslope of site. No channelization upstream or downstream. Downstream of crossing, 49% gradient slope with no channelization. Road material deposited on slope. Forested area downslope. No fish access or habitat. No fish.

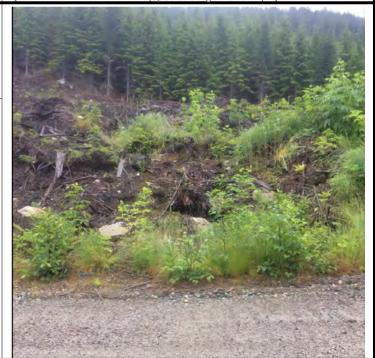
Crossing site looking upslope.

Road drainage. Crossing is a shallow depression on road with no cross ditch, conveying road flow and any runoff from steep upslope areas across road. No channelization upstream or downstream. Downstream of crossing, 45% gradient slope with no channelization. Forested area downslope. No fish access or habitat. No fish.

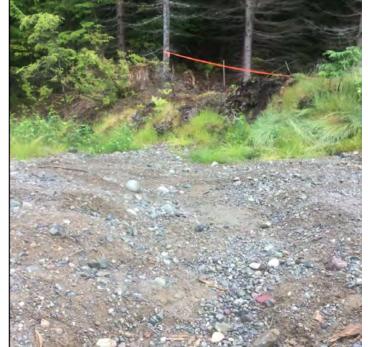
Road surface drainage. Crossing is cross road drainage ditch, conveying road flow and any runoff from steep upslope areas across road. No channelization upstream or downstream. Downstream of crossing water enters ditch, flows along road then off of road embankment into forest, with no channelization. Forested area downslope. No fish access or habitat. No fish.

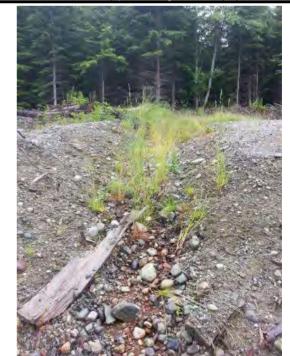
Excavated ditch no natural channel development. Drains over road then along the northern road ditch to site Branch 13C-247. Non-fish bearing.

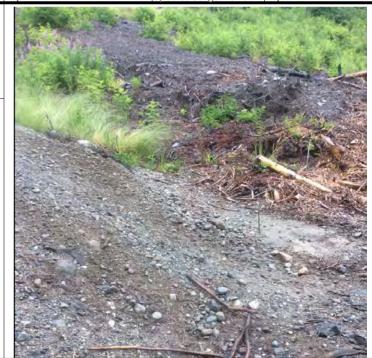
Ditch drainage. Crossing is cross road drainage ditch, conveying road flow and any runoff from steep upslope areas across road. No channelization upstream or downstream. Upstream area is logged and mulched. Downstream of crossing, upstream ditch joins crossing ditch and dischargees into forest with no channelization. Road material deposited on slope. Forested area downslope. No fish access or habitat. No fish.

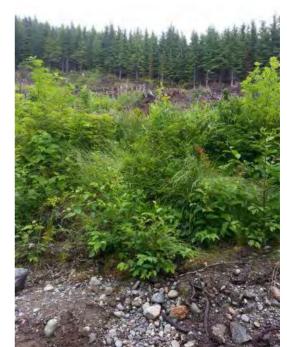
No channel development upstream or downstream of road. Evidence of surface flow at a gradient of 48% present for 30m downstream of crossing then disappears into forested vegetation.

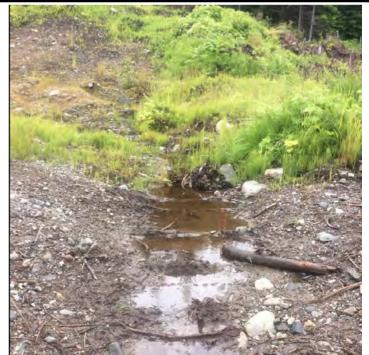
Crossing site.

$\label{lem:constraint} \mbox{Ditch drainage. Crossing is cross road drainage ditch. No channelization upstream}$ or downstream. Road material deposited on slope. Drains into deforested cut block area down slope. At time of survey there is a small amount of visible overland flow. No fish access or habitat. No fish.

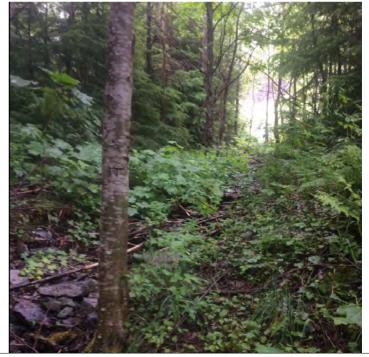
Site is upstream of a known barrier at site TL20A. Channel development is present downstream of road with cobble gravel substrates. Upstream of road crossing channel is filled with boulder and large woody debris. Confluence with site Branch 13C_2855 located approx 30 m downstream. Red alder dominant with western hemlock. Channel dry during time of survey. No fish access or habitat.

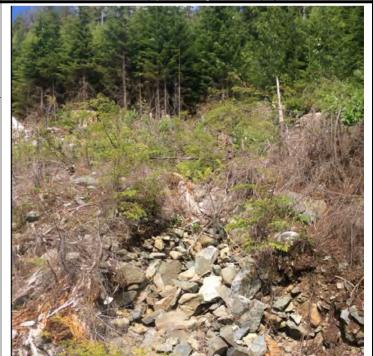
On road looking uphill.

Site is located upstream of known barrier at TL20A crossing. Stream has water only in spring or during storm events. No fish access.

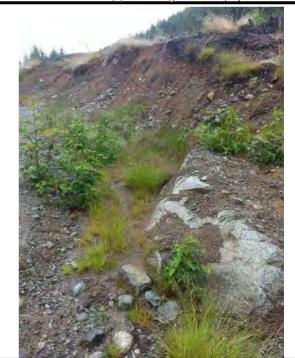
No channel development upstream or downstream of road. Evidence of surface flow at a gradient of 43% present for 10m downstream of crossing then joins with drainage across road. Non-fish bearing.
