BRITISH COLUMBIA HYDRO AND POWER AUTHORITY
TERRACE – KITIMAT TRANSMISSION PROJECT
ENVIRONMENTAL AND SOCIO-ECONOMIC EFFECTS REPORT

Fisheries and Aquatic Habitat

Appendix B.1

Aquatic Catalogue

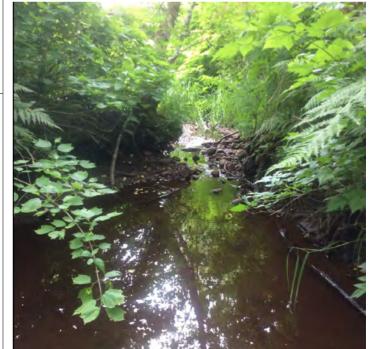
Beaver dam immediately upstream of existing bridge structure has impounded upstream habitat causing a lack of defined channel, and habitat is composed of fine and organic substrates and resembles wetland habitat. Upstream of dam wetted width is approximately 3m with valley width of 20 m. Additional dams and beaver activity present upstream. Coho observed and captured upstream and downstream of bridge structure via dip netting. Due to presence of breeding amphibians at site, electrofishing was not conducted. Fish bearing stream, despite temporary barriers. Crossing is located 20 m upstream of confluence with Lone Wolf Creek, a known fish-bearing creek.

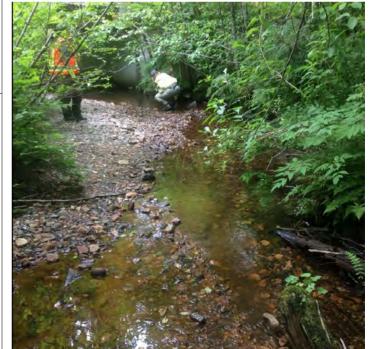
Stream is good quality salmonid habitat, excellent for juveniles. Abundant coho young of the year and 1+ age observed. No barriers between bridge and Wedeene River. Good habitat variety and cover variety. Typical low gradient riffle pool habitat with large woody debris creating diversity. Abundant small and large gravel, minimal cobble. Fish bearing.

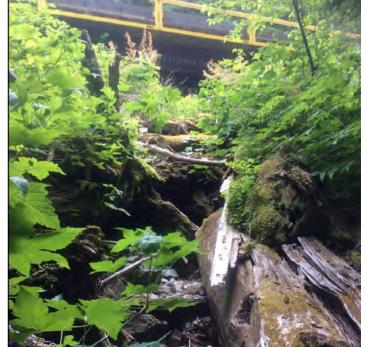
Steep (22- 25%) gradient stream with subsurface flow (dry) until approximately 30 m downstream of crossing structure. Intermittent surface flow then present downstream, surface flow upstream of bridge would only be possible during extreme high water conditions. Water velocity is likely to be high during this time due to boulder and woody debris jams and likely impassable to fish. 2 m drop barrier filled with cobble boulder and large woody debris downstream of bridge with 10 cm plunge pool. Substrates gravels cobbles, boulders, and bedrock. Entrenched with bedrock outcroppings on valley walls. Downstream of first barrier habitat is step pool with abundant cascade and waterfall. Impassable to

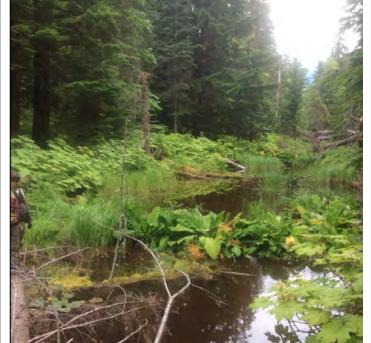
Wetland system, with wetted width of 15 m at crossing and composed of organic substrates. Beaver dams observed approximately 10 m upstream, with flow cutting channel through. Old growth hemlock dominant forest along riparian edge with skunk cabbage, Devils club and emergent reed grasses. Yellow water lily present as in-stream vegetation. Large woody debris, water depths combined with high tannin content and undercut banks providing cover. Downstream of TL69 wetland area approaches 30 m in diameter between valley walls, with large portion of wetted width hidden by emergent grasses. Fish observed feeding on surface near crossing location. No spawning due to organic substrates, poor overwintering (adequate depth, potential for low dissolved oxygen), moderate rearing, moderate migration. Habitat 400 m downstream becomes more channelized and contains coarse substrates covered in a thick layer of rust colored algae. Many beaver dams >5 were observed some without flow over top, however can not be ruled a permanent barrier. One coho captured 400 m downstream. No permanent gradient barriers observed between fish capture and crossing site. Fish bearing stream.

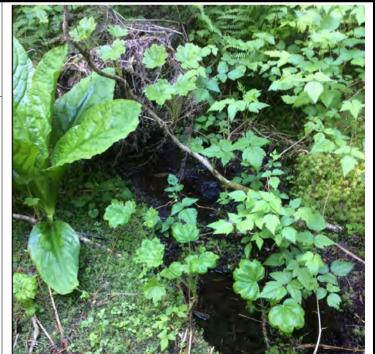
Non continuous sections of channel with small pools. Dry sections of channel throughout. Flows very low, running subsurface in places and overland in others. Vegetated channel with small patches of alluvial sediments, dominated by organic debris, shows minimal evidence of scouring flows during freshet. Small discontinuous channelized sections up to 30 m at surveyed sites, upper and lower ends becomes undefined non-visible channel. Maximum pool depth is 15 cm, residual pool of 10 cm. Non-fish bearing due to discontinuous habitat, low flows, lack of evidence of higher flows during freshet.

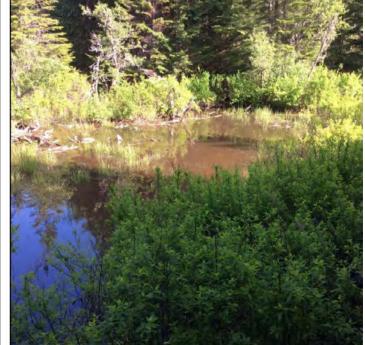
Large beaver impounded area located upstream of culvert crossing. Culvert is blocked with beaver debris and is not passing water. Beaver impounded area is very broad and shallow, with high temperature and low pH. No fish were captured with minnow traps placed in beaver pond. Suspect no fish currently present in beaver pond. Downstream consists of broad, flat, dewatered and muddy braided channels, with abundant vegetation in channels. Water is only present in discontinuous small pools. No scour observed downstream or alluvial sediments. Fish access not possible during low flows. During floods, access may be possible from downstream fish bearing streams. Habitat would be marginal during flood conditions, currently habitat is not available downstream. Seasonal fish use during high flow conditions is possible.

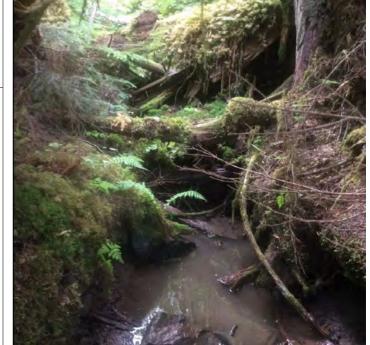
Stream is narrow, defined channel with no flowing water. Channel is full of fallen woody debris in places, with abundant vegetation in and beside the channel. These woody debris accumulations may limit fish access during high water, but are not rated as permanent barriers. Some small residual pools are present, with depths of less than 0.1 m and widths of 0.3 to 0.2 m. Currently, no fish habitat due to low water. May offer limited rearing habitat only during high flow periods. Not fished, no sufficient water depths.

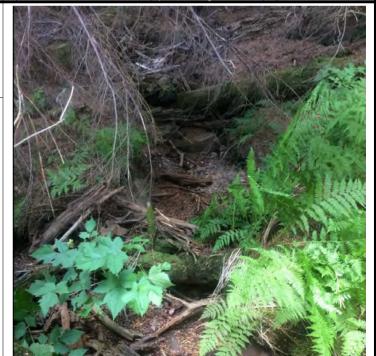
Channel is dry at site, with well defined channel from 30 m upstream and downstream. Above 30 m, channel becomes intermittently defined. Channel below crossing site has some small steps and cascades that may limit fish access, but are not confirmed barriers. At high flows, they may be passable by fish. Channel is dry downstream for approx 100 m, before groundwater seep feeds channel and provides flow. Downstream wetted channel supports juvenile fish. Several small salmonids were observed, including one coho fry. Crossing site may be accessible to fish during high flows. No barriers between fish bearing wetted stream and crossing site, gradient is moderate. Crossing site is likely fish bearing.

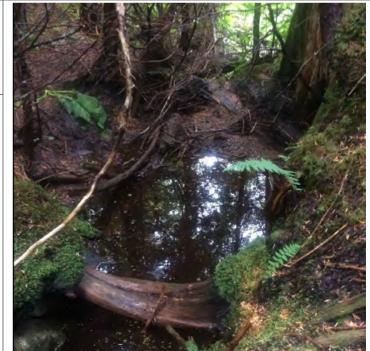
Site consists of a small, visible channel, downstream of a clearcut and mulched road right of way. Disturbance has eliminated the channel at the crossing site, but it is visible downstream. Upstream was low gradient small channel, dominated by fines and organic debris. Water is currently low, with minimal potential fish habitat. During high water, rearing and migration may be possible for salmonids. This stream appears to be a tributary of the known fish-bearing creek located to the south east, crossed by the bridge to the south. No barriers to fish passage were identified downstream, so fish access to site is possible during high water. Electrofishing survey done downstream from crossing location, no fish caught or observed. Potentially fish-bearing seasonally.

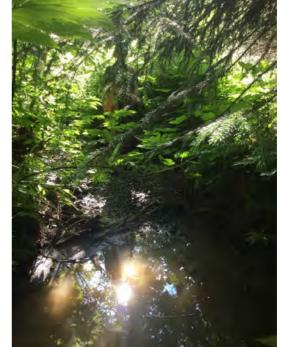
Intermittent wetted areas, coarse gravels and cobbles, with fines. Diverse cover. Poor connectivity. Downstream of bridge perched culvert approx 200 m, 1 m drop on 1200 mm diameter at railway. No fish captured during sampling. Potential for fish presence in higher flows if barrier were removed.

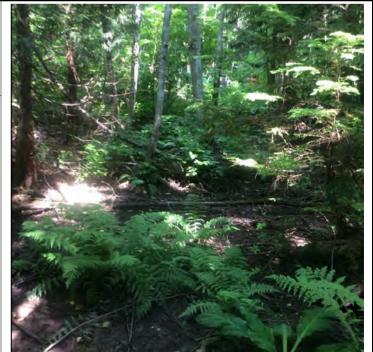
Downstream extent of survey area.

No scour or alluvial deposition. Site is a dry depression with organics substrate. No defined banks. No fisheries potential.

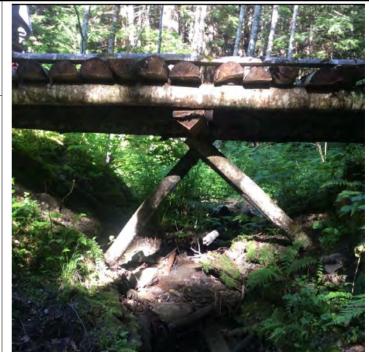
Diverse forest, species consisting of alder, hemlock, cedar, shrubs are Devils club, ferns. Overall channel comments: fairly diverse channel although shallow in places and lacking deep pools. Spawning habitat exists downstream of the bridge. Low flows at time of survey. Mature forest offers good shading and understory fills gaps in places.

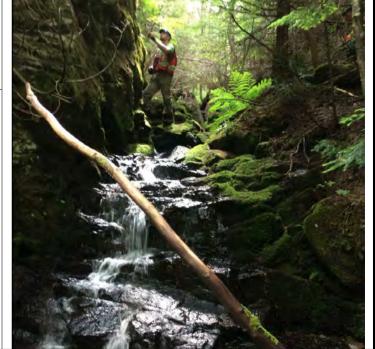
There are two bedrock chute/cascades immediately downstream of the road crossing. Gradient in the chute is high (>20%) and has two cascades each with a drop of approximately 2 m and is a barrier to upstream fish passage. Road crossing has be deactivated and one of the 2 culverts removed. Remaining culvert is high and dry and channel flows around it. Upstream of the road crossing, the habitat is very different. It is an old remnant pond created when the road was active. The culverts backed up the water and flooded the upstream channel. Now that the crossing is deactivated, the pond is gone and the habitat is dominated by fine sediments with vascular plants in a broad valley. Morphology downstream of TL10 is bedrock chute habitat for about 40 meters before flowing in a cobble gravel stream. Electrofishing and minnow trapping upstream habitat did not capture any fish. Electrofishing was conducted in the pool immediately below the barrier and a cutthroat trout was captured quickly. The stream is therefore rated as fish-bearing up to the barrier, but non-fish bearing at the crossing site and above.

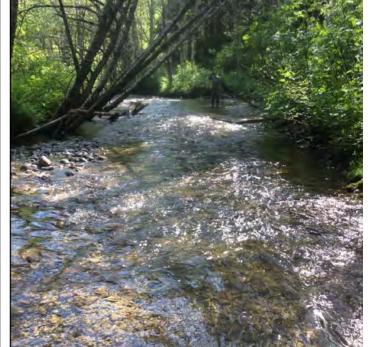
Channel is excellent fish habitat for all life stages and for all salmon and trout species. Abundant variety of habitat types: main cobble/gravel channel, side channels with pea gravels, tributary inlets, shallow riffles-run for spawning, deep pool for holding and rearing. Good large woody debris abundance to scour deep pools. Only signs of disturbance are channel constriction at bridge abutment and elevated mid-channel bars. There is a fisheries sensitive zone present approx 70 m downstream of bridge: stream runs against bedrock and turns 90 degrees to south. At this point, channel is braided and is joined by a tributary from the north. Abundant pools with pea gravels are present here with excellent spawning for trout and rearing for all juvenile species. No electrofishing was conducted done to avoid damaging potential redds. Dip netting in pools confirmed coho presence.

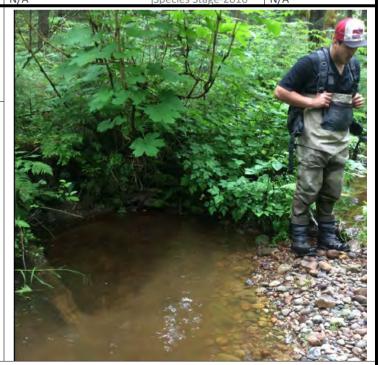
Channel meanders significantly more than is marked on the FWA 20k map. Red algae present throughout site, coating channel substrates.

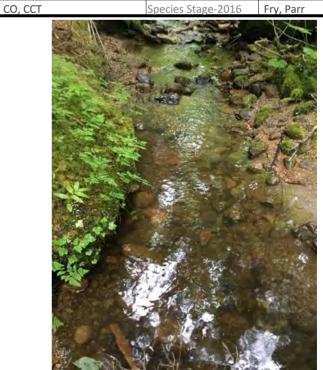
Open canopy upstream of culvert causes thick understory growth of Devils club, salmon berry and huckleberry that completely covers channel. Further upstream the channel opens up and cover is primarily provided by large woody debris. Downstream of culvert, less overhanging vegetation however abundant undercut banks provide cover. Hanging culvert and plunge pool at crossing.

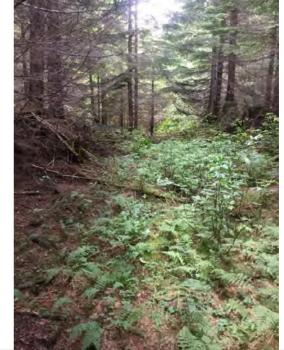
Upstream view of NVC.

No scour or channel. Dry depression. Some alder shrubs. Looks to be an old trail.

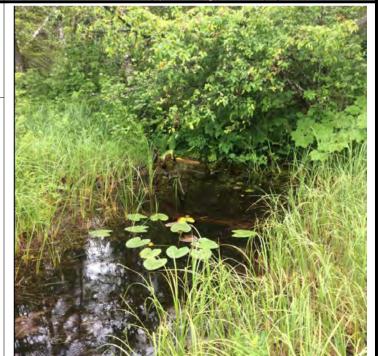
Bog habitat, sphagnum moss throughout, deep peat. Approx 80 m wide bog. No fish habitat, no fish access, no fish captured. Lab tea, sphagnum moss, sundews, water lily, bog cranberry, dwarfed cedars and hemlock, sedge patches.

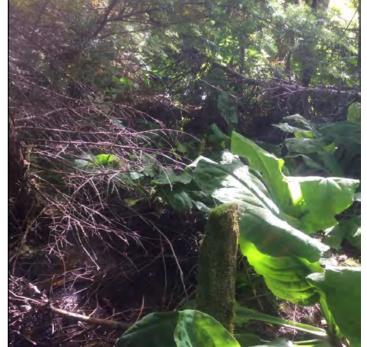
Impounded open water wetland habitat upstream of crossing location approx 10 m wide with depths greater than 1 m. Dry overflow channel present on road. Small amount of flow making path through road, potentially in buried culvert. Downstream of crossing areas of defined channel alternate with a braided non defined channel with minimal flow. Coarse substes are only associated with the road. No barriers to fish passage were observed up to 300m downstream and no obvious terrain barriers however at current flow levels migration would be limited to rearing fish. No fish captured or observed.

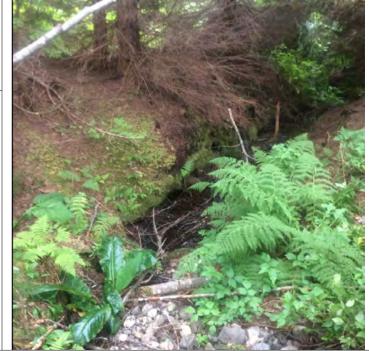
Approximately 50 m upstream of road the channel loses definition and becomes a series of intermittent pools in a wetland area with ferns, sedges and hardhack. Culvert inlet is not where channel meets road, flow appears to currently be subsurface at road. Organics and fine sediment substrates with no coarse material observed for 100 m downstream of crossing. At 100 m downstream, an old road barrier is present, with only subsurface flow seeping through. Downstream of this barrier substrates are gravels cobbles and fines for 60 m then the drainage broadens into a wetland habitat with organic substrates and no defined channel. No access for fish through downstream barrier. No fish captured during electrofishing upstream or downstream of road barrier.

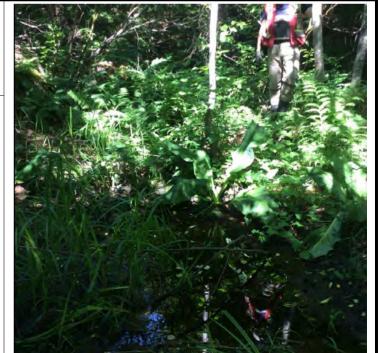
Seep at foot path.

Stream is a groundwater seep flowing in a very poorly defined channel. Mostly it flows overland and pools in depressions. Abundant red algae in channel. Steep (25%) slope at site.

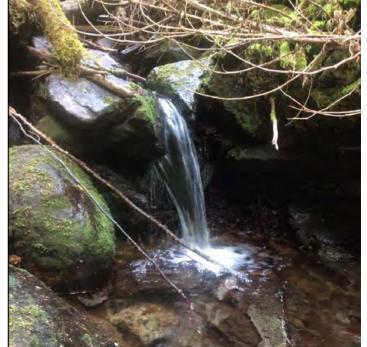
Assessment done at barrier site downstream of crossing site, so no channel dimensions for the actual crossing site are available. Barrier site is long (60 m) cascade pool section, with several small falls. Channel is narrow boulder bedrock chute, with an average 30% gradient. Short ~5 m sections with gradient of >50%. Falls at upstream end is 0.9 m tall, with a 0.1 m plunge pool. Not passable by juveniles or adults at any conditions. No plunge pool for adults to jump barrier falls. Juveniles not able to jump this height. Cascades section downstream is also too steep and shallow for passage. No fish potential at crossing site.

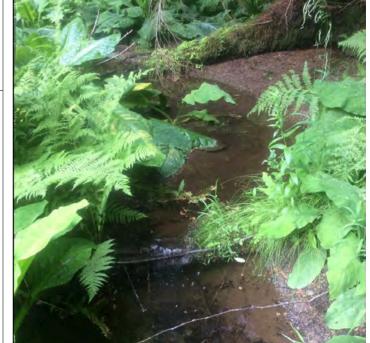
Stream at crossing site consists of a defined channel, tortuously meandering through a broad valley bottom. Channel is dominated by fines, with some small patches of gravels or cobbles. Channel banks and valley bottom is dominated by shrubs: ferns, salmon berry, Devils club. Channel is joined by a tributary approx 25 m upstream. Flow rate and volume is approximately doubled by the tributary. Crossing site appears to be a wood culvert that is passing water, but with no visible passage under the road. Habitat is generally moderate for salmonid rearing and migration, and poor to nil for spawning and overwintering. Lamprey ammocoete captured 30 m downstream of crossing. Fish access to site demonstrated by lamprey presence.

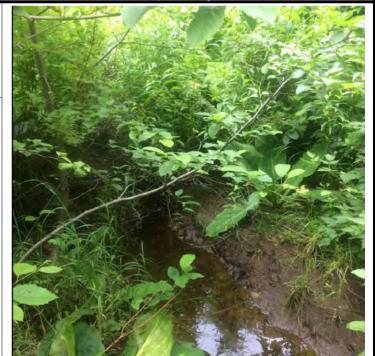
Immediately upstream of road, habitat is impounded by blocked or collapsed culvert and water appears to be draining through road material. Organic substrates and fines are dominant with some small sections of pea gravels downstream of road crossing. Approx. 30 m downstream of crossing, defined channel is broken into several channels and spreads laterally in widened valley. Dolly Varden captured downstream of road during electrofishing effort. Road appears to be a barrier as flow through is subsurface, however no electrofishing was completed upstream due to poor substrates and channel conditions.

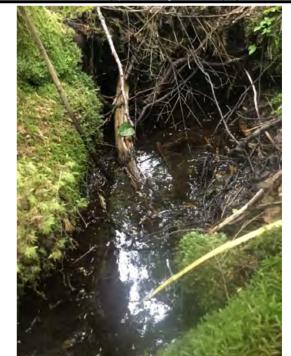
From the centre line the watercourse flows in a defined channel downstream through wetland and coniferous vegetation. Creek is shallow and pool habitat is rare. Some sections of subsurface flow and drops (~0.5 m) may impede fish movements. Upstream of the centre line the watercourse becomes non-classified drainage. All measurements were taken in the channelized section. Bed materials are fine materials throughout study area. No coarse substrate. No fish captured. Creek changes to non-classified drainage only 5 m up of crossing, and poor channel conditions/some subsurface sections.

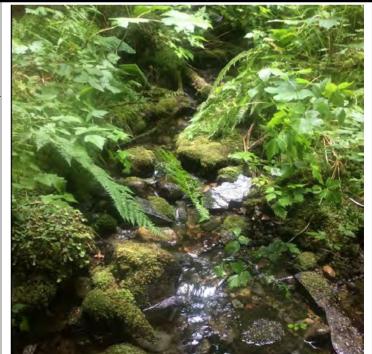
Stream is very nice, well defined channel. However, barrier to fish passage was identified downstream. Fishing done at crossing sites and immediately upstream of barrier, no fish captured. Fishing for 55 seconds below barrier captured 2 coastal cutthroat trout parr. No fish access above barrier site. Crossing sites upstream are non-fish bearing.

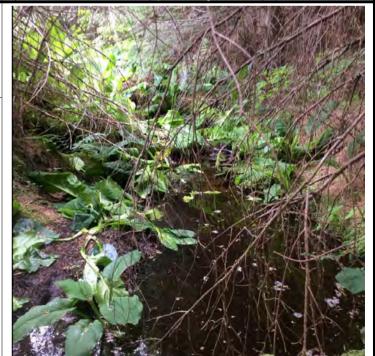
1 m diameter wooden open bottom culvert. 8 m culvert length. Moderate trout rearing, although none captured. Beaver dams throughout reach, possible barriers or barriers downstream. Poor migration, no spawning, poor overwintering due to low flows and low oxygen in beaver ponds.

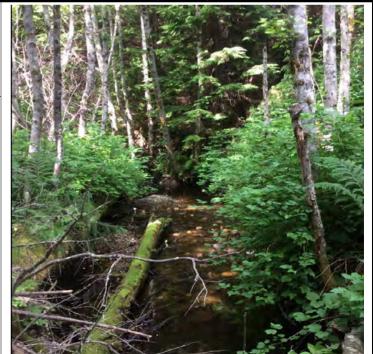
Excellent habitat for trout and small salmon, good habitat variety, diverse channel. Good undercut and large woody debris cover. Recommend clear span bridge crossing, not culvert. Good habitat directly under crossing site.

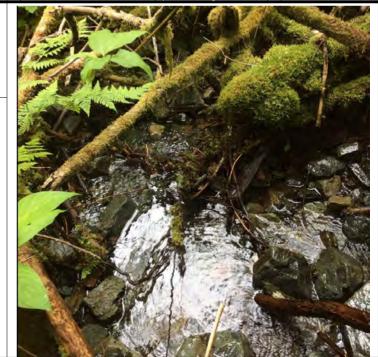
$\label{eq:moderate} \mbox{Moderate quality habitat for young trout. Some pools offer good cover with}$ undercuts woody debris and overhanging vegetation. Some steps down to pools, poor migration potential at time of survey.

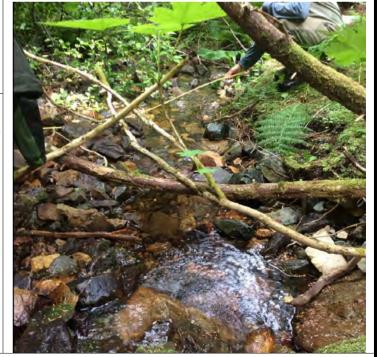
Large pools on both sides of road with no fish present. No evidence of culvert. Suspect that old wooden culvert may have collapsed. Barrier found to fish passage downstream of site. Series of steep cascades and falls. Section is approx. 16 m long with large elevation drop, estimated to be 10 m. No fish passage possible up cascades. Juvenile coastal cutthroat trout captured downstream of cascades.

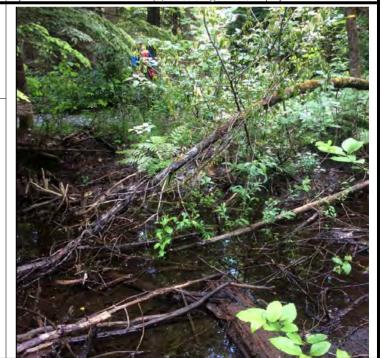
Upstream of site. Upstream of existing road (RD165).

No visible channel upstream of road. Small pool upstream of road, no flowing water. Mud and vegetation including skunk cabbage.

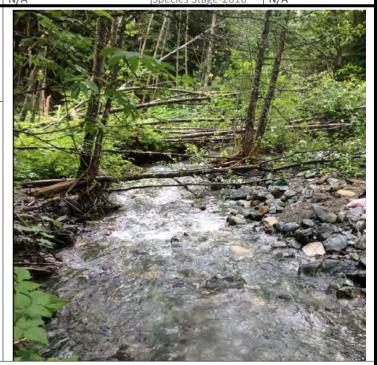
Large series of falls downstream of site, 3 falls, 4 to 6 m tall. No access for fish up falls. Braided channel at crossing site. Good rearing trout habitat. RB captured, likely resident population upstream of falls barriers. Cascade at upstream end of site acts as partial barrier for small fish. Adults may pass during high flows.

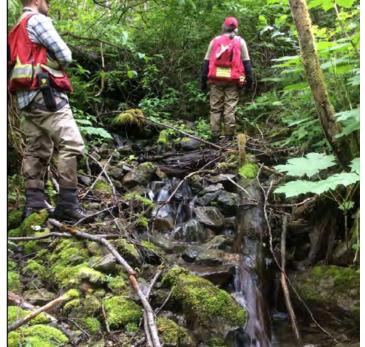
Channel too steep to support fish habitat at crossing location. Crossing site was electrofished in 2016, no fish were captured. Stream was electrofished approximately 300 m downstream and captured juvenile rainbow trout.

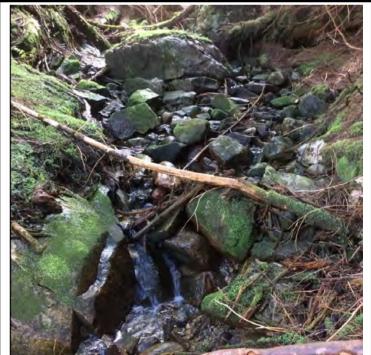
Narrow small stream in steep rocky gully. Boulders, cobbles, present throughout, possibly indicating high flows that would remove fine particles. Upper reach is flatter and slower moving, gradient increases towards downstream end of reach. No barriers to passage observed in reach. Fish access is dependent on fish access to lake outlet stream upstream. Habitat generally moderate to poor for small juvenile salmonids. Large fish would have trouble accessing site due to limited water depth. Downstream of site there is a short section of channel with a gradient of 37%. This steep section may be a barrier to fish passage. Downstream fish access should be re-evaluated at a different time of year to confirm fishbearing status.

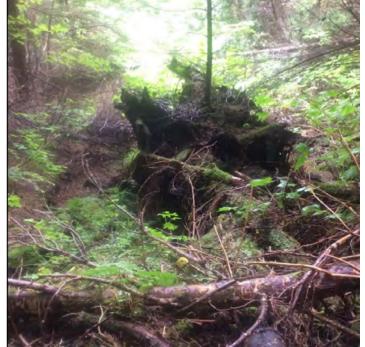
Crossing site.

Crossing site is steep, dry gully, choked with fallen large woody debris. Large cobble and boulder substrates present. Drainage is steep, 38% grade at site. No fish habitat, no fish access, no fish present. Short channel segments <5m long observed through the woody debris. No measurements taken due to abundance of woody debris.

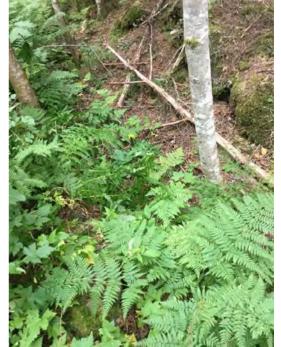
Small ditch on upstream side of road passes through 300 mm culvert to cross road. Downstream of culvert there is no channel, scour or alluvial deposits. No water, flow or fisheries potential at this location.

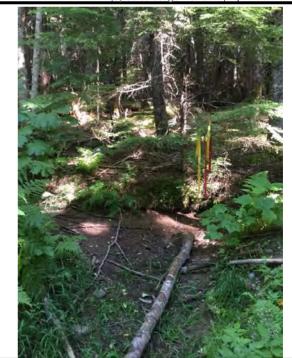
At crossing, on road. Upstream only scour hole, no channel development.

No scour, no water at time of survey. Depression area, likely collects runoff or snowmelt. No alluvial deposition/substrates.

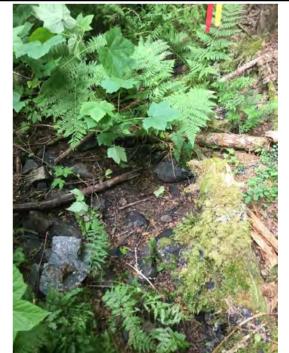
Ditch on the upstream side of the road crosses the road through a low area. Downstream of the road there is channel development for approximately 5m before becoming non-classified drainage. Further downstream there is no channel development, scour or alluvial deposits. No water was present at time of survey. No fisheries potential.

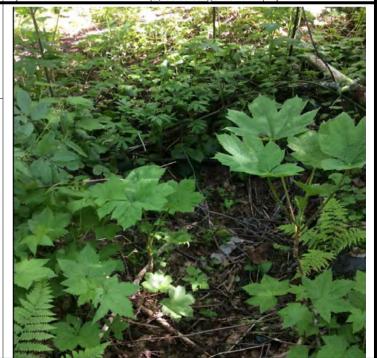
$\label{eq:continuous} \mbox{Downslope of road has some small intermittent pools. Very low flow runs}$ subsurface for majority of length of the site. Dry gully again further downslope.

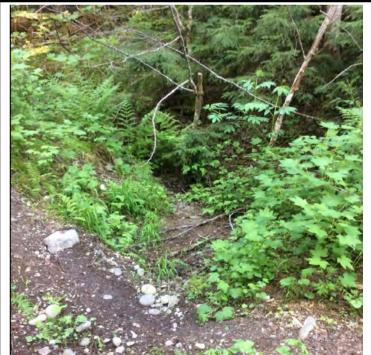
Cross drainage ditch carrying ditch flows across track and down steep slope. Slope downstream of crossing is > 45%. Joins larger creek approx 40 m downslope. Some short intermittent scoured sections. No water, too steep for fish.

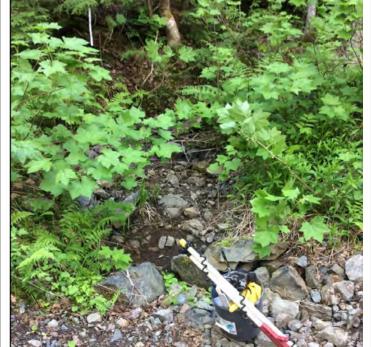
Cross road drainage ditch, fed by ditches on upslope side of road. No natural channel observed upstream of crossing site.

No water, no fish, and steep slope.

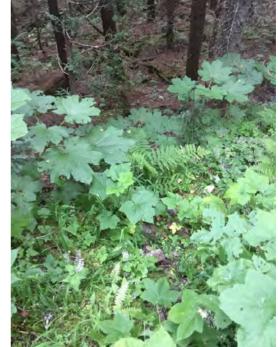
Small ditch crossing the road. Upstream of the road the channel runs in the roadside ditch for approximately 30m. Downstream the channel disappears into an open forest floor. No channel development, alluvial deposits or fisheries potential.

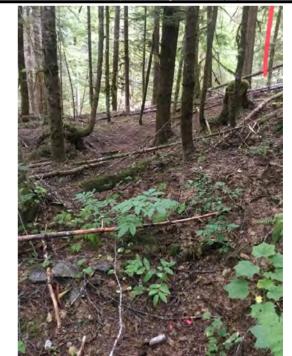
From road at the crossing location looking upstream.

Small ditch crossing the road. No defined channel upstream or downstream of the $\,$ road. No alluvial deposits or continuous channel. Only gravel or cobble is at the road crossing. No fisheries potential.

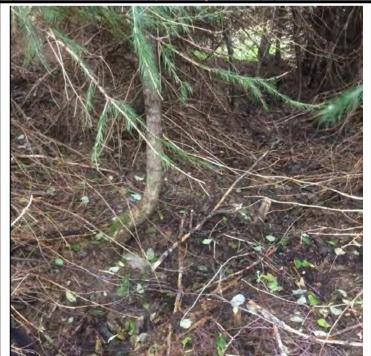
Road drainage ditch feeds into culvert inlet. Upstream of inlet steep forested slope. Downstream of outlet dry drainage ditch through mixed wood forest. Nonfish bearing. Feeds into wetland habitat assessed as non-fish bearing.

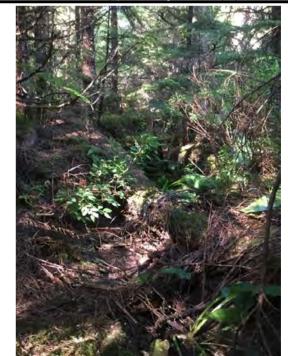
Stream has poor channel development upstream of the culvert. Below culvert the channel becomes more confined and has a steeper gradient. Mostly dry channel with some small isolated pools at the downstream extent not connected by overland flow. Stream may contain fish habitat at high-flow conditions.

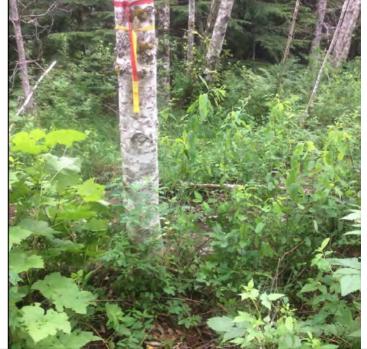
Site consists of an upslope ditch drainage that collects upslope runoff, then drains to the west to join the drainage at site Rd6r 2356, upstream of that marked crossing site. No cross road drainage was identified at site Rd6R_2357. No culvert or overland flow evidence can be found at this site. Downstream has no channel development or evidence of flowing water. It is a local landscape depression, with no fish potential or fish habitat. Non-fish bearing.

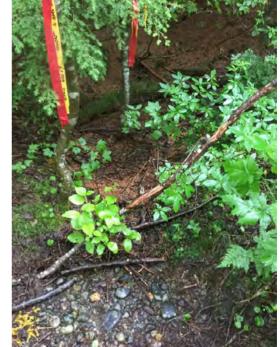
Shallow ditch crossing over the road. No defined channel upstream or downstream. Gravels present on ditch on road but no coarse substrate upstream or downstream. No scour, flow or continuous channel.

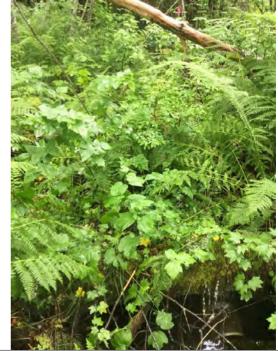
Short section of channel, some isolated water, 10 m section of scour with some alluvials. Set traps initially but further investigation shows no continuous channel > 100m. Water about 40 cm deep in places, channel is 1-2 m wide. Alder forest thick understory near wet NCD . Salmon berry, club, elderberry etc.

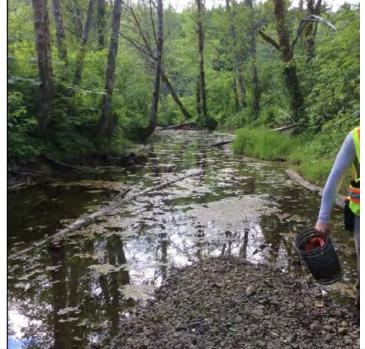
Back-channel habitat offers excellent rearing for young salmon and trout. Abundant coho and threespine stickleback observed and captured in the channel upstream and downstream of the crossing site. Three culverts are present at the crossing site. Two are crushed, but the largest (800 mm diameter) culvert is intact and allows fish passage at higher flow periods.

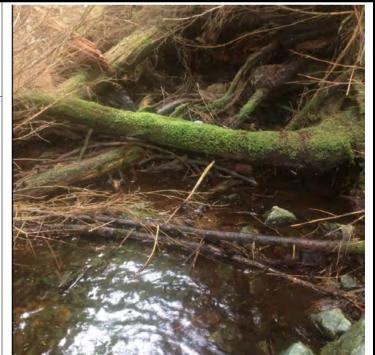
Site has a flowing defined channel in a steep-walled valley, with a moderately high gradient. Site is outlet stream for lake, located upstream of a barrier waterfall. Site has diverse habitat, with pools, riffles, cascades. Abundant cover, mostly provided by overhanging vegetation. Coarse substrates at downstream end of site, becoming more fine upstream. Moderate to good quality stream for salmonids, if a resident population is present in the lake. Upstream of site, stream becomes intermittently defined and wider. Upstream, 60 m downstream of lake, stream flows subsurface. Water flows from under a defined overflow channel from the lake. Currently no fish access to site from lake, although presence of scoured channel indicates that water may periodically flow at high water. Electrofishing done at crossing site, no fish captured or observed.

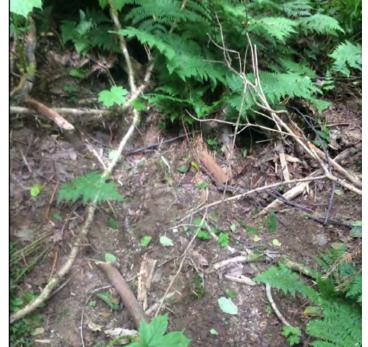
No visible channel downstream of crossing sites TL38 and TL37. No water, no flow, and no fish habitat, therefore no habitat at road site.

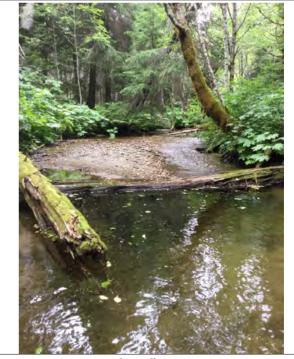
Side and mid bars observed throughout study area. Fish observed throughout study area. Creek has good riffle/pool habitat. High cover diversity.

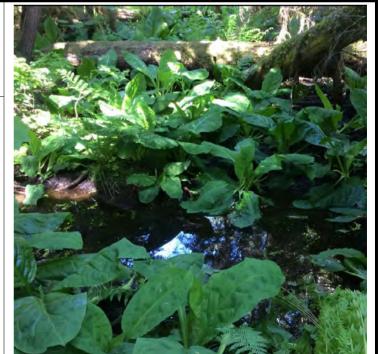
Crossing site is located upstream of a barrier site found approximately 1 km downstream. Crossing is therefore rated as non-fish-bearing. Crossing is partially blocked at culvert inlet by beaver sticks, but is passing some water. Large deep pond is located upstream of blocked culvert, with abundant instream vegetation, mosses, algae. Amphibians abundant in pool, but no fish observed or captured during minnow trapping and electrofishing. Downstream channel section consists of small, minimally scoured channels and discontinuous pools. Multiple dewatered sections act as a barrier for fish passage. No fish access to site, non-fish-bearing.

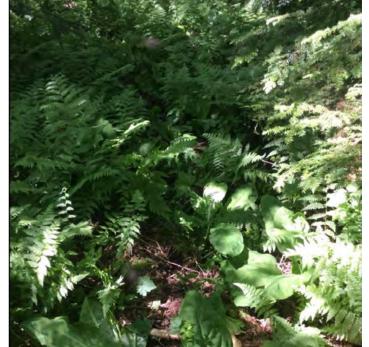
No channel is present at crossing. Actual crossing site is sta 0+854. Culvert is 400 mm approx 6 m long corrugated steel pipe. Inlet is elevated above ditch bottom. Ditch located adjacent to road immediately upslope. Location confirmed by presence of flagged sta 0+854. Upslope of roadside ditch is very steep, approx 80-100%. Downstream of site has a low, broad, and undefined damp area with skunk cabbage and ferns. One small pool with stagnant water was observed 20 m downstream of crossing. No scour or channelization observed in this area. Possibly the very top of a drainage. No fish habitat or access potential at any time of year.

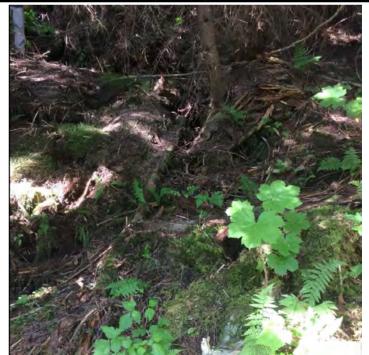
Culvert drains upslope ditch across road. Slope below outlet is very steep, approx 58%. Incised channel present for approx 50 m downslope of outlet. Beyond 50 m, stream becomes broad and undefined with no visible channel. Channel measurements are for 50 m section of channel between pipe outlet and undefined area downslope. Above culvert, only the roadside ditch is present, approx 1 m wide, 0.5 m deep.

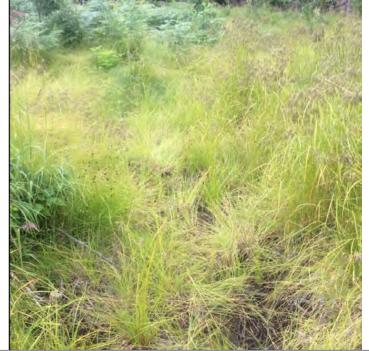
Crossing site consists of a downstream wetland area in a clearcut patch. No culvert could be found at the crossing site. Upstream drainage consists of ditch flow only, that drains to the south to a different culvert site. Drainage is a local depression in the wetland area with an undefined, muddy bottomed area. No water present. Further downstream, the drainage enters a forest. Overland flow evidence is visible, between low areas where water could pool. No evidence of channelization, no scour, no deposition. No fish habitat, non-fish bearing.

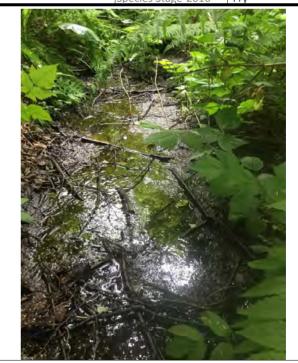
Channel flows alongside road in the ditch for approximately 35m. Channel is overgrown by shrubs and had gravel/cobble substrate. Further upstream the channel turns into the forest and becomes dry with isolated pools. Substrate here is entirely fine materials. Watercourse picks up some gravel from the road which is present just downstream of the culvert. Further downstream the bed material is primarily sand. Overhanging vegetation is the dominant cover throughout the study area. Watercourse discharges into the Wedeene river approximately 100m downstream of the culvert.

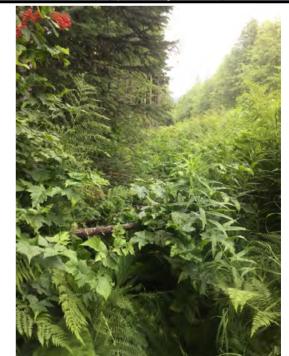
Upstream of the culvert the watercourse is isolated shallow pools that runs parallel to the road in the ditch. A wetland area drains into the channel that may provide fish habitat during high flow seasons. Some cobble and gravel substrate in the ditch but fine materials found elsewhere. Downstream of the culvert, the channel widens and flows over fine material substrate. High amount of algae growth in the wetted area provides abundant cover for fish. Multiple juvenile fish observed downstream of the culvert.

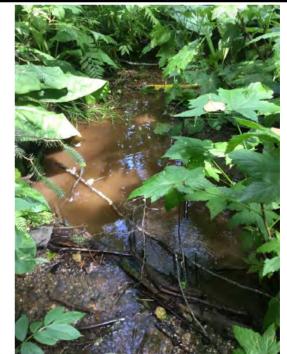
Channel flows in an irregular wandering pattern downstream of the culvert with multiple side bars. Cover in this area is provided mainly by overhanging vegetation and small woody debris. Upstream of the culvert the channel flows in the ditch parallel to the road for approximately 50m. This section is straight and heavily overgrown by shrub species (trees cleared for road ROW). Further upstream the channel turns into the forest where the gradient increases and the morphology changes. Gradient measured to 30% however step pool morphology may still allow fish passage. This section is confined and the substrates consist of gravels and cobbles.

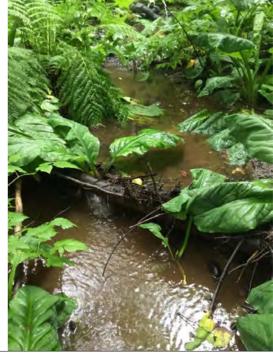
Watercourse characteristics upstream and downstream vary considerably. Upstream - small, unconfined, uniform channel with little pool habitat. Substrate is primarily fines and gravels. A small wetland 20 m wide by 30 m long is just upstream of the culvert. Good cover among wetland sedges. Downstream - confined channel with slightly larger gradient. Substrate is gravel, cobble and boulder. More riffle/pool habitat. Gravel substrate dominant because it is present upstream and downstream. Fines is subdominant because of high amounts upstream of the culvert and moderate amounts below. Cobble and boulder are common downstream but not found upstream.

Creek crossing underneath road has two culverts though majority of flow appears

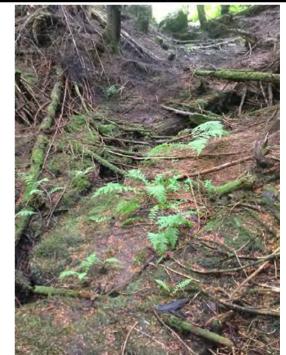
Defined channel from culvert to another drainage approximately 40 m downstream from culvert. This section of channel is filled with woody debris from spacing which has collapsed into the channel. Channel is mostly dry with limited flow near the confluence. Upstream of the culvert there is 30m of defined channel before the drainage becomes a non-classified drainage. Some gravel and cobble likely from the road creates one side bar. Otherwise, the channel substrate is comprised of fine materials.

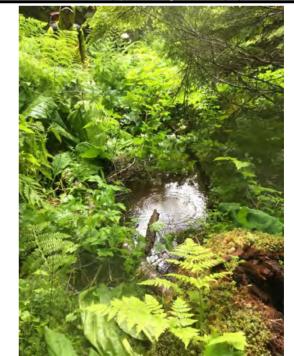
Creek assessed up to 200 m checking for fish barriers. A beaver dam and several small drops were observed. Downstream of the culvert the channel is confined with steep valley walls. Upstream the valley walls are much lower and the creek is occasionally confined. Trees cut down for spacing are discarded into the creek completely covering the channel. Small beaver dam upstream of the culvert impounds a small amount of water. Upstream of this the channel is completely dry.

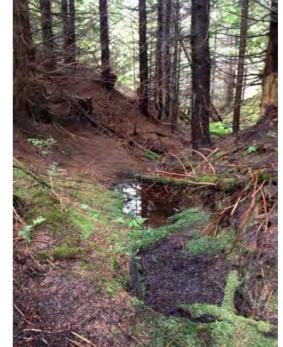
No scour, alluvials, and no continuous channel, some pockets of water.

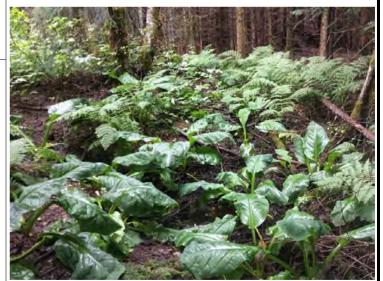
Trees cleared on the upstream side of the culvert for about 30 m. Thick growth of shrubs in this area completely hides the channel.

50 m downstream the channel becomes dry, then widens and then becomes undefined. Flow upstream becomes subsurface flow. Subsurface flows extend approx 29 m before flowing at the surface again. Surface flow is over organic materials without defined banks or scour (non-classified drainage). This section extends at least another 30 m. The non-classified drainage and subsurface flow creates a fish barrier for all species. No fish captured.
