# 2016–2017 Dam Safety Program Report

2016 spillway repairs at WAC Bennett Dam

# Dam Safety Program Report April 2016 – March 2017 (F2017)

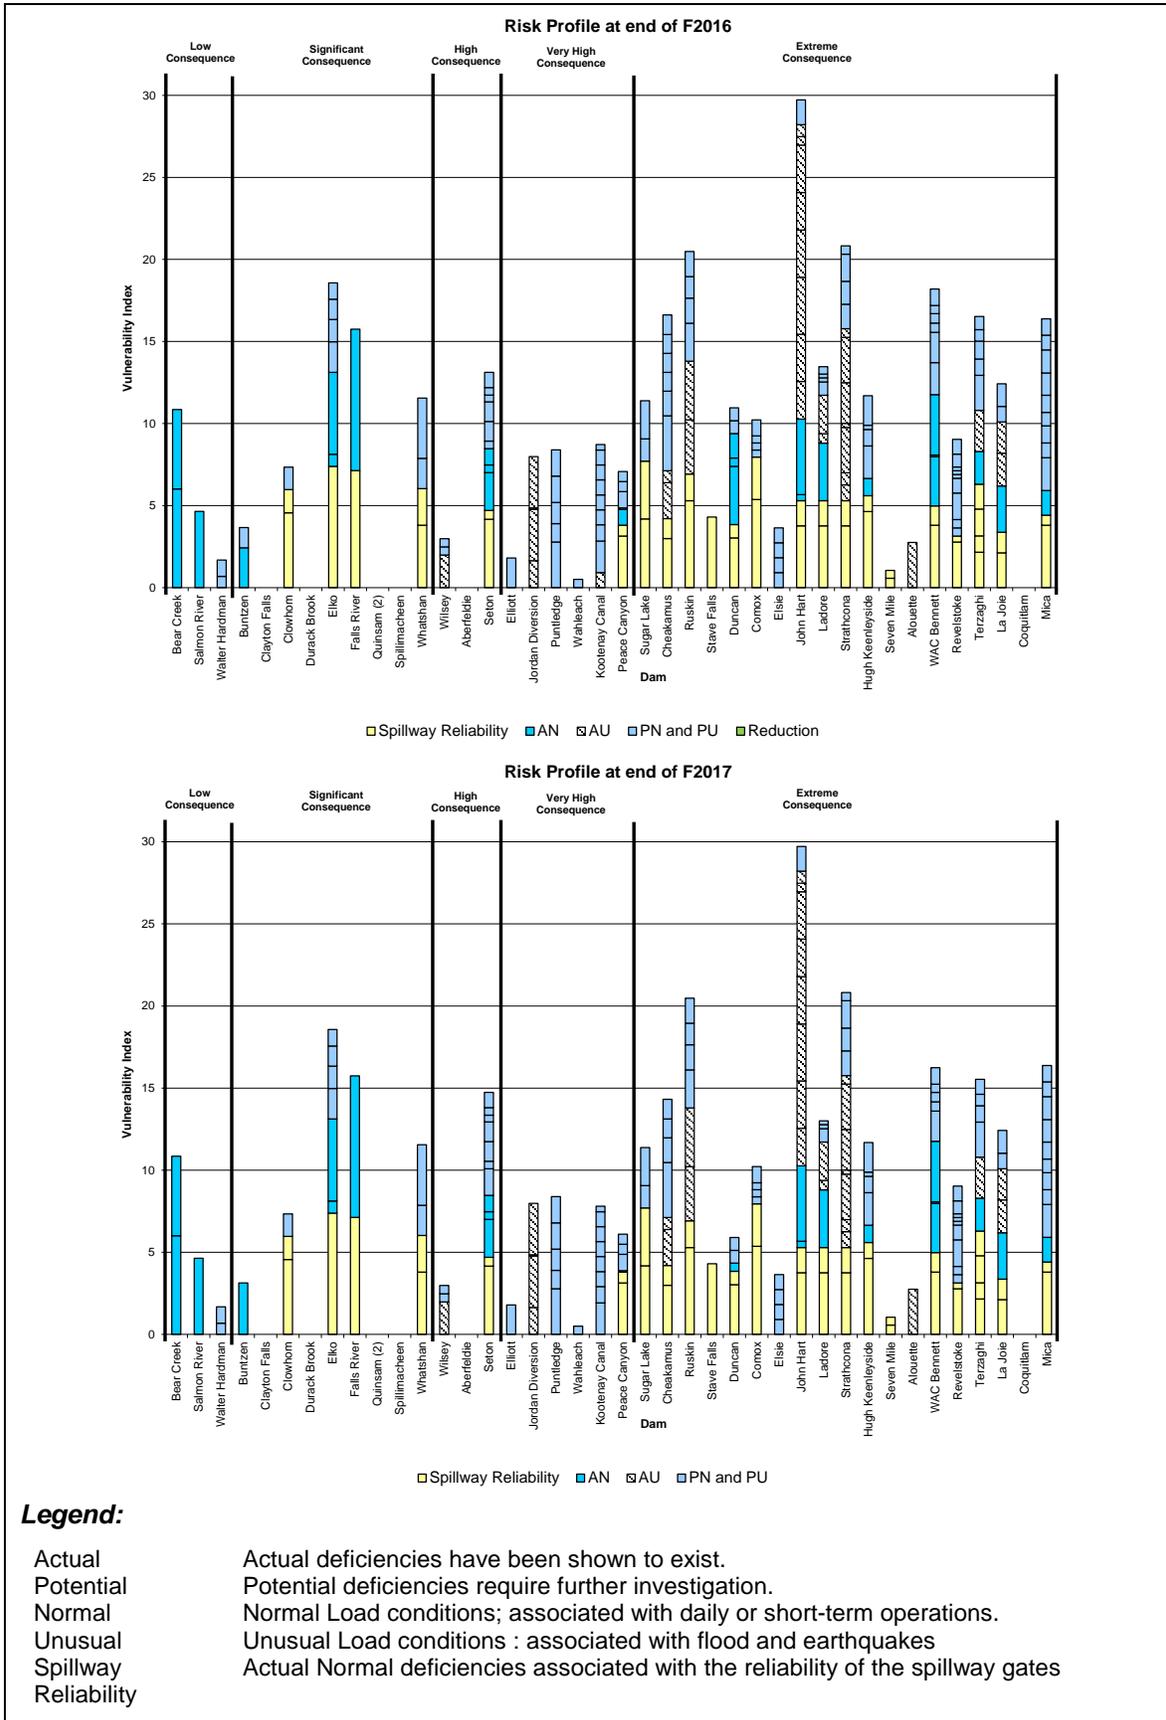
**FIGURE 1: RISK MATRIX**

**How to Interpret Risk Matrix:**

The vertical axis, the Vulnerability Index (Rating), is a qualitative assessment of future dam performance from all causes – the higher the rating the higher the likelihood of poor performance. The horizontal axis shows the dam in increasing order of consequence as classified in the BC Hydro Dam Safety Governance Manual.

The VI rating is plotted against the estimated consequences of failure to represent a measure or index of risk. The Risk Matrix (Figure 1) represents the fiscal year-end status for all the dams with identified actual deficiencies and potential deficiencies for the past two years. The dams are shown in groups as per their consequence category based on the BC Dam Safety Regulation.

There has been an overall decrease in the VI this past year due to decreases at Duncan, WAC Bennett and Terzaghi Dams, as well as smaller decreases at Buntzen, Kootenay Canal, Peace Canyon, Cheakamus, and Ladore Dams, (see Figure 1). There have been small increases at Buntzen and Terzaghi Dams.

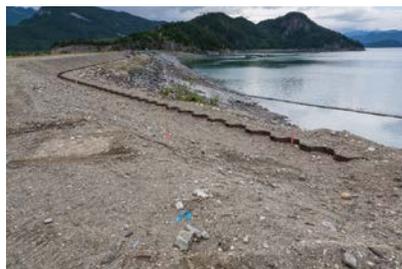
Sheet pile wall layout

A project was initiated in January 2016 to address this issue on an urgent basis, with a target for completion prior to freshet 2016 (i.e. July). A decision was made in early January to install a new sheet-pile cutoff wall from the top of the dam intersecting the existing dam core over the 500 foot of length from the left abutment. The field work was carried out from May to June, and the project documentation was completed by July. The top of the sheet-pile has now been constructed to the same elevation as the original designed top of the core, consistent with the remainder of the dam. With the successful completion of the construction, the restriction on surcharging the Duncan Reservoir was successfully removed prior to the 2016 freshet.

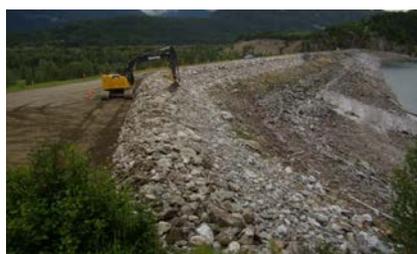
Restoration of the upstream rip rap

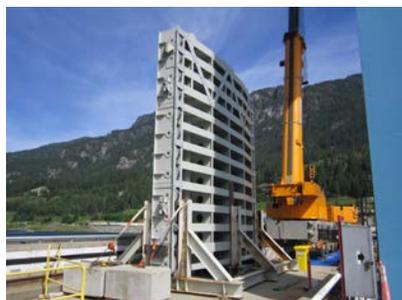
Hugh Keenleyside gates

The Hugh Keenleyside Dam Gate Project, initiated to improve the power supply and distribution, gate controls, strengthen the tower at the spillway, and replace drives and hoist at the spillway and the low level outlets, has been put in service in F2017. There are a number of outstanding deficiencies currently being rectified. Once these are completed, the resultant reduction in Vulnerability Index will be reported.

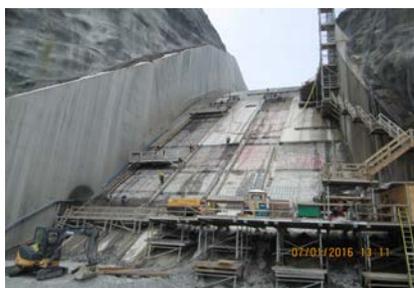
*Resurfacing of lower portion of spillway chute, July 2016*

This project carried out repairs to the spillway chute concrete surface at the W.A.C. Bennett Dam. Safe access to the chute was achieved in August 2011 following completion of rock slope stabilization works which allowed for a complete chute inspection.

- installation of waterstops in the upstream construction and contraction joints,
- repairs of significant cracks by removal of the cracked concrete and replacement with new concrete, and
- minor patching of other cracks.

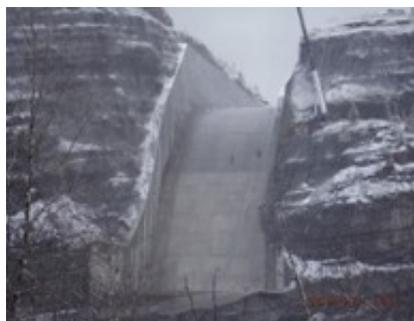
*WAC Bennett Dam Spillway Chute – completed, September 2016*

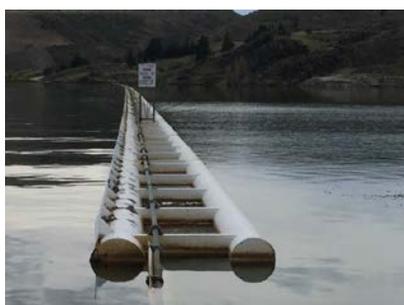
Possible 'next generation boom'

For (ii), pilot projects to explore "next generation boom" design, which will encompass both debris interception and public safety functions, and will comprise steel or plastic pontoons rather than timber sticks, will be initiated at Kootenay Canal and Seven Mile in F2018.

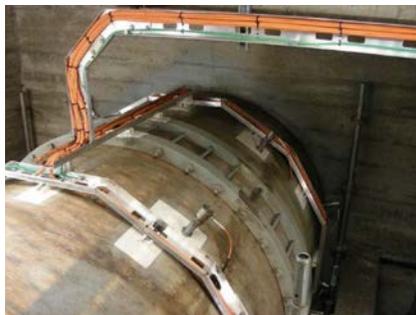
Flowmeter Layout PIV4 Cable Tray

Installation and alarming of flowmeters on the penstocks have been completed previously. Detailed design of instrumentation to monitor for movements of the penstocks and powerhouse, as well as design for automatic closure of the penstock inlet valves, were carried out in F2017.

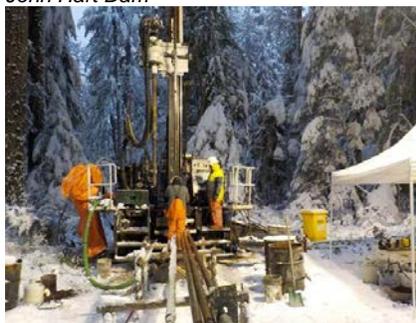
John Hart Dam – Geotechnical Investigation

In F2017, work continued in further developing the upgrade options, which were presented to the John Hart Advisory Board in July. To gain additional stratigraphic information and geotechnical properties, a field investigations program was completed in the area downstream from the Middle Earthfill Dam. This information was used to update the stability analyses and models. For the Middle Earthfill Dam, the preferred option is to construct an upstream berm (into the reservoir) combined with a new plastic concrete cut-off wall downstream of the existing slurry trench wall. Two options were assessed for the North Earthfill Dam, including a similar berm option on both the upstream and downstream slopes or an excavate/replace option. Upgrades planned for the Concrete Dam include a roadway deck upgrade, reinforcing of the upper portions of the dam with anchors, and construction of a free Overflow Spillway. Full replacement of the major spillway gate system components (spillway gate structure, hoist tower structure, hoist system, power supply) is recommended, and designs for this new system were started.

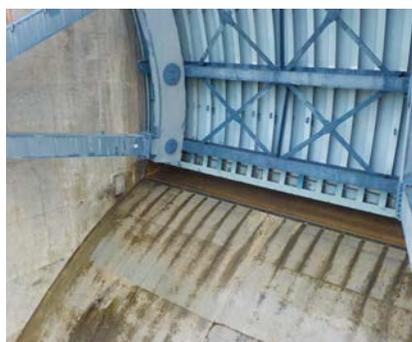
Peace Canyon Spillway Gate

This Project is focussed on selected gate components above deck level only, and will include adding defence in depth to the power arrangements and improving remote control of the gates from GM Shrum Control Room. The Project is currently in Definition Phase.

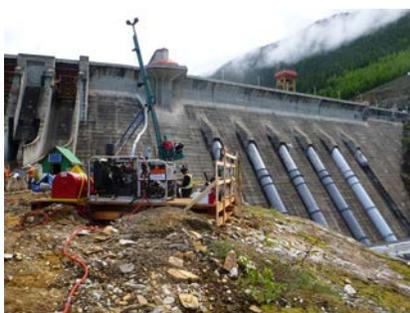
*Drilling in the Marble Shear Block*

The Marble Shear Block is a large rock mass located on the right bank of the canyon at the Revelstoke Concrete Dam. At the time of construction, some movement of the block occurred during excavation for the dam and powerhouse. Extensive stabilization measures were implemented, and no significant movement has occurred since in the area of the dam and powerhouse. However, downstream of the powerhouse, the Marble Shear is still considered potentially unstable and water levels must be maintained to reduce the likelihood of slope movement.

Significant work was carried out in 1998/99 to reduce water levels but they have since increased. In 2012, a number of drains were cleaned by high pressure jetting and six existing drains were reamed. Ten new drains were also installed at the head of the Marble Shear Block Drainage Adit. The drainage trenches on top of the Marble Shear Block were cleared to reduce ponding. While these measures did impact water levels slightly, the average water level is still above the originally defined acceptable limit.

It was concluded that in order to assist in monitoring these thresholds, two additional in-place inclinometers should be installed within the Marble Shear Block and a detailed LiDAR surveying of the spillway chute should be completed. The work for installation of the new in-place inclinometers was completed in F2017, and the LiDAR survey will be carried out in F2018.

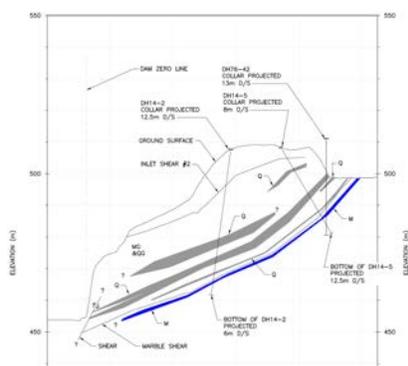
*Geological Model Output*

This project was initiated in F2014, starting with a stability review using updated instrumentation readings and a new numerical model. This work concluded that the stability of the current slope was better than previously analyzed, so long as the Marble Shear Drainage Adit is efficient in draining the toe of the slope. Additional instrumentation was recommended to better evaluate the ongoing performance of the slope.

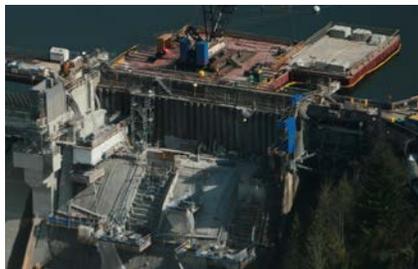
*Construction Bulkhead*

In F2017, new spillway gates 3 and 4 were successfully constructed and placed in-service, and the temporary bulkhead was again successfully moved and re-attached to the dam for the last phase of construction. Work has also begun on the construction of the final pier and spillway gate. The re-assessment of the Ruskin Dam continued in F2017, moving to the more complex modelling stage. These analyses will determine whether there is a need for additional anchors.

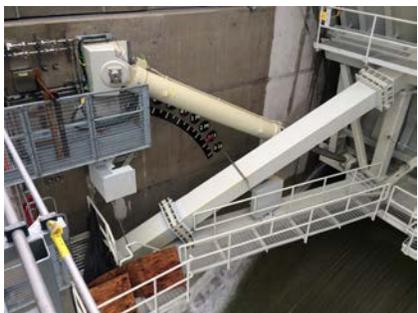
*New Spillway Gates*

The dam safety component of the Ruskin Project includes the upgrading of the concrete dam and abutments to address seismic and seepage risks. Previously, work was completed on the right abutment, in the demolition of the old gates 1 to 3, construction of the new piers and new spillway gates 1 and 2. Work was also initiated at the intake structure and the left abutment, with the construction of a reverse filter berm and anchoring of the intake structure.

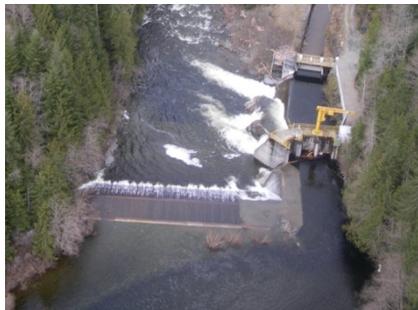
*Salmon River Diversion Dam*

In F2015, the selected alternative included an upstream fish passage on the right bank in the footprint of the existing fishway, a new fishscreen and minimal upgrades to the dam and canal. By F2016, work had been completed on the final design of the upstream fish passage, with preparation for construction in spring/summer of 2016. The design of the fish screen and dam/canal upgrades were in progress and the total project costs were updated and re-estimated at \$43M. By late F2016, because of the updated cost estimate, a decision was made to cancel construction of the fish ladder and to proceed with the decommissioning solution.

In F2017, the decommissioning option was designed and cost estimated, with summer of 2017 targeted for removal of the dam. An application to cease operations was filed and approved by the British Columbia Utility Commission, and the preliminary design report was submitted to the Comptroller of Water Rights for approval.

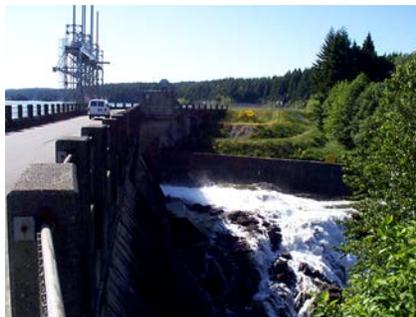
Strathcona Dam Spillway

- Selection of the preferred Low Level Outlet alignment on the right abutment and the preferred options which would involve a tunnel or a channel. This option will combine the spillway and low level outlet functionality, and will make it possible to significantly reduce the level of effort in upgrading the existing spillway for post-seismic operability,
- Completion of a conceptual design cost estimate, and
- Identification that the existing gated spillway structure could be converted into an Overflow Spillway structure. Together with the new Low Level Outlet, the two structures would retain the ability to safely pass the flows downstream into the Campbell River system, while greatly reducing the costs.

Therefore, a decision was made to include the spillway upgrades with the Low Level Outlet upgrades, to proceed as one project (with a name change to Discharge Upgrades).

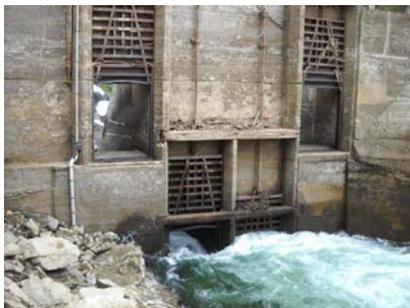
Sugar Lake- Low Level Outlets

This Project is originally part of the “Tier 2” Gate Program, which is intended to address only the more immediate concerns associated with deteriorated conditions and potential common cause failures associated with the low level gate system.

As the Project progresses, a potential opportunity have been identified that dam safety risks can be substantially addressed by modifying the current operation of stoplogs without capital improvement of the low level gate system.

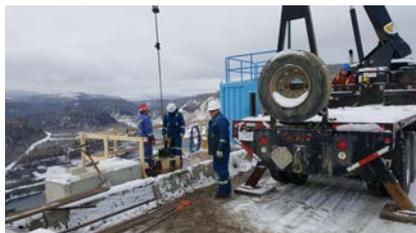
Investigating unplugging techniques for cross-arm device

A number of open casings (observation wells, drillholes and cross-arm device) were installed in the core of the dam during construction and later, during sinkhole remediation. The water levels in some of the casings (the observation wells) have been observed to fluctuate and to suddenly drop indicating a potential for damage to the core of the dam. Annual geophysical measurements are carried out in some of these casings. As such, long-term access to the casings in the dam core is, and will continue to be, a valuable means of monitoring core performance.

In F2017, the contractor was successful in unplugging a casing originally used for a cross-arm device that had been blocked for many years by a seismic hammer. The hammer was freed by over-reaming, and fell to the bottom of the casing. The remainder of the open casings, including this cross-arm device and the remaining selected drill holes will be grouted up in F2018.

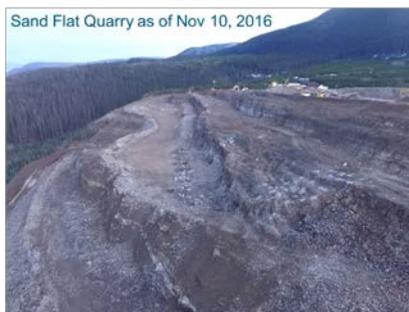
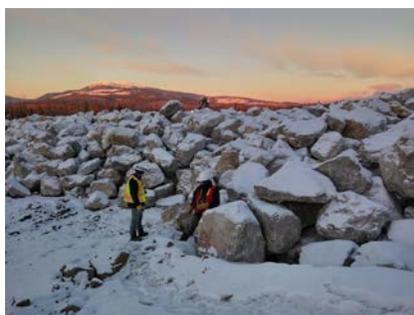
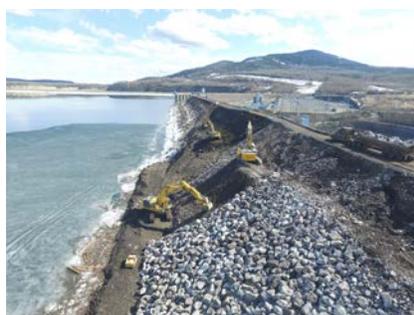
Sand Flat Quarry Site, November 2016

Class 1 Rip Rap at Main Stockpile Area

Start of rip rap placement from left side of dam, March 2017

Deterioration of the existing rip rap and resulting over-steepening of some sections of the upstream slope have been noted and monitored for a number of years. In F2012, the Rip Rap Upgrade Project was initiated to replace the deteriorated rip rap.

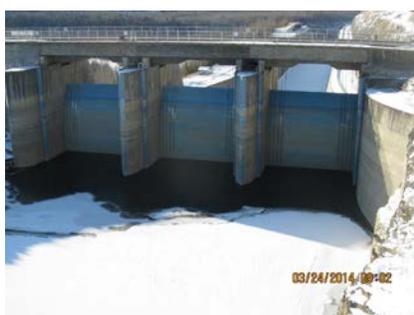
W.A.C Bennett- Spillway Gates

This Project is focussed on selected gate components above deck level only. This will include replacing defective drivetrain components (e.g. cracked pinions), adding a post-seismically operable diesel generator and other redundancies as appropriate. The Project is currently in Definition Phase.

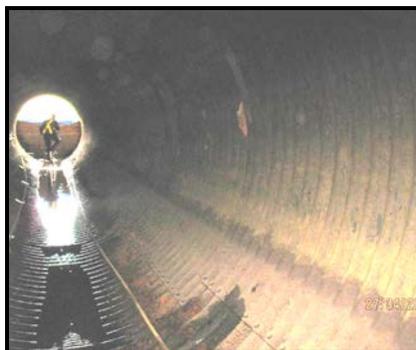
Wahleach – tailrace tunnel, steel section

- Inspection of the tailrace tunnel,
- Identification of a single viable alternative, which includes upgrades to the concrete by local repairs and by repainting of the steel section; and
- Hydraulic modeling of the tailrace tunnel with the selected options.

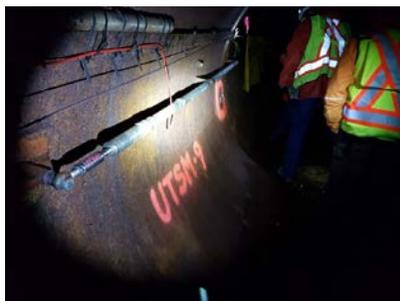
Wahleach, UT-SM9 at the Upper Tunnel lining break.

In January 1989, the deforming rock mass within the Wahleach slope pulled apart the steel lining in the horizontal portion of the upper tunnel. In addition 7 buckled zones were found in the inclined part of the power tunnel and one in the surge shaft. This incident initiated a major slope investigation and instrumentation program by Dam Safety. The portions of the original power conduit located within the deforming mass have been replaced by a new power conduit and operated for the first time in June 1992.

An array of boreholes and surface instruments was established on the slope to provide monitoring of its performance and of the power conduit conditions during power tunnel operations. Key instruments are connected to an automatic data acquisition system (ADAS). The functionality of the extensometers has been plagued with problems over the last several years. Efforts to rehabilitate these instruments were carried out in 2007 and 2011 with short term success. At this time, there is only instrument to provide real time monitoring of the movement of the Wahleach Slope, which is alarmed on a 24/7 basis. Considering the consequences to the powerhouse and the tight transportation corridor below the slope, redundancy in real-time measurement of the movement of the Wahleach slope needs to be re-established.

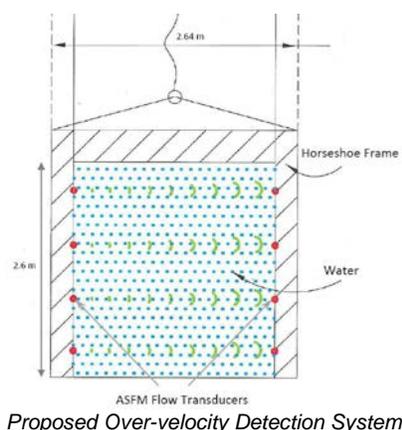
*Proposed Over-velocity Detection System*

The original mechanical over velocity detection (OVD) system at the Wahleach Lake intake was replaced by an electronic-based system in 1996, as the original system was unreliable, resulting in several false trips of the intake gate. However, the electronic OVD systems were plagued by several problems and operating issues, and taken out of service in 2003 due to false trips. The decision at that time was to fix and reinstate the old mechanical system, which has been in service since that time. In February of 2011, the mechanical system closed the intake gate in error as it was operating beyond the limit of its range. The Penstock Inlet Valve in the Valve House however did not close, and the unit was not shut down. As a result, the tunnel and penstock experienced a rapid de-watering which jeopardizes tunnel rock stability.

Given this risk, this project was initiated in F2017 to review and propose/implement upgrades to the OVD system at Wahleach intake. At this time, it is considered that the OVD at the Penstock Inlet Valve, which is a newer design, is adequate. Work completed in F2017 included the assessment of options for a new OVD device, with a recommendation for a new model device which measures the flow by the Acoustic Scintillation Method.

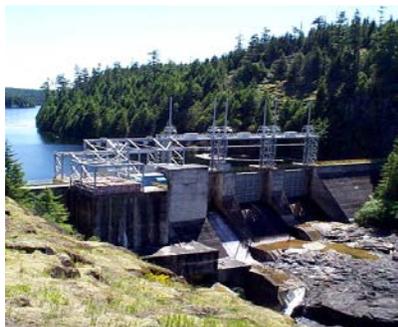
Ladore Dam

Ladore Dam is a concrete gravity dam located downstream of Strathcona Dam and upstream of John Hart Dam. The dam has previously been upgraded to withstand a peak horizontal ground acceleration of 0.56g.

This project was initiated to assess the seismic performance of the dam for the updated seismic hazard of 0.68g. The screening level assessments of the dam and spillway structure have been completed. The project documentation was completed in F2017. The project concluded that the Ladore Dam structure can withstand the design earthquake loads, and upgrades are not required.

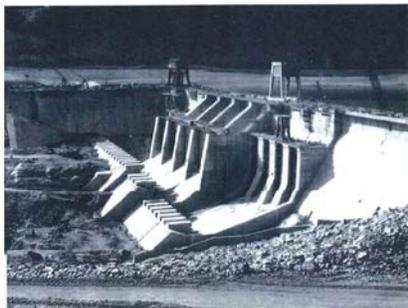
*Hugh Keenleyside Low-Level Outlets  
(right side of photo, taken after  
construction)*

Since operations began at Hugh Keenleyside Dam in 1968, concrete erosion has been occurring at the Low-Level Outlets, which, if left untreated, could compromise proper operation and maintenance of the facilities. Previous investigations indicate that the damage is likely due to both cavitation and abrasion, depending on the particular area.

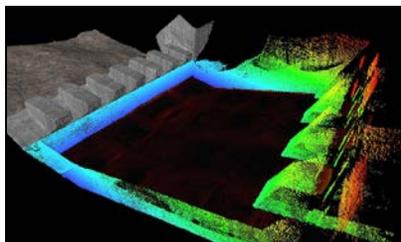
*Underwater survey and quantification of  
concrete damages*

- Underwater survey of the North Ports, and quantification of concrete damages,
- Hydrotechnical modelling of water discharges from spillways and low level outlets,
- Documentation of the operational and damage history, and
- Continuation of the field measurement of the total dissolved gas in water and updating the predictive equations for the total dissolved gas.

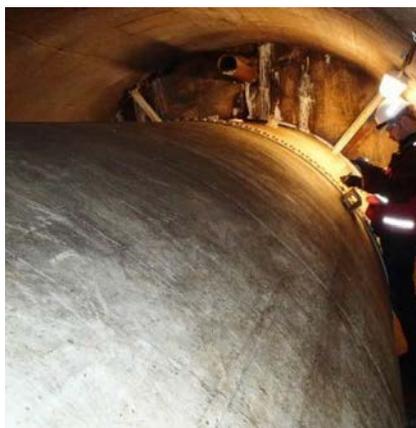
*La Joie- South Conduit*

La Joie Dam is classified as an extreme consequence dam under the British Columbia Dam Safety Regulation. One of the key dam safety issues identified is to secure high reliability post-earthquake operational control of the reservoir. Low level discharge is provided by both the south conduit (power generation and bypass) and the north conduit (controlled by hollow cone valves). Previous work has been completed to improve the seismic performance of the north conduit, including the installation of new hollow cone valves.

The objective of this project is to determine the earthquake level for which post-seismic operability of the south conduit can be expected, to determine the level of concern at which discharge may be impacted. This project was initiated in F2017. The work included a site visit by the team, followed by dynamic analysis of the south conduit. This work is targeted for completion in F2018.

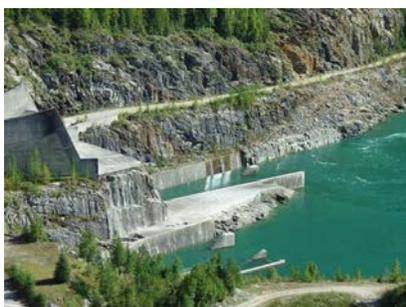
Spillway and Outlet Works Flip Bucket

Mica Dam is the largest and most upstream of the three dams built on the Columbia River and its tributaries in British Columbia. The Mica Dam facility consists of an embankment dam, ogee weir spillway, radial gates, intake tower, water conveyance conduits and a powerhouse.

The objective of this project is to assess the seismic performance of select components of the Mica spillway and outlet works. The assessments shall be completed on the basis of ensuring post-maximum design earthquake operability of the spillway and outlet works. This project was initiated in F2017 with development of a design plan. The seismic assessment of the select components will be carried out in F2018.
