## **Peace River Water Use Plan**

### **Peace River Spill Total Dissolved Gas Pressure Monitoring Program – June/July 2021**

**Reference: GSMON-11**

**January 2022**

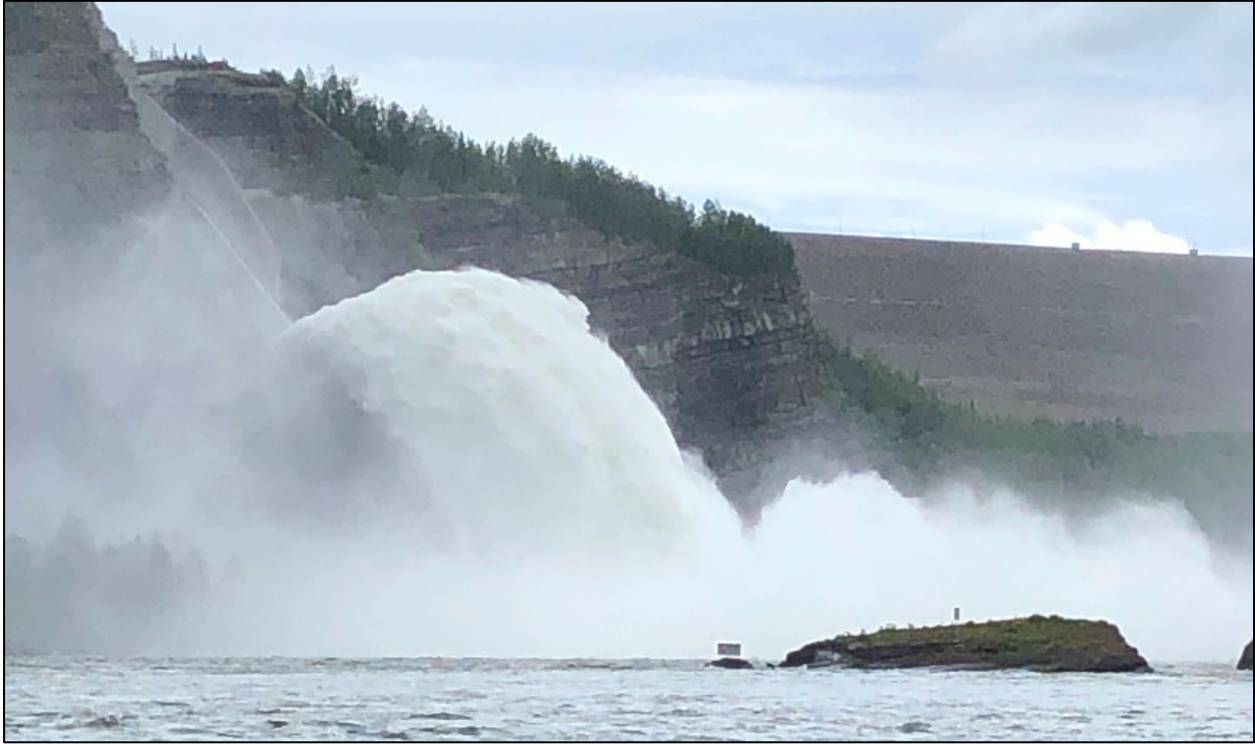
The design of the WAC Bennett spillway appears to be particularly conducive to the entrainment of air bubbles within the spillway discharge stream after it leaves the deflection bucket and prior to its contact with the plunge pool below (Fig. 2). Additionally, a prominent scour hole has developed below the spillway over the 50-year life of the facility. Sounding of the plunge pool during the 2021 spill monitoring program indicated a maximum scour depth of approximately 40 m.

Figure 2. WAC Bennett Dam Spillway, July 17, 2020; 570 cms.

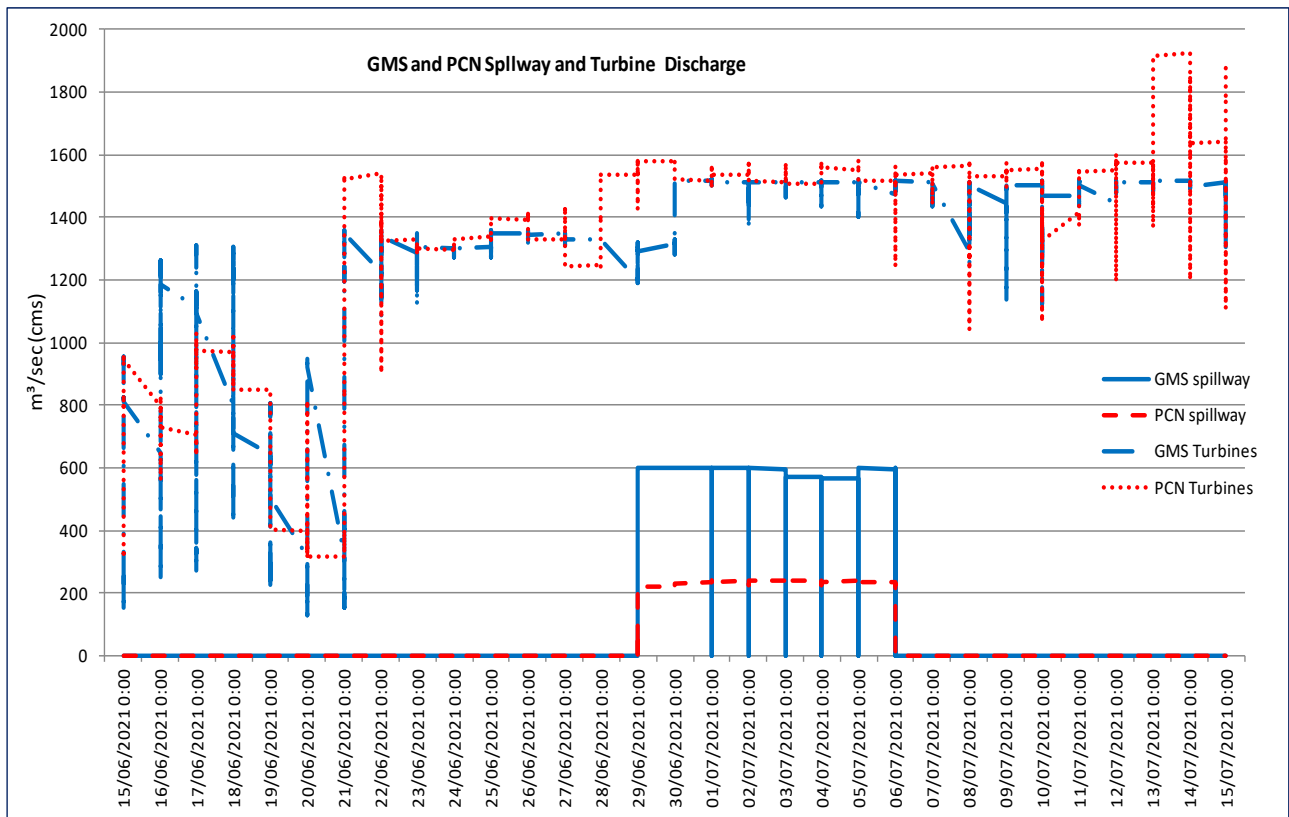
In June 2021, BC Hydro determined it was necessary to release water from the WAC Bennett and Peace Canyon dam spillways in order to offset low turbine discharge and slow the rising elevation of Williston Reservoir. Spills were initiated at both dams on the afternoon of June 29, 2021 and continued for 7 days until the afternoon of July 6, 2021 (Fig. 3). The Peace Canyon spillway operated continuously for all 7 days at an average discharge rate of 230 cms (maximum 242 cms). During the same 7 days, water was released from the Bennett Dam spillway through a series of irregular daily pulse spills each consisting of a 600 cms release approximately 16 hours in duration followed by a pause averaging nine hours in length (Fig. 3). Turbine output volumes from both generating stations remained relatively stable at approximately 1,500 cms throughout the spill period (Fig. 3).

Figure 3. Spillway and turbine discharge from GMS and PCN generating stations during the 2021 spill event, June 15 – July 15, 2021.

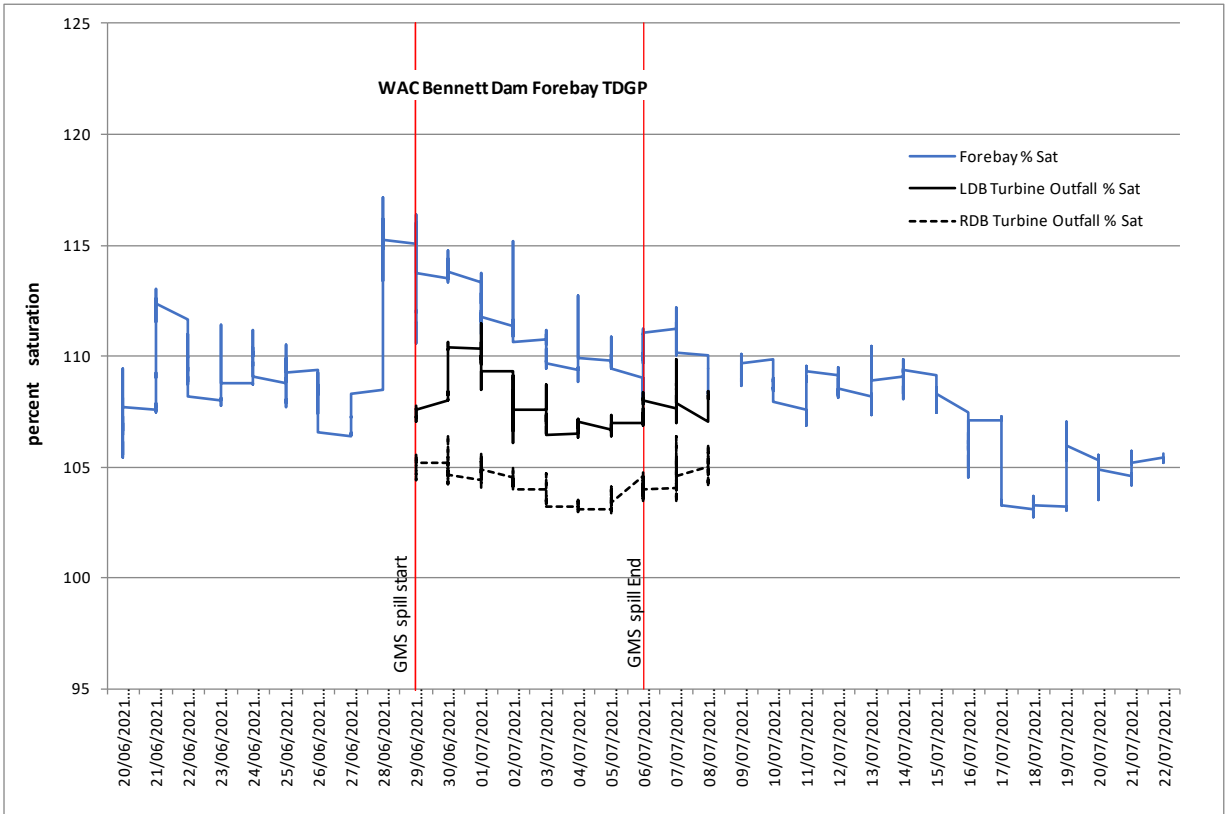
Total dissolved gas pressure was recorded in the Bennett Dam forebay approximately 500 m upstream of the spillway gates between June 19 and July 22, using a HydroLab Model MS5 TPG meter. Interim data downloads and battery replacements occurred on June 29 and July 8. Data recorded at the Bennett Dam forebay site indicated significant supersaturation of forebay surface waters prior to entry into the spillway (Fig. 4). Forebay saturation levels recorded during the June 19 to July 22 monitoring period ranged from 103% to 117%, peaking on June 28, one day prior to the spill then declining to 108% by the end of the 7-day spill. Forebay saturation levels were noticeably higher than in 2020 when July forebay saturation levels peaked at 111% (DES 2021). Figure 4 also includes TDGP levels recorded for left bank and right bank turbine outflow upstream of the spillway between June 29 and July 8. These values are assumed to approximate saturation levels in the forebay at the respective depths of the left and right bank penstocks intakes, with the shallower left bank intake averaging 108% and the deeper right bank intake averaging 104%.

Figure 4. Percent gas saturation levels (TDGP) recorded in the WAC Bennett Dam forebay and GMS turbine outflow, June 19 – July 22, 2021.

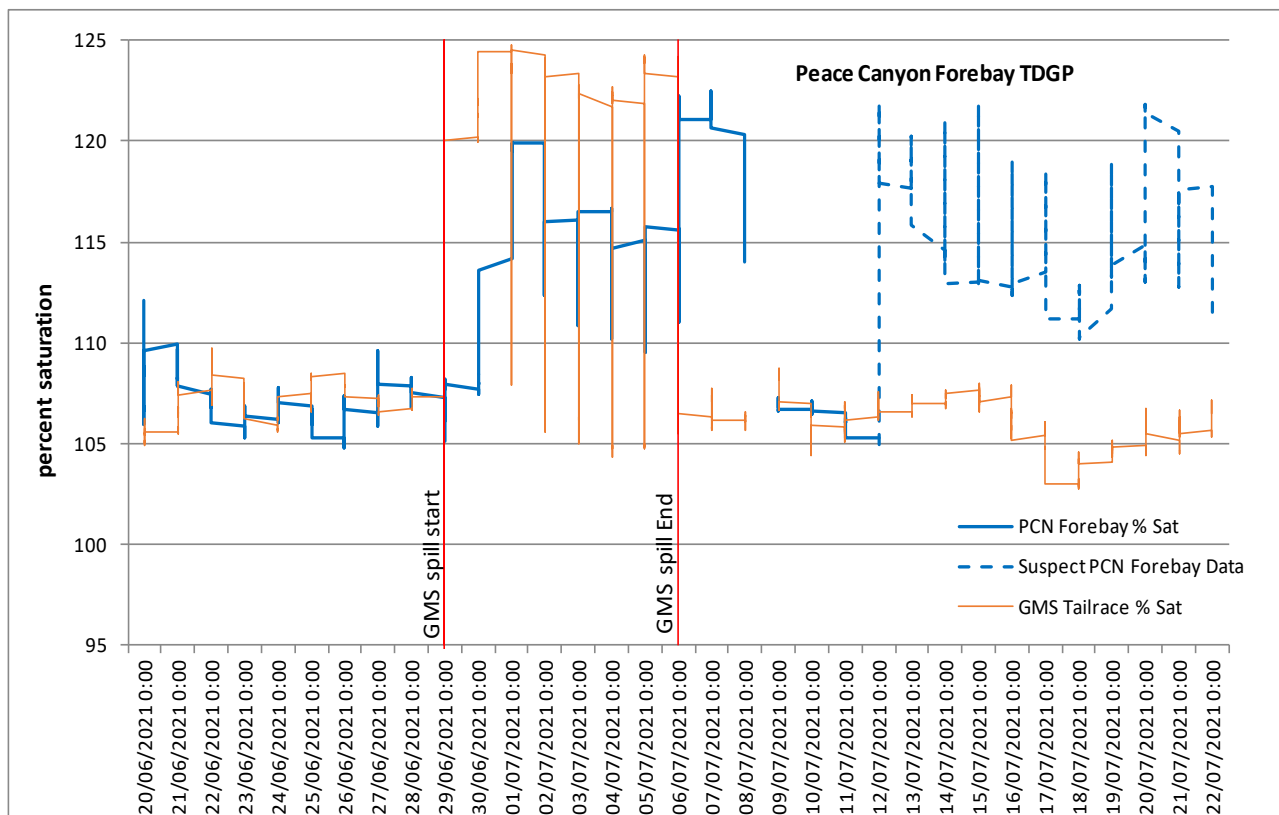
Figure 7 summarizes saturation levels recorded in the PCN forebay and compares them with Bennett Dam tailrace values recorded at the upstream end of Dinosaur Reservoir. As expected, PCN forebay values recorded prior to the spill matched background levels recorded at the Bennett Dam tailrace station during the corresponding pre-spill period. Upon opening the Bennett Dam spillway a delay of 24-36 hours was evident before PCN forebay values began to rise (Fig. 7). During the 7-day Bennett Dam spill, gas saturation levels at the PCN forebay averaged 116%. These levels were comparable to the levels recorded at the same station in 2020 despite higher saturation levels in water entering the reservoir through the Bennett Dam tailrace in 2021. In 2020, saturation levels at the PCN forebay during the Bennett Dam spill were 3 percentage points lower than water entering the reservoir (120% vs 117%). The decline in saturation levels over the length of the reservoir increased to 7 percentage points during the 2021 spill (123% vs 116%). This may be partially due to the daily pulse configuration used in 2021, whereby spill operations at GMS were suspended for approximately 9 hours each day.

Figure 7. Percent gas saturation (TDGP) levels recorded in the Peace Canyon forebay, June 19 – July 22, 2021; (GMS tailrace TDGP added for reference).

The PCN forebay meter appeared to have collected reasonable data until July 12, six days after the spill, when TDG pressure values unexpectedly spiked, and remained high for the remainder of the monitoring period. Readings after July 12 were inconsistent with values recorded upstream at the GMS tailrace and downstream in the PCN tailrace and were considered erroneous.

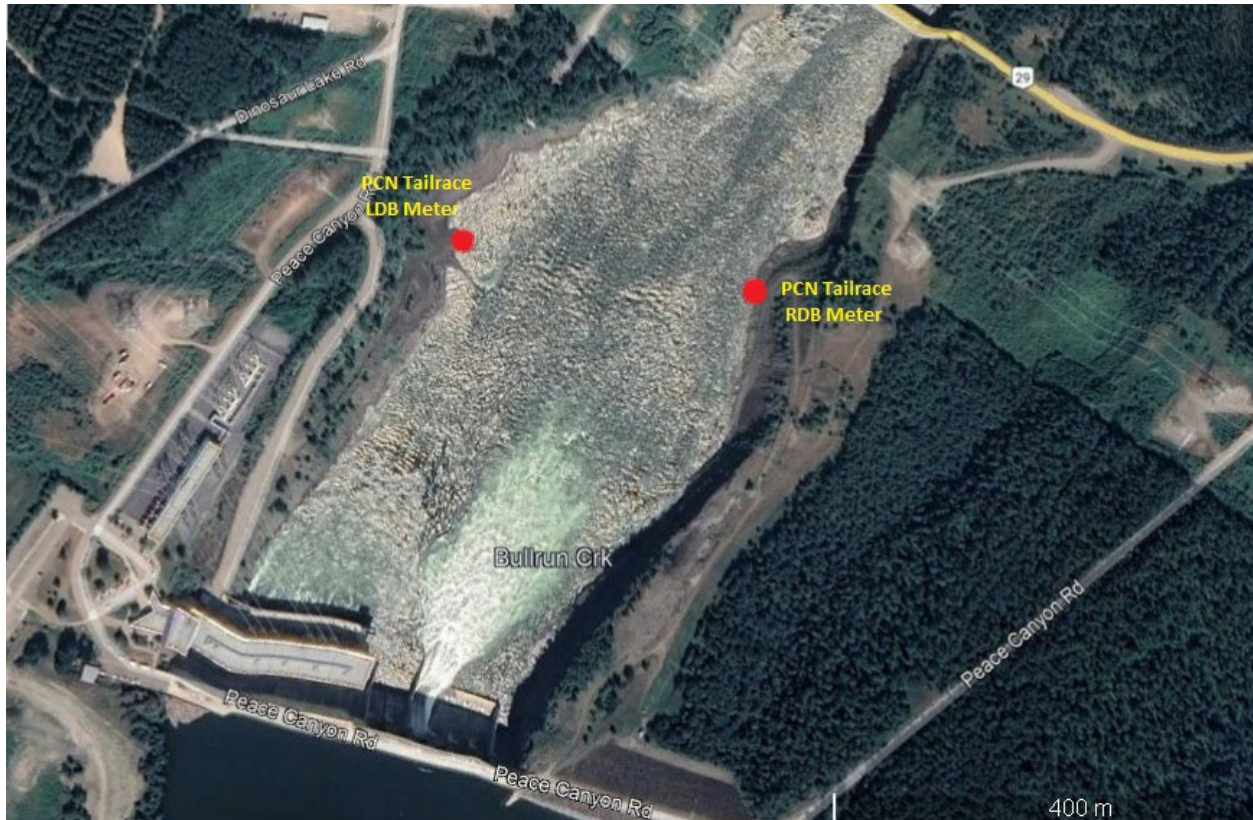
Unlike the Bennett Dam tailrace, where spillway discharge enters the approximate centre of the channel, spillway discharge at PCN enters along the right downstream bank while turbine outflow

enters along the left downstream bank (Figure 8). During spillway operation, the LDB meter is assumed to sample water from turbine outflow and the RDB meter is assumed to sample primarily spillway discharge. However, it is suspected that these flows are not necessarily laminar and that circulation currents, which vary with discharge volume, may be a confounding factor.

Figure 8. Satellite image of Peace Canyon dam and tailrace during 2021 spillway operation, 2021; (GoogleEarth).

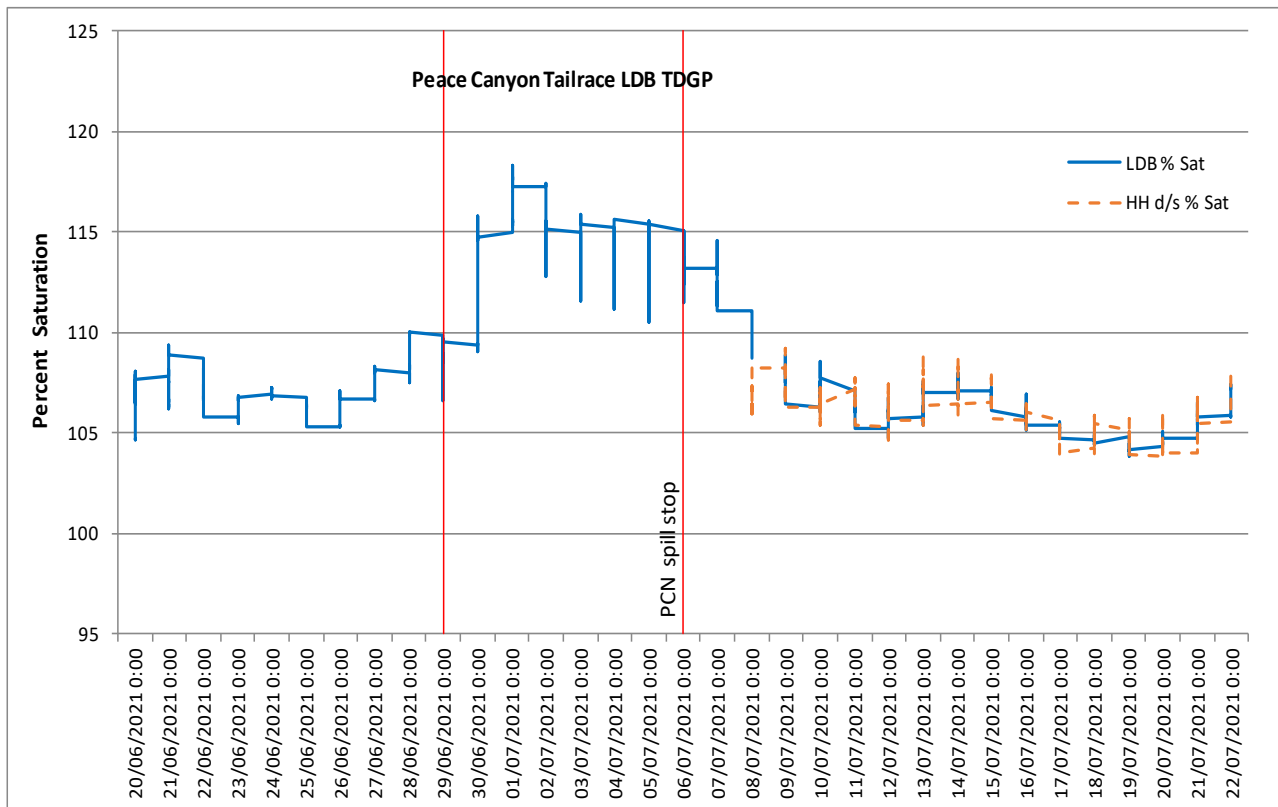
Salvageable gas saturation data from the Peace Canyon tailrace LDB and RDB, respectively, and the Hudson's Hope downstream station are summarized in Figures 9 and 10. Percent saturation levels recorded by the LDB meter closely tracked those recorded at the PCN Forebay before and during the PCN spill supporting the assumption that turbine outflow passing this station is relatively unmixed with spillway discharge. Although post-spill data from the PCN forebay is limited, LDB saturation levels tracked those from the Hudson's Hope downstream station post-spill. In addition to a 24-36 hour delay in the increase of saturation levels at the PCN forebay, Figure 9 also suggests an approximate 3 day delay in the return to background levels post-spill as spill-induced dissolved gas is flushed from Dinosaur Reservoir. During the PCN spill, saturation levels recorded by the RDB meter (Fig. 10), which was assumed to receive primarily PCN spillway discharge, averaged 4 percentage points lower than corresponding readings from the LDB and forebay, but returned to background levels matching the LDB and Hudson's Hope downstream stations at the end of the spill. This decline

Figure 9. Percent gas saturation levels (TDGP) recorded at the Peace Canyon tailrace LDB and Hudson's Hope downstream station, June 19 – July 22, 2021.

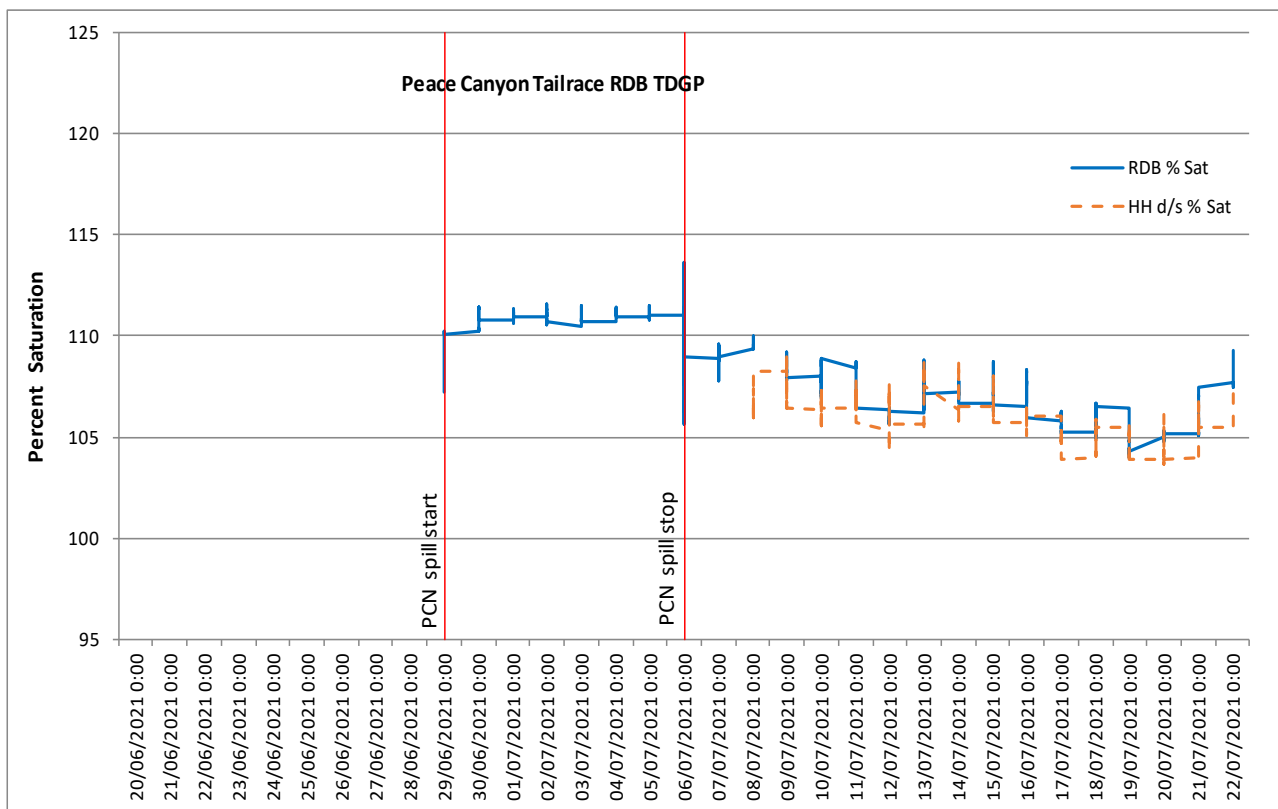
Figure 10. Percent gas saturation levels (TDGP) recorded at the Peace Canyon tailrace RDB and Hudson's Hope downstream station, June 19 – July 22, 2021.

in saturation levels during the spill supports the assertion that the Peace Canyon spillway may partially mitigate high TDGP levels entering the Peace River during simultaneous operation of the Bennett Dam spillway by “flashing off” gas when total pressure is relatively high. The failure of the Hudson’s Hope downstream meter during the spill precluded the collection of further evidence of this phenomenon.
