*Turbidity Levels in Hayward Reservoir*

# **Turbidity Levels in Hayward Lake Reservoir**

**Year 1 (September 2005 – April 2006)**

## **Summary Report**

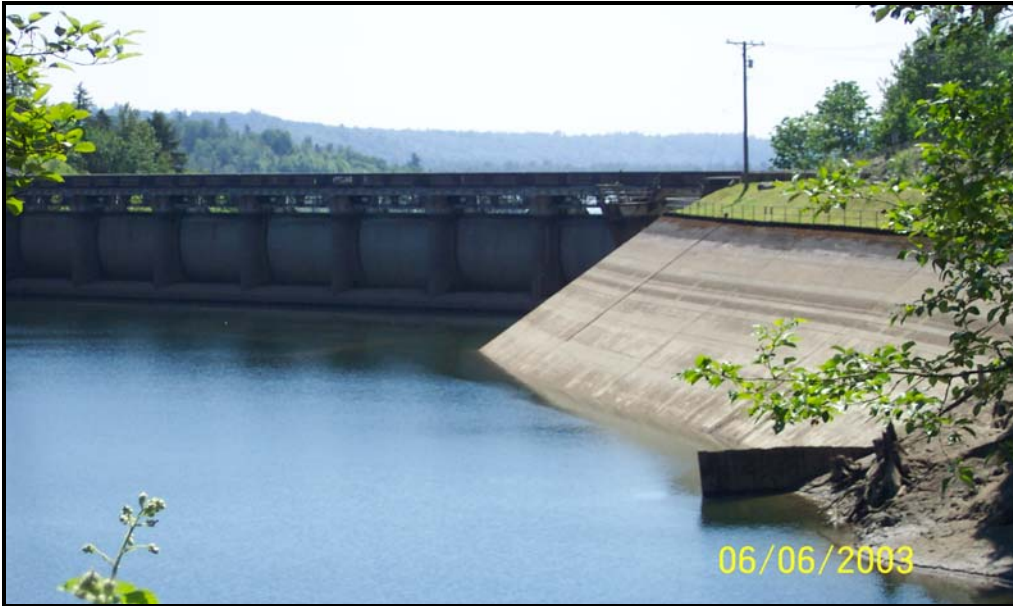
**Site 1 Ruskin Dam Forebay:** This site is located close to the Ruskin Dam, access is by foot from the Railway Trail parking lot. Shoreline area is concrete due to proximity to dam.

Appendix A contains archive images of each sample location at the lowest reservoir elevation experienced during the 2005/06 sampling sessions (April 25, 2006 40.59 m). These images highlight the extent, condition and topography of the drawdown zone at each site.

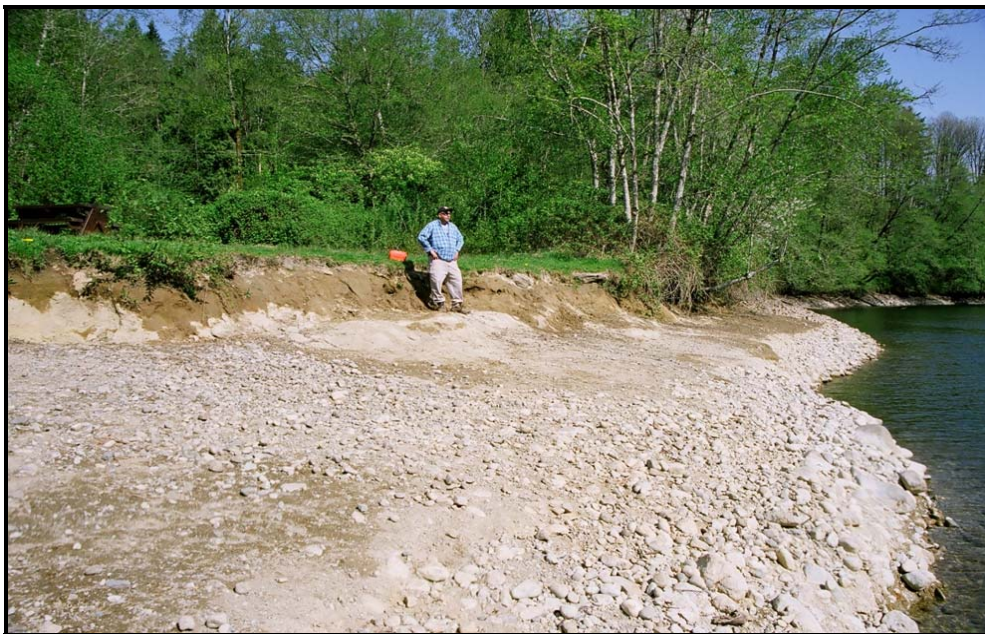
**Site 2 Hayward Lake Reservoir Recreation Area:** This site is located at the furthest downstream swimming area at the rec. site. The shoreline is exposed rock and soil, with little vegetation. Access is by foot.

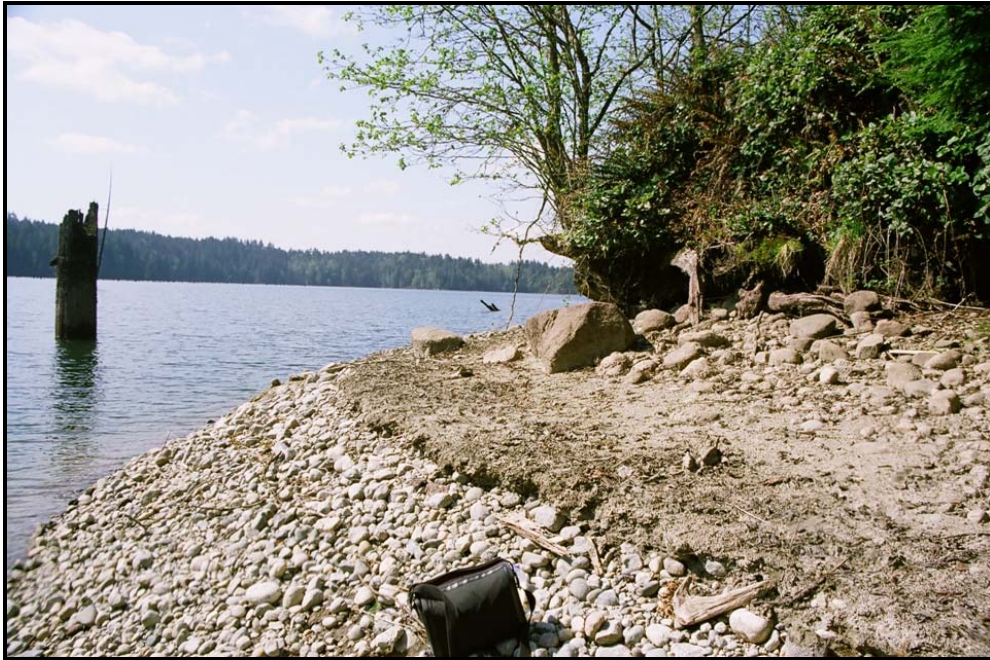
**Site 3 Mid Hayward Lake Reservoir:** This site is accessed by vehicle, a 1.7km drive from the Hayward Lake Recreation Area site 2. Shoreline is heavily vegetated with shrubs and trees.

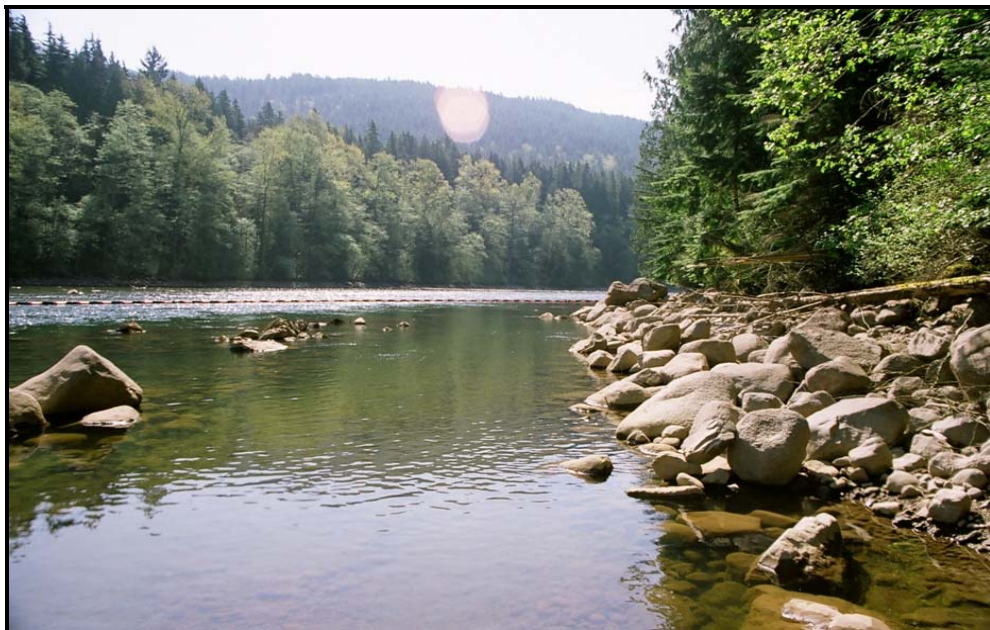
**Site 4 Downstream of Stave Falls Tailrace:** This site is accessed on foot from the recreation site and is approximately 400m downstream of the Stave Falls tailrace. The shoreline is boulder strewn and well vegetated.

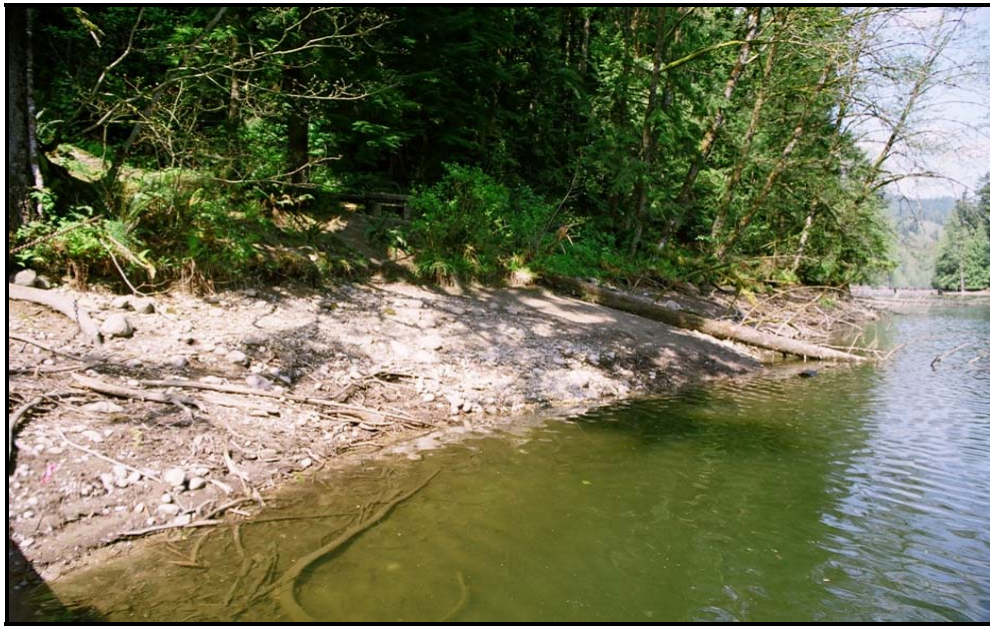
**Site 5 East Shore Hayward Lake Reservoir:** This site is accessed on foot from the East side of the road that crosses Ruskin Dam. A ten minute walk along the Reservoir Trail takes you to this site, located at a floating bridge that crosses a section of the reservoir. Shoreline is well vegetated with trees and shrubs.
