Peace and Williston Recreational Access Feasibility Study Feasibility Study for Boat Launch Ramps along the Peace River

FINAL REPORT

March 5, 2010

MN Project 6683

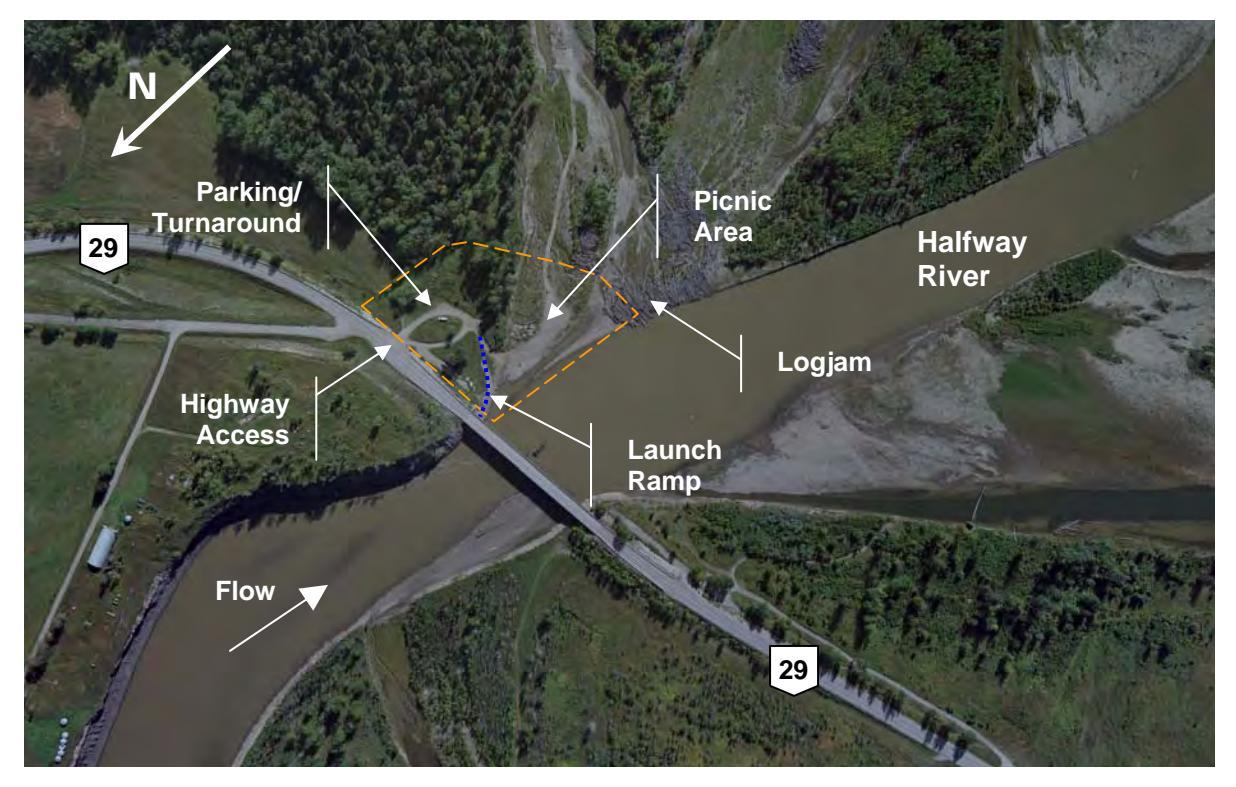
Figure 3.1: Existing Boat Launch Ramp Site at Halfway River

Figure 3.1 shows the overall layout of the site. The general boundary of the site is outlined in a yellow broken line. The relief at the site is relatively high, as indicated in Drawing No. 6683-100 in Appendix A.

The water level at the site was unusually high (approximately 433 metres relative to geodetic datum at the 97th percentile, see Section 4.1) at the time of the site visit. The water was also unusually turbid. Consequently, the physical condition of the boat launch ramp could not be investigated as part of the reconnaissance survey. Information was obtained from BC Hydro staff, boat users, and the underwater contours from the hydrographic survey. Photo No. 5 shows the upper portion of the ramp a few days after the site visit, when the water level had subsided by almost one metre.

Based on the assessment of environmental conditions at this site, it is recommended that the existing Halfway River site be upgraded. This site is already disturbed and the proposed upgrades would have the least impact on the surrounding environment providing that the limits of construction are properly flagged and an Environmental Monitoring Plan (EMP) is followed.

We recommend upgrading the existing facilities at this site.

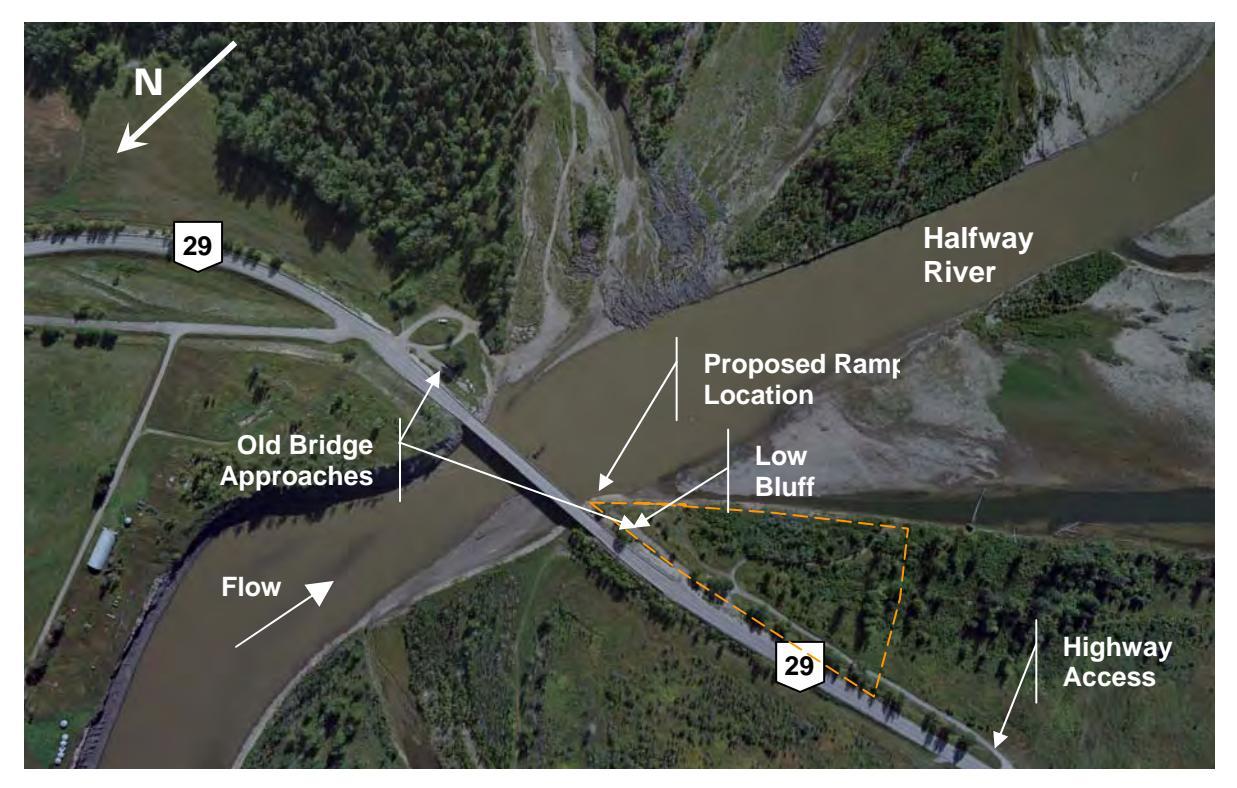
Figure 3.2: Halfway River West Bank Site

The shoreline at and immediately south of the bridge is a steep, riprap-protected bank. Moving further south, a low, soft bluff is present (see Photos No. 13 to 15). Starting approximately 50 m south of the bridge, a flat sandy beach is present (see the foreground in Photo No. 1; this beach was not visible during the initial site visit because of the high water level). The area near the sandy beach is not suitable for a boat launch ramp, since the water remains shallow for a long distance from shore, and the physical works required to overcome this would affect the valuable shoreline habitat downstream (see Photo No. 16). However, a new launch ramp could be constructed at the southern boundary of the riprap, in the location indicated in Photos No. 17 (taken from the bridge) and 18 (taken from downstream). This ramp would be similar to the existing ramp, except that it would be aligned more directly into the flow of the river.

Although a boat launch ramp is feasible at this location, a higher ramp toe elevation would limit boat launches at lower water levels. Also given its close proximity to the existing boat launch ramp, this site is not recommended.

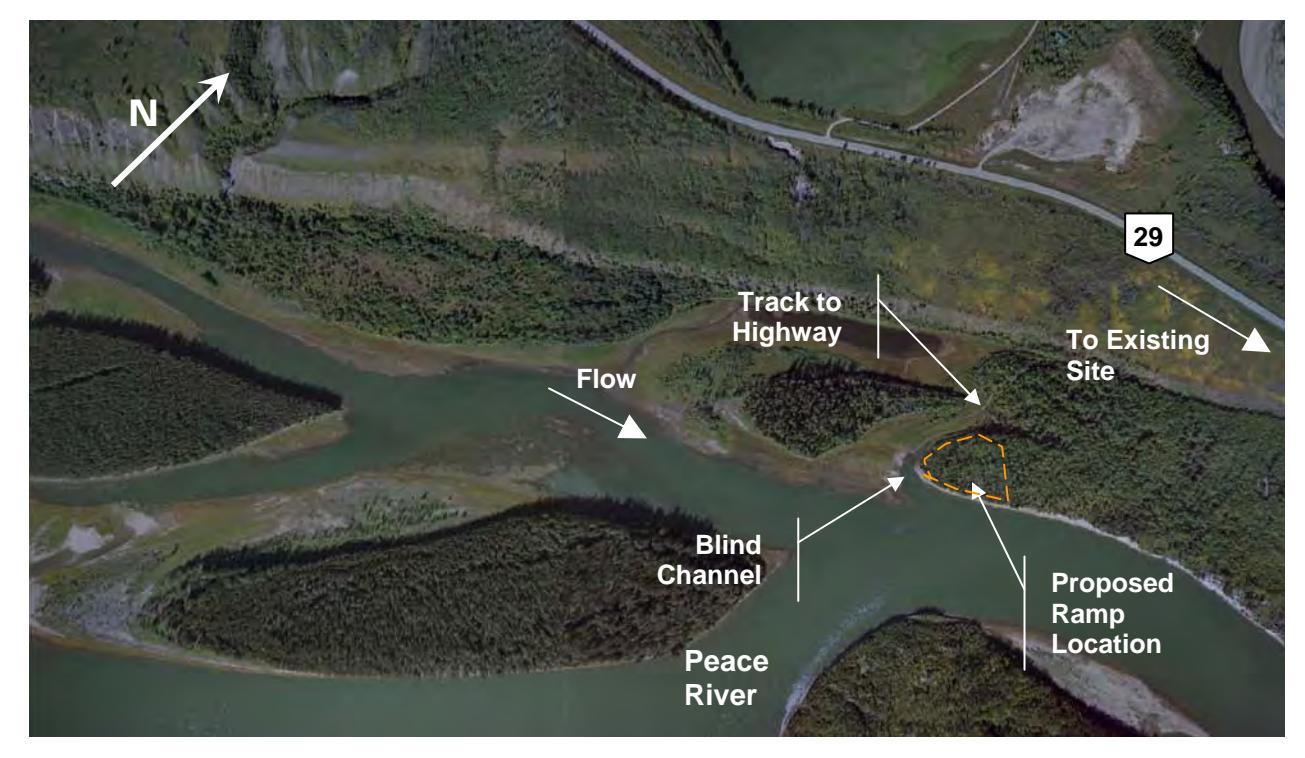
Figure 3.3: Peace River Site near Confluence with Halfway River

The shoreline at the site is characterized by a soft, low bluff (typically 2 to 3 m tall) fronted by a narrow, mixed sand and gravel beach. The upland wooded area has a relatively high relief. Photos No. 20 to 22 illustrate the shoreline condition at the site.

- Additional shore protection armouring may be required upstream and downstream of the potential boat launch ramp location to maintain stable bank. It is recommended that a hydraulic model and analysis should be done at the design stage to ensure bank stability;
- The site is more exposed to winds compared to the Halfway River site; and,
- Significant expense would be associated with the construction and maintenance of an access road to the site, and other new infrastructure.

This site is not recommended because development of a boat launch facility would be more costly than upgrading the existing boat launch ramp, as well as the environmental sensitivity of the location.

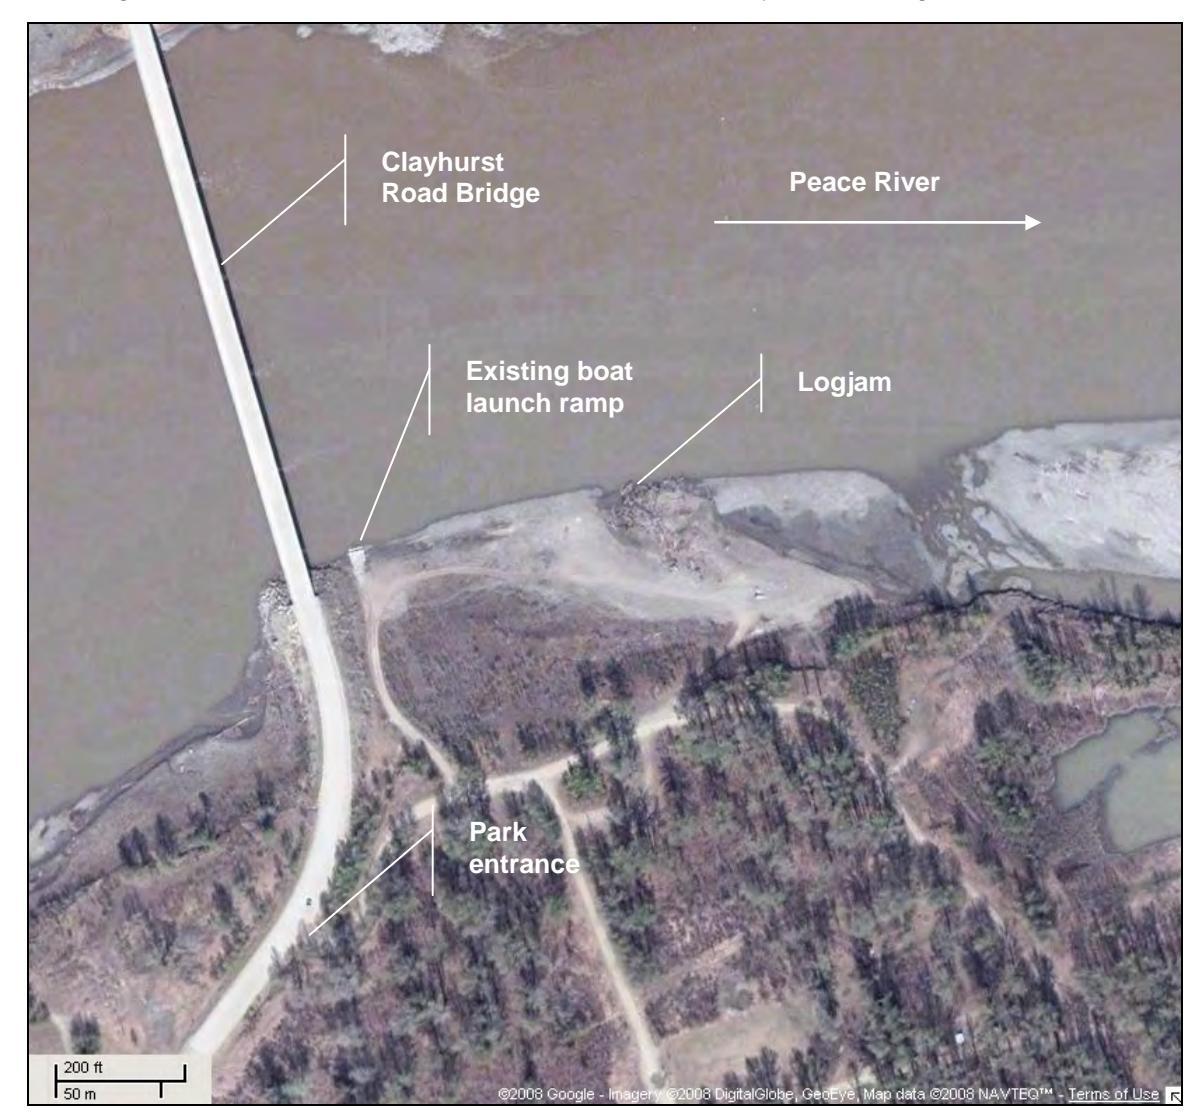
Figure 3.4: Blackfoot Park Site

Due to the flat topography and shallow water east of the site in the area indicated in Figure 3.4, no suitable boat launch areas were found in the park downstream of the site. Additionally, the logjam would form a barrier to boat access when it is in a relatively large configuration. Similarly, no suitable areas were observed upstream, and it would be undesirable for park users to be required to cross over Clayhurst Road to use the ramp. Consequently, no alternative sites were investigated in detail.

The main disadvantage of the site appears to be occasional high currents, which have damaged the riprap slope. The concrete boat launch ramp may have suffered direct damage from falling and tumbling riprap or other debris; it may also have suffered indirect damage from scour caused by the high currents. However, both of these problems can be overcome through appropriate engineering of the riprap, ramp, and scour protection.

- The riprap revetment at the bridge abutment will be repaired and the toe reinforced with rock characterized by a median diameter D₅₀ of approximately 1,000 mm (the rock presently appears to have a D₅₀ no greater than 500 mm);
- The existing boat launch ramp will be replaced by a single lane ramp approximately 45 m long and 7.0 m wide, matching the existing ramp. The toe of the ramp is at an elevation 381.0 m. The ramp surface will be made of concrete for ease of maintenance. The slab surface will also have a grooved pattern for improved ramp traction. The slope of the ramp is 10% to match the existing ground levels;

- A fixed walkway will be constructed adjacent to the ramp; and,
- A scour pad will be constructed to protect the base of the riprap revetment and will be continuous with the foundation of the new walkway and boat launch ramp. The scour pad will be constructed of riprap characterized by a D₅₀ of approximately 500 mm, and will be grouted beneath the new boat launch ramp.

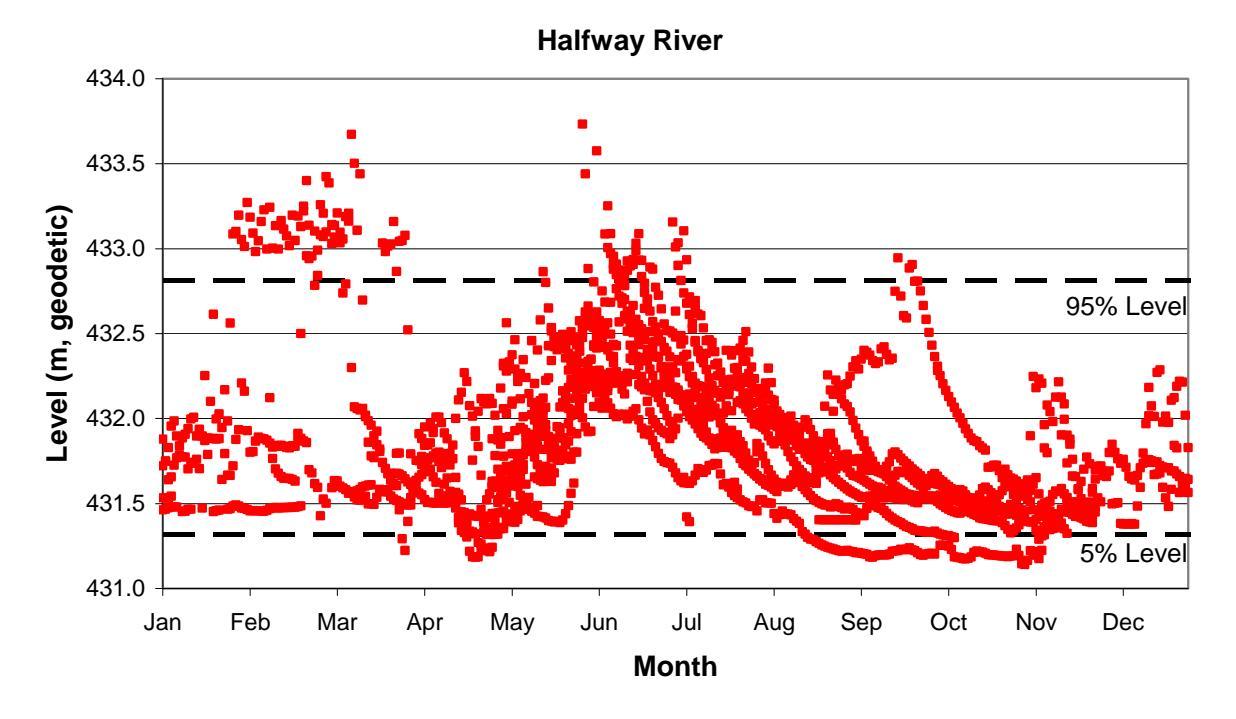
Figure 4.1: Water Surface Elevations at Halfway River

Design elevations are based on the water levels provided by BC Hydro and obtained from the Environment Canada web site, for the Halfway River gauging station. These water levels are quoted relative to an arbitrary datum. Moffatt & Nichol has converted these measurements to geodetic datum based on the water surface measured during the site visits and the real-time water surface elevations provided by BC Hydro. These conversions should be considered approximate (accuracy 0.2 m at best).

Based on these measurements, Figure 4.1 shows the annual variability in water level at the Halfway River site.

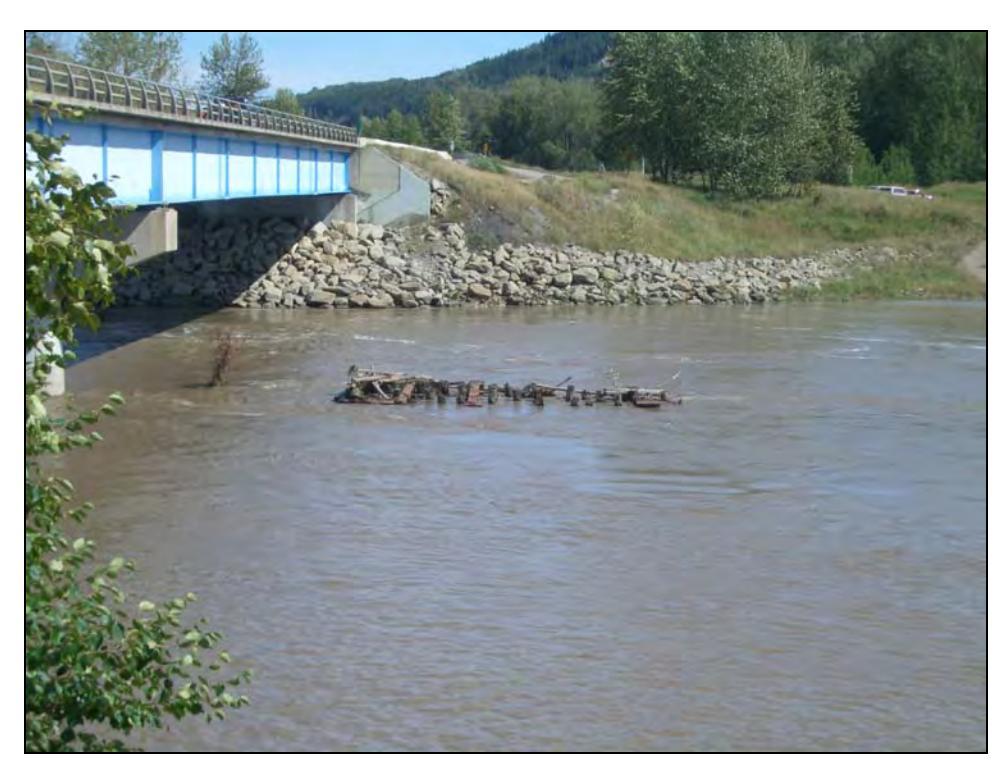
Photo No. 5: Taken on 8-25-2008 at Halfway River, Existing Site by Golder Associates Approach to the (submerged) boat launch ramp; water level is approximately 1 metre lower compared to Photo No. 2.

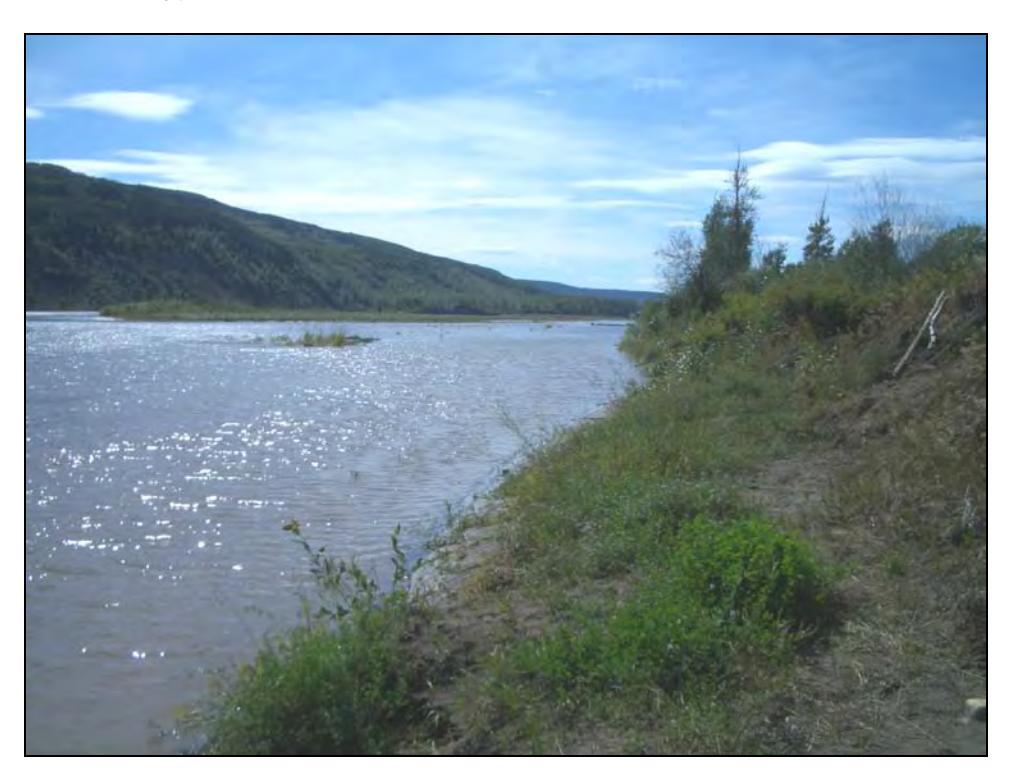
Photo No. 15: Taken on 8-13-2008 at Halfway River, West Bank Site Typical condition of the soft bank at the West Bank site.

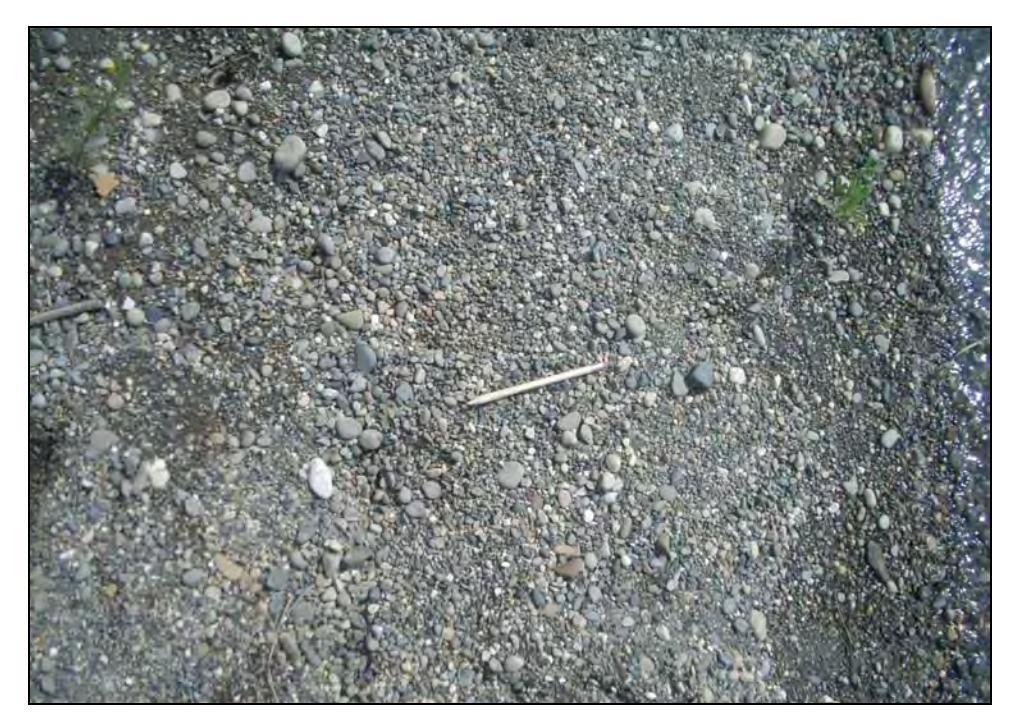
Photo No. 21: Taken on 8-13-2008 at Peace River Typical bluff condition at Peace River site.

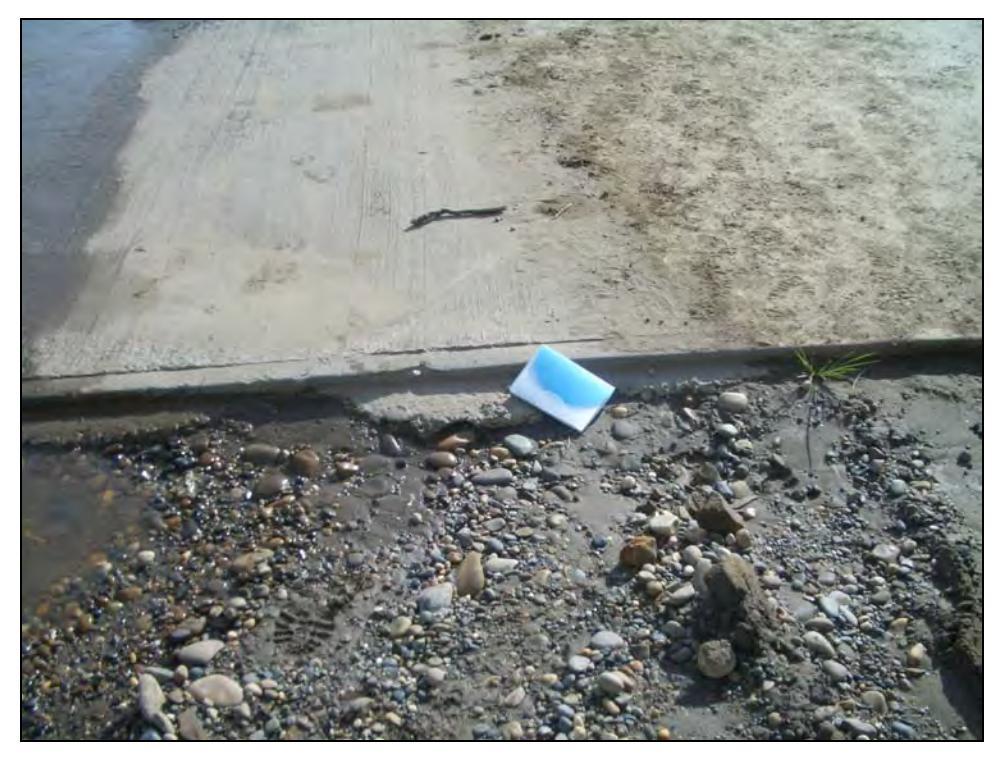
Photo No. 28: Taken on 2008-08-14 at Blackfoot Park View to the east (downstream) including the boat launch ramp. The portion of the concrete exposed at this high water level appears in good condition.

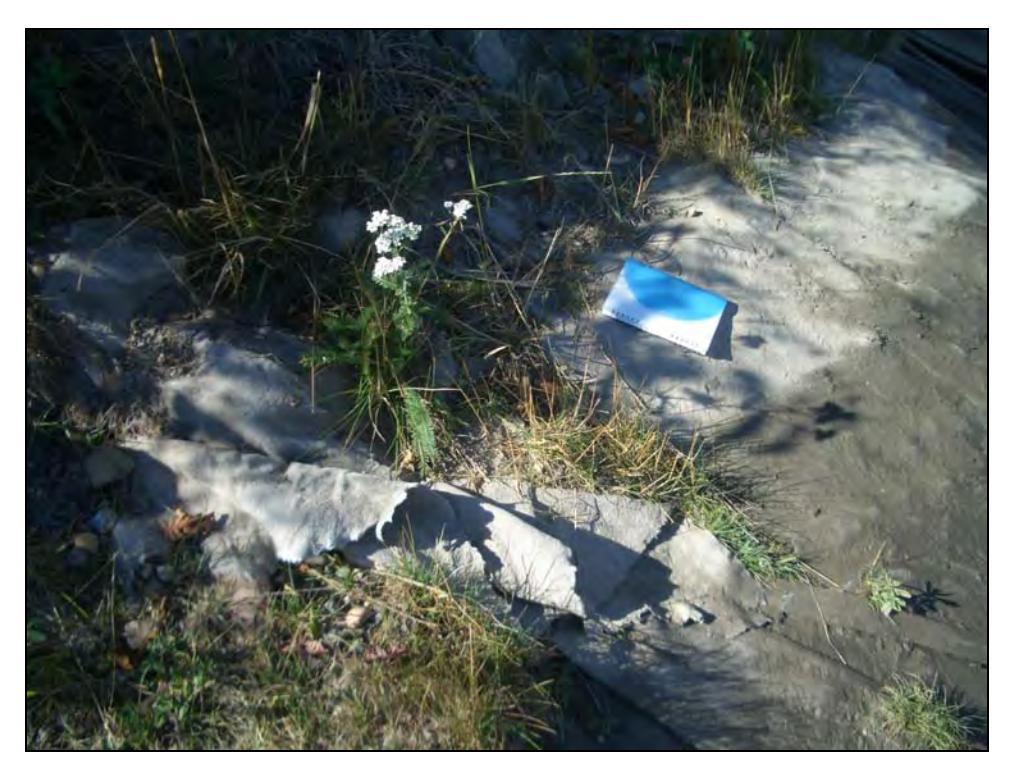
The riprap slope protecting the bridge abutment has lost several rocks, although the remainder of sections of the slope and the exposed geotextile are in good condition: see Photos No. 33 to 36.

Photo No. 35: Taken on 2008-08-14 at Blackfoot Park Lower part of the revetment, with geotextile exposed. Note the exposed roots suggesting the loss of rock is relatively recent or ongoing.

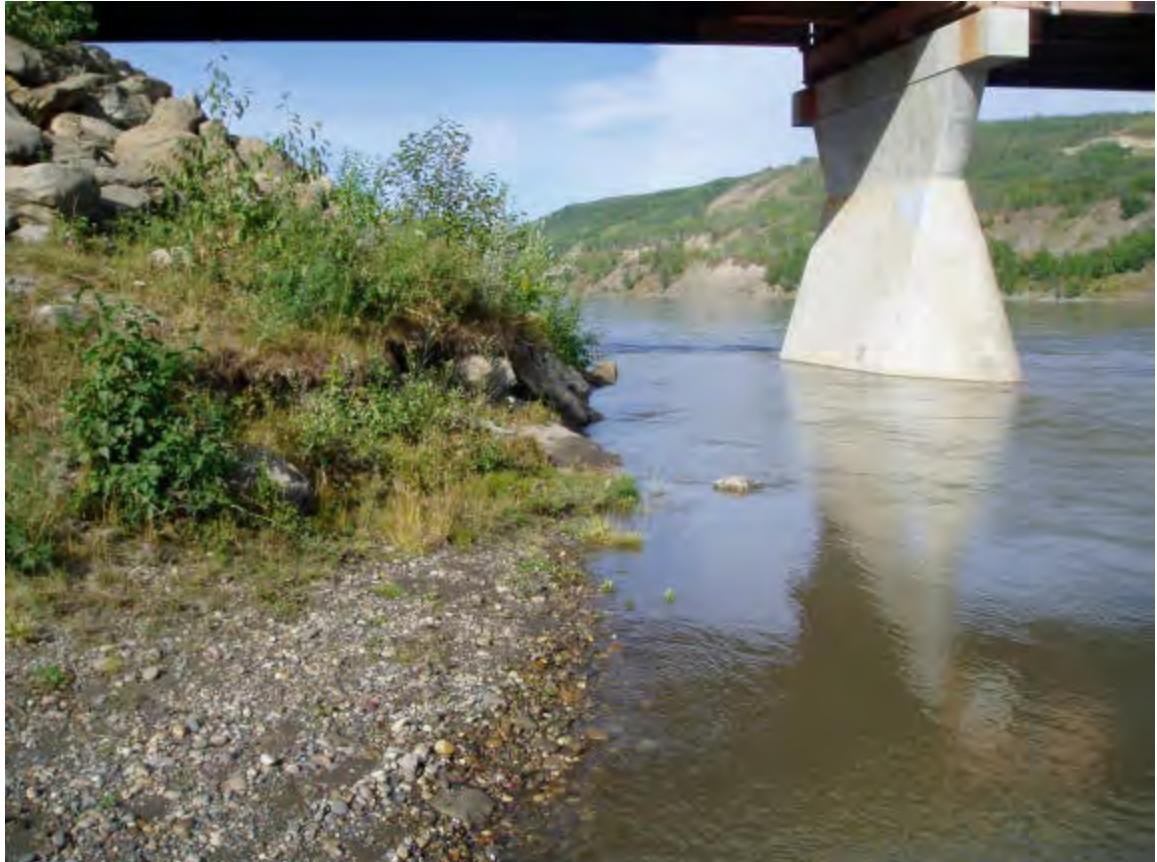
Plate 30. Area of riprap under bridge that needs additional scour protection.
