***LOWER MAINLAND BCH
HABITAT RESTORATION
2000-2001***

Conference Centre Marsh: "Moody's Channel Side Pond Complexes, Phase II"

Cheakamus River Off-Channel Rehabilitation 2000-2001

M. Foy, Biologist; H. Beardmore, Engineer; J. Neri, EIT
Resource Restoration Group, Habitat Enhancement Branch
Lower Fraser Area, Pacific Region, Fisheries & Oceans Canada
October, 2000

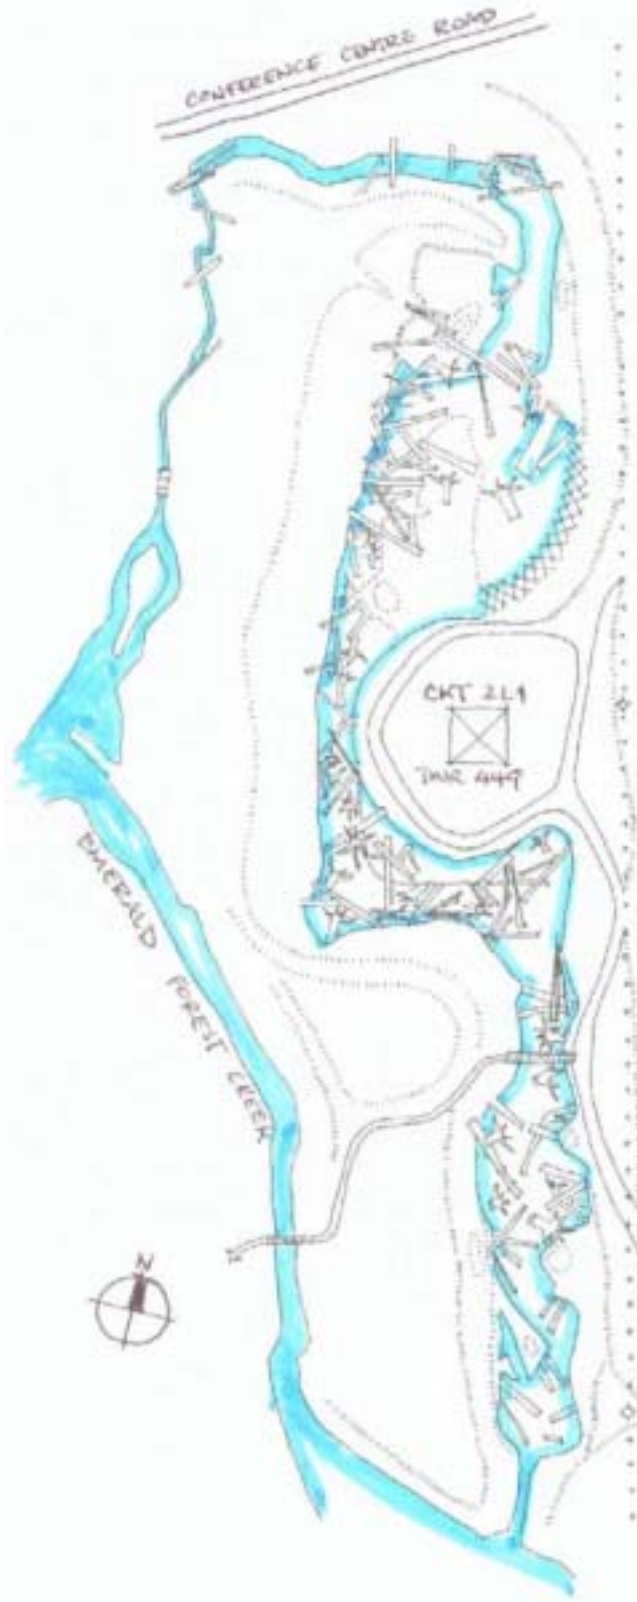
Figure 1. Sketch of the site. (Carl Halvorson, NVOS)

The transmission line roadway enters the site in the northeast corner of the sketch along the top of bank and is shown surrounding the tower.

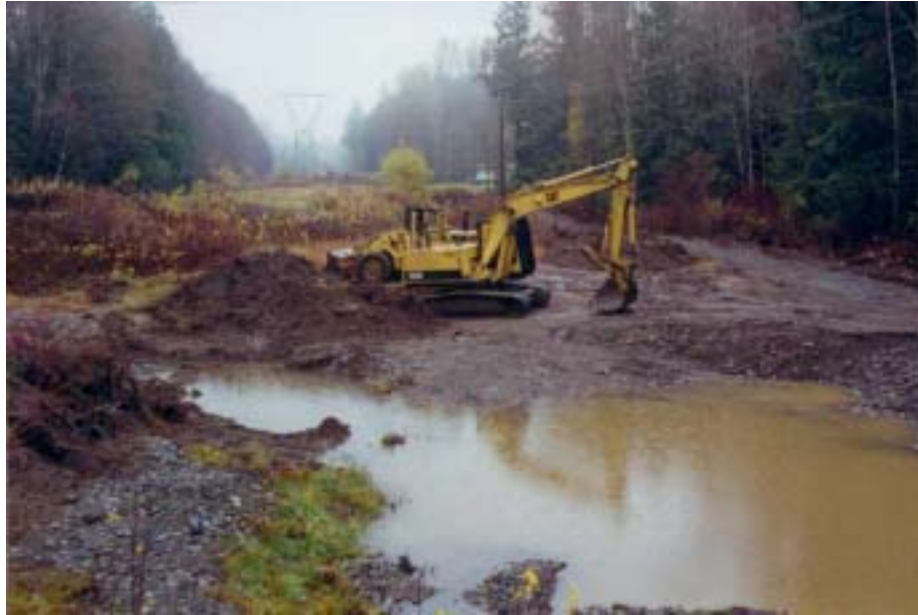
2

Figure 2.
*Beginning of
construction at the
very north end of
the site.*

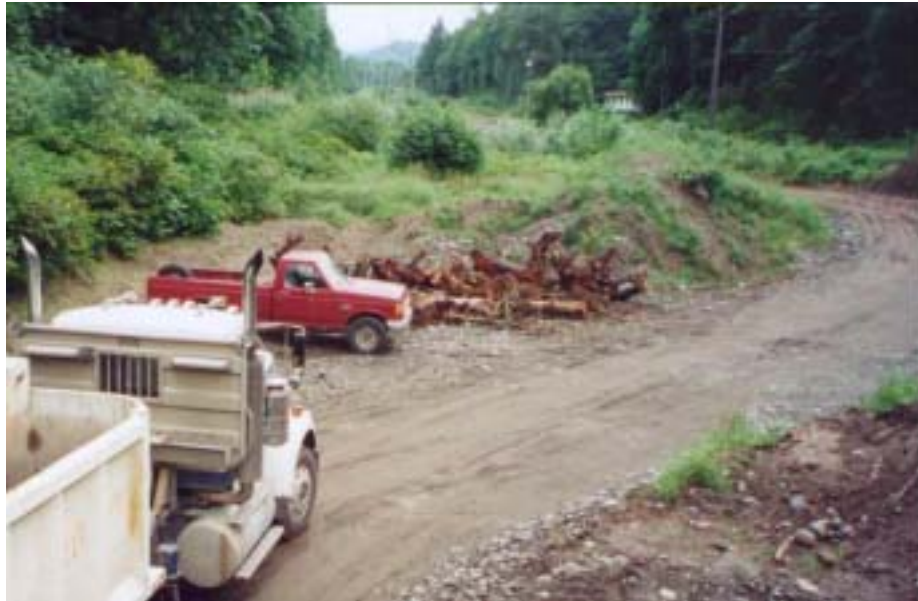
3

Figure 3. *Early in
construction just
north of the
transmission line
tower.*

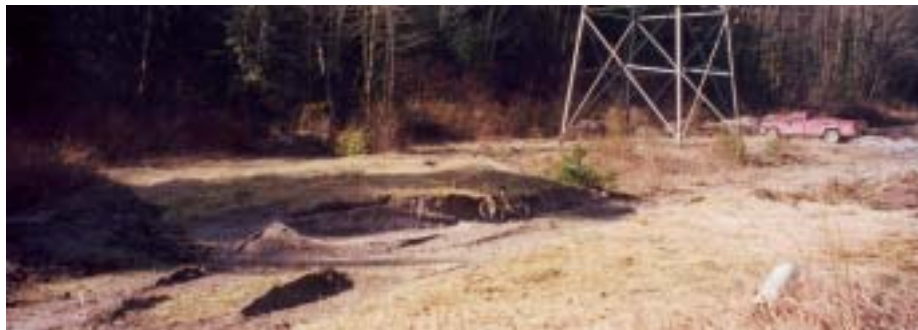
4

Figure 4. *The site
around the base of
the transmission
tower early in
construction.*

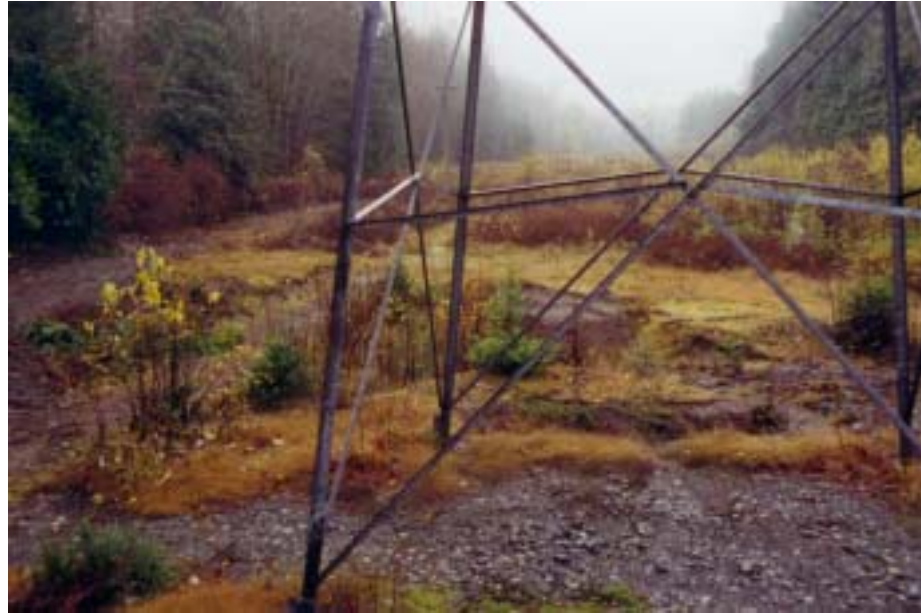
5

Figure 5. A view southward from the transmission line tower early in construction.

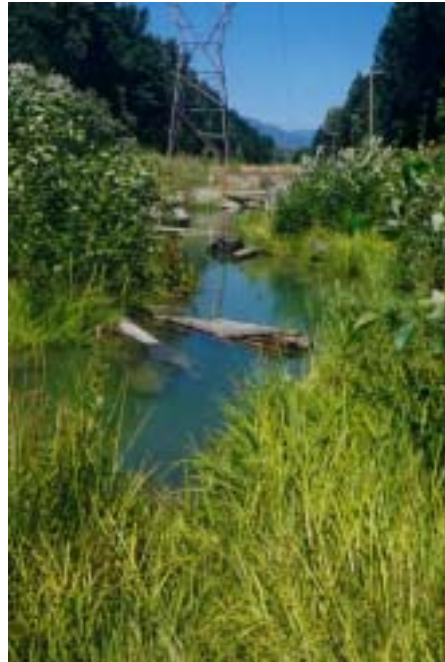
6

Figure 6. The southern-middle quarter of the site, showing the footbridge and the transmission tower.

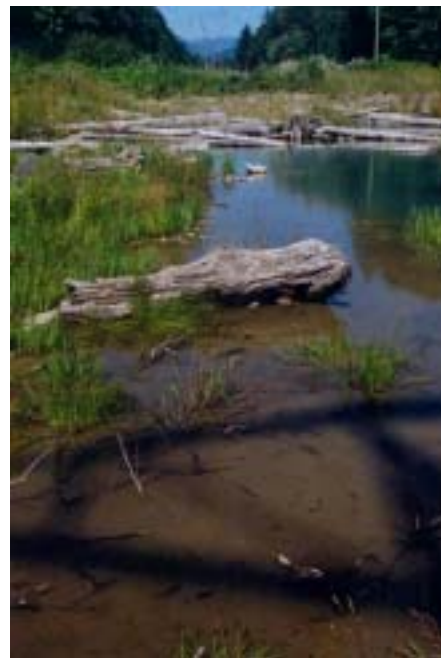
7

Figure 7. The northern portion of the site.

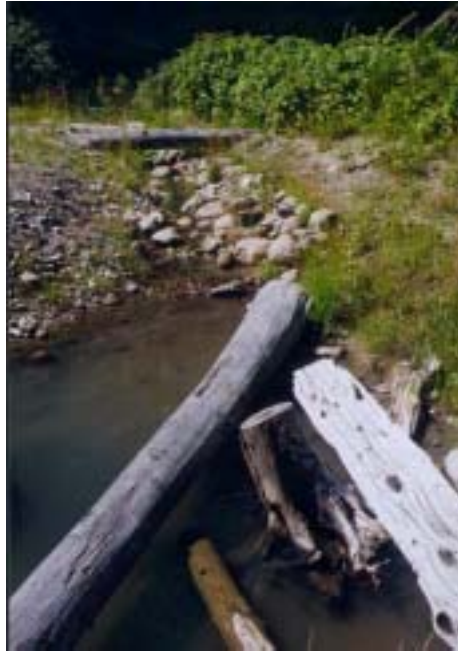
8

Figure 8. The outlet to the marsh of the inlet stream at the north end of the site.

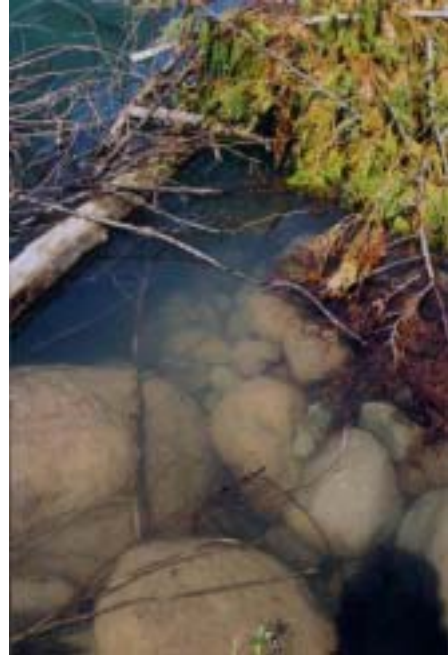
9

Figure 9. A look into the waters of the habitat to see a few young coho.

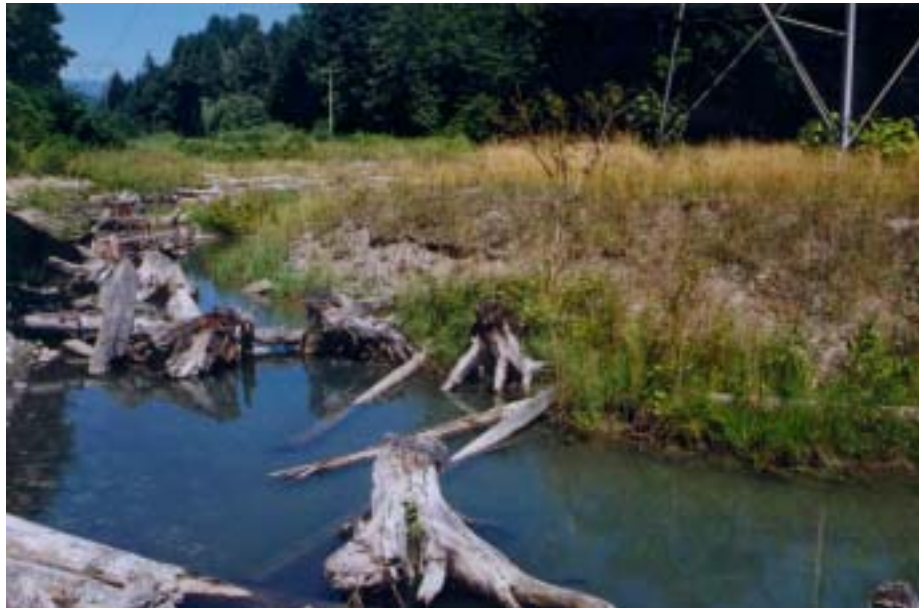
10

Figure 10. The habitat just north of the transmission line tower.

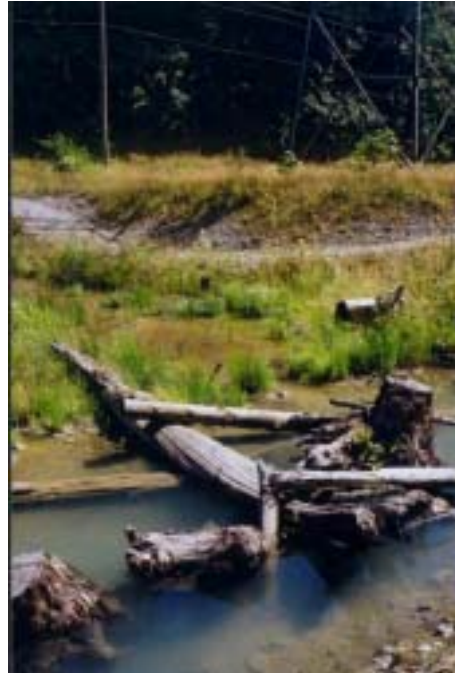
11

Figure 11. The channel and trail connecting the north section with the south alongside the base of the transmission line tower.

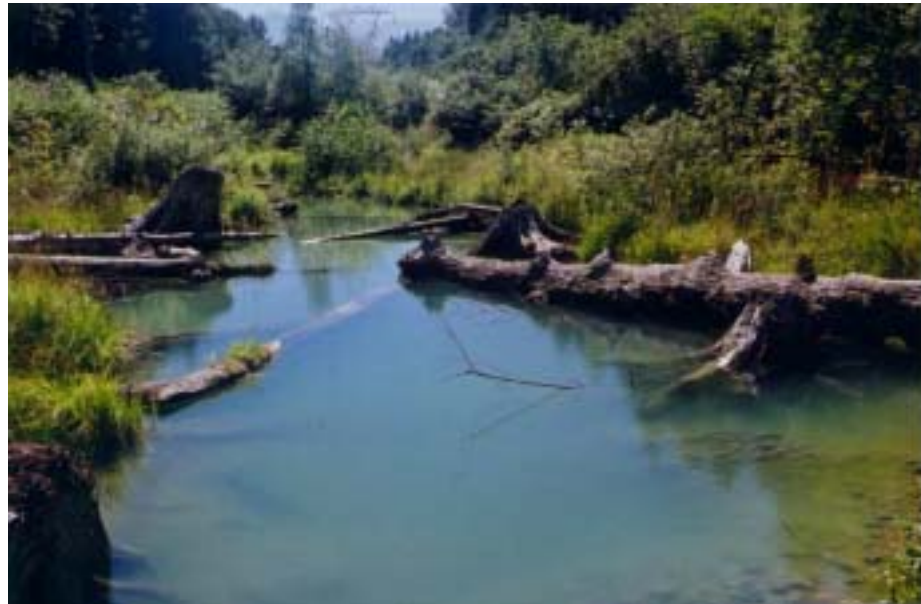
12

Figure 12. The southern outlet of the habitat connecting it to a portion of Emerald Forest Creek that crosses the transmission line right of way.
