# **Jordan River Pink Salmon Incubation Study**

March 31, 2003

**M.C. Wright**

**BC Hydro Bridge Coastal Fish and Wildlife Restoration Program**

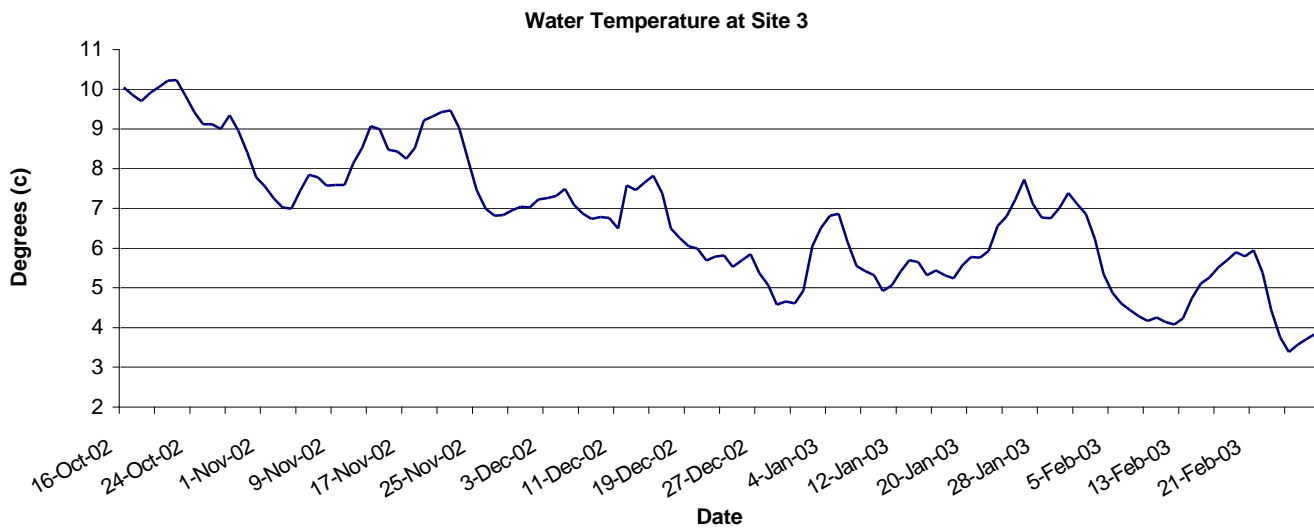
Figure 3. Mean daily water temperature (°C) recorded at three sites on the Jordan River, October 2002 – February 2003.

Intragravel water temperatures at the three incubation sites provided information on accumulated thermal units (ATU's) for predicting stages of development. Data collected with the Hobo Temperature loggers was summarized and data was input into a WinSIRP Excel spreadsheet to determine the time when 50% of the pink eggs would hatch and the approximate time of emergence. Water temperatures were similar for Sites 1 and 3 while Site 2 was slightly warmer by 0.5 to 1.0 degree Celsius (Figure 3). The model predicted that the time to 50 % hatch would be Dec. 9, 2002 and the time of emergence would be approximately Feb. 9, 2003. On December 5 100% of the eggs had hatched in the two cassettes checked. On February 14, 2003 >90% of the fry were buttoned up. Water temperatures at this time were low (approximately 4.0 °C). The remainder of the cassettes were removed on Feb. 28 and >95% of the fry were buttoned up. When fry were released in mid and late Feb., over 80% of the fry immediately swam to the stream bed and wiggled into the substrate, others swam along the surface. Although the fry were buttoned-up in early February, under natural conditions, emergence and migration into the estuary would likely occur later, since timing is strongly influenced by photoperiod (M. Sheng, *pers. comm.*).

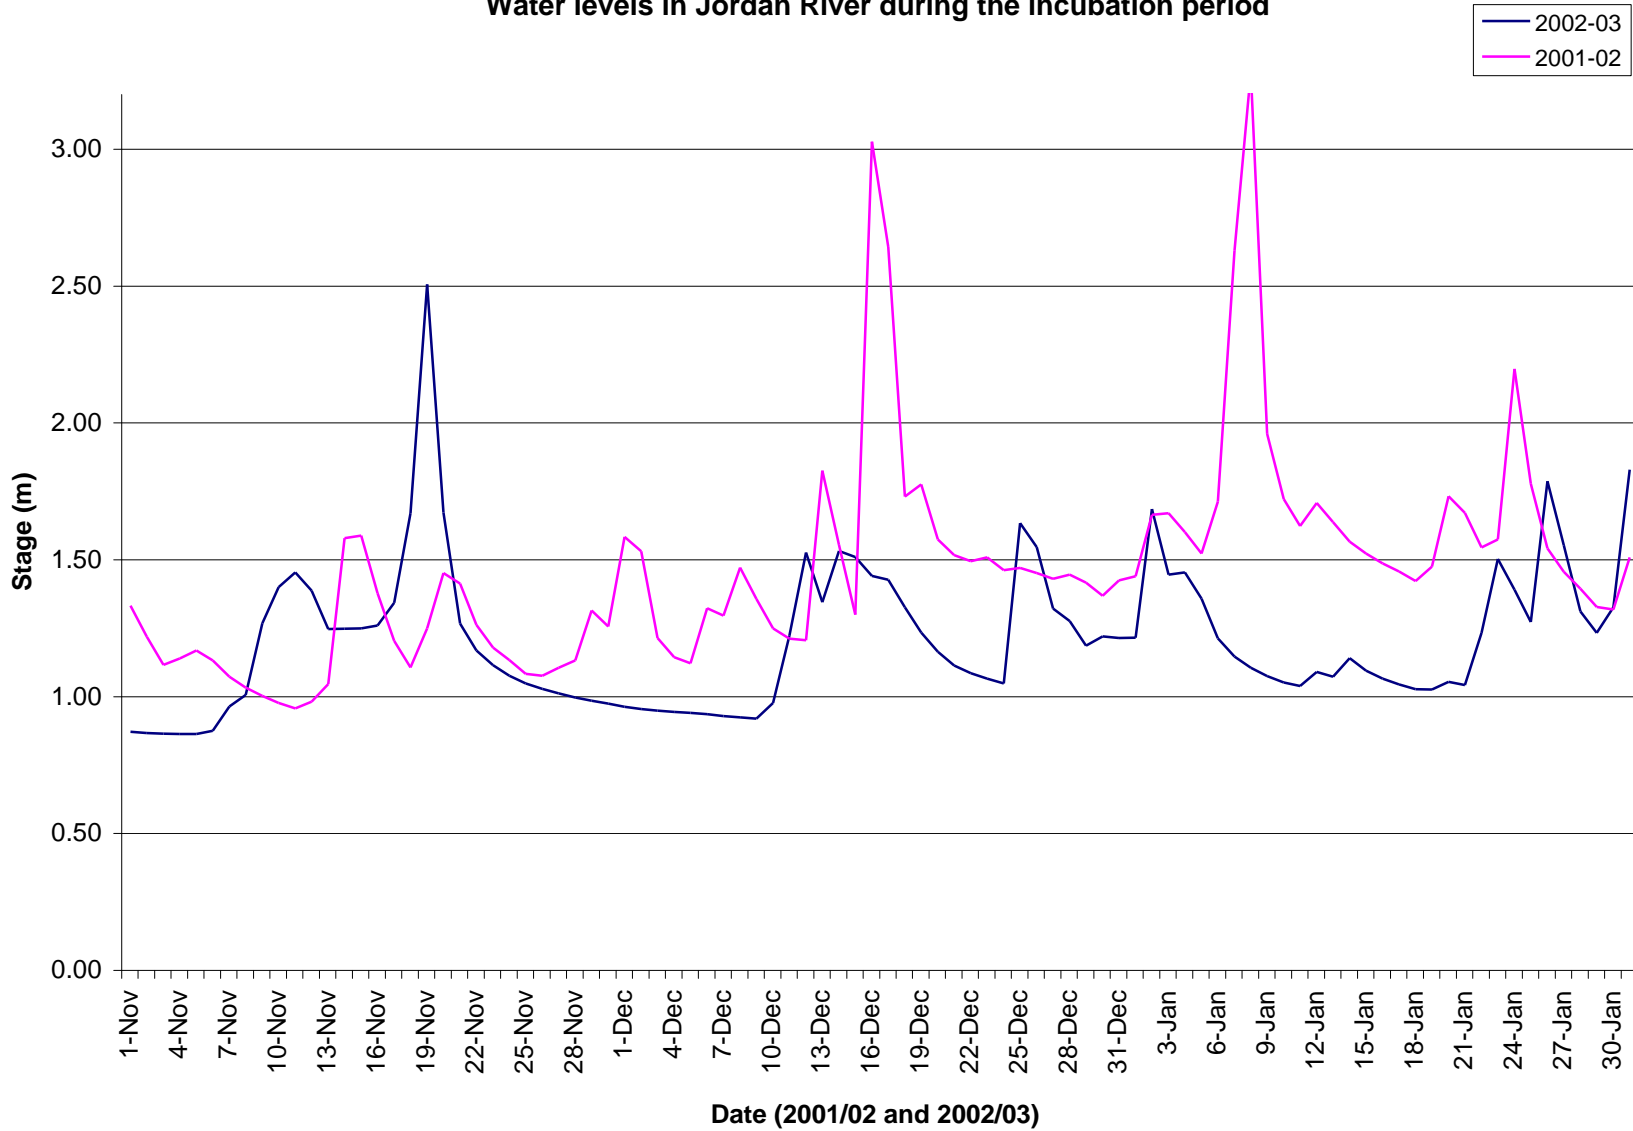
Figure 5. Comparison of water levels in the Jordan River during the pink salmon incubation study (2002/03) to the same period in 2001/02.

Stage information obtained from BC Hydro's gauging station data logger is presented in Figure 4 and Figure 5. Discharge data collected for the lower Jordan River by BC Hydro was not available at the time of reporting. During the 2002 – 2003 incubation period water levels and flow remained low for prolonged periods of time compared to the same period in 2001 – 2002 (Figure 5). Water levels below a stage of 0.94 m provided water velocities that were barely detectable at Sites 1 and 2 (Appendix 2). At Site 3 velocities were significantly higher. The low water velocities at Sites 1 and 2 would lead to low intragravel flow, which would affect the delivery of oxygen to incubating eggs. The higher velocities observed at Site 3 would have provided higher intragravel flow resulting in the higher incubation success observed for that site.

Water levels in the fall and winter of 2001 – 2002 were significantly higher and remained above a stage of 1.2 m. Figure 4 shows a more typical hydrograph for the fall/winter of 2001 – 2002, while the hydrograph for the fall and winter of 2002 - 2003 is more of an anomaly. Regardless, the prolonged low stage observed in 2002 – 2003 contributed to the lower than expected survivals at Sites 1 and 2.

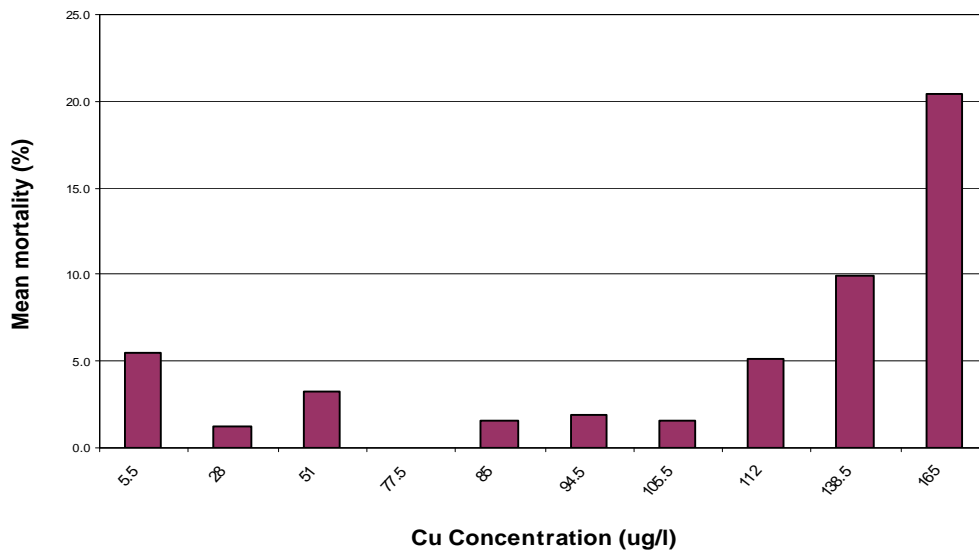
Figure 6. Mean mortality (%) observed for varying copper concentrations used in the Jordan River pink salmon bioassay.

Mortality of pink fry during the 96 hr bioassay ranged from 0 to 20.5 %, with the greatest mortality exhibited in fry exposed to 165 µg/l copper (Figure 6 and Appendix 4). Although the results from the 96 hr copper toxicity bioassay indicate an increasing mortality of pink salmon fry with exposure to increasing copper concentrations, the bioassay failed to meet the parameters of an LC50 test (the "lethal concentration" of a chemical that kills 50% of the test animals in a given time). Pink mortality did not follow the pattern typical of other LC50 copper bioassays (Figure 7).

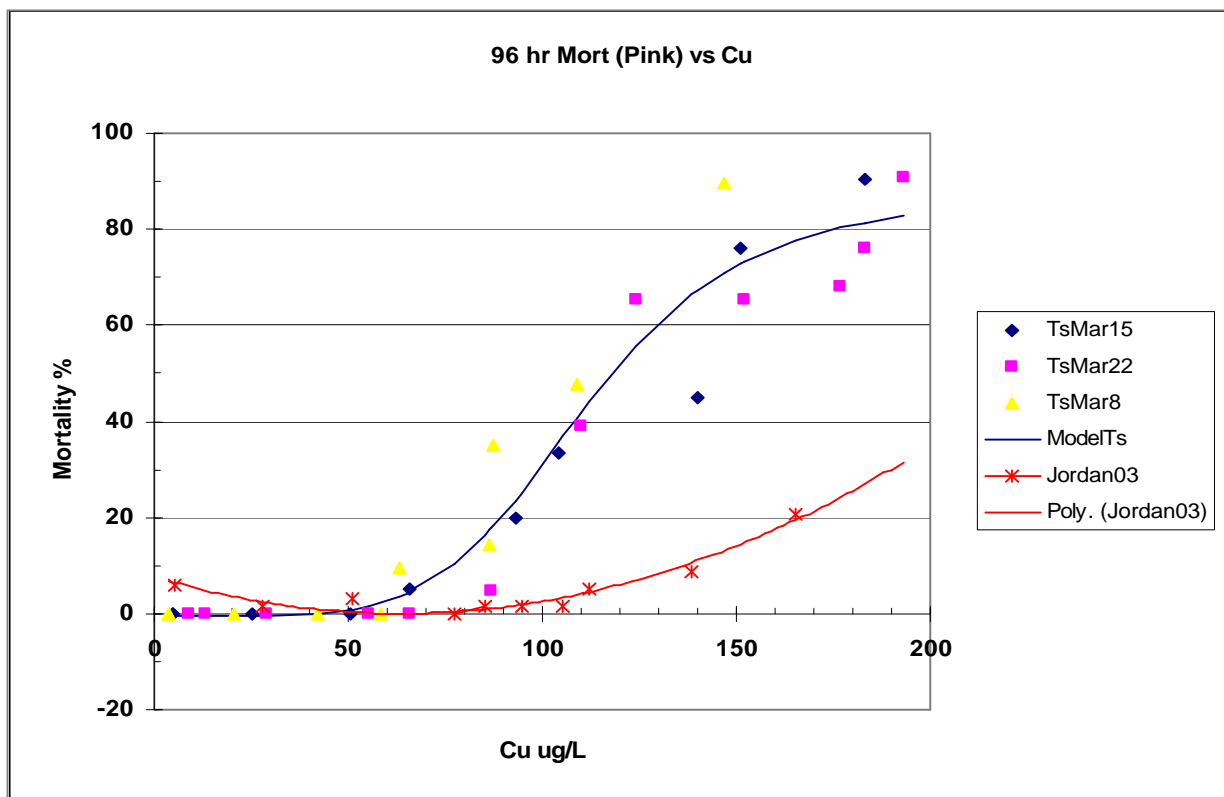
Figure 7. Mortality of pink fry as a function of copper concentration for Tsolum (1999) and Jordan Rivers (2003). The Tsolum least square model is for combined data (Mar. 8, 15, and 22) (Sweeten and McLean, 1999).

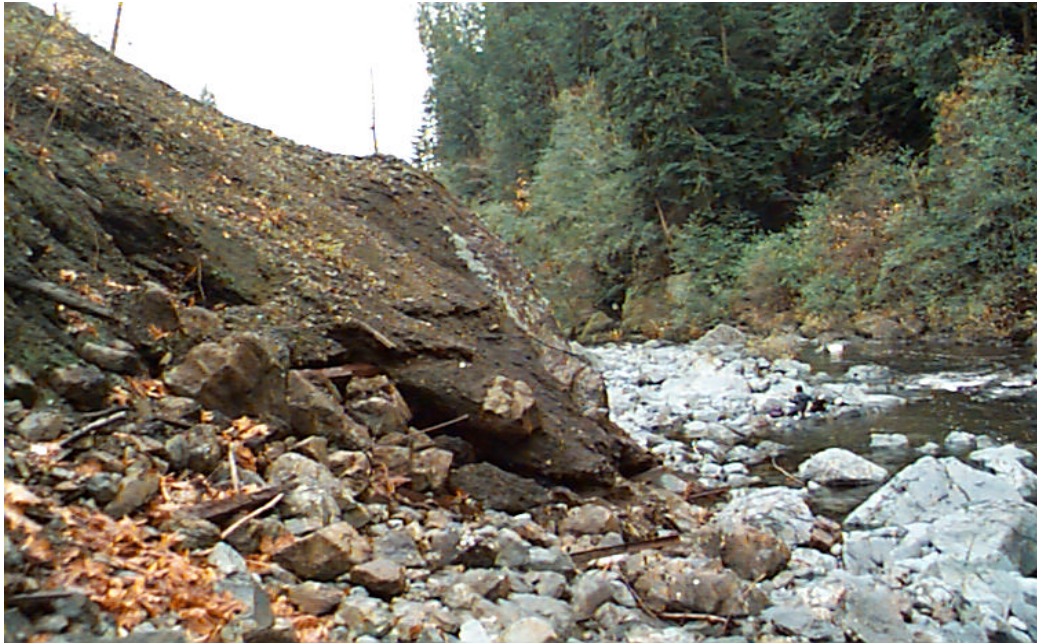
**Plate 1. Photograph looking downstream from the left bank at Site 3 on the Jordan River. Note mine tailings on the left bank.**

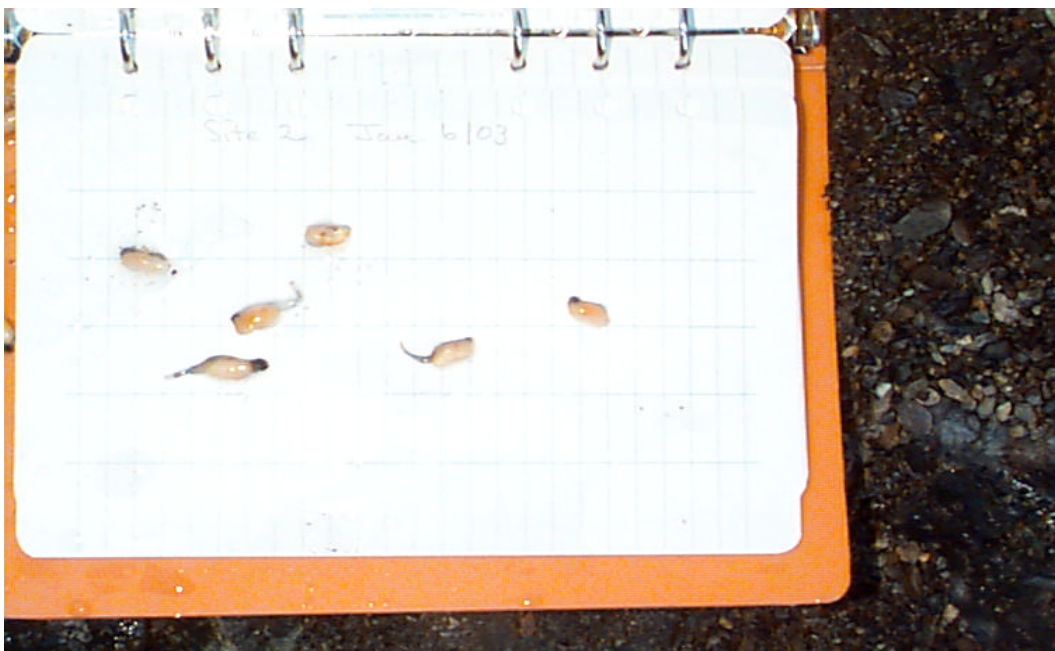
**Plate 4. Dead alevins removed from an incubation cassette at Site 2 on January 6, 2003.**

The results of the study show that incubation success was low for Sites 1 and 2, with Site 2 having the lowest survival (Table 1). At Sites 1 and 2, mean survival was 15.0% (range: 2.0 – 35.5) and 8.0% (range: 0.0 – 20.5) respectively. The majority of the mortality at Sites 1 and 2 was at hatch. Mean mortality at hatch for Sites 1 and 2 was 65% (range: 37 – 97) and 57% (range: 10 – 84). Egg to fry survival at Site 3 was high with a mean survival of 87.0% (range: 43.0 – 99.0). Plates 2 and 3 are examples of incubation cassettes checked on January 6, 2003. Plate 4 shows dead alevins.

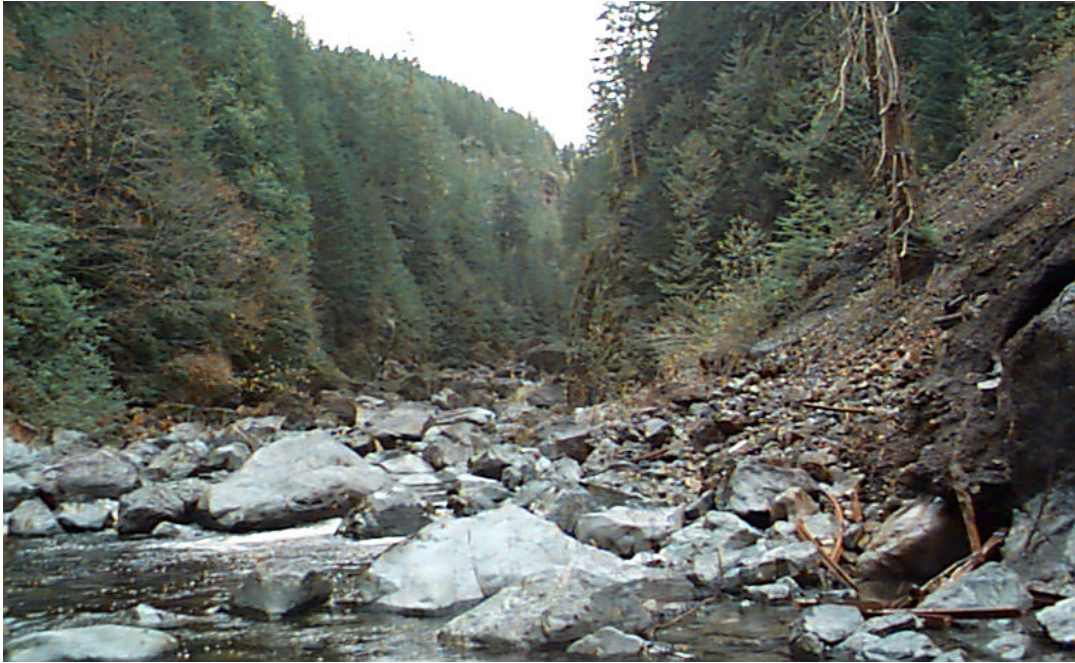
**Plate 5. Looking upstream from Site 3 at the Jordan River. Spawning substrate was limited to isolated patches interspersed throughout the boulder substrate.**

low. Both the quantity and quality of spawning and rearing habitat limit fish production in the Jordan River. In most areas spawning substrate is limited to isolated patches dispersed amongst large boulders (Plate 5).
