Coquitlam-Buntzen Water Use Plan

Reference: COQMON #2

Coquitlam River Rampdown Fish Stranding Monitoring

Implementation Year 14

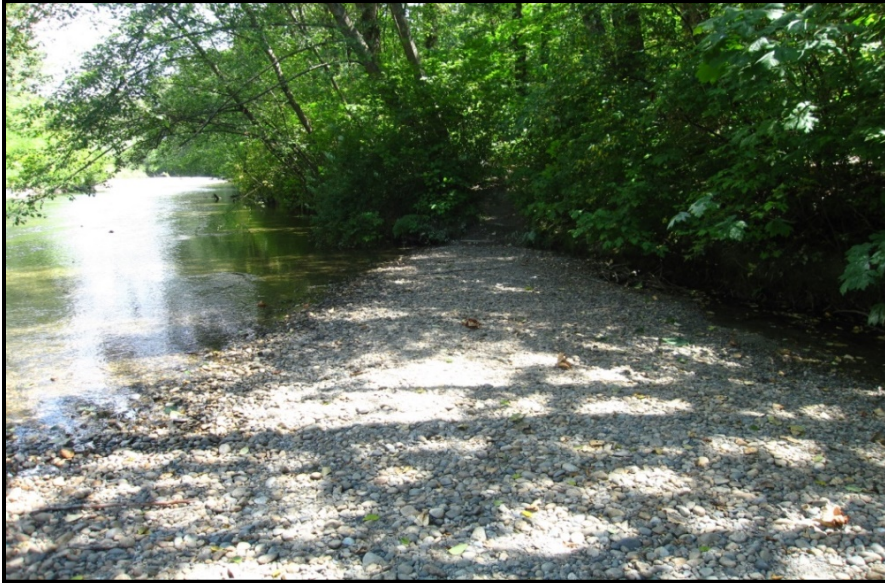
Figure 6 Site A1 showing gravel bar separating river mainstem (left) with isolated pool (right), following rampdown June 1 2012.

Site A1: This area is characterized by dense tree and shrub riparian river margins that contain many depressions that form isolated pools. The substrate is mainly sand/silt and vegetated cover, along with some areas of exposed gravel and cobble.

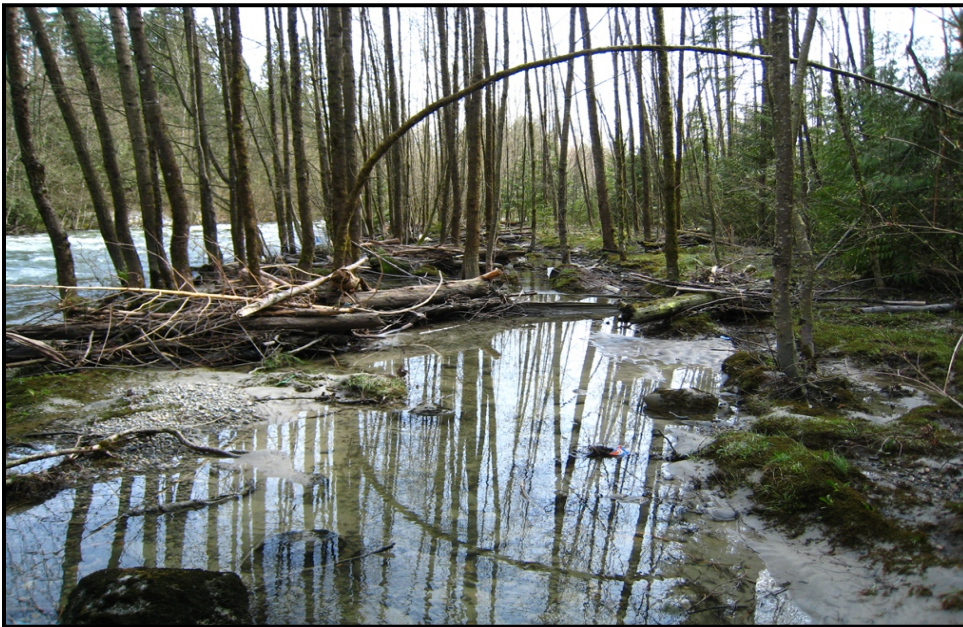
Figure 9 Site B2, showing isolated pool formed during flow reduction, this site strands juveniles, adults and redds. Substrate is primarily sand/silt.

becomes inundated during a full 3 LLO release, and is one of the earliest sites to begin dewatering during.

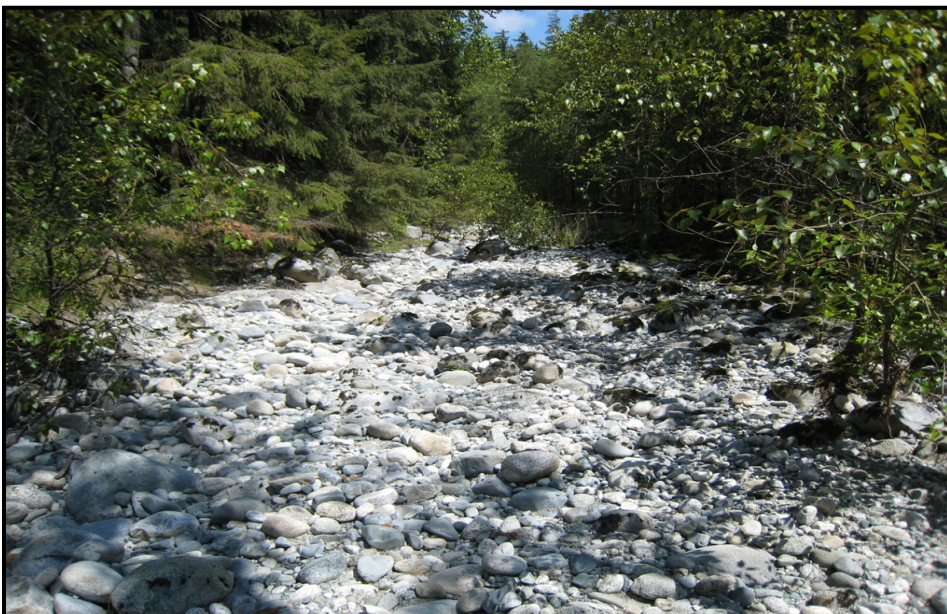
Figure 10 View of site C1 side channel that is wetted during single gate openings. This site typically has one of the highest incidences of stranding on the Coquitlam River.

Site C1: This site is a long side channel composed of gravel and cobble substrate. It drains rapidly and forms many isolated pools that do not retain water well. This site experienced the highest number of stranding during the past two years.

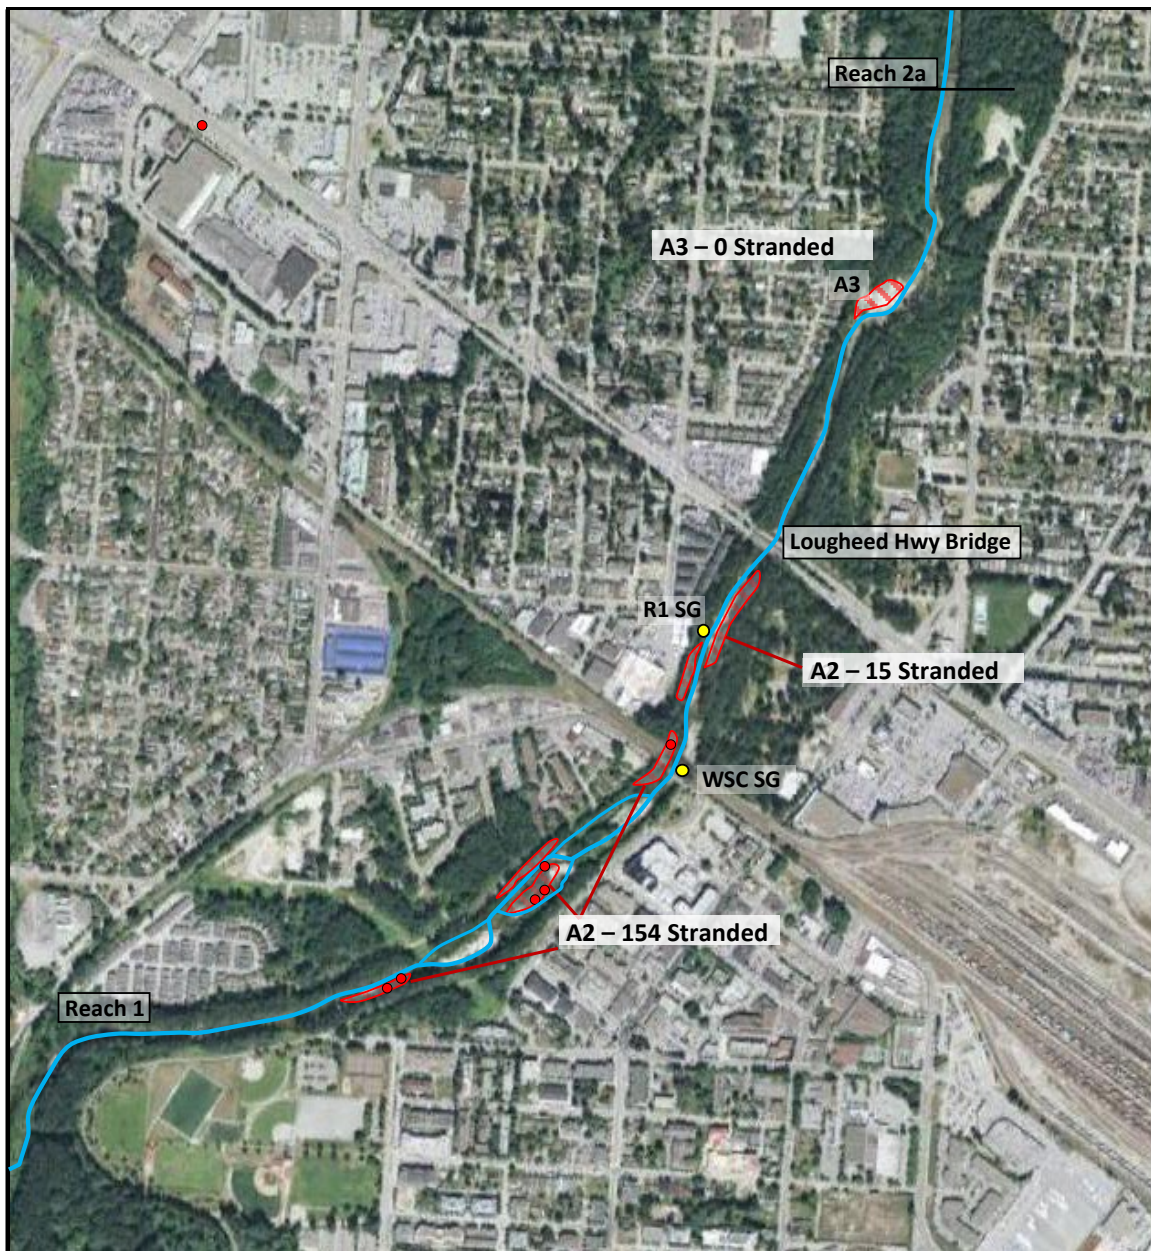
Figure E

Coquitlam River Stranding, Site A, Reach 1.
