Columbia River Project Water Use Plan

Mica Tailrace Fish Indexing Study

Annual Report – Year 4

Reference: CLBMON-60

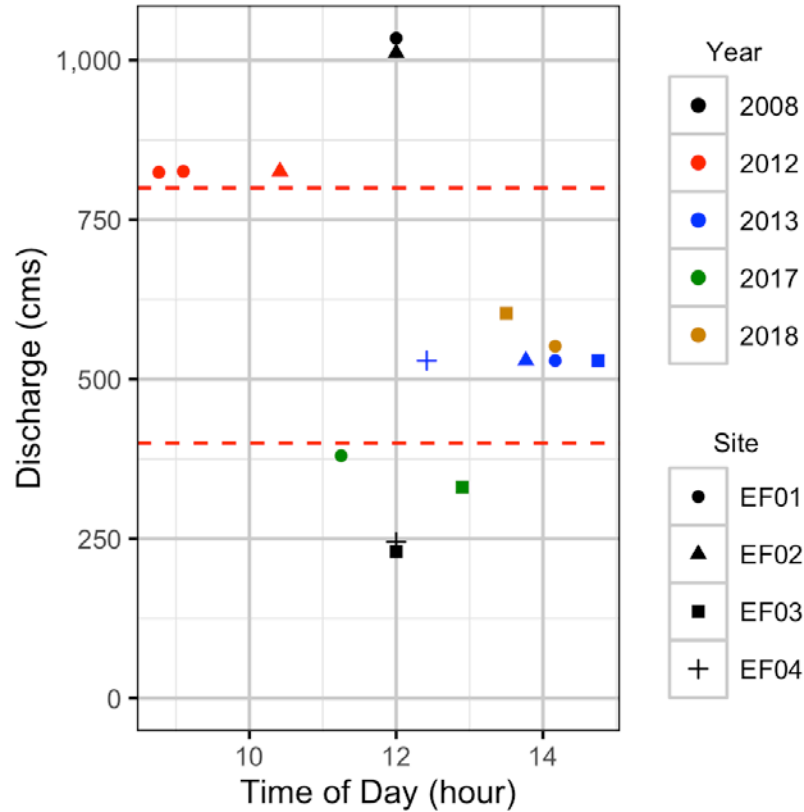
Figure 6. Mean discharge for the period three hours before and during each backpack visit.

Annual discharge from Mica Dam for 2008 to 2018 is summarized in Figure 4. Additional turbines, Mica 5 and 6 became operational on January 28th, 2015 and December 22nd, 2015, respectively. Boat electrofishing occurred over a range of flows (Figure 5). Generally, sampling was conducted within the desired range (400-800 m³/s); however, unexpectedly high flows (~1,300 m³/s) were encountered during the capture sessions at sites EF01, ES03 and ES04. Backpack electrofishing, in both 2017 and 2018, was attempted at flows within the target range (Figure 6).

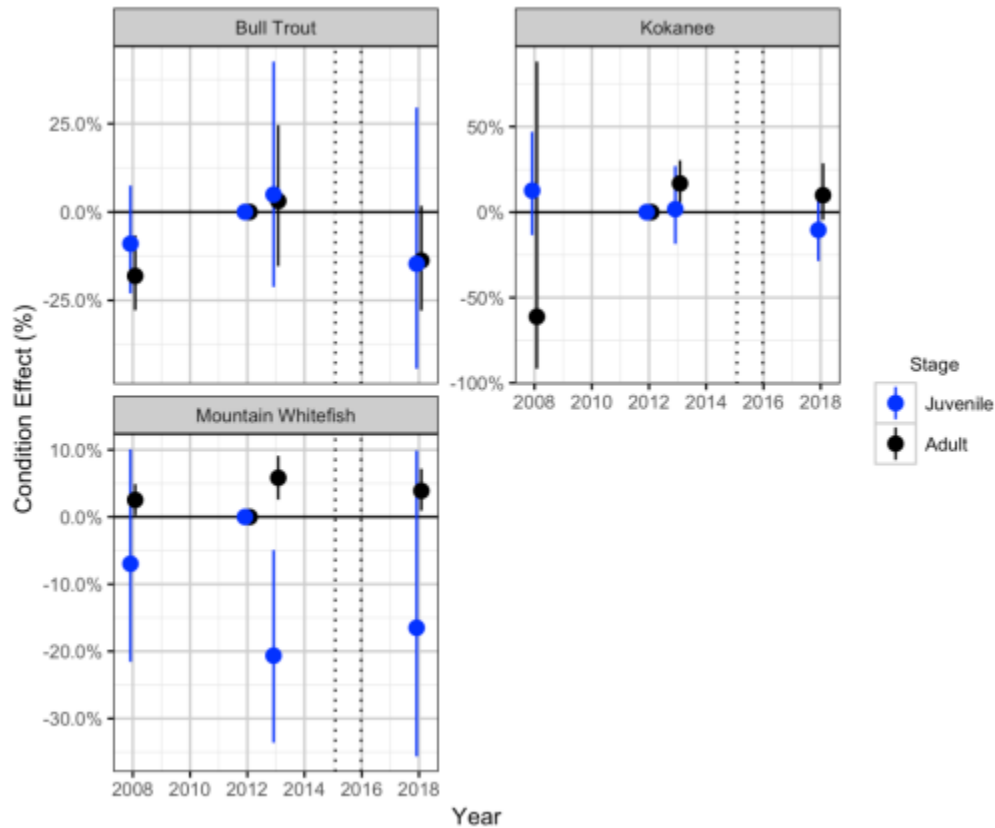
Figure 9. Expected percent change in body condition with respect to 2012 (with 95% CRIs).

The body condition of BT and MW was assessed with respect to their percent change in weight for a typical fish within a size class as compared to 2012 condition values. A typical fish for the small size class was 300 mm for BT, 80 mm for MW and 80 mm for KO. A typical fish for the large size class was 600 mm for BT, 250 mm for MW and 250 mm for KO. Figure 9 presents fish body condition for each sampling year compared to the first year of the program (2012). In 2018, a small decrease in body condition was observed for BT for both small and large fish. KO juveniles were smaller than in 2012, while the juveniles

The annual variation in fish body conditions was generally low across all fish species (Figure 9). Body condition of Bull Trout decreased compared to 2012, but was not significantly different.

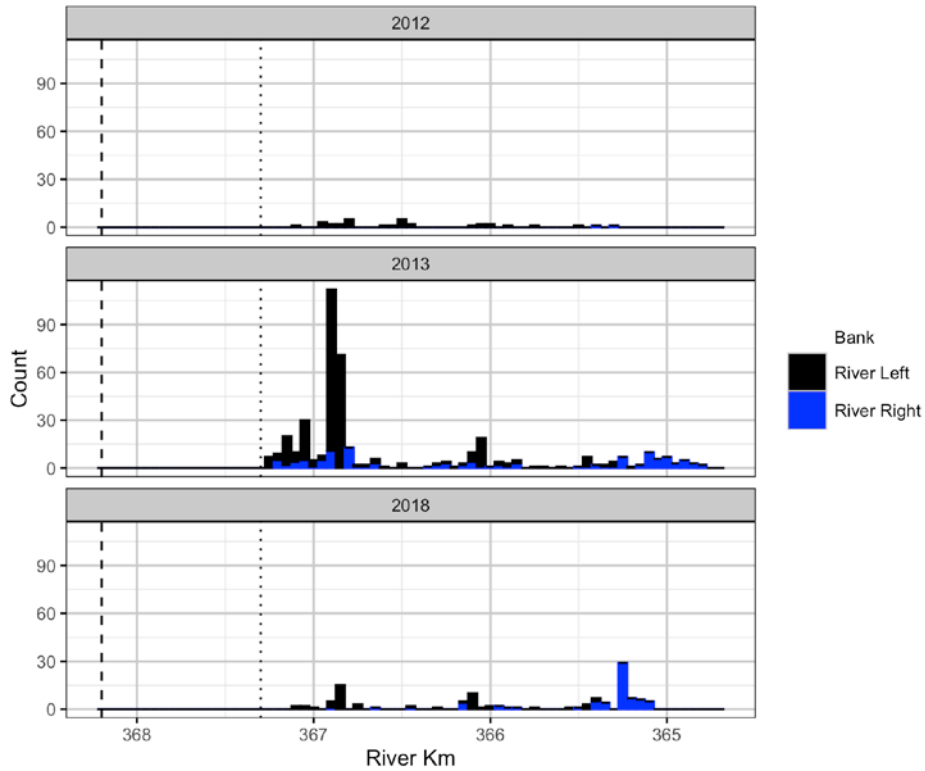
Figure 10. Boat counts by river km and bank for adult Bull Trout. Mica Dam is indicated by the vertical dashed line and the log boom by the vertical dotted line.

Figure 11. Boat counts by river km and bank for adult Kokanee. Mica Dam is indicated by the vertical dashed line and the log boom by the vertical dotted line.

Figure 12. Boat counts by river km and bank for adult Mountain Whitefish.

Figure 13. Boat counts by river km and bank for juvenile Mountain Whitefish. Mica Dam is indicated by the vertical dashed line and the log boom by the vertical dotted line.

Figure 14. Boat counts by river km and bank for adult Rainbow Trout. Mica Dam is indicated by the vertical dashed line and the log boom by the vertical dotted line.

The actual fish counts are plotted by bank, river km and year in Figure 10 to Figure 14. A general pattern of higher counts along the left downstream bank was observed in 2018 in most species. Bull Trout were more evenly distributed between the two banks, although, Bull Trout were only observed on the left bank above river km 366.5 (Figure 10). Kokanee were primarily observed along the left bank, however, the number of observations along the right bank increased below river km 365.5 (about halfway in the area; Figure 11). Adult Mountain Whitefish observations were more numerous along the left bank in all years of the study (Figure 12). The number of observations along both banks increased drastically above river km 366.5 in 2018. Few observations of juvenile Mountain Whitefish (Figure 13) and adult Rainbow Trout (Figure 14) were made in 2018 and the majority were from along the left bank.

Sampling location did not appear to have an impact on the distribution of the fish (Figures 10 to 14 and Appendix 2). With respect to the right and left banks of the tailrace, no specific pattern of fish distribution is evident between pre- and post-operation years. It was noted that adult Bull Trout and adult Mountain Whitefish were more numerous between km 365.5 and 366.5, however, it is unclear what is driving that increase. As this observation was only made in 2018, it is possible that it was a single event and not related to any specific environmental conditions. The results of the 2019 field program may help to verify whether or not this is a pattern under post-operation conditions.

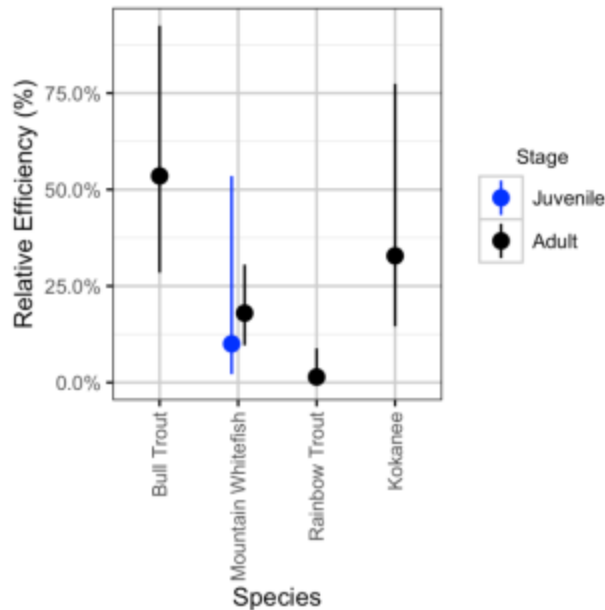
Figure 15. Predicted boat catch to count relative efficiency (with 95% CRI).

The relative abundance model estimated how efficient counting was relative to netting (Figure 15). Overall the netters caught 53% of the observed Bull Trout, 18% of the observed adult Mountain Whitefish, 10% of the observed juvenile Mountain Whitefish, and 33% of the observed Kokanee. Less than 10% of the Rainbow Trout observed were netted.

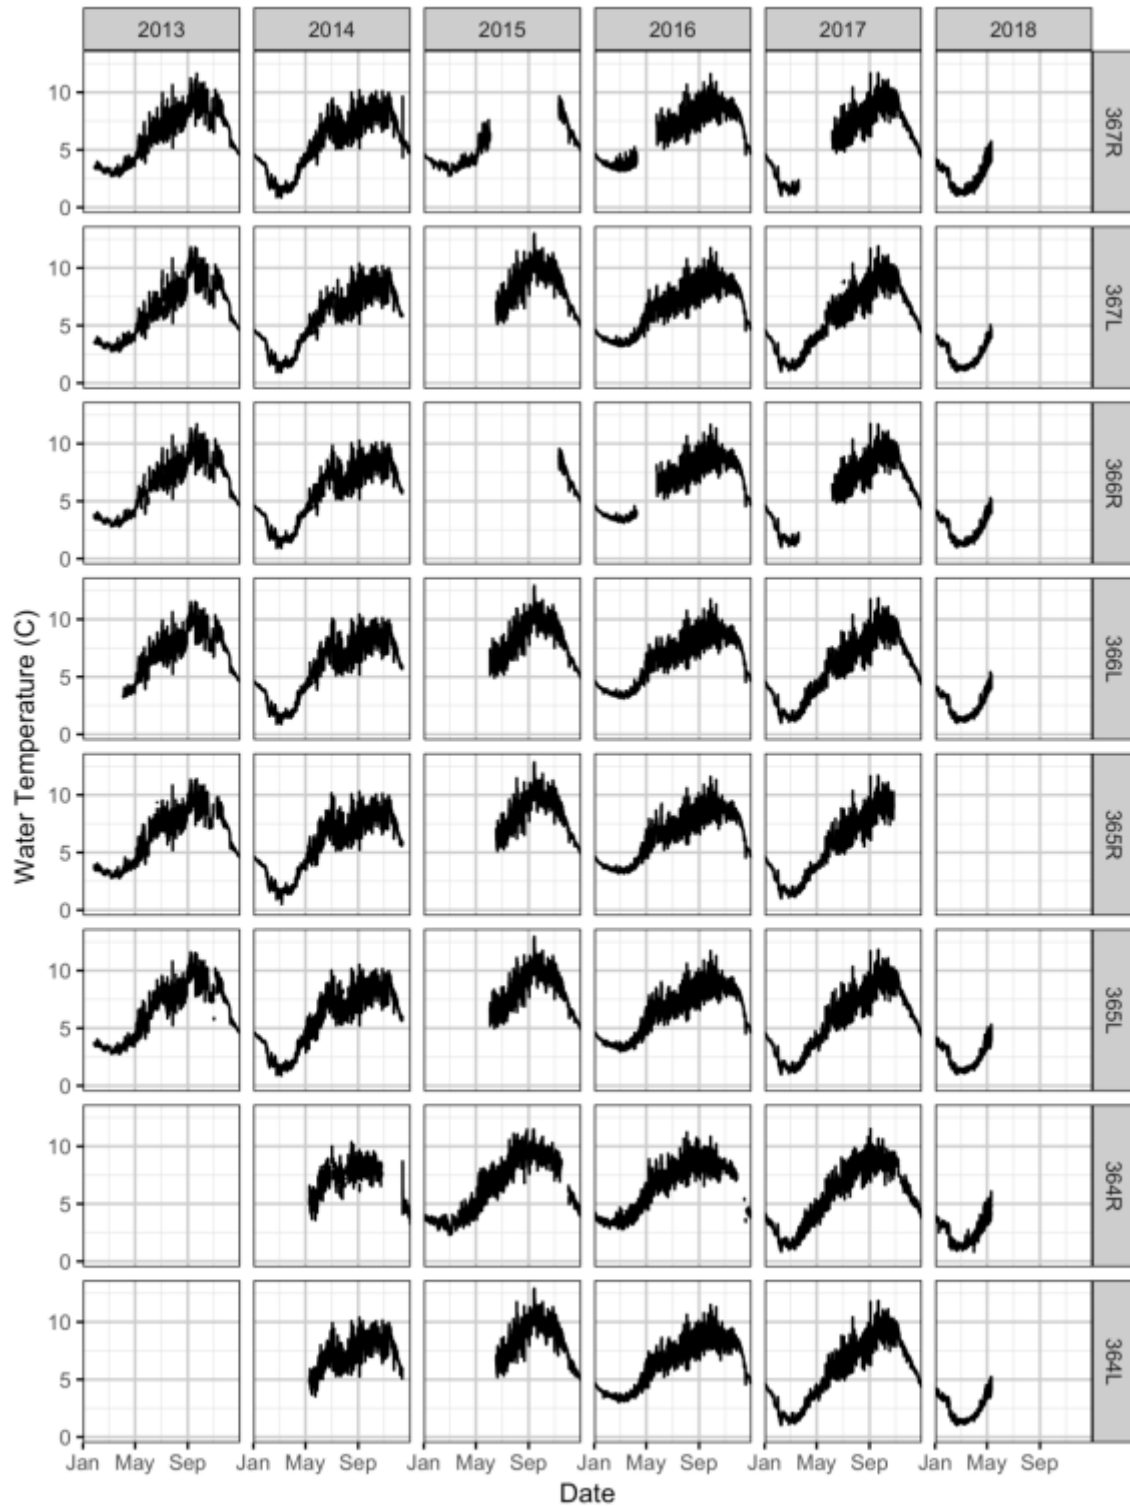
Figure 16. Hourly water temperature in the Mica Dam tailrace by date, year and site.

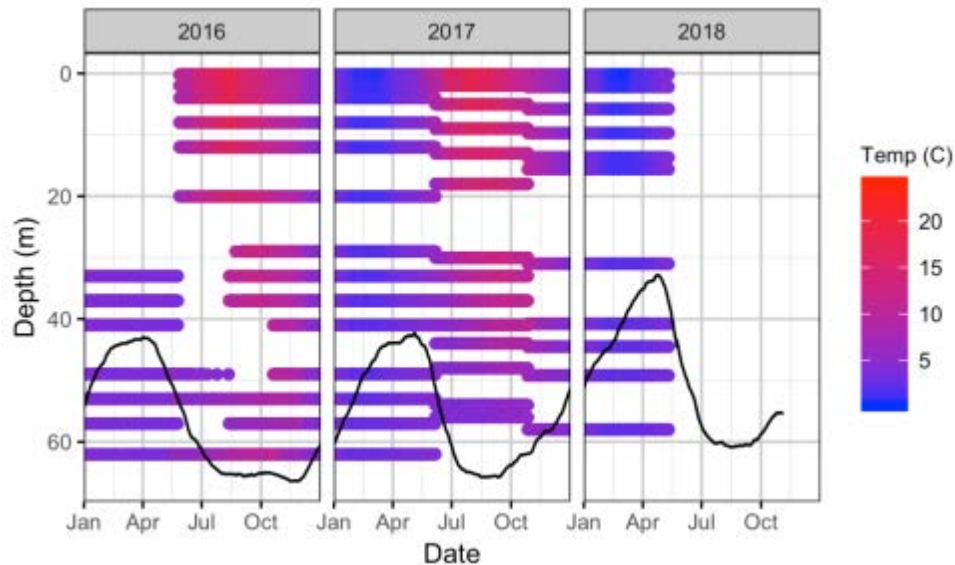
Figure 19. Hourly water temperature in the Mica Dam headpond by date, depth and year. The black line represents the location of the turbine intakes in the water column relative to the vertical arrays.

Water temperature profiles for the headpond from 2016 to 2018 are plotted in Figure 19. A general trend of colder temperatures in the winter and then warming throughout the late summer and early fall is observed across all depths and years. The most recent temperature headpond data has yet to be downloaded. Next year, we will test whether the level of discharge influences the temperature difference between the water at the intake versus that immediately downstream of the dam.

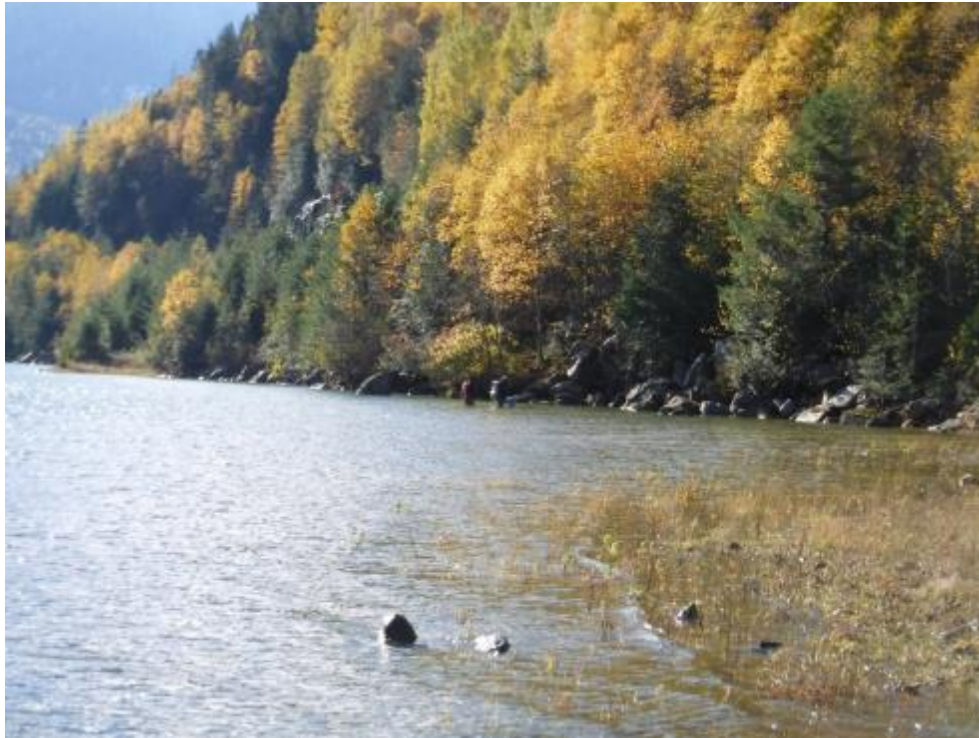
Photograph A.1-1: Backpack electrofishing site EF01.

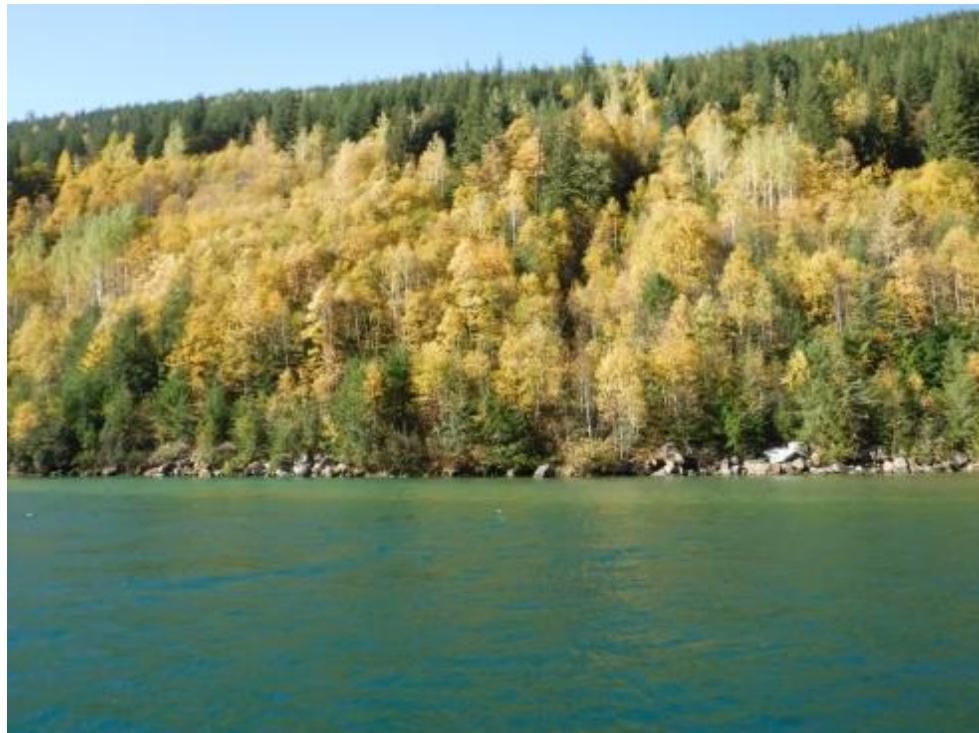
Photograph A.1-2: Backpack electrofishing site EF02. The water was too deep to safely electrofish the site.

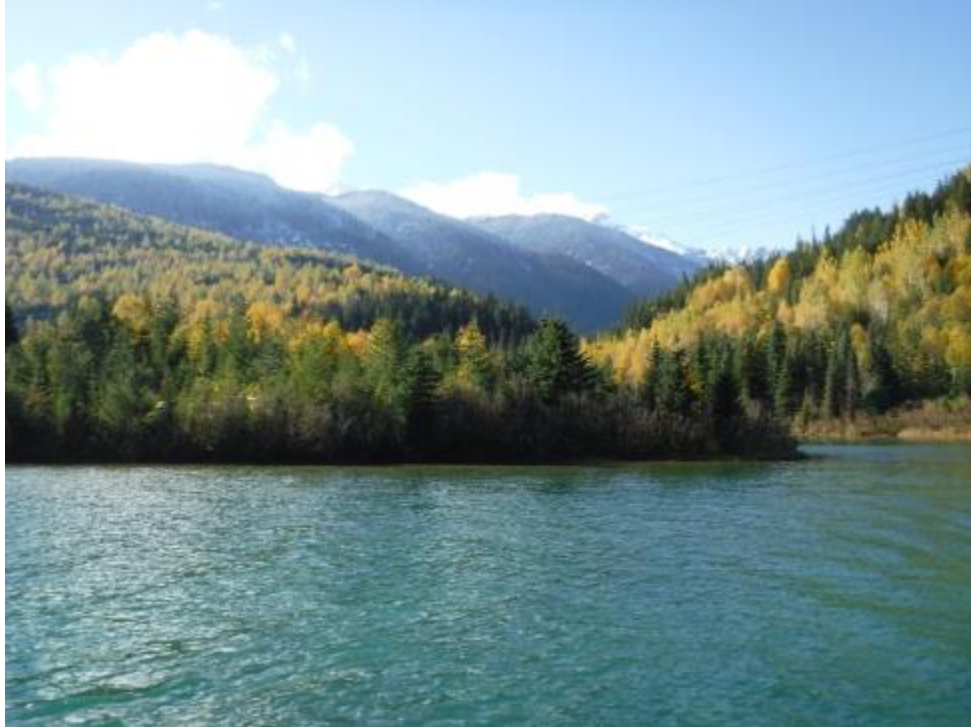
Photograph A.1-3: Backpack electrofishing site EF03. Located slightly downstream of Nagle Creek. The water was too deep to safely electrofish the site.

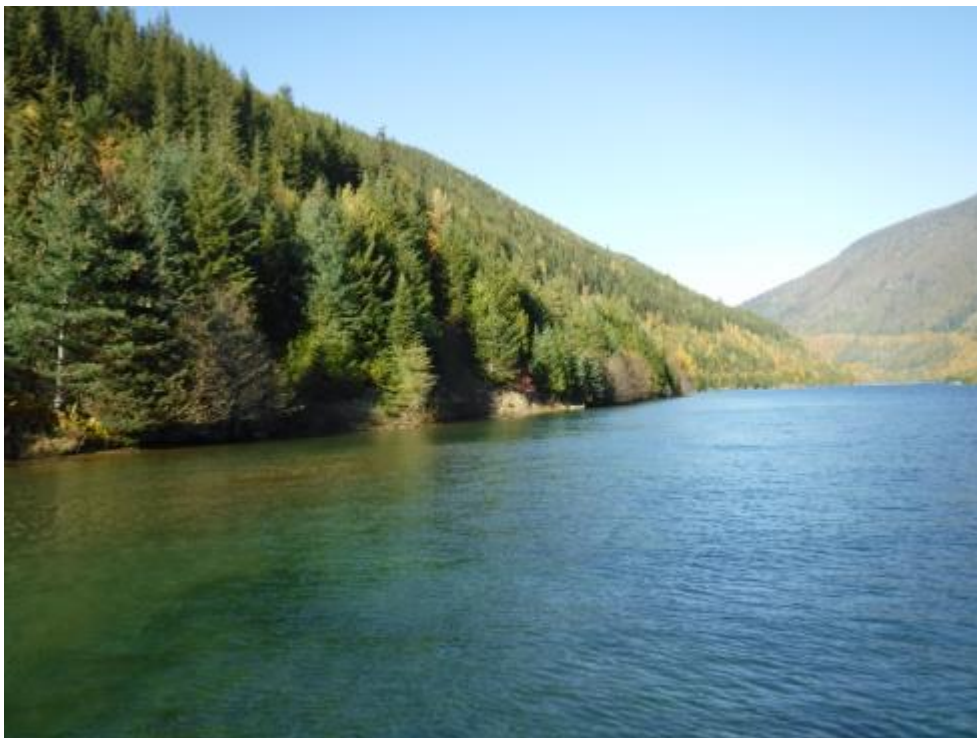
Photograph A.1-4: Alternate backpack electrofishing site for EF03. Located slightly upstream of Nagle Creek. The water was too deep and the bed sediment was too unstable to safely electrofish the site.

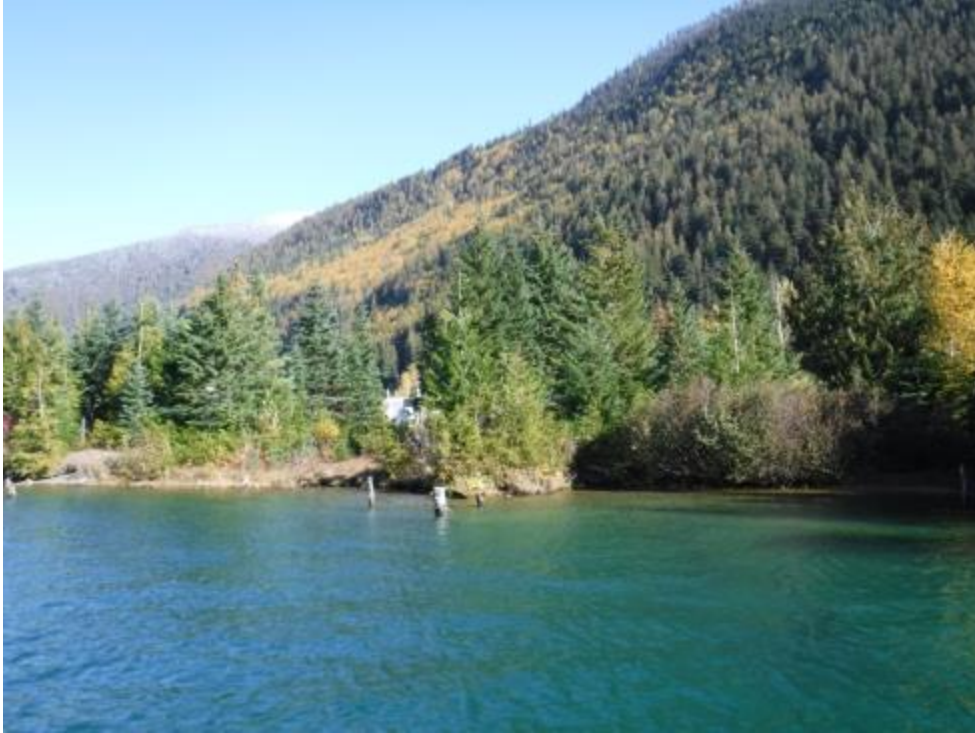
Photograph A.1-5: Backpack electrofishing sites EF04. The site was determined to be unsafe to backpack electrofish due to high water and steep drop-offs.

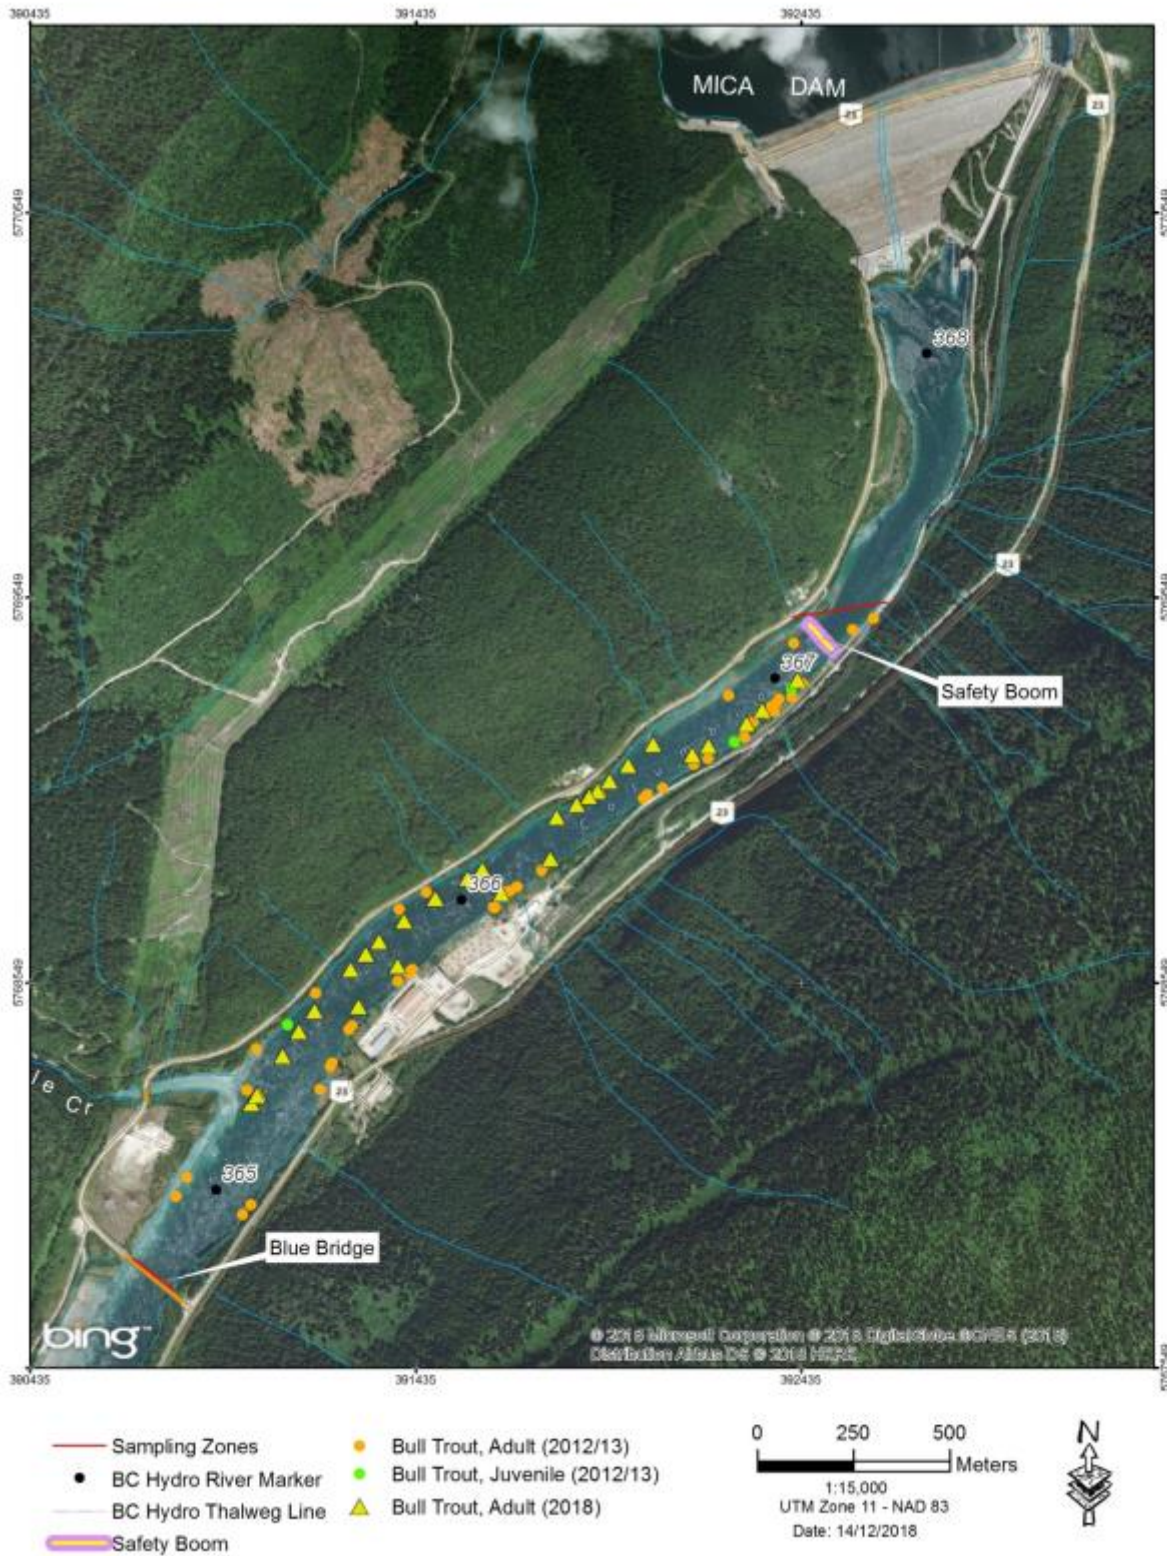
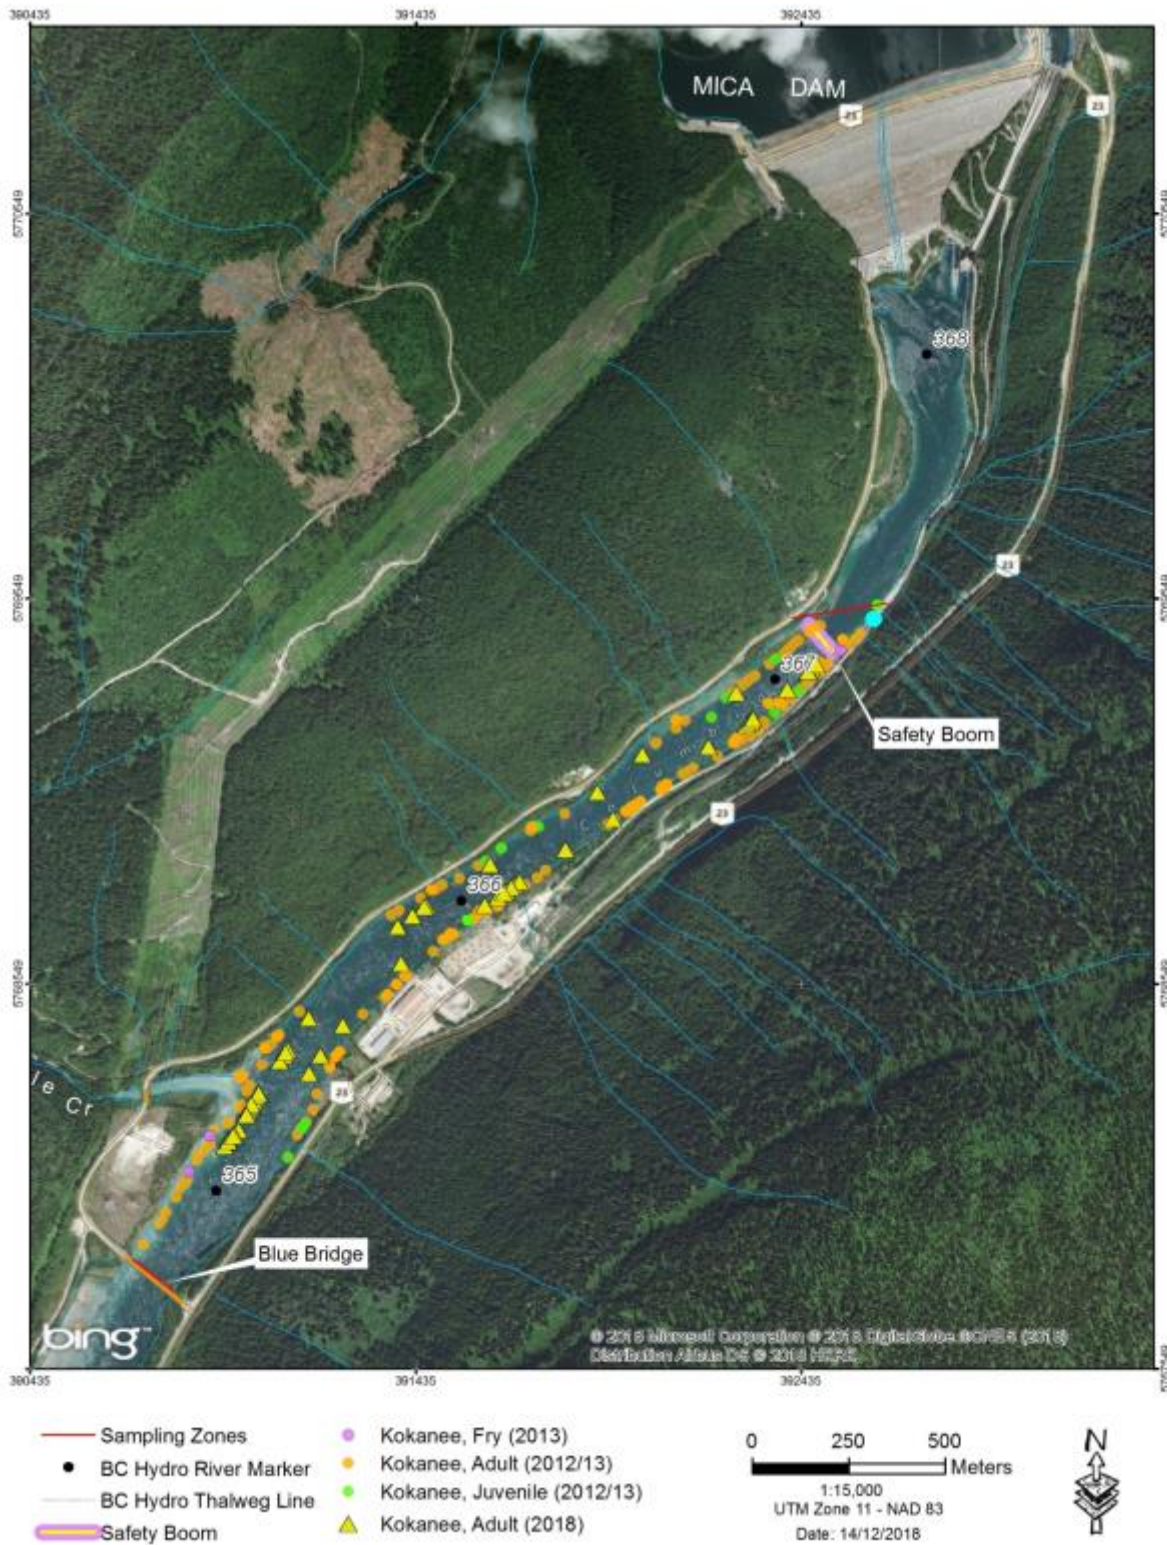
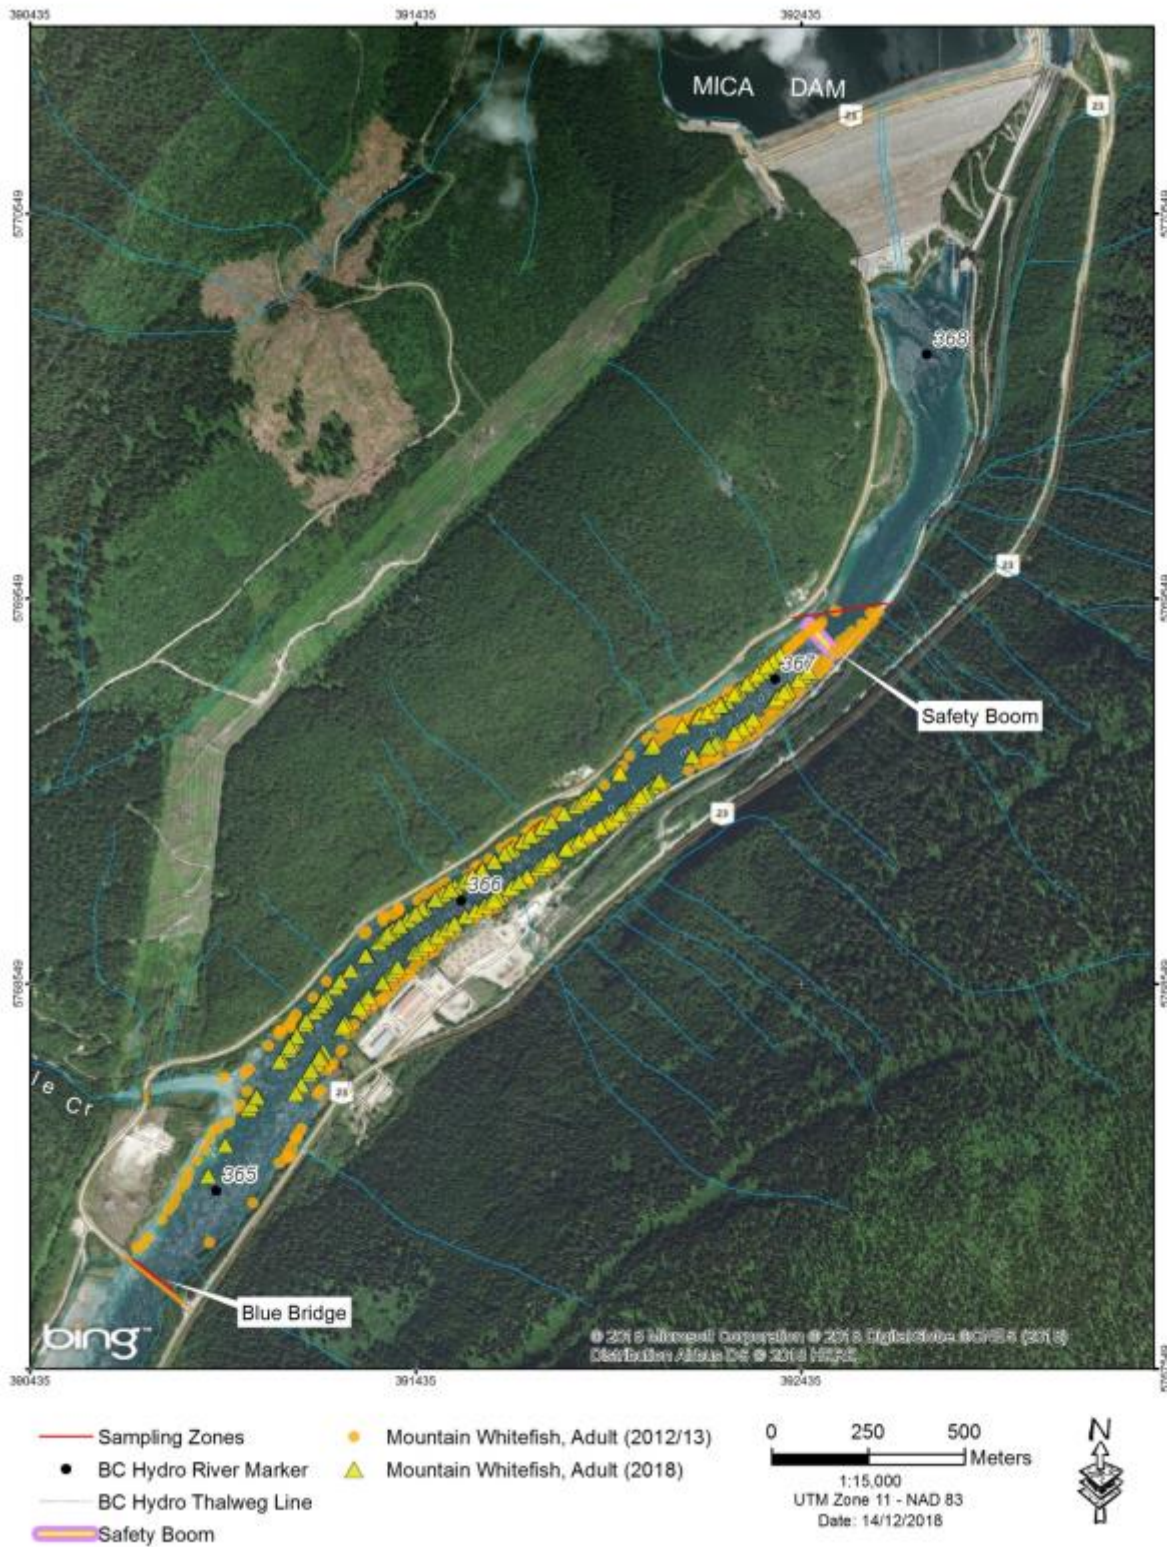
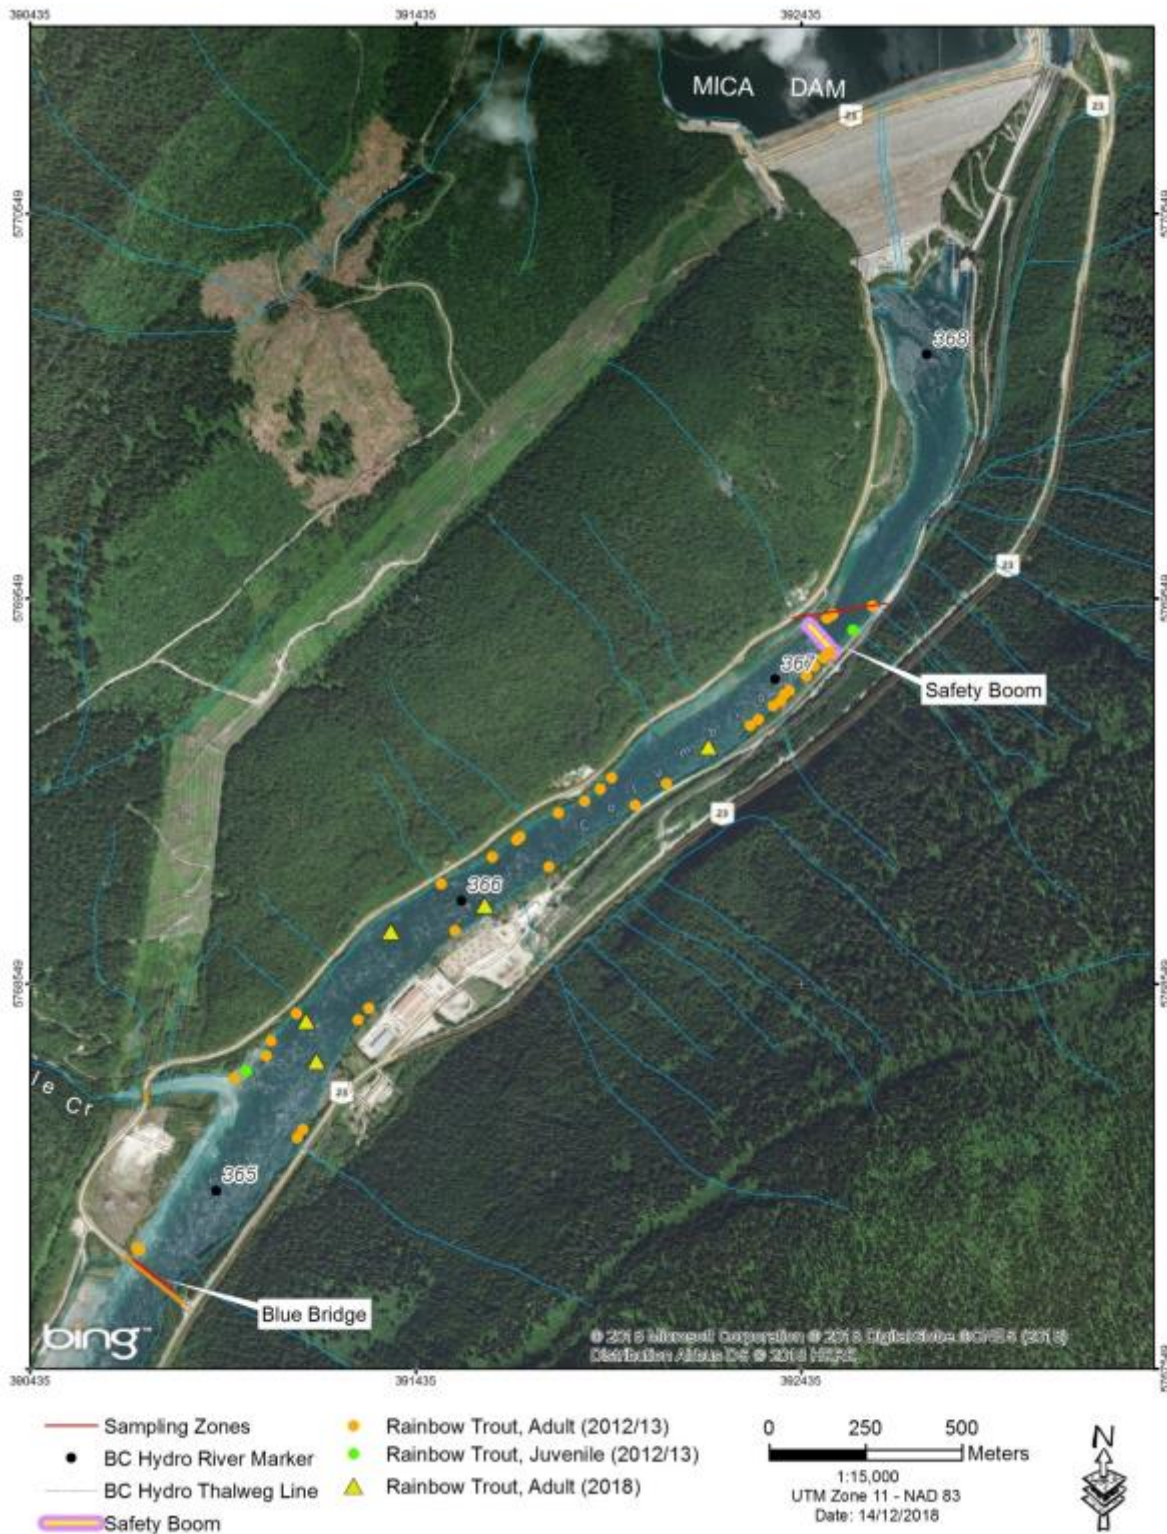
Figure A.2-1: Distribution of Bull Trout observations in the study area below Mica Dam.

Figure A.2-2: Distribution of Kokanee observations in the study area below the Mica Dam.

Figure A.2-3: Distribution of adult Mountain Whitefish observations in the study area below the Mica Dam.

Figure A.2-4: Distribution of juveniles Mountain Whitefish observations in the study area below the Mica Dam.

Figure A.2-5: Distribution of Rainbow Trout observations in the study area below the Mica Dam.

Figure A.2-6: Counts of adult and juvenile Mountain Whitefish in the study area below the Mica Dam.

These distribution data are also shown on maps with each fish's georeferenced location marked spatially (Appendix 2).

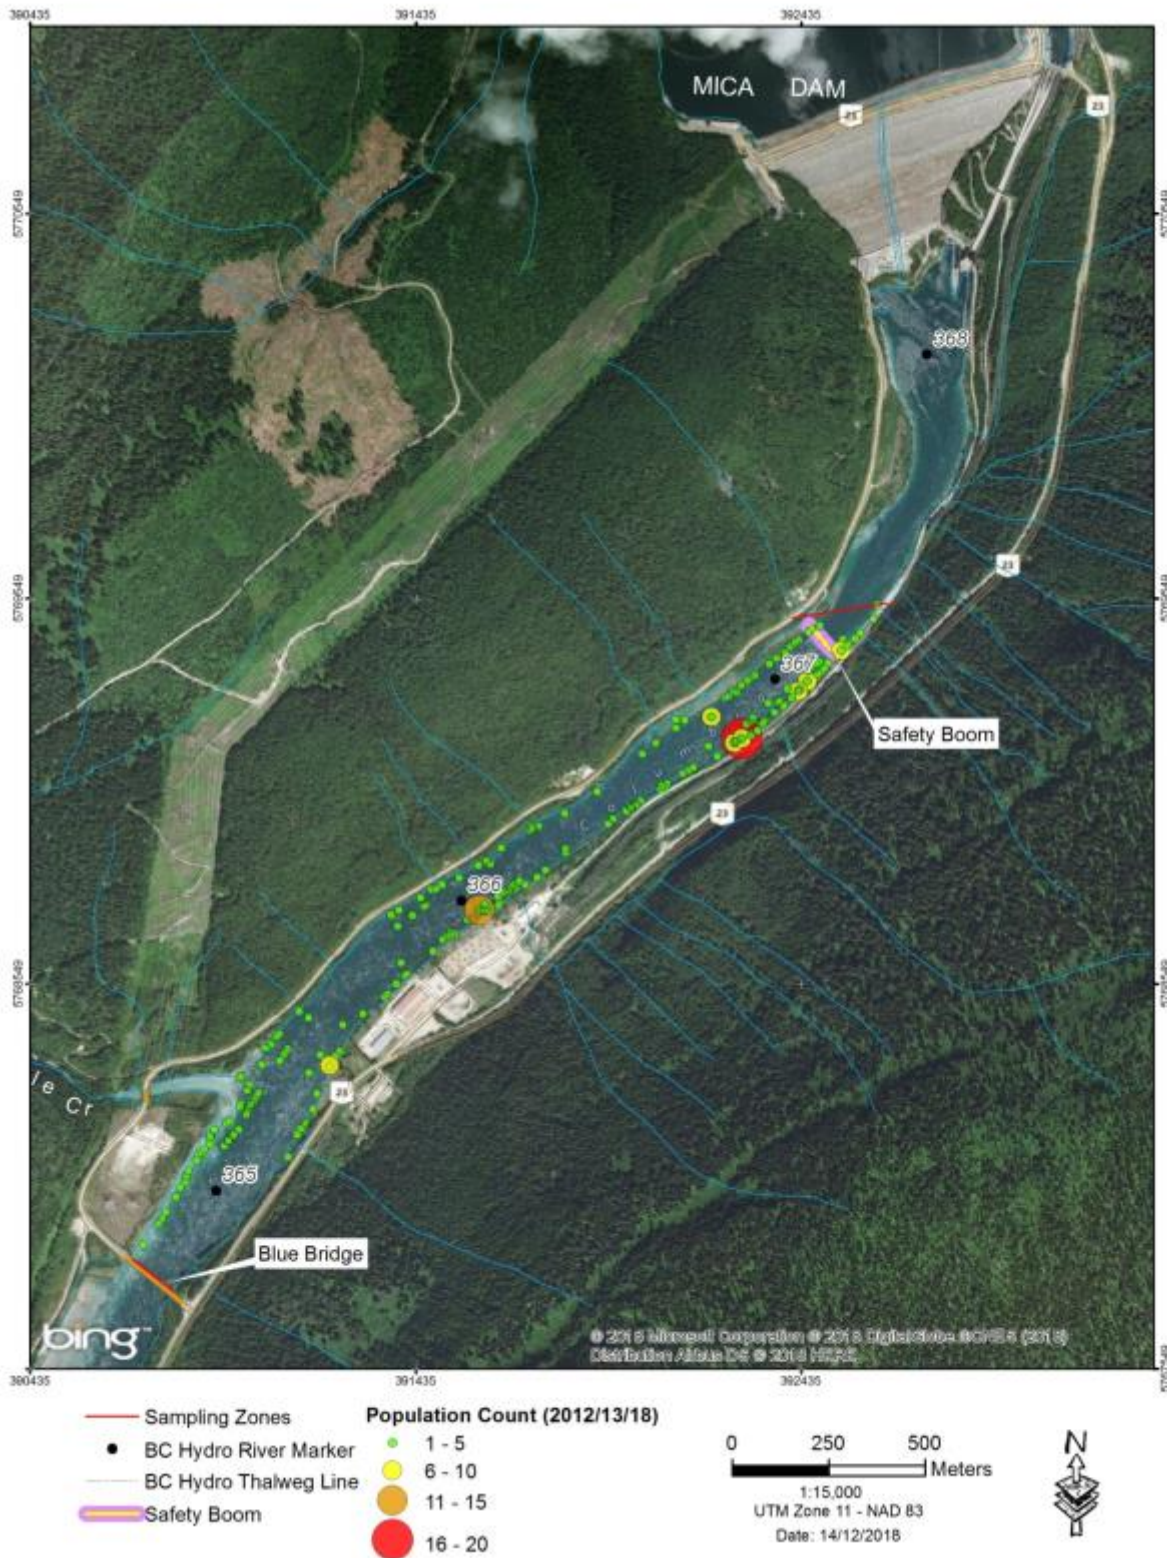
Figure A.2-7: Counts of adult and juvenile Kokanee in the study area below the Mica Dam.
