# Storm report:

The most damaging storm  
in BC Hydro's history

**Report**

January 2019

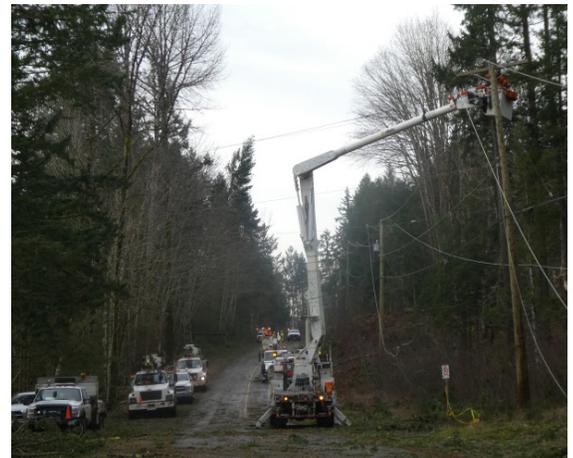
Crews repairing extensive damage in Nanaimo.

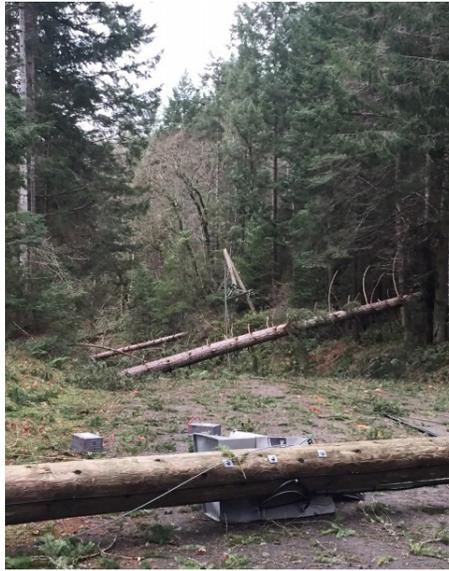
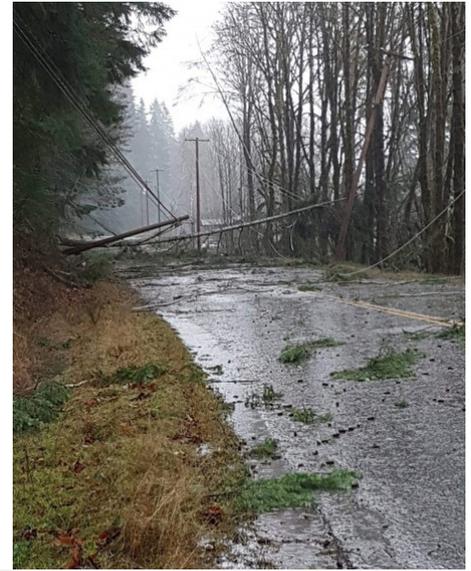
Trees made many roads inaccessible—particularly on the Gulf Islands.

All customers in the Lower Mainland and the Fraser Valley were restored by December 24; however, however, the damage on Vancouver Island and the Gulf Islands was particularly challenging and took longer to repair. The Ministry of Transportation and Infrastructure noted there were trees down on 100 per cent of the roads in some of the southern Gulf Islands. This made access extremely challenging in some places.

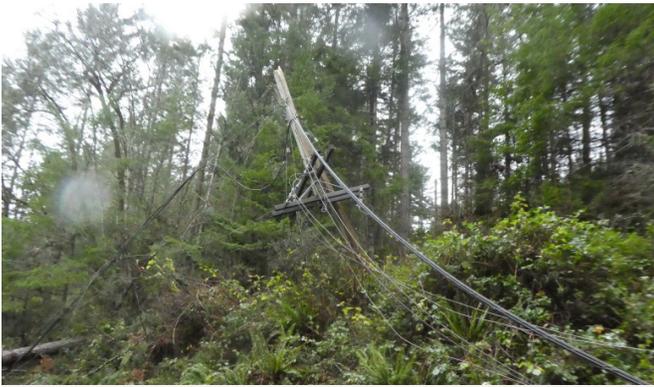
Example of infrastructure damage on Gabriola Island.
