Peace Project Water Use Plan

Williston Reservoir Trial Tributaries

2019 - Ole Creek Engineering Inspection Report

Site Inspection Report

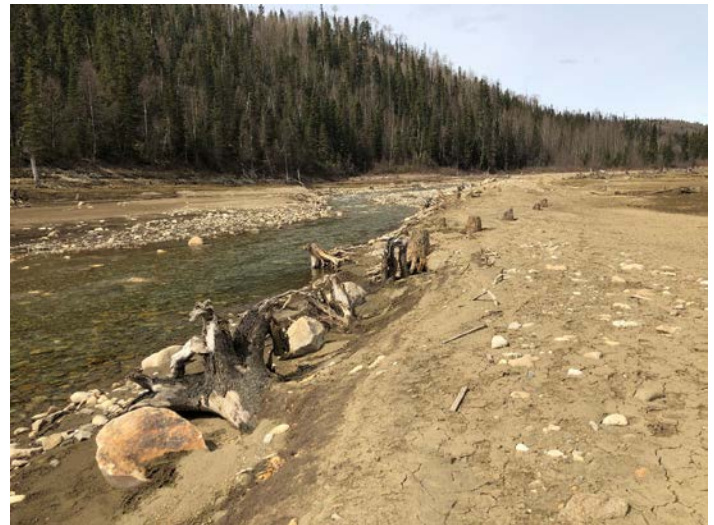
PHOTO 30: LWD at Berm 'D' (repeat of 2016 Ph#23)

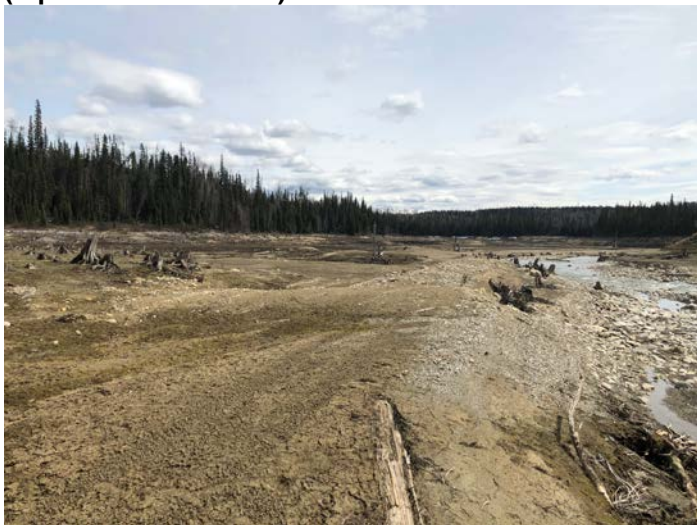
PHOTO 37: Downstream line of buried LWD
