Peace River Project Water Use Plan

*Williston Reservoir Wetland Demonstration Site 6-2 Airport
Lagoon. Final Report*

BC HYDRO - WILLISTON RESERVOIR WETLAND DEMONSTRATION SITE 6-2 AIRPORT LAGOON

Completion Report BC Hydro Report # N3589

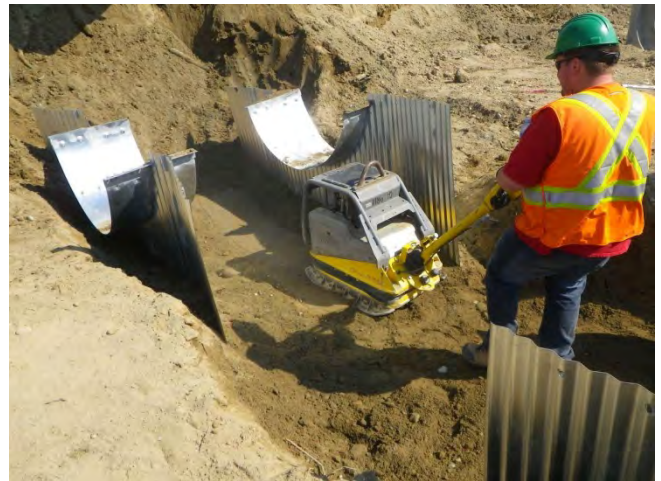
Photo 12 – Compaction.

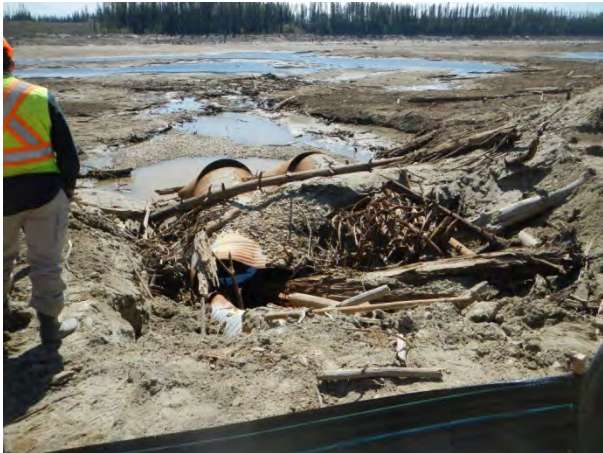
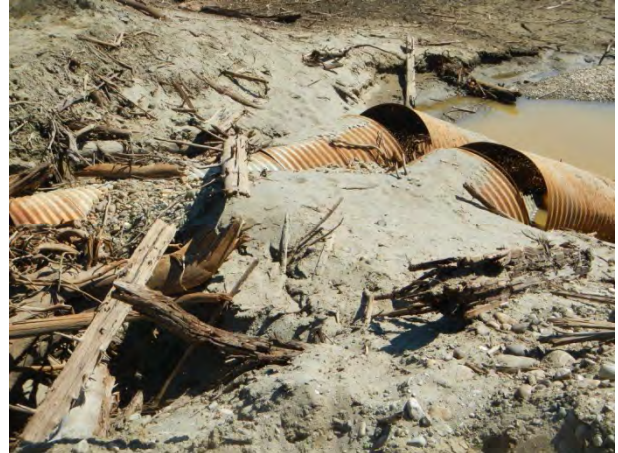
Exited Culvert

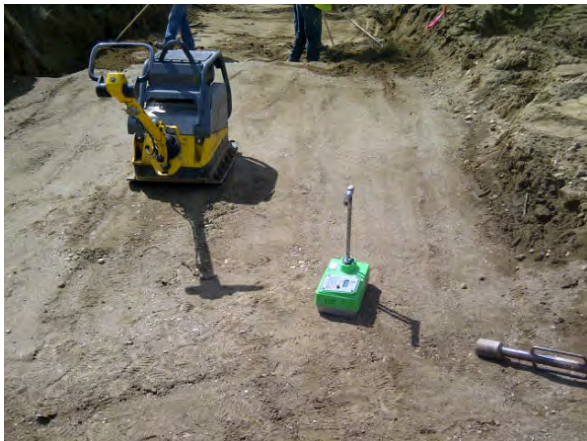
Testing density for 1st layer above Geo-grid

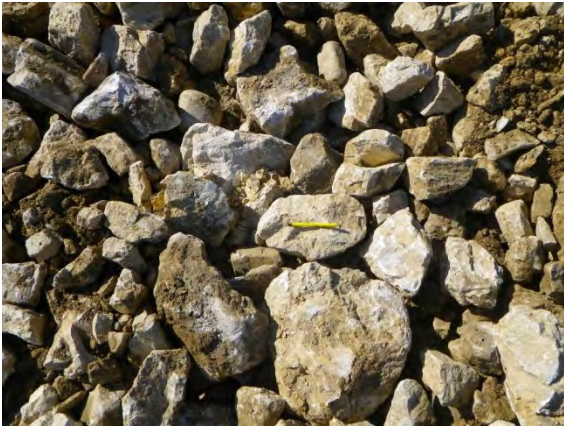
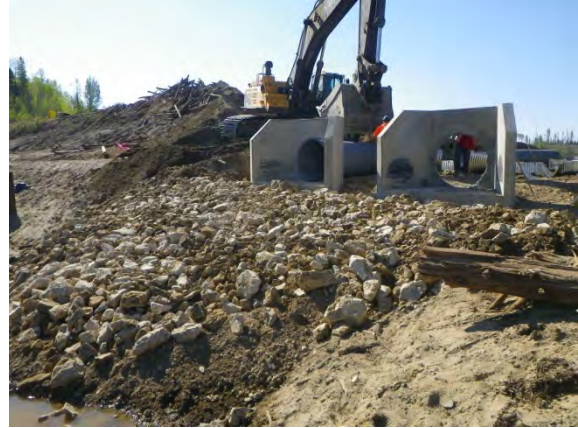
Rip Rap added

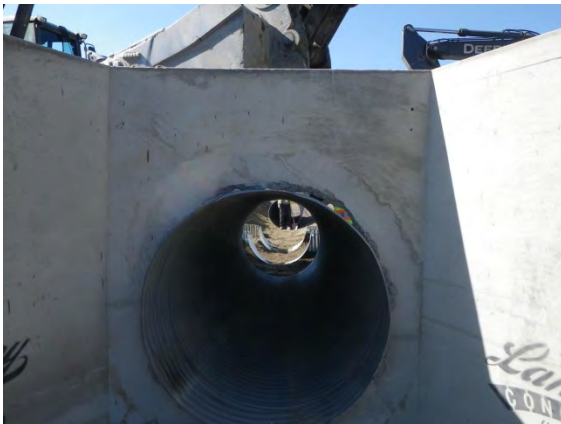
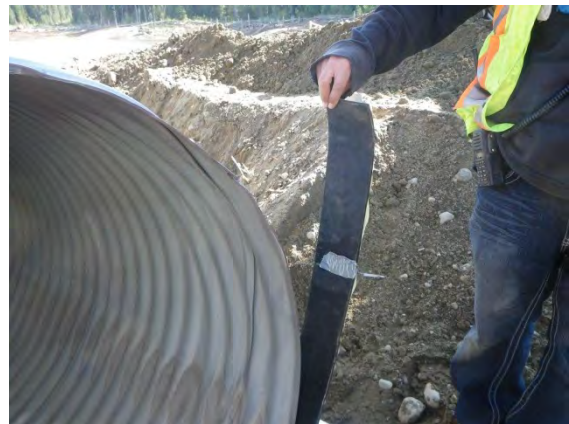
Erecting culvert against the concrete head

Seals for tying culvert pieces together

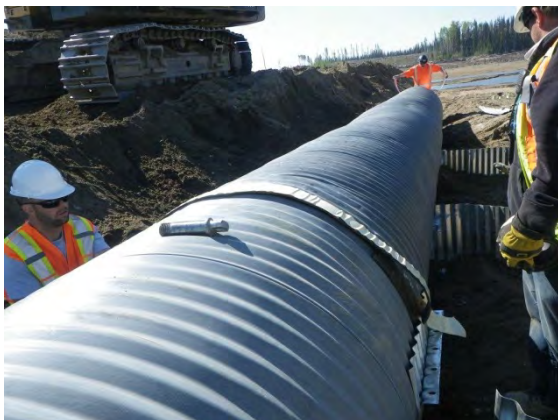
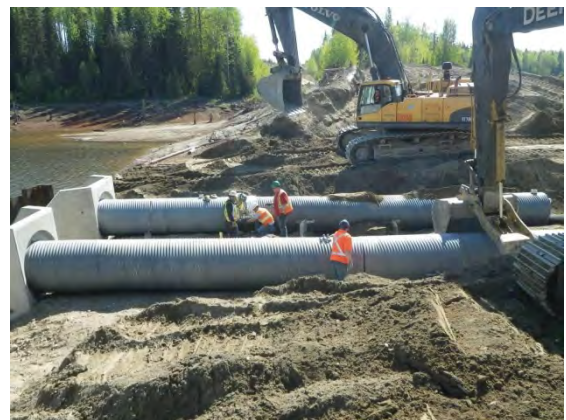
Tying culvert pieces together

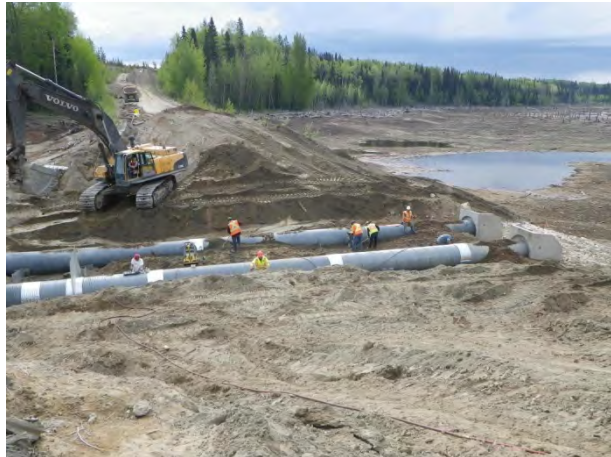
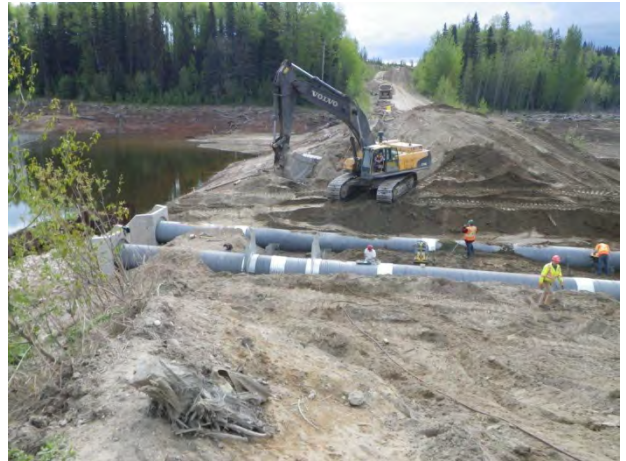
Culvert construction progress showing downstream and upstream

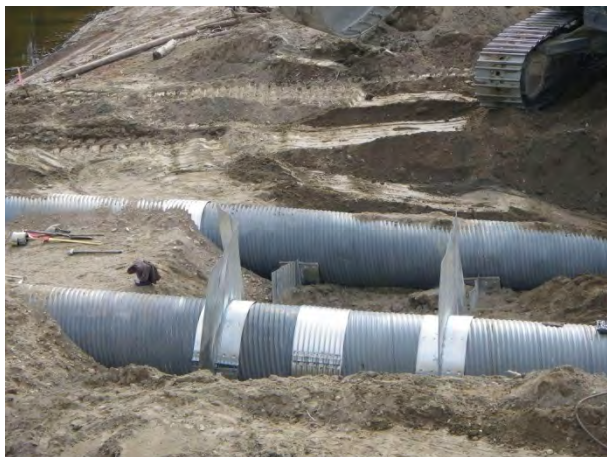
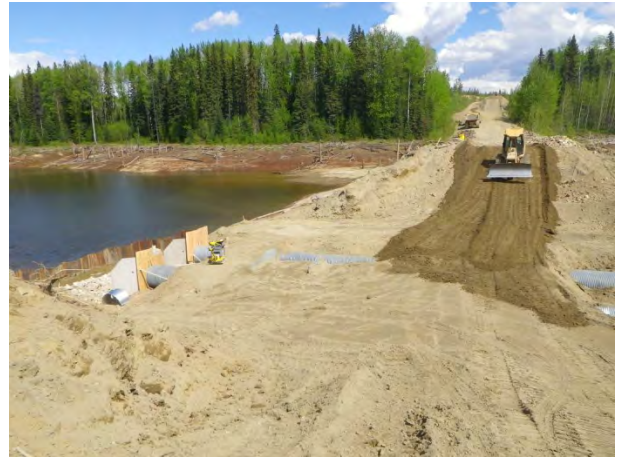
Culvert construction progress to top of culverts

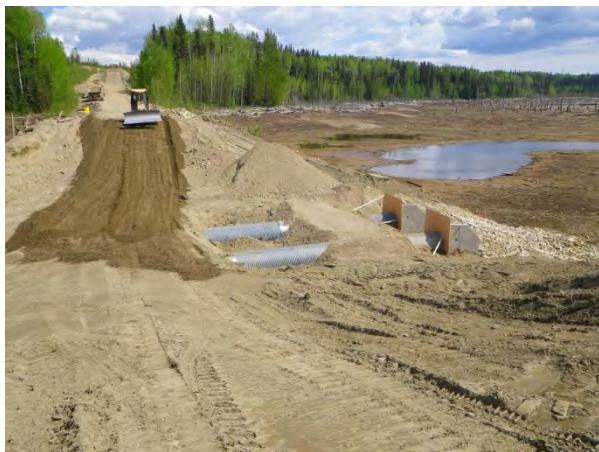
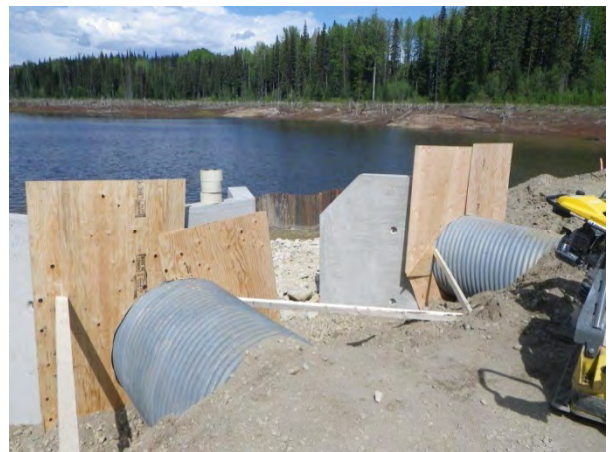
Culvert construction progress showing downstream and upstream

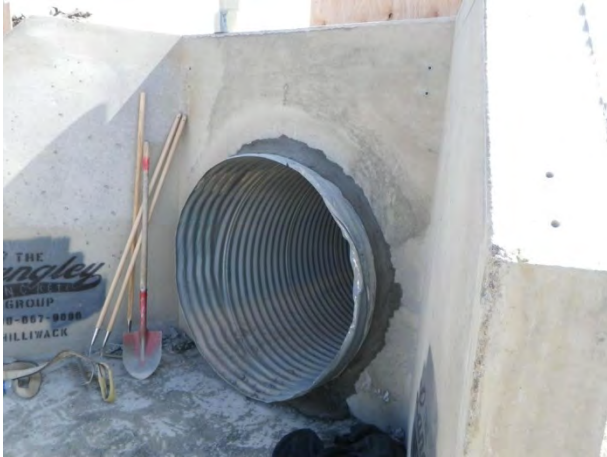
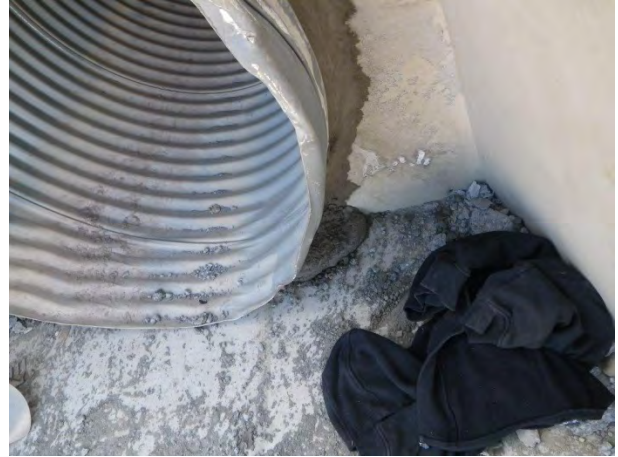
Culverts with grout against concrete heads, upstream

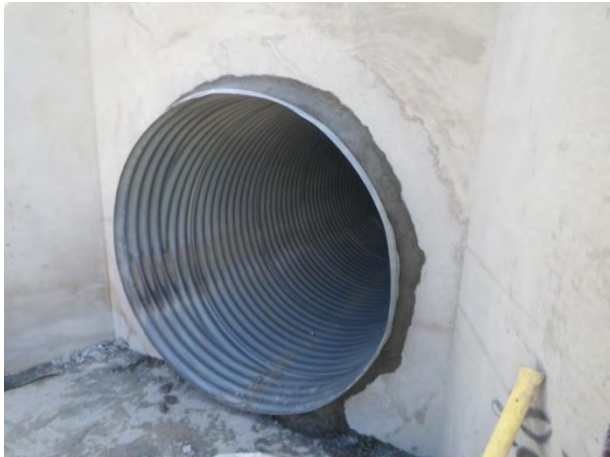
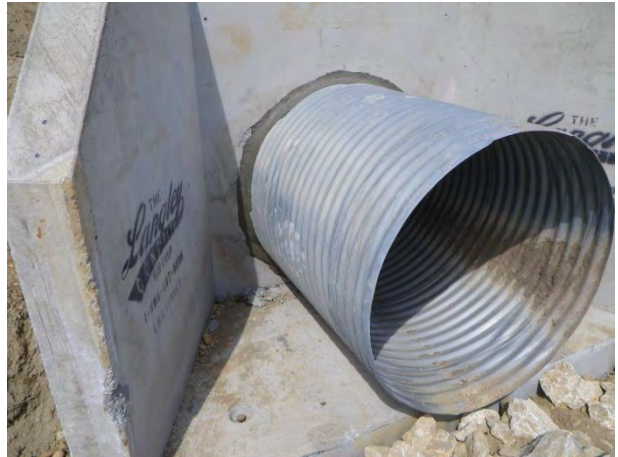
Culverts with grout against concrete heads, downstream

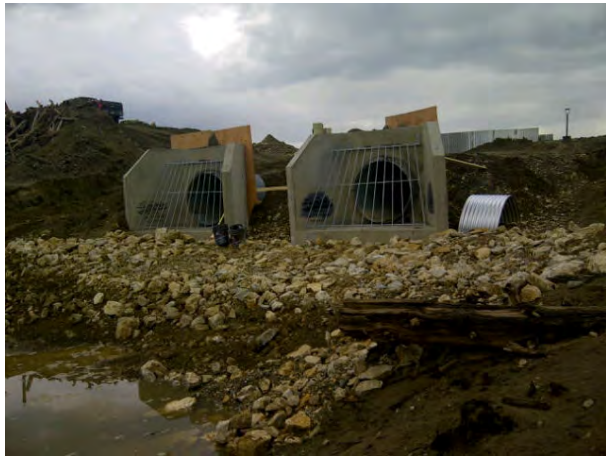
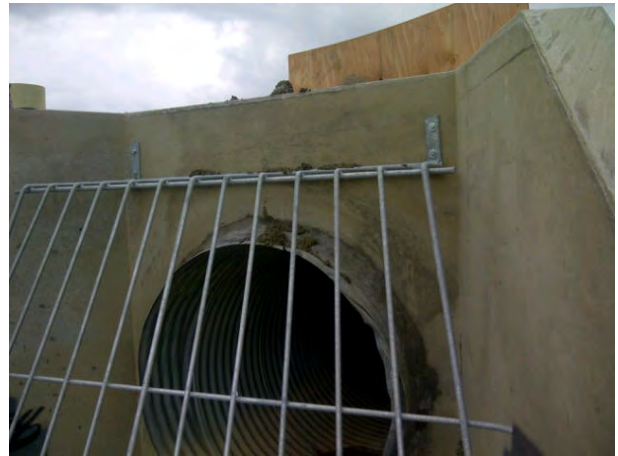
Erecting steel guards against concrete heads

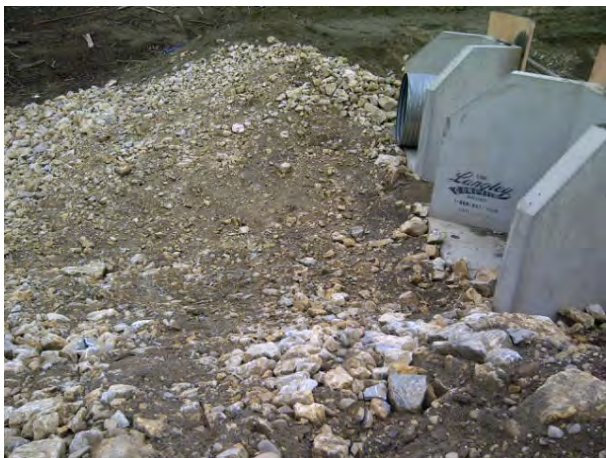
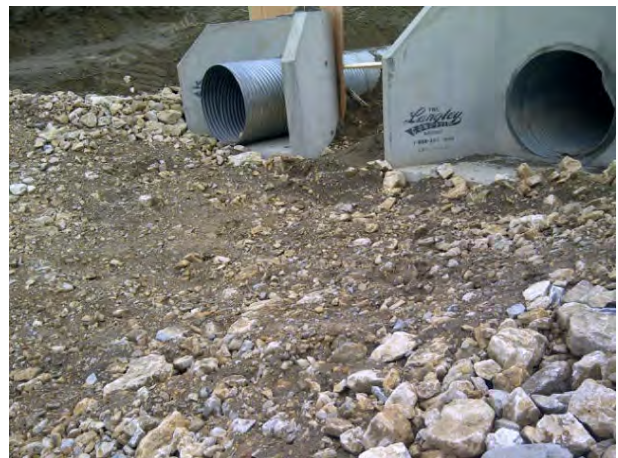
Rip Rap against concrete head

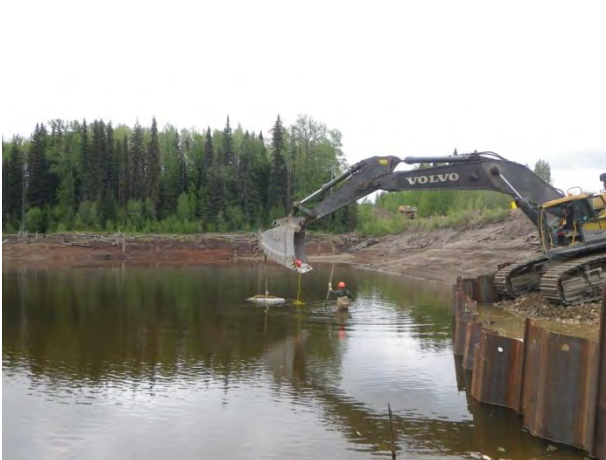
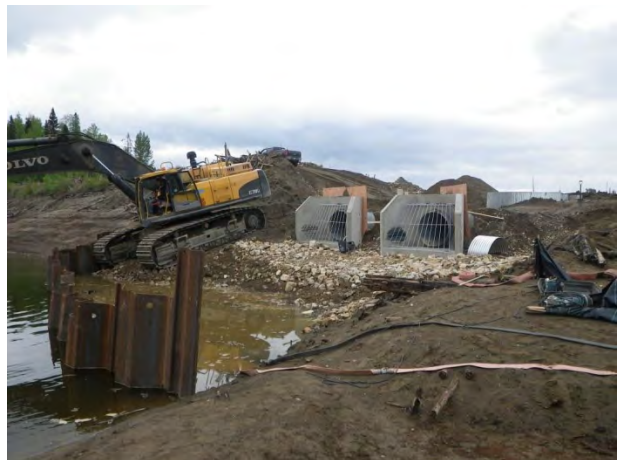
Placing concrete blocks for anchors, upstream.

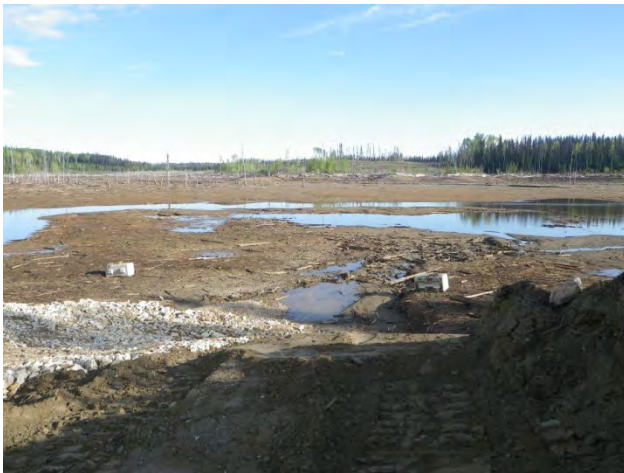
Concrete blocks for anchors

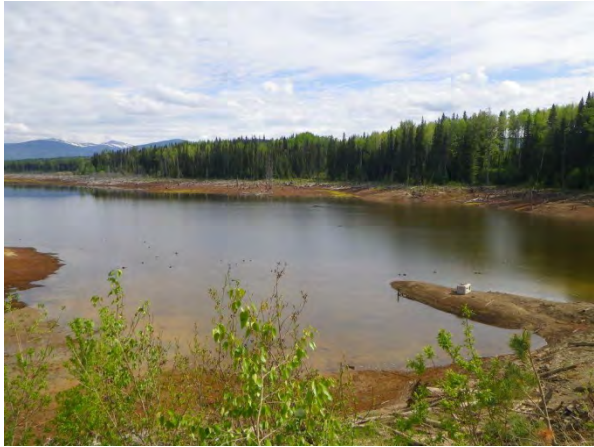
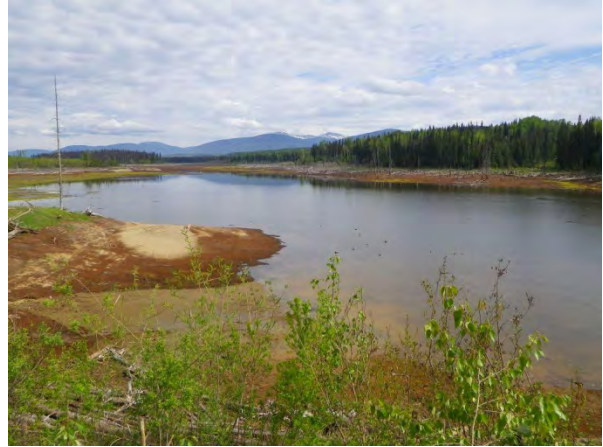
Concrete blocks upstream.

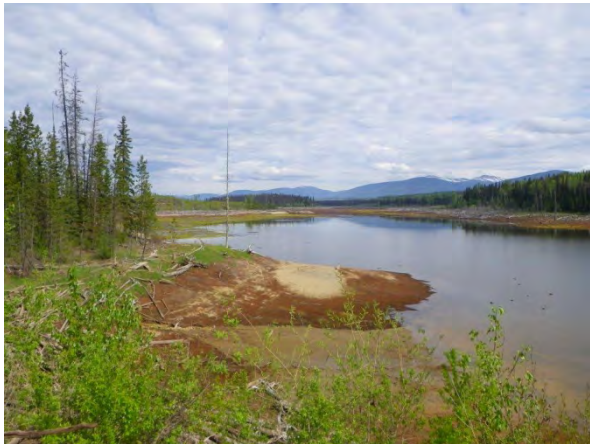
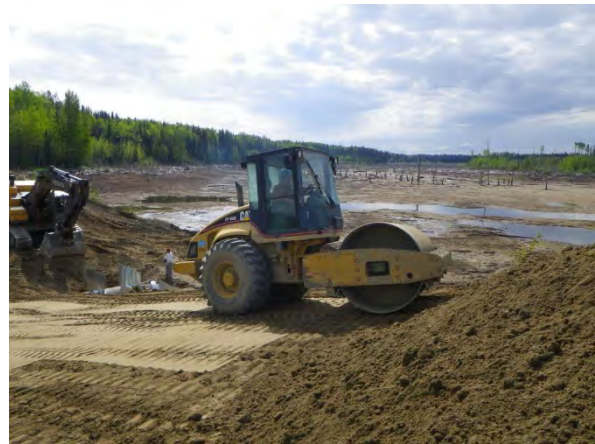
Compaction progress, road above culverts

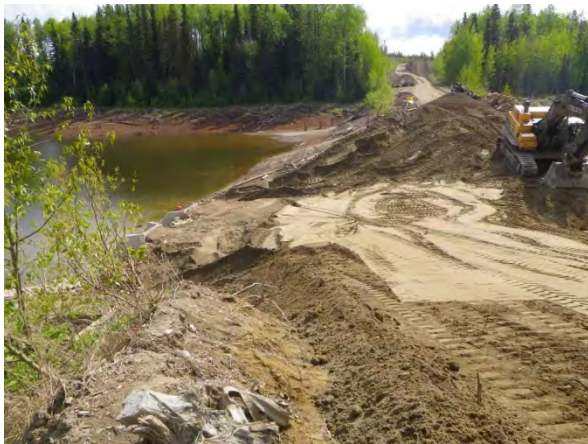
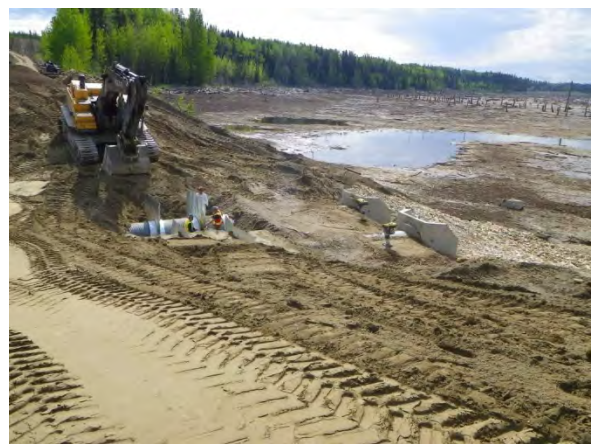
Upstream compaction progress for the road

Downstream compaction progress for the road

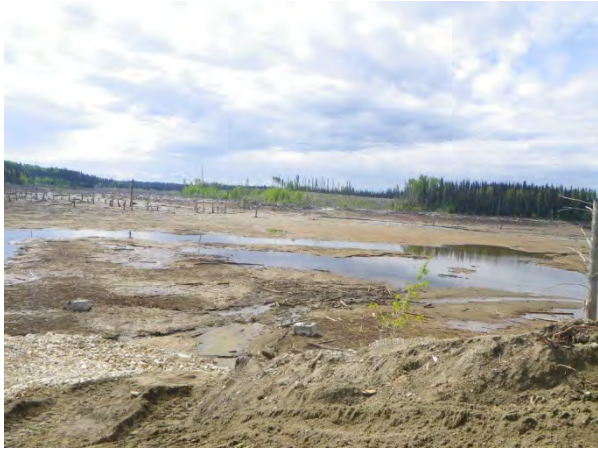
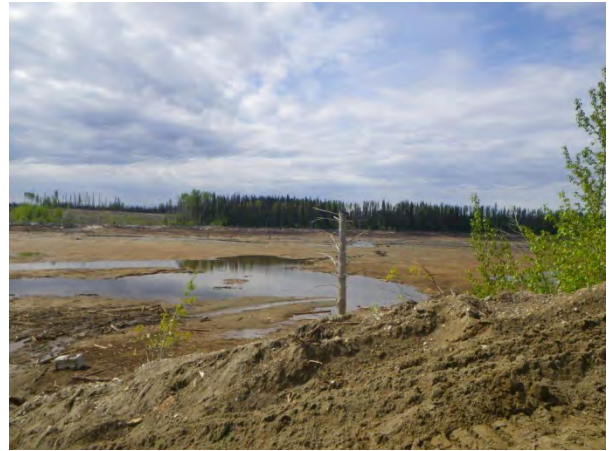
During construction, downstream view

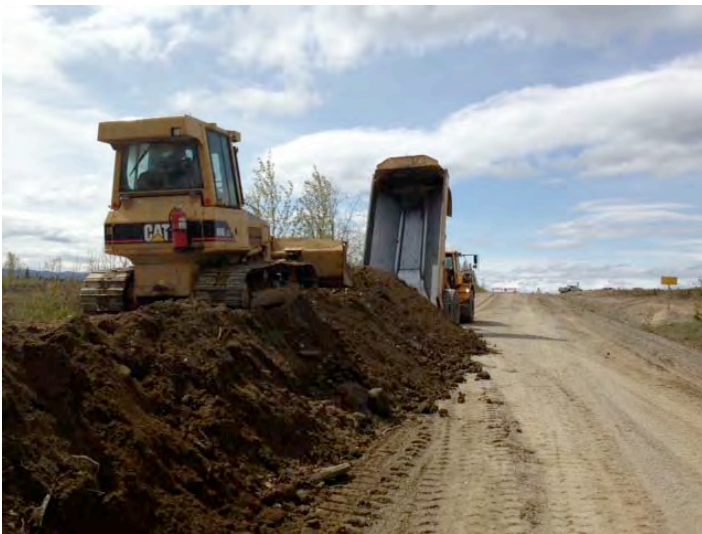
Maintaining stockpile

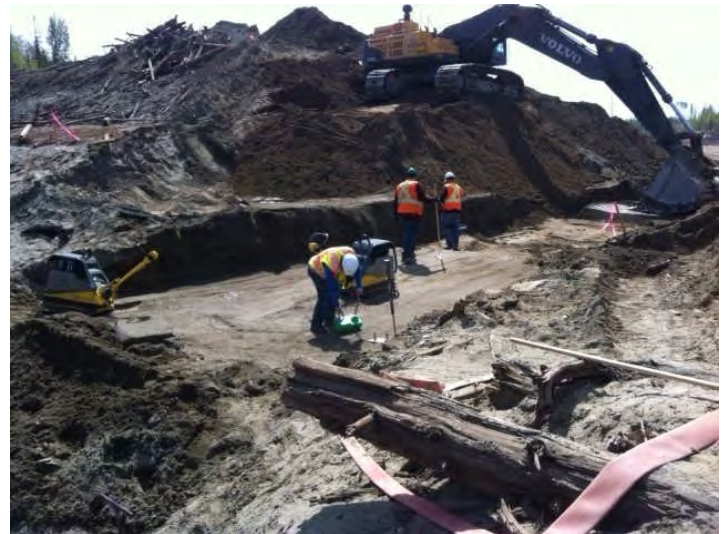
Geo Tech testing densities

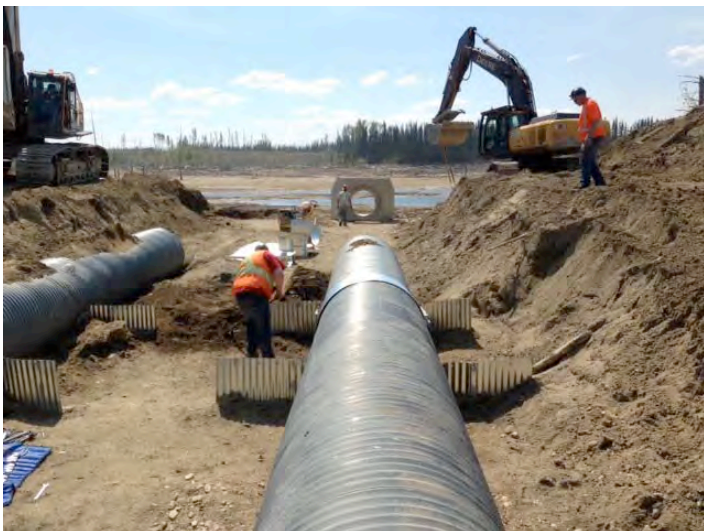
Placing culverts

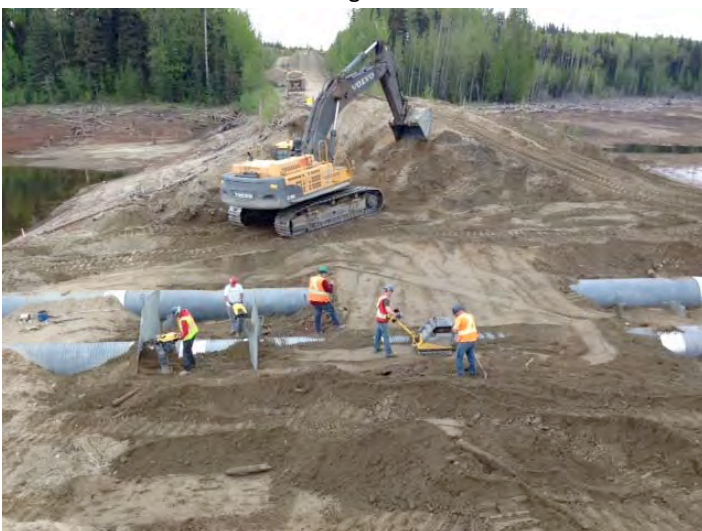
Backfilling culvert

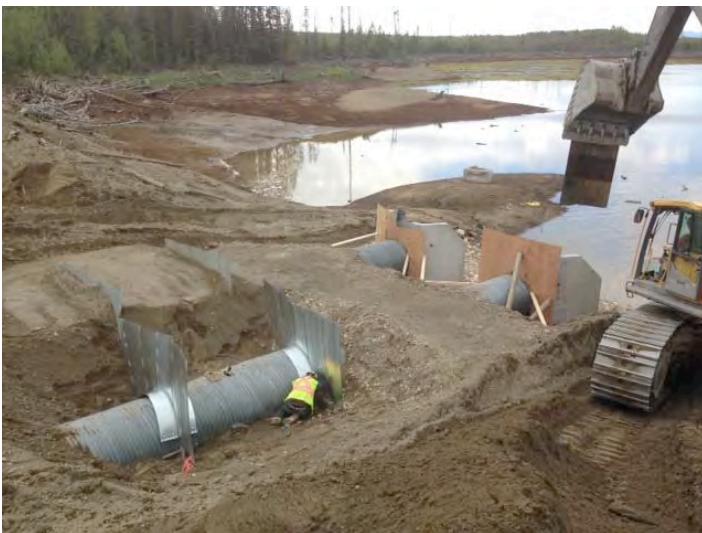
Installing Collars

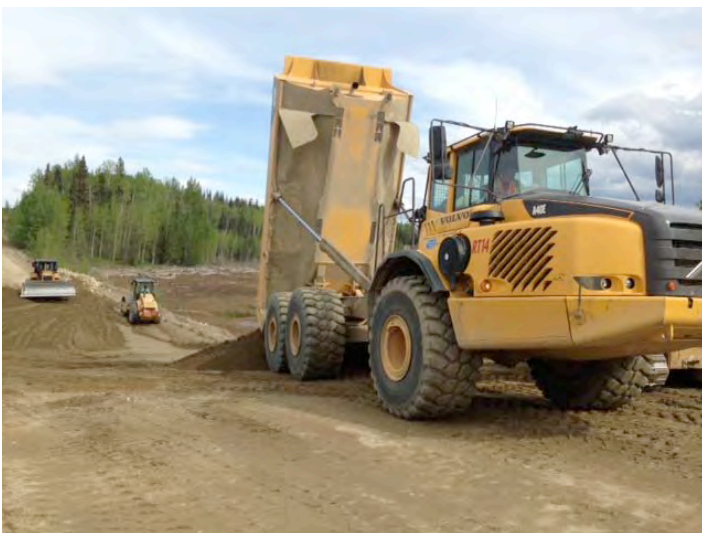
Spotting Loads

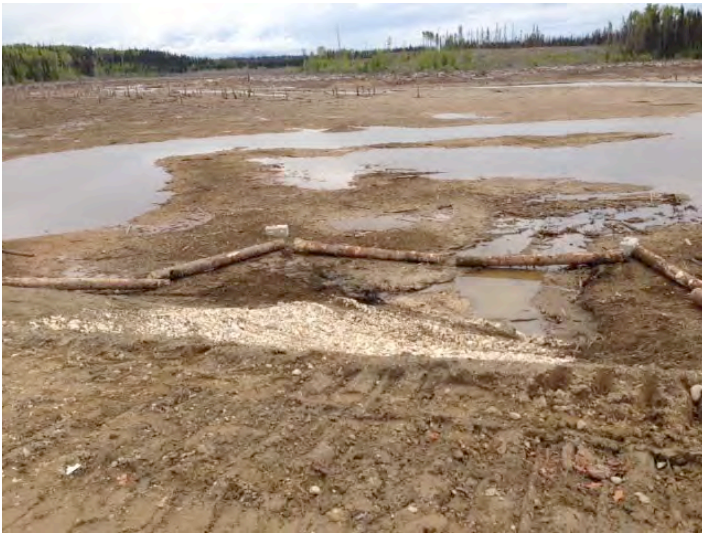
Downstream log boom

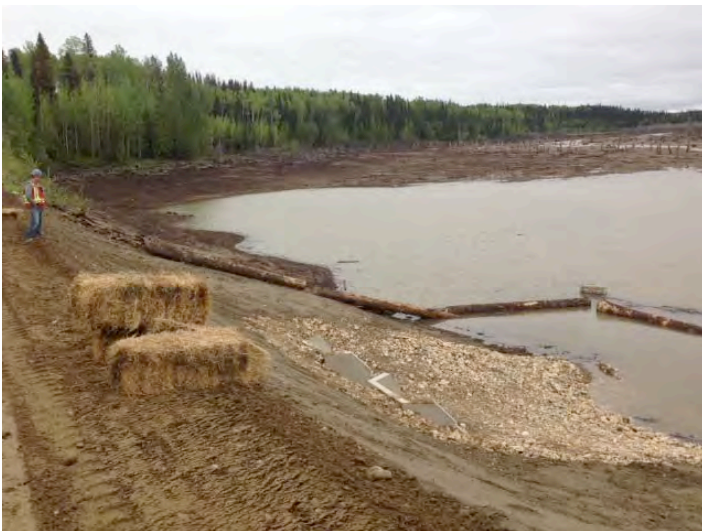
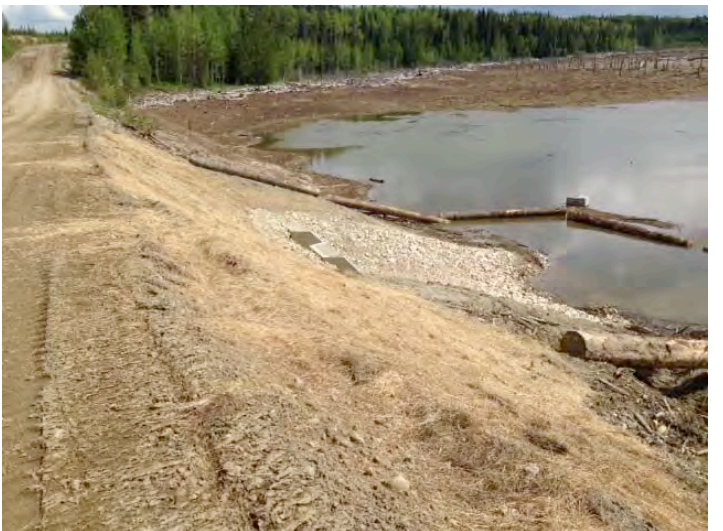
Straw and seeding completed
