Peace Project Water Use Plan

Williston Reservoir Trial Tributaries

Ole Creek 2016 Engineering Inspection Report

Site Inspection Report

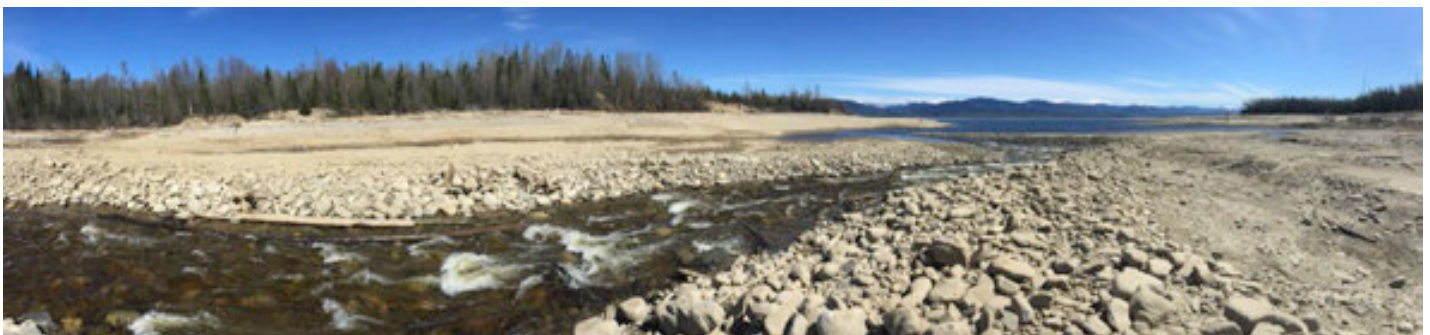
PHOTO 14 (Panoramic): Looking at Berm 'B' from Berm 'D'

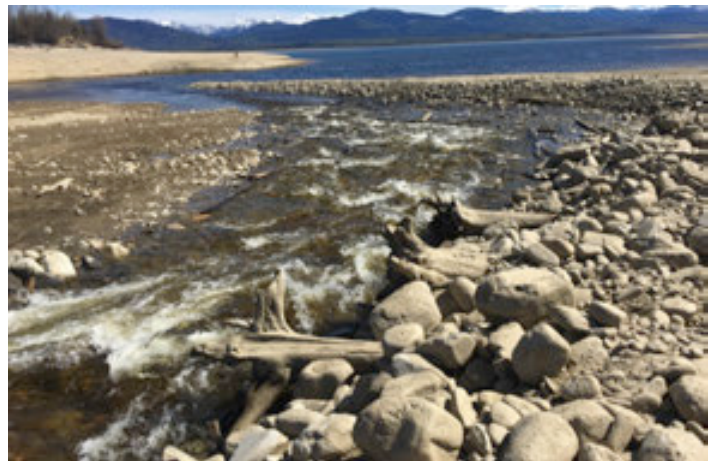
PHOTO 30: LWD Looking downstream

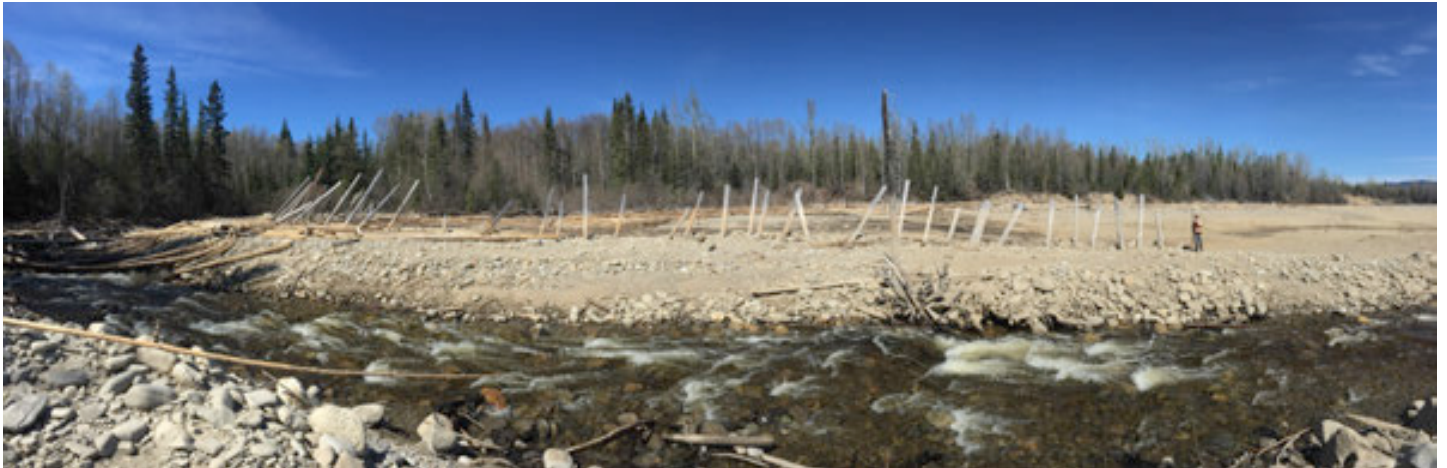
PHOTO 31 (Panoramic): Berm 'A' and left bank woody debris catcher

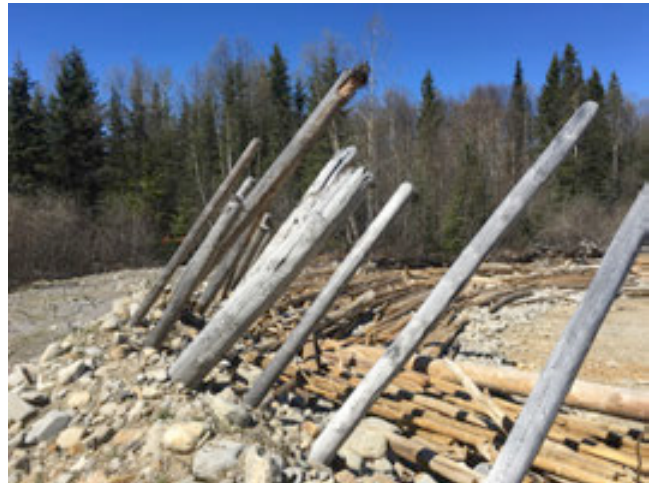
- The woody debris catcher has largely been effective and has captured much log debris and has prevented blockage of the creek mouth (see Photos 33, 34 & 39). Some of the upright logs in the woody debris catcher have sustained impact damage. Three upright logs have broken and a few have shifted by log impact, many show rubbing and impact damage near the base of the logs (see example Photos 40 & 41).

PHOTO 39: logs caught by woody debris catcher

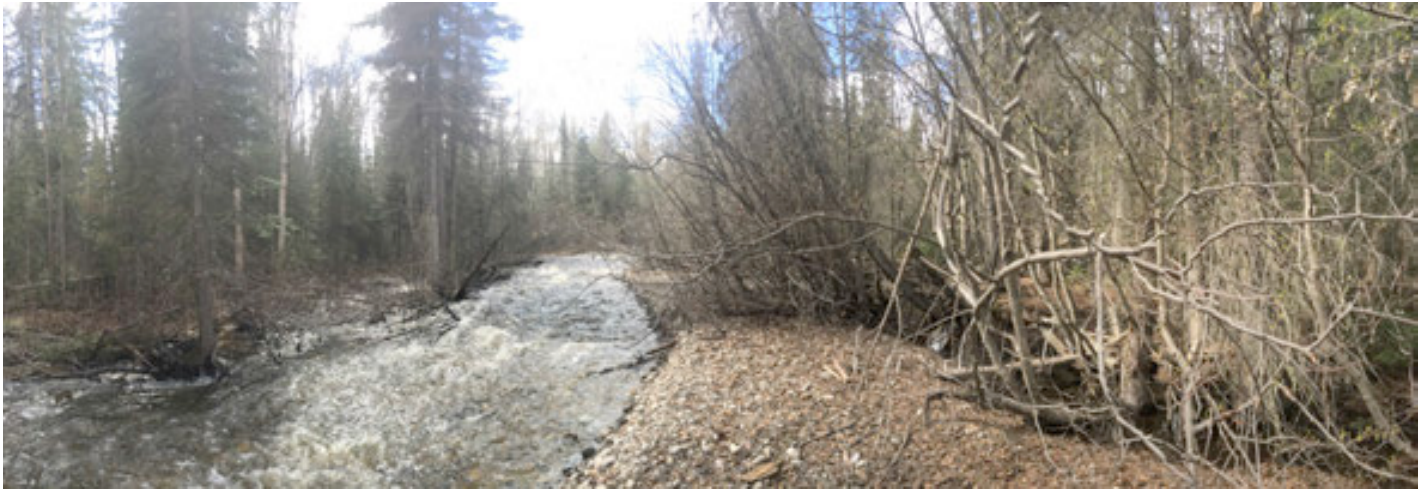
- Gravel/cobble deposited during a large event perhaps about 5 years ago (The environmental monitoring contractor commented that 2011 flow was high in this area). This has changed the course of the creek and it is now undermining tree roots, which will cause trees to fall over and potentially create log jams. The channel has become less defined and more unstable since the 2014 observation. Selective removal of trees at risk of falling across channel could be considered and monitoring is recommended during the annual inspections.

PHOTO 53 (Panoramic): Upstream end of gravel bar on left looking upstream
