Columbia River Project Water Use Plan

CLBWORKS-30C Arrow Lakes Reservoir Wildlife Enhancement Program – Physical Works

2024 Burton Wetlands Engineering Monitoring & Inspection

RE: CLBWORKS-30C – WILDLIFE ENHANCEMENT PROGRAM AT BURTON FLATS
2024 Burton Wetlands Engineering Monitoring & Inspection
Our File 0478.229-300

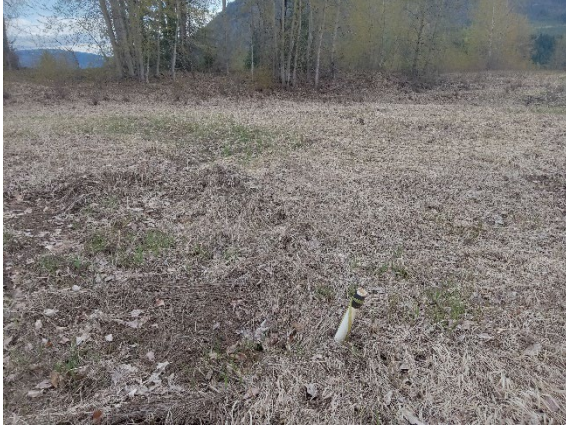
Photo 1: Piezometer 1 Standpipe

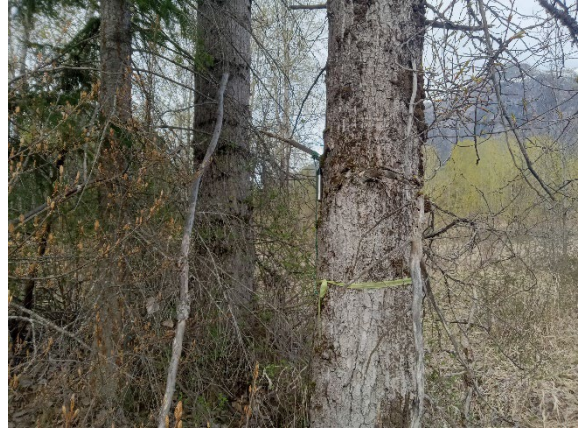
Photo 2: Barometer 1 Sensor Hanging from Tree

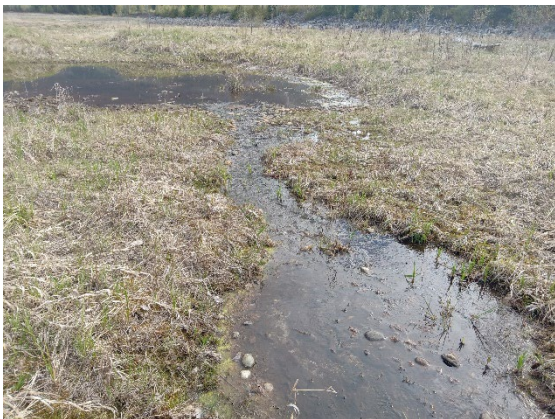
Photo 3: Water Flowing into Wetland A1, Looking North

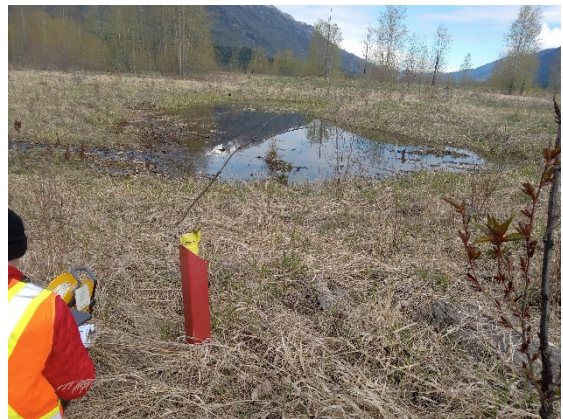
Photo 4: Wetland A1 and Piezometer, Looking West

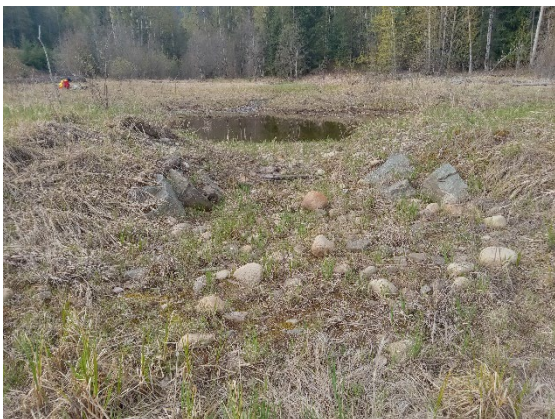
Photo 5: Outlet of Wetland A1, Looking South

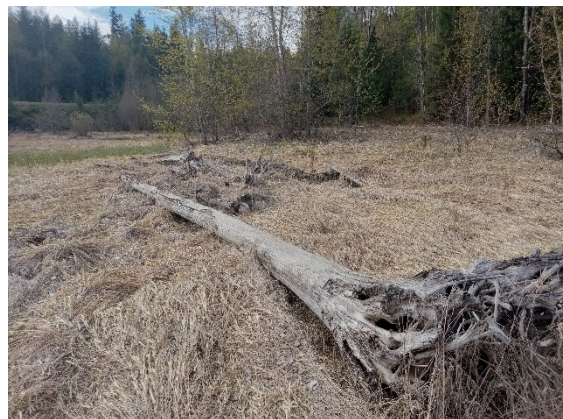
Photo 6: Woody Debris Deposited South of A1

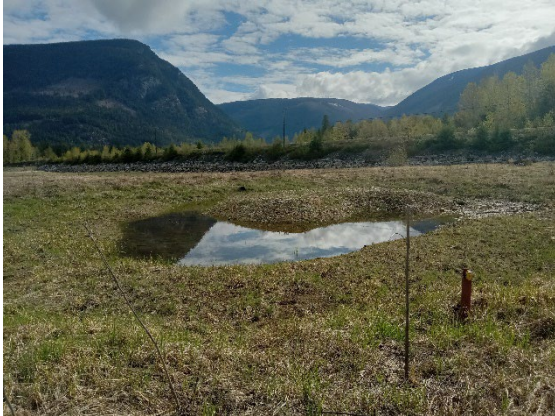
Photo 7: Wetland A2 and Piezometer, Looking East

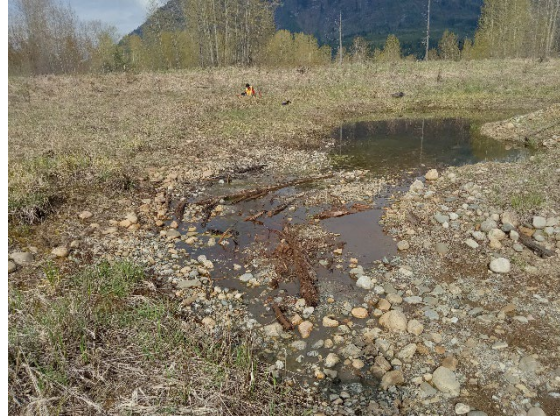
Photo 8: Woody Debris in Wetland A2

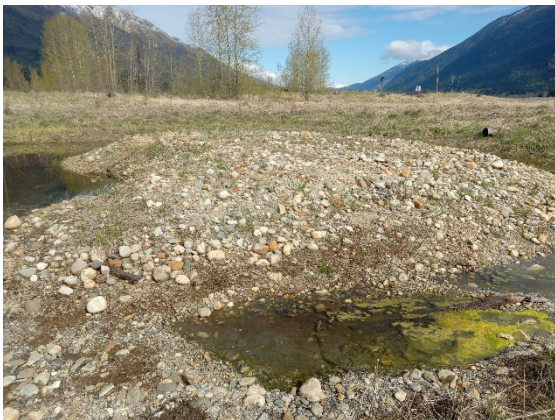
Photo 9: Wetland A2 Island, Looking North

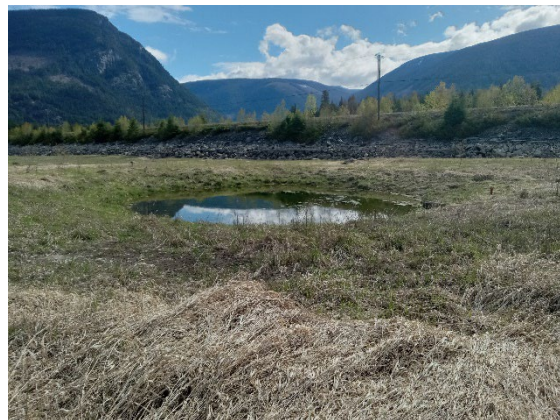
Photo 10: Wetland A3 and Piezometer, Looking East

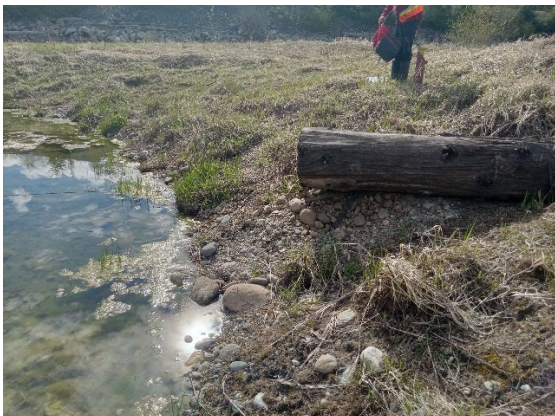
Photo 11: Embedded Log at South Edge of A3

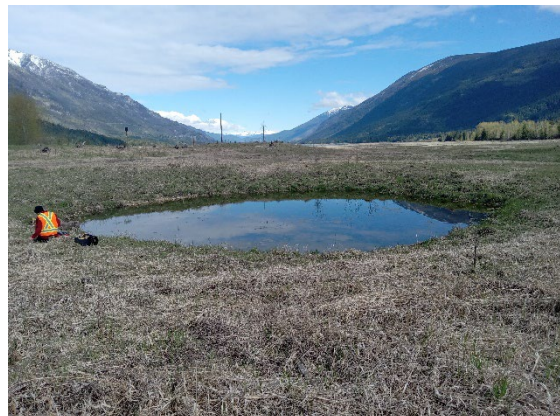
Photo 12: Wetland A3, Looking North

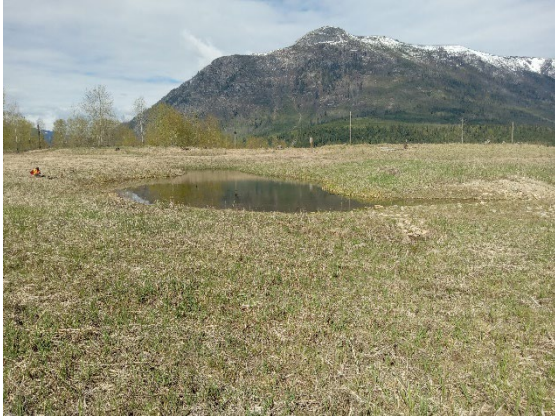
Photo 13: Wetland A4 and Piezometer, Looking West

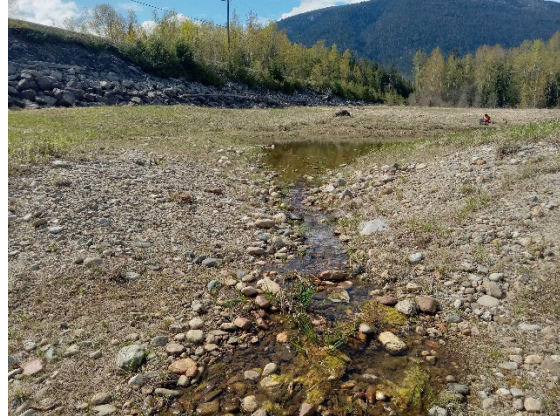
Photo 14: Wetland A4 Outlet, Looking South

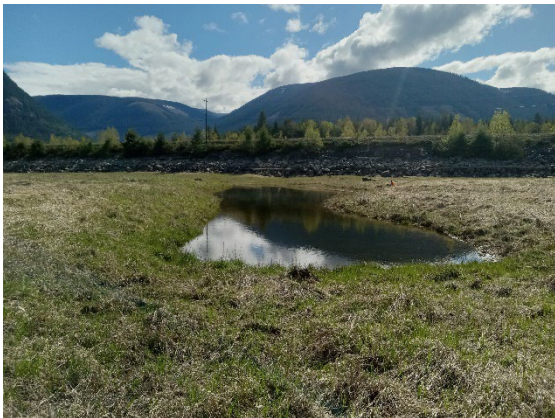
Photo 15: Wetland A4, Looking East

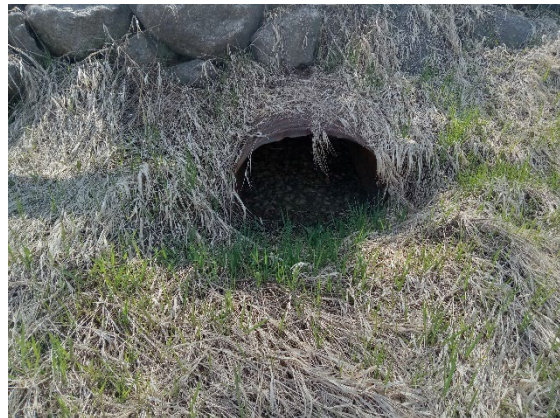
Photo 16: Highway Culvert Near A4

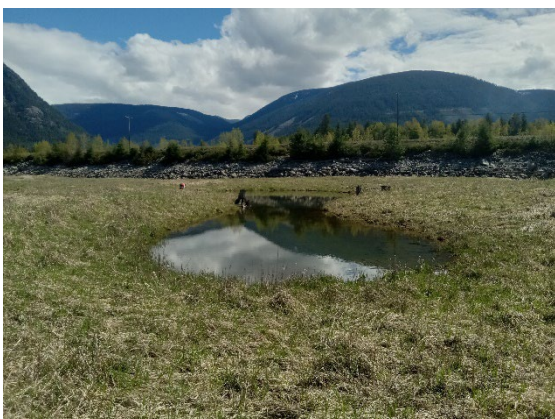
Photo 17: Wetland A5, Looking East

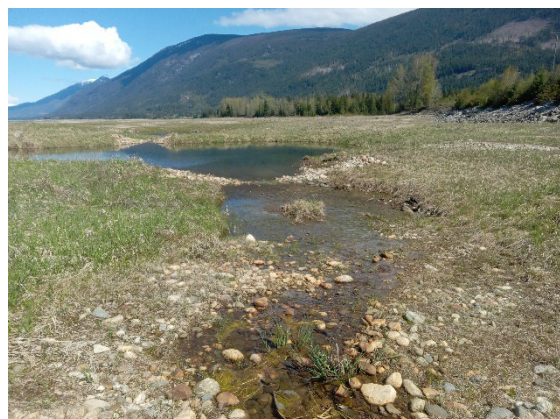
Photo 18: Water Flowing North from A4 to A5

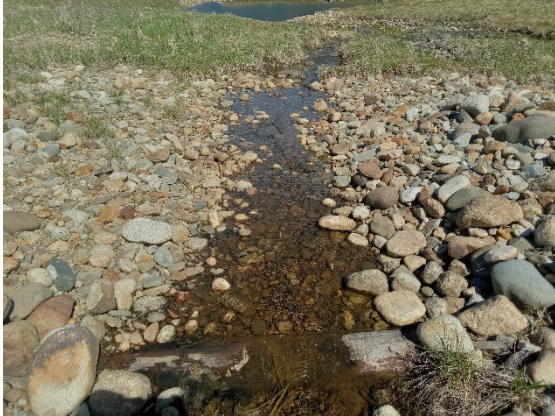
Photo 19: Wetland A5 Outlet

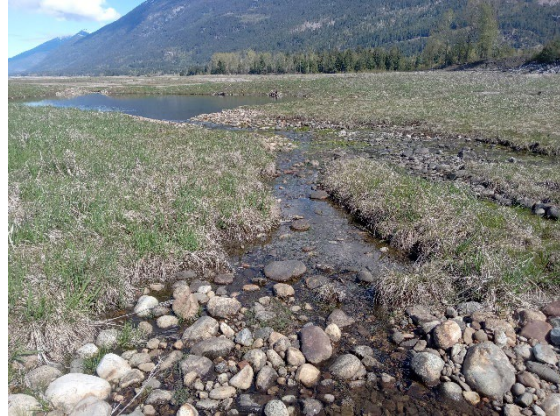
Photo 20: Minor Erosion in Channel from A5 To A6

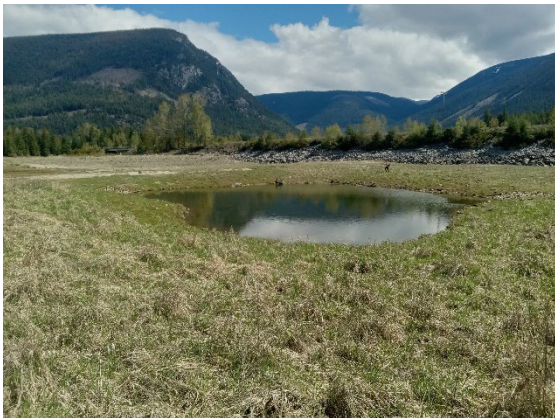
Photo 21: Wetland A6, Looking Northeast

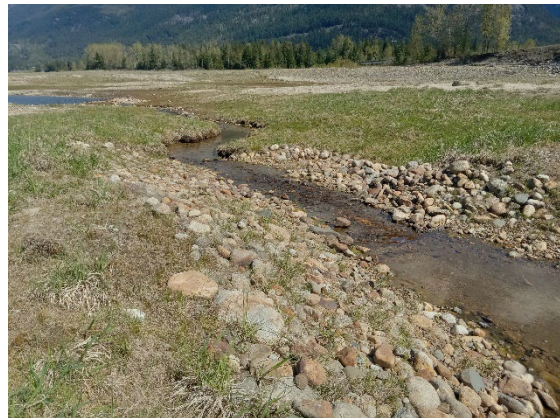
Photo 22: Wetland A6 Outlet

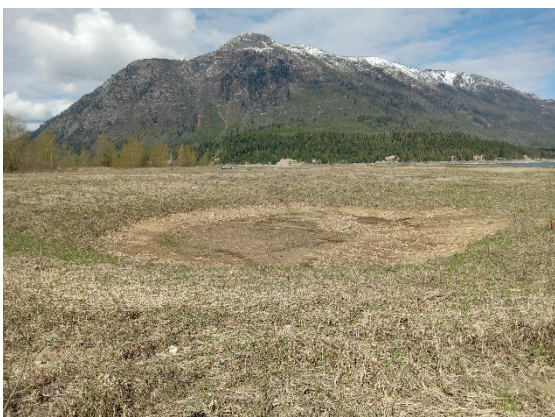
Photo 23: Wetland B1 and Piezometer, Looking West

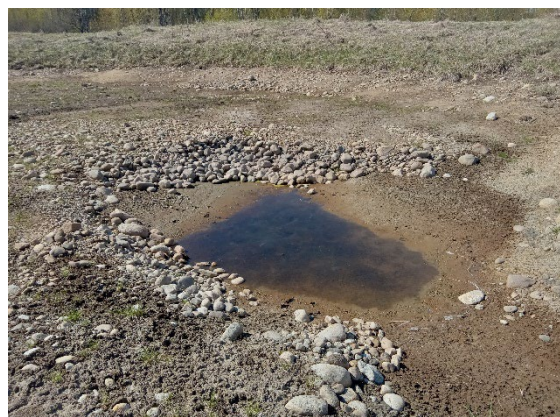
Photo 24: Wetland B1 Deep Pool

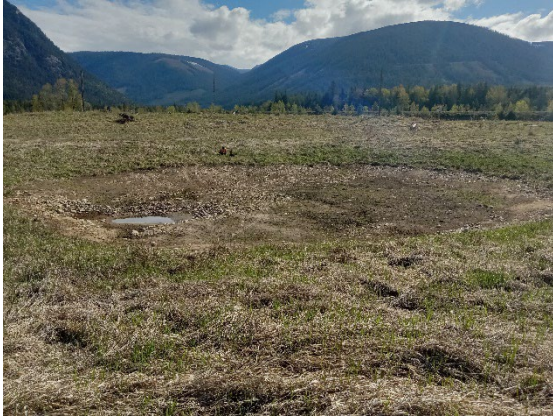
Photo 25: Wetland B1, Looking East

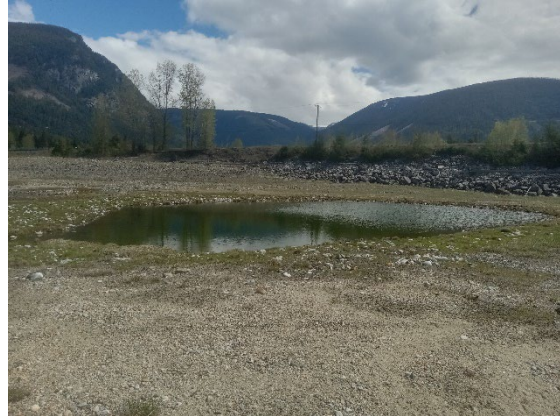
Photo 26: Wetland B2, Looking Northeast

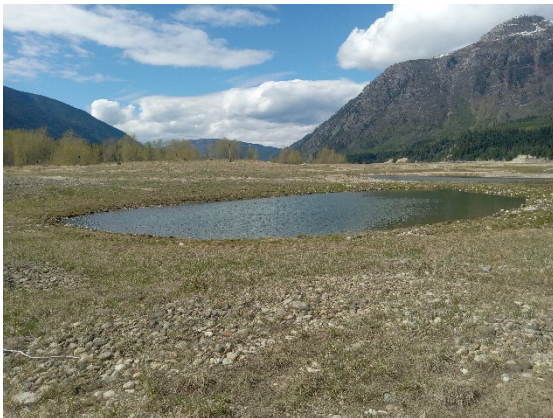
Photo 27: Wetland B2, Looking North

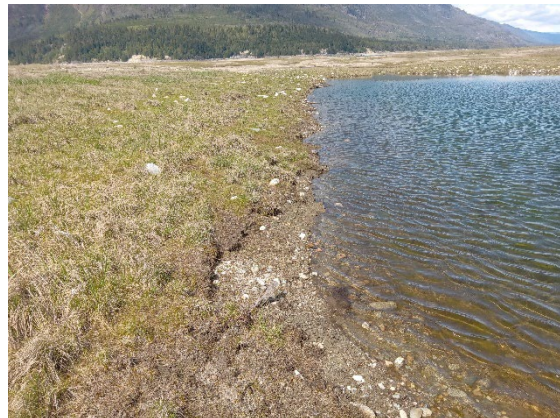
Photo 28: Minor Wave Erosion at South Edge of B2

3. Monitor the edges of Wetland B2 and Ponds D1 and D2 up to their respective high-water marks for signs of worsening impacts due to wave-induced erosion, such as impacting inlet or outlet function, or eroding back to another feature such as a pond, mound, or channel. These ponds are more susceptible to erosion from wave action given the lack of established vegetation and the exposed fine soils on their slopes. Increase of established vegetation that may occur with time, or placement of similar cobble material to what is observed at some of the inlet and outlet channels may potentially reduce this erosion.

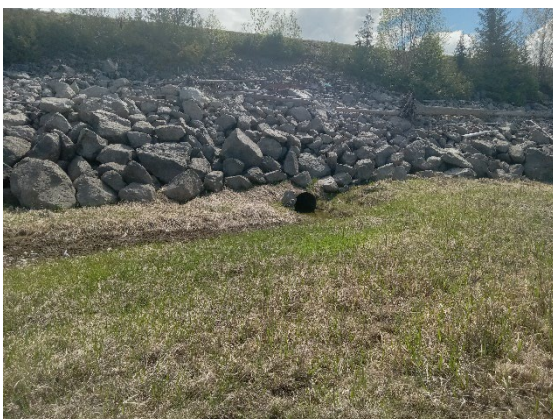
Photo 29: Highway Culvert Flowing Towards B2

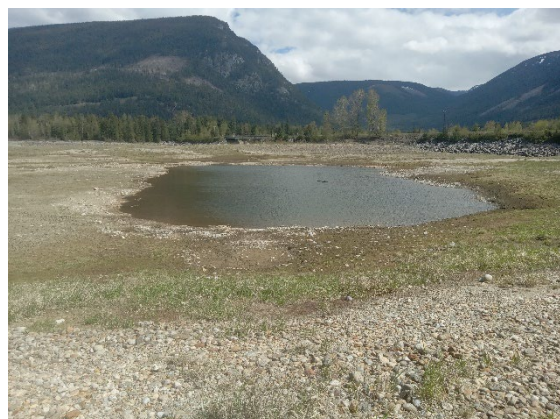
Photo 30: Pond D1, Looking Northeast

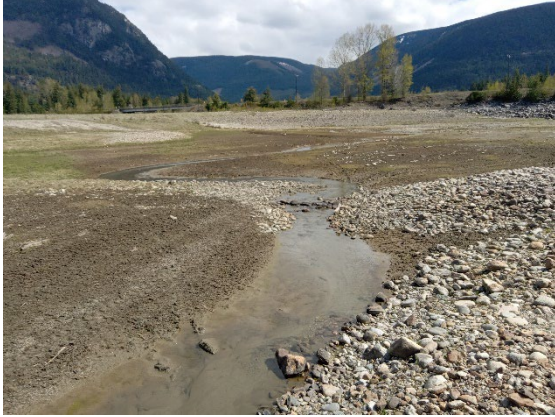
Photo 31: Channel Flowing from B2 towards D2

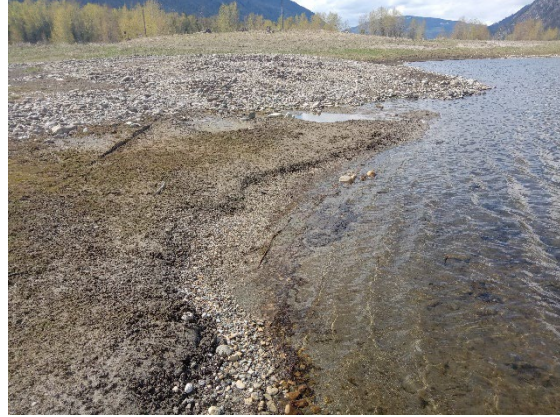
Photo 32: Minor Wave Erosion at D1

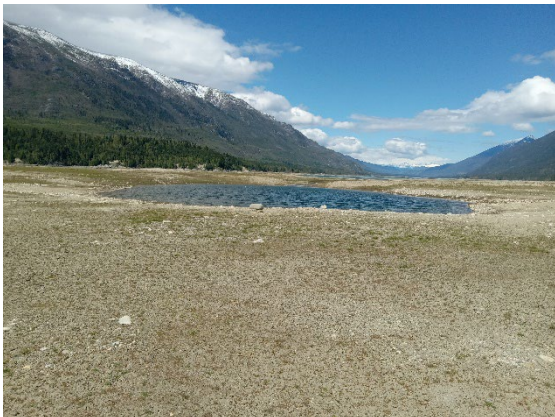
Photo 35: Pond D2, Looking Northwest

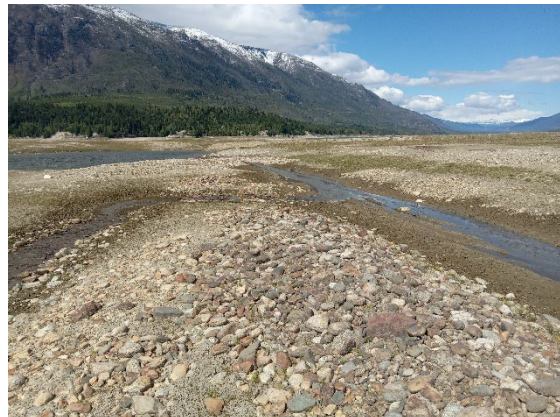
Photo 36: Inlet Channel From B2/D1 To D2.

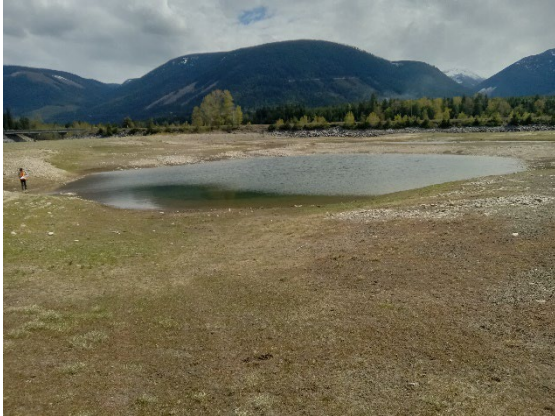
Photo 37: Pond D2, Looking Northeast

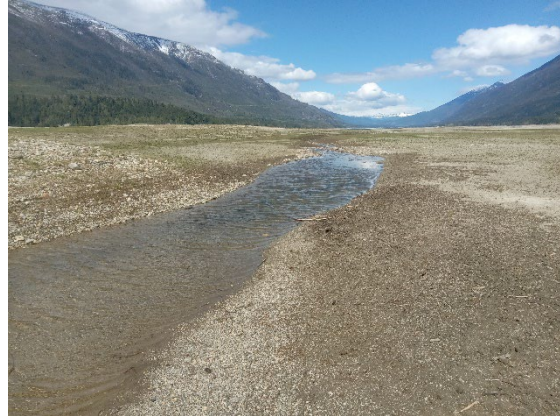
Photo 38: D2 Outlet Channel, Looking North

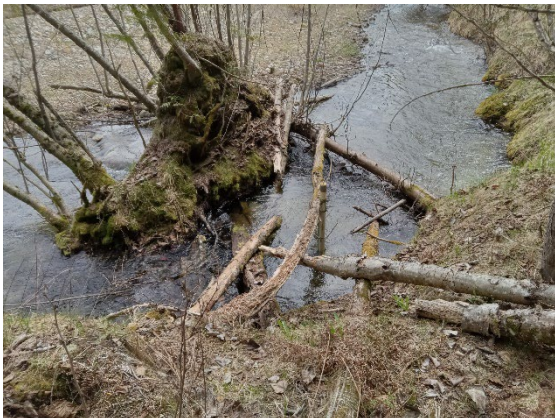
Photo 39: Burton Creek Gauge (prior to securing the gauge during the fall visit)

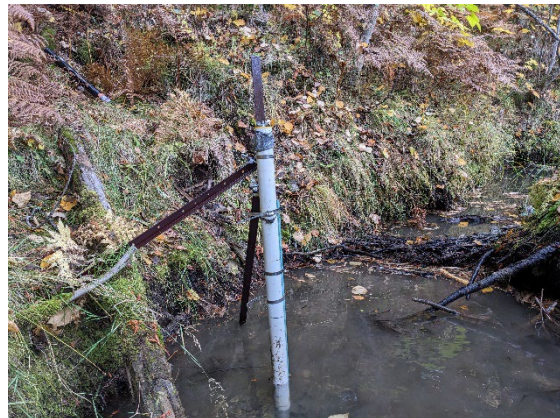
Photo 40: Burton Creek Gauge Following Re-Securing During Fall Visit (October 17, 2024)

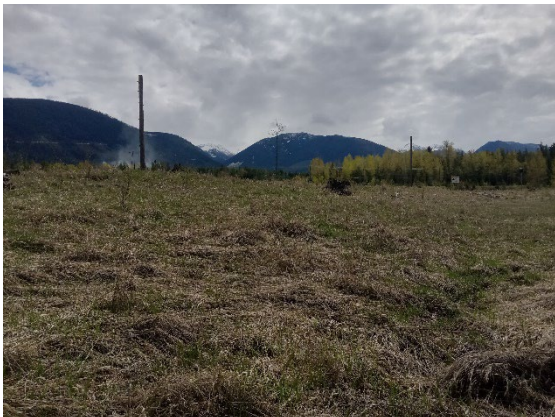
Photo 41: West Side Of Mound C2

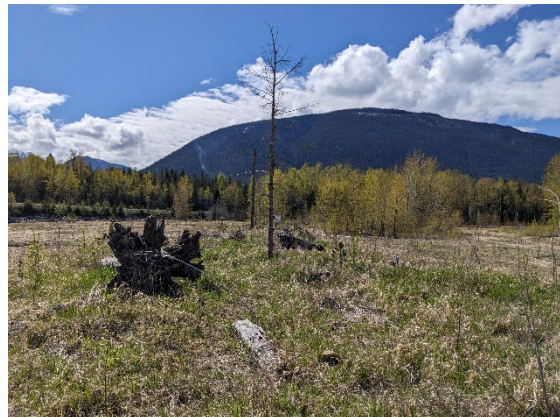
Photo 42: Top of Mound C2, Looking South Toward Mound C3

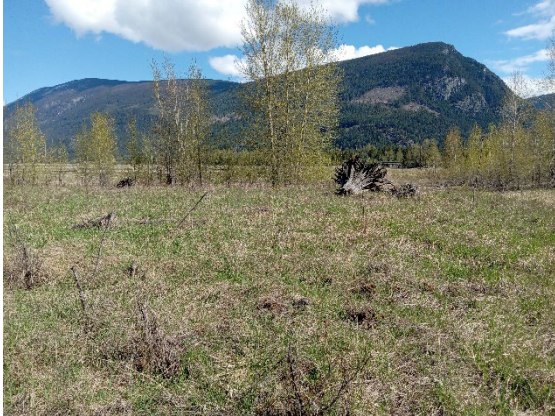
Photo 43: Top of Mound C3, Looking Northeast

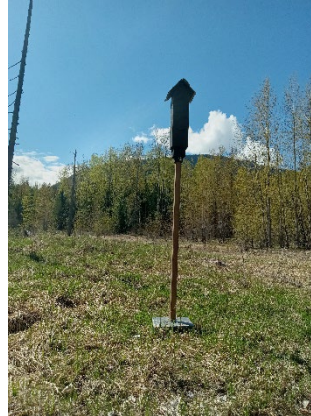
Photo 44: Bat Box On Mound C3

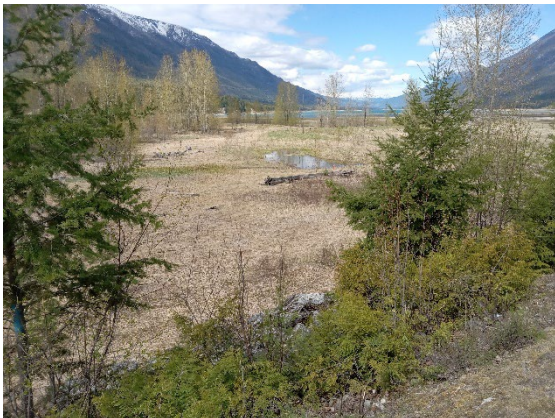
Photo 45: Wetland A1, Looking East From Hwy 6

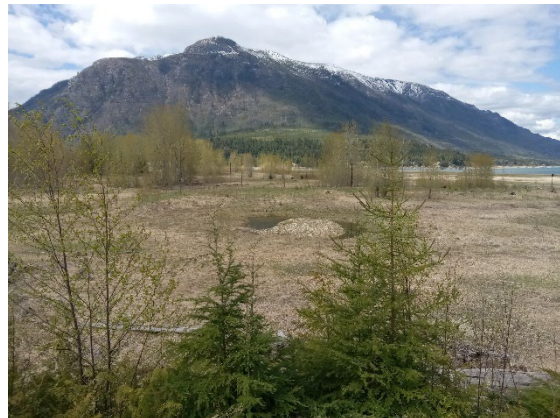
Photo 46: Wetland A2, Looking East From Hwy 6

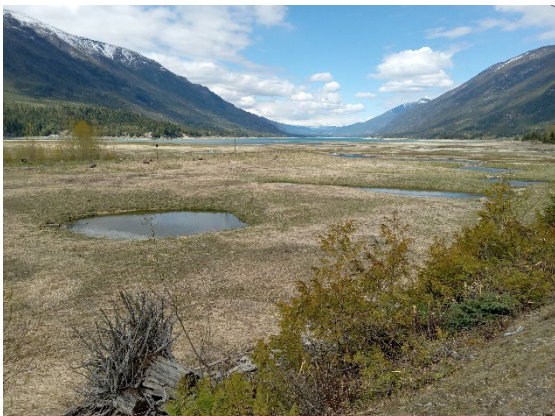
Photo 47: Wetland A3, Looking East From Hwy 6

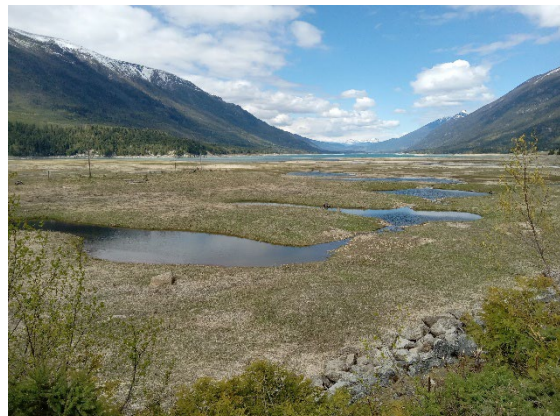
Photo 48: Wetland A4, Looking East From Hwy 6

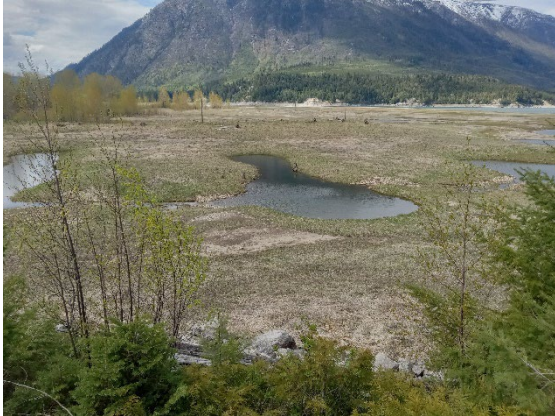
Photo 49: Wetland A5, Looking East From Hwy 6

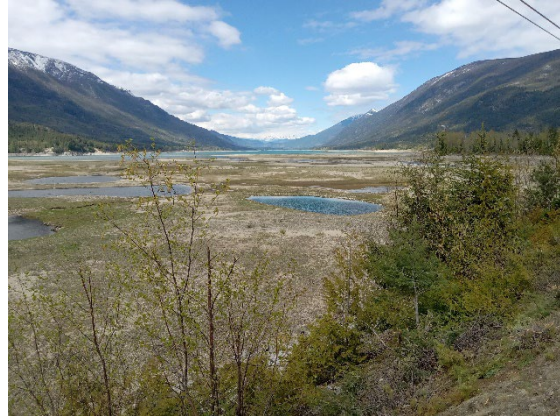
Photo 50: Wetland B2, Looking North from Hwy 6

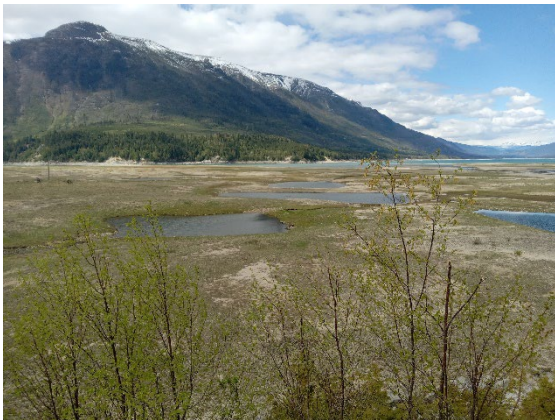
Photo 51: Wetland A6 and Ponds D1 and D2, Looking Northeast from Hwy 6

2. Monitor the erosion that is occurring on the south slope of Pond D1. The erosion is not presently a concern as it does not appear to be presently impacting the function of the works. However, if the erosion continues above the high-water line/edge of vegetation, input from a qualified professional should be sought to recommend remedial measures, which may include placing coarse granular material along the slope and eroded areas to prevent cutback into Mound C2 and/or connection to an upstream pond. This feature should be inspected during the yearly (or twice-yearly) monitoring visits in the Spring to note potential increases in the rate of erosion.
