Columbia River Projects Water Use Plan

Kinbasket Reservoir and Mid-Columbia River Boat Launch Ramps Feasibility Study

Reference: CLBWORKS-18

October 5, 2007

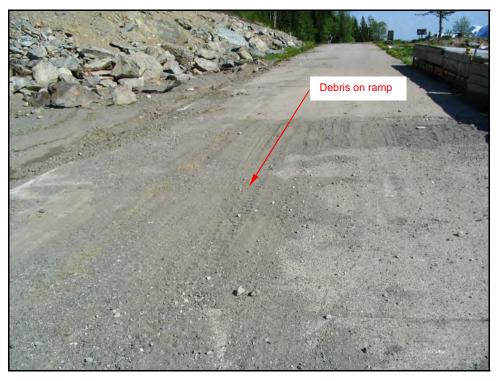
At the time of the field visit, a portion of the existing concrete boat launch ramp was covered with sediment carried by rain and snow runoff from the adjacent road embankment. To alleviate the problem, a new ditch was excavated along the toe of the road embankment to channel the surface water away from the ramp. The road embankment slope will require stabilization works to prevent the embankment fill from migrating on to the boat launch ramp (see photograph 5 in Appendix B).

Photo No. 10: Taken on 2007-05-25 at Valemount Marina Boat launch ramp showing debris on the ramp from adjacent sloped area.

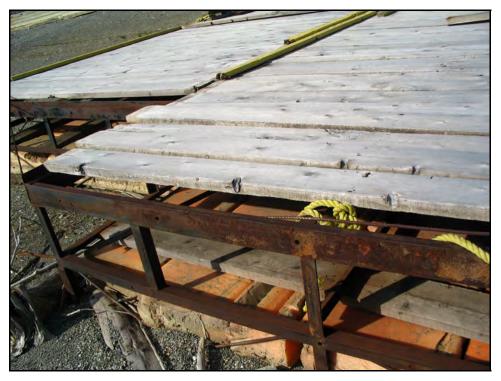
A cursory examination of the existing walkway and boat slip floats revealed that there is some minor corrosion of uncoated sections of the structural steel frame members of the walkway and marina floats as shown on photographs 16 and 18 in Appendix B.

Photo No. 18: Taken on 2007-05-25 at Valemount Marina Close-up view of steel frame member for marina floats.

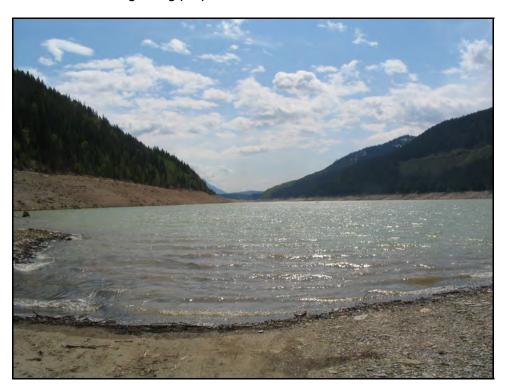
Photo No. 26: Taken on 2007-05-23 at Nixon Creek

The Nixon Creek site is an undeveloped site with no infrastructure for a boat launch ramp. Access to the reservoir is a gravel ramp with a natural slope of approximately 7%, with the end of the existing boat launch ramp facing south where it is exposed to prevailing southern winds and waves as shown in photograph 26.

End of existing gravel boat launch ramp. A view of the southern fetch near the end of the existing boat launch ramp. Note long southern fetch and wave action at end of ramp site.

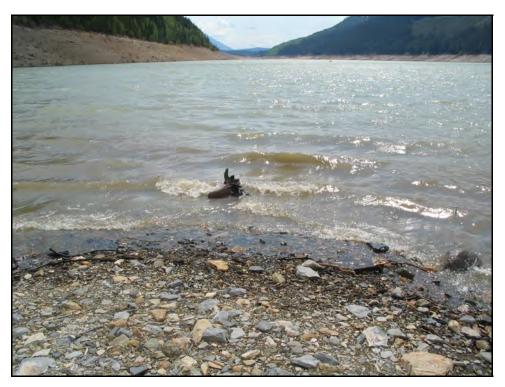
Photo No. 27: Taken on 2007-05-23 at Nixon Creek End of existing gravel boat launch ramp. A southern view from the end of the existing boat launch ramp site. Note wave action at end of launch ramp.

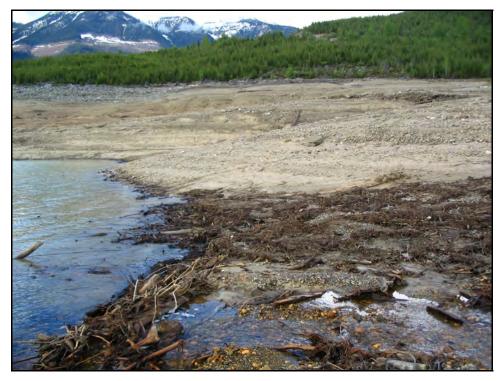
Photo No. 40: Taken on 2007-05-23 at Bush Harbour View of existing high level boat launch ramp. Note stream meandering down the slope.

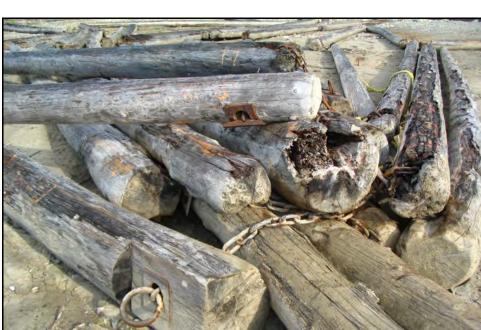
Photo No. 50: Taken on 2007-05-23 at Bush Harbour Close-up view of abandoned log breakwater located at top section of Bush Harbour.

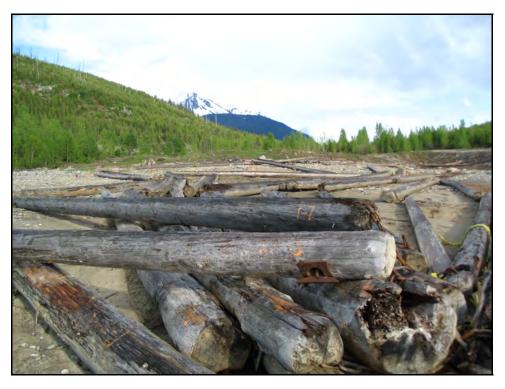
Photo No. 51: Taken on 2007-05-23 at Bush Harbour Close-up view of other abandoned log breakwaters at Bush Harbour.

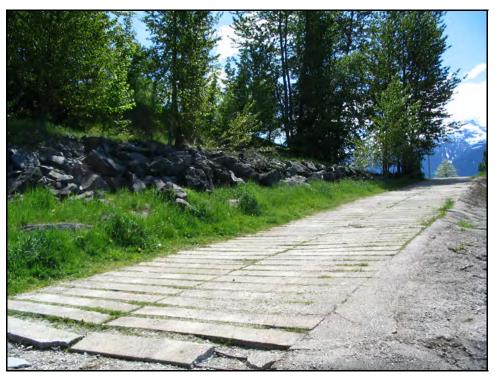
Photo No. 61: Taken on 2007-05-24 at Centennial Park Broken Concrete planks at the end of the boat launch ramp.

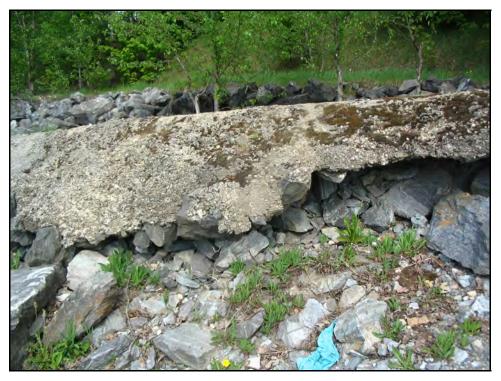
Photo No. 65: Taken on 2007-05-24 at Centennial Park Close-up view of damaged concrete planks in the boat launch ramp.

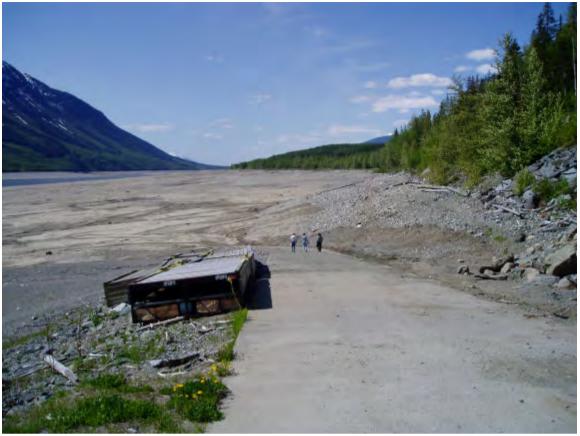
Plate 1. Looking north along the existing boat ramp at Valemount Marina.

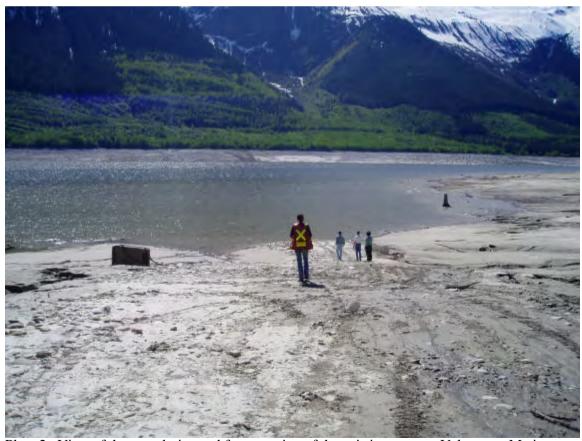
Plate 2. View of the area designated for extension of the existing ramp at Valemount Marina.

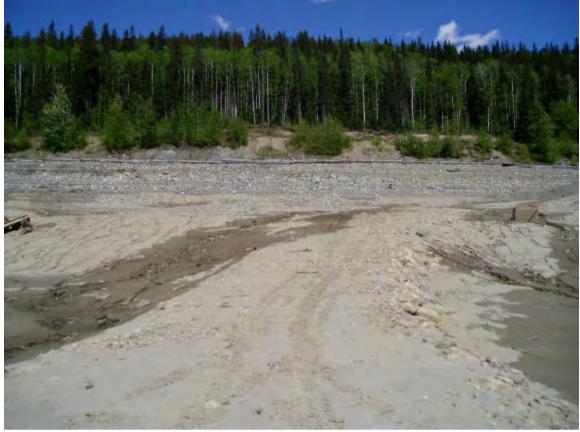
Plate 3. Looking east towards the upland area at Valemount Marina. Forested area has been previously harvested.

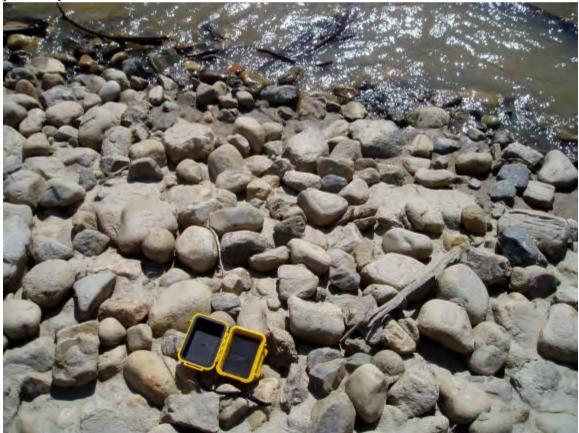
Plate 4. Lakebed substrate located at the end of the proposed extension of the ramp at Valemount Marina.

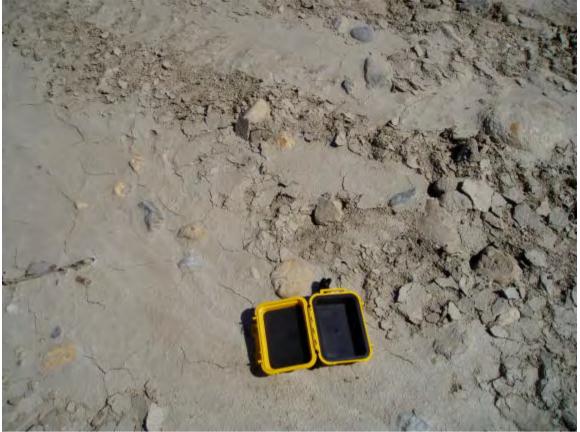
Plate 5. Lakebed substrate indicating abundant sediment is deposited at this location. Typical of area designated for ramp extension.

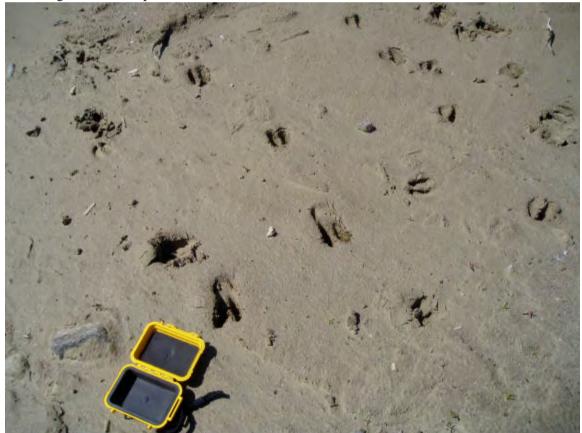
Plate 6. Showing the extent of ungulate usage near water seepage areas upslope of the proposed extension.

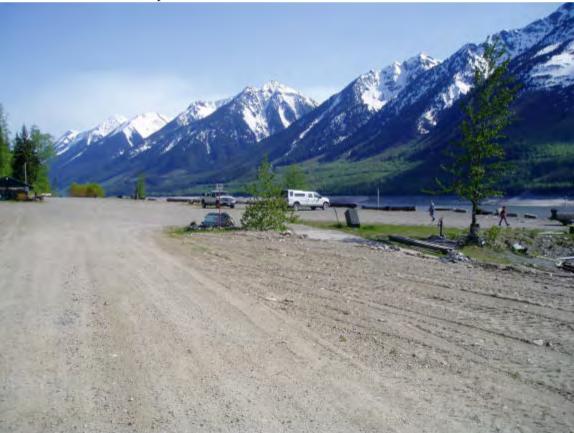
Plate 8. Looking south at developed upland area used for parking and camping during peak season.

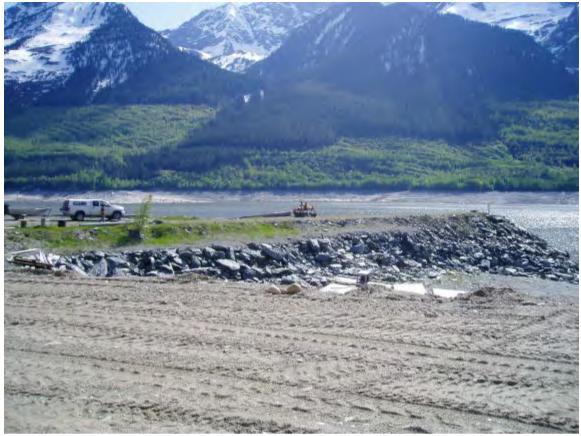
Plate 9. Looking east towards constructed spit designed to protect existing boat ramp.

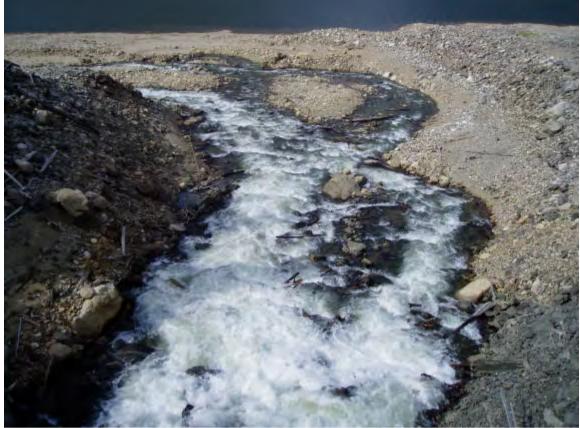
Plate 12. Looking west at mouth of Bulldog Creek at current reservoir levels.

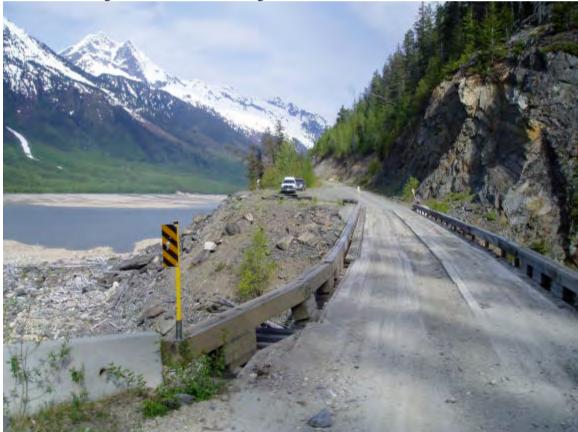
Plate 13. Looking north along East Canoe FSR and bridge over Bulldog Creek.

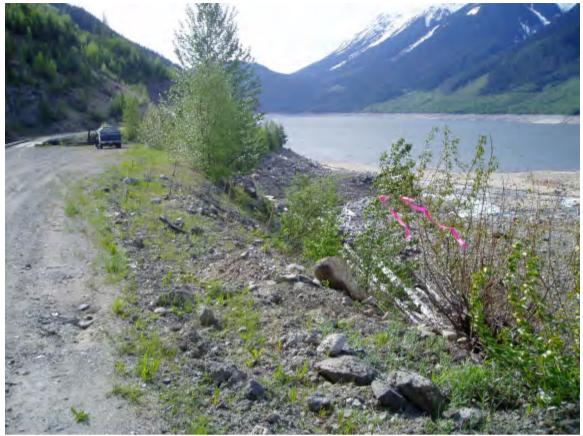
Plate 14. Pink flags indicate possible point of access for construction of new ramp at Bulldog Creek.

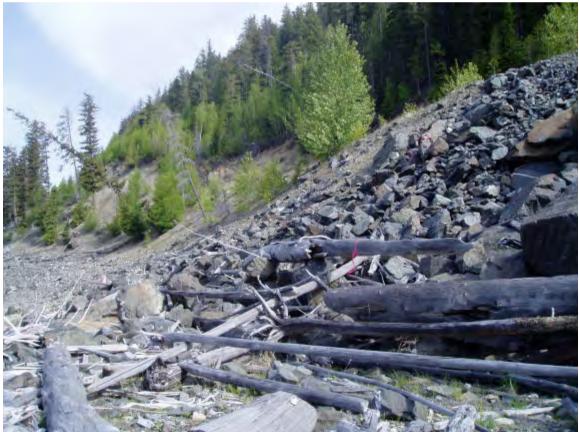
Plate 15. View of the slope below road at Bulldog Creek. Pink flag indicates possible road centerline.

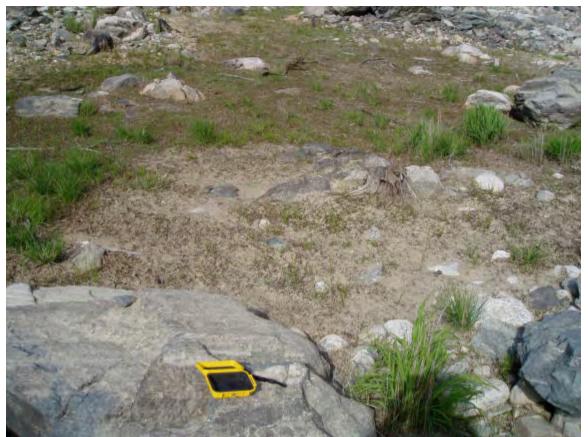
Plate 16. View of the sediment and vegetation in low elevation area that Bulldog Creek uses very temporarily as reservoir levels rise.

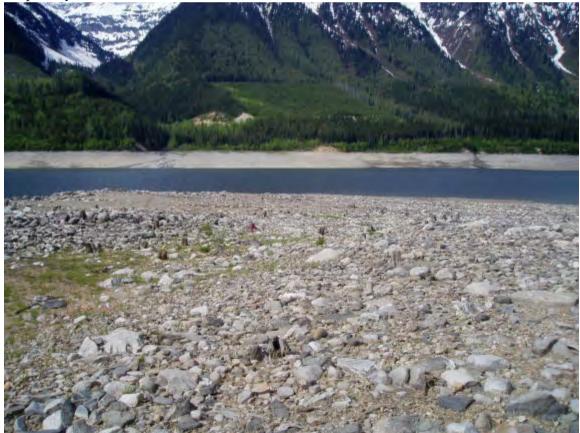
Plate 17. View of the proposed boat ramp location at Bulldog Creek.

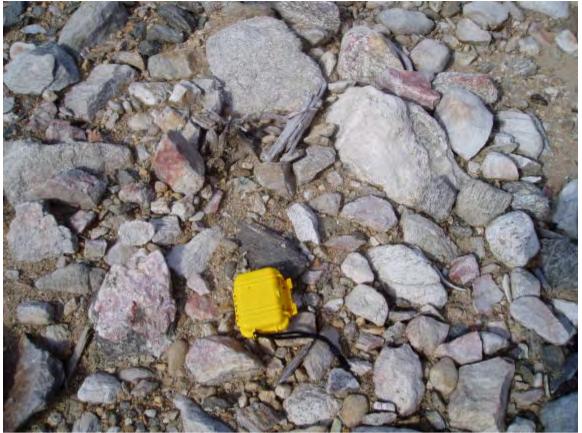
Plate 18. View of the substrates which would be impacted during construction of road at Bulldog Creek.

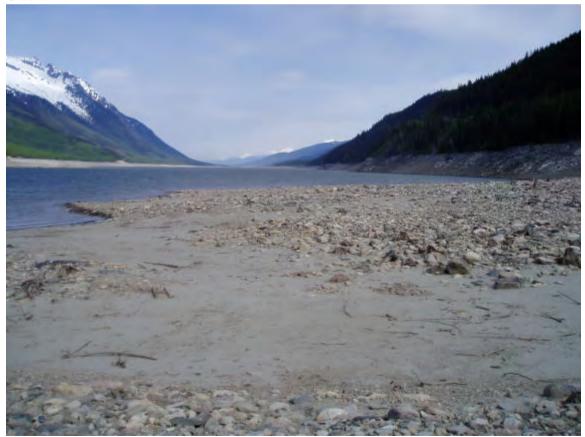
Plate 19. View of the lakebed at the proposed Bulldog Creek site.

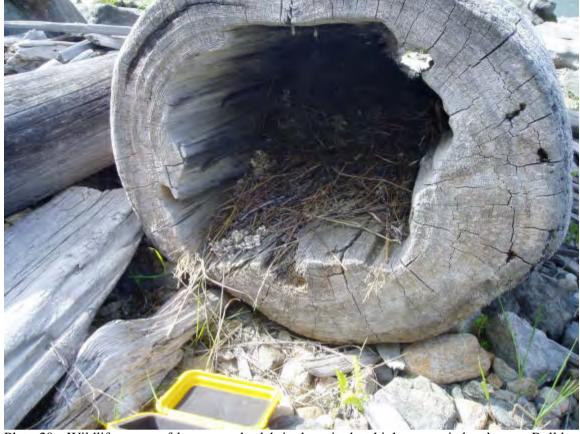
Plate 20. Wildlife usage of large woody debris deposited at high reservoir levels near Bulldog Creek.

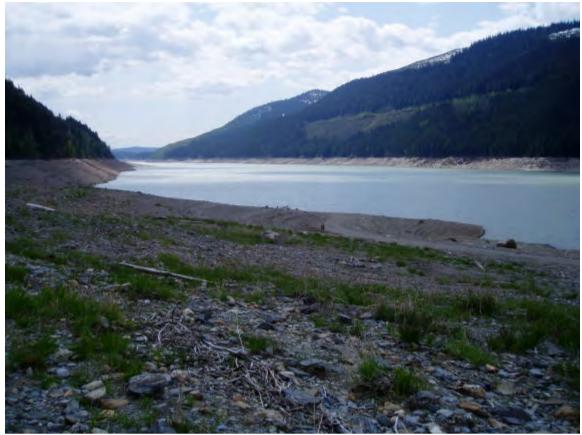
Plate 21. Looking south towards access road and existing boat ramp at Nixon Creek.

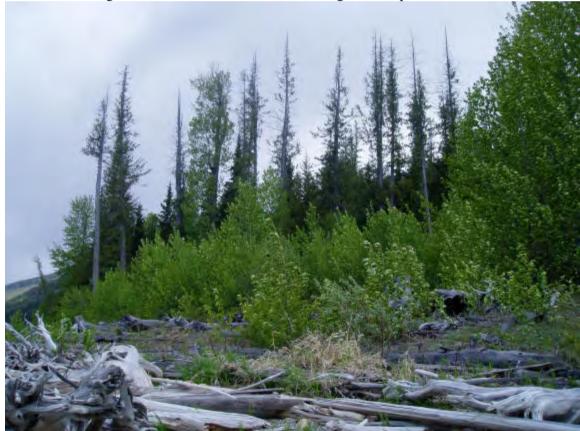
The upland area at Nixon Creek currently provides habitat for a variety of songbird species, ungulates, bears, and small furbearers (Appendix 1; Plate 22). Evidence of black bear was observed along the roadway leading to the site and deer tracks were observed in the finer substrates near the end of the existing boat ramp (Appendix 1; Plate 25). Evidence of caribou further up in the Nixon Creek drainage has been recorded (McLellan and Flaa 2003). The upland area has not been designated as ungulate winter range but an enhanced resource development zone (Govt. of BC 1995).

Plate 22. Current upland area located by Nixon Creek boat ramp.

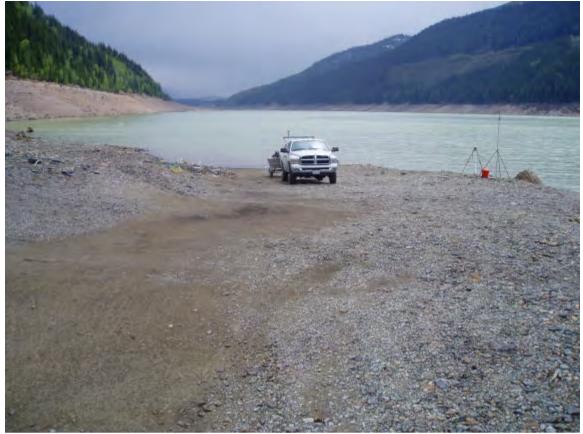
Plate 23. Gravel boat ramp currently used at Nixon Creek.

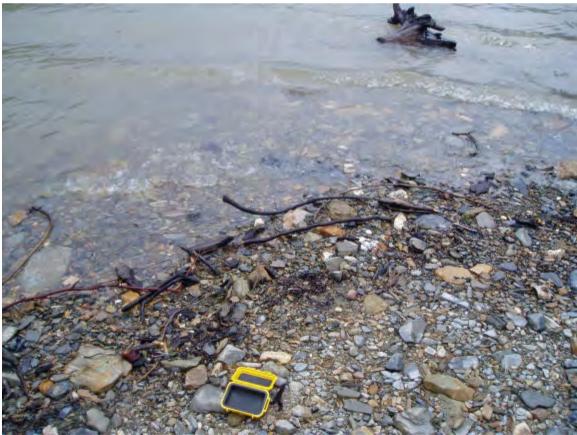
Plate 24. Lakebed substrates at location of possible extension of ramp at Nixon Creek.

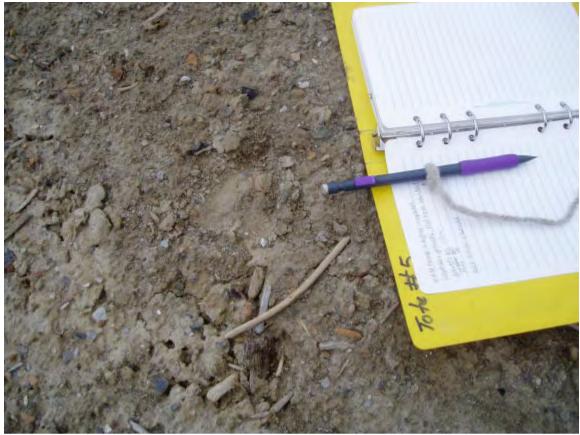
Plate 25. View of ungulate (deer) tracks upslope of the existing ramp at Nixon Creek.

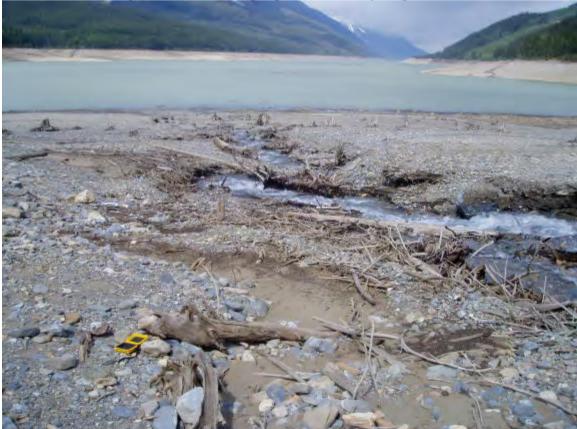
Plate 26. View of confluence of Nixon Creek with Kinbasket Reservoir. Located 700 m north of boat ramp.

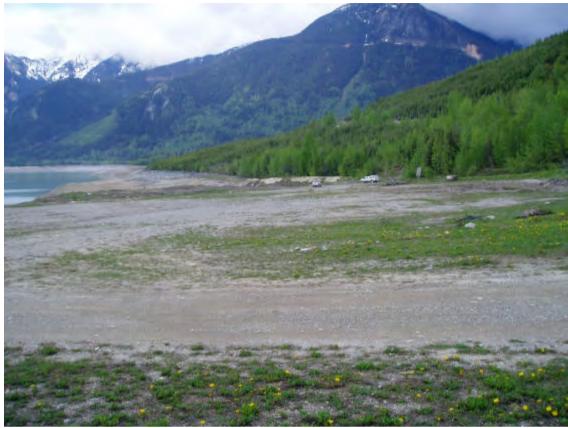
Although the upland area has been significantly disturbed, it does provide habitat for a variety of songbird species, ungulates, grizzly bears, black bears, and small mammals (Appendix 1; Plate 27). American robin, northern flicker, killdeer and kinglet were some of the bird species observed in the area. A bear carcass was observed near the upland area and had likely been poached since the feet and head had been removed. Grizzly bear tracks were observed along the lakeshore between the gravel ramp and the berm and ungulate tracks were observed in the upland area (Appendix 1; Plate 32). A red-tailed hawk was observed flying overhead.

Plate 27. Looking north at upland area at Bush Harbour.

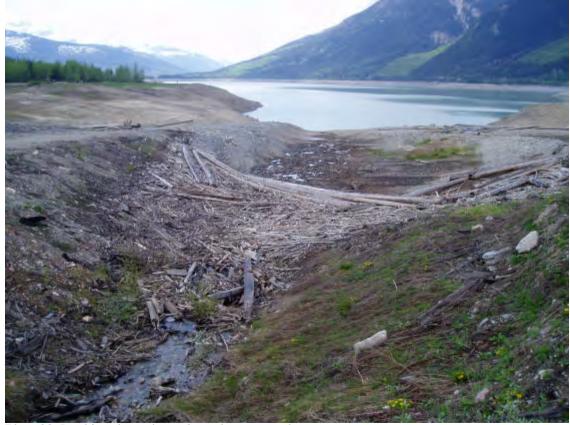
An unnamed tributary to the reservoir was observed in the vicinity of the boat ramp (Appendix 1; Plate 28). It currently flows north along the eastern edge of the existing berm likely created as a high water level ramp. At the current reservoir levels, some minor falls over LWD were observed which may be barriers to upstream migration (Appendix 1; Plate 31). In addition, a 100 m long culvert was found that transports the flows from the stream upslope of the parking area to the start of the berm. During the assessment, this stream was greater than 20 m away from the existing ramp and should therefore not be affected by the construction.

Plate 28. Looking downslope along the unnamed stream.

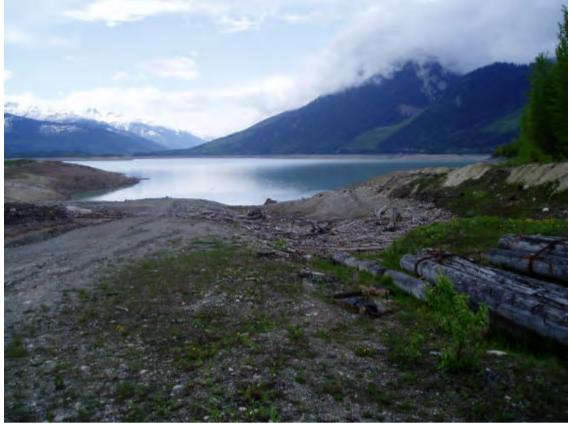
A non-classified drainage was observed immediately east of the ramp proposed for extension (Appendix 1; Plate 29). There was a defined channel through the lower sections of the drainage where the flows were scouring out some of the fine lakebed substrate but upslope of the high water mark, it flowed over the vegetation. During the summer, this drainage is likely dry but if flows are present during construction, isolation measures will be required to prevent sediment mobilization (Section 4.2.4).

Plate 29. View of existing ramp at Bush Harbour.

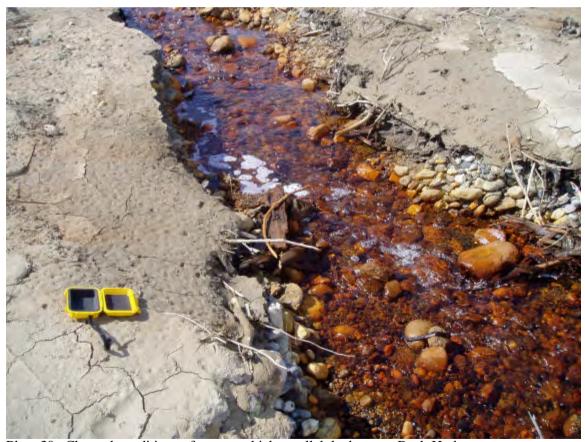
Plate 30. Channel conditions of stream which parallel the berm at Bush Harbour.

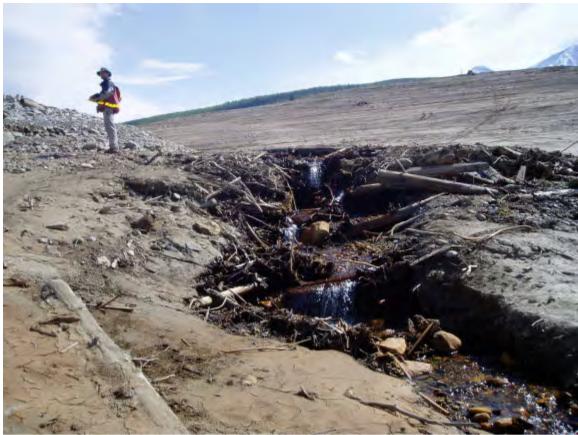
Plate 31. Upstream view of potential barriers to fish use at low reservoir levels. Note end of current high water ramp at upper left of frame.

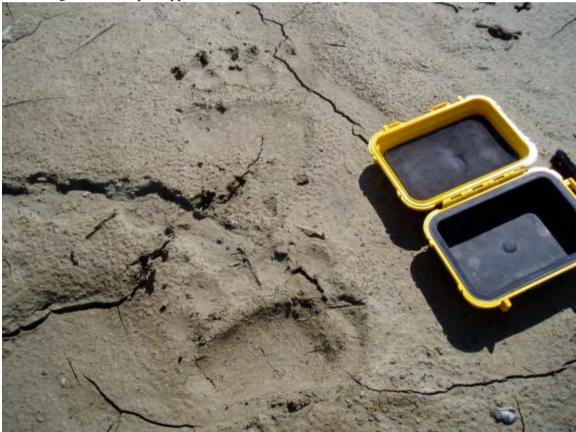
Plate 32. View of the grizzly tracks observed near stream and just upslope of the current reservoir level.

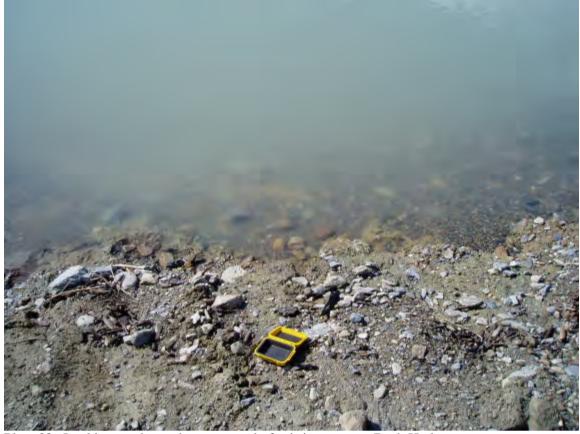
The lakebed substrates at the end and along the existing boat ramp are cobbles and gravels which appear to have been deposited during the creation of this gravel ramp (Appendix 1; Plates 33 and 34). The surrounding lakebed substrates are dominantly fines and silts. The fine substrates in this area do not provide adequate rearing or spawning habitat for most species in the waterbody. There was an absence of aquatic vegetation and LWD surrounding the boat ramp.

Plate 33. Looking north at substrate at end of existing ramp at Bush Harbour.

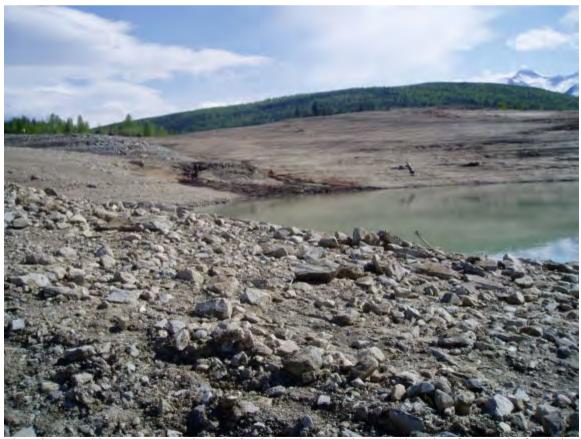
Plate 34. Looking west towards end of existing berm and stream location from end of existing ramp.

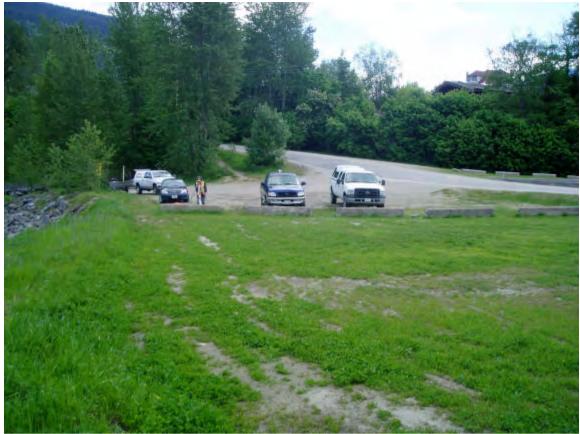
The upland area surrounding the existing boat ramp location is developed and used as local park. There are adequate parking areas and the access road is paved (Appendix 1; Plate 35). It is likely that the vegetated areas nearby provide habitat for songbirds, small mammals, amphibians and reptiles.

Plate 35. Looking east towards the existing upland areas at Centennial park boat ramp

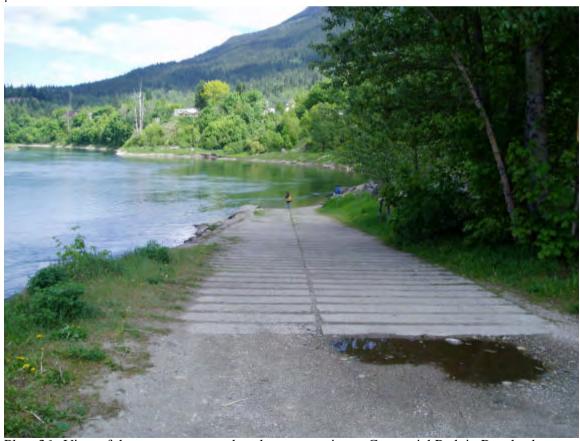
The existing concrete plank ramp (Appendix 1; Plate 36) will be extended by 24 m with no changes to the upper part of the ramp or the existing parking area. A floating walkway attached to steel piles will be constructed. A total disturbance footprint area of 120 m² will be required to extend this ramp and the disturbance footprint of the piles will be minimal. A rumble mound breakwater may also be proposed 40 m upstream of the end of the ramp to provide decreased water velocities for boaters during deployment. This breakwater would be approximately 90 m long and have a base of 35 m wide creating a disturbance footprint on the channel bottom of 3150 m².

Plate 36. View of the current ramp and upslope vegetation at Centennial Park in Revelstoke.

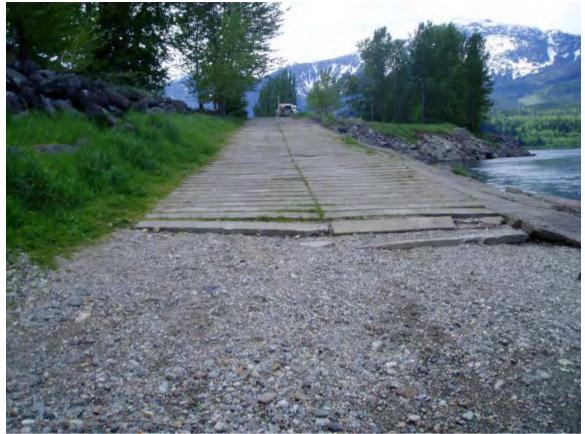
Plate 37. Looking southwest at current ramp conditions at Centennial Park. Note riprap bank protection downstream of ramp.

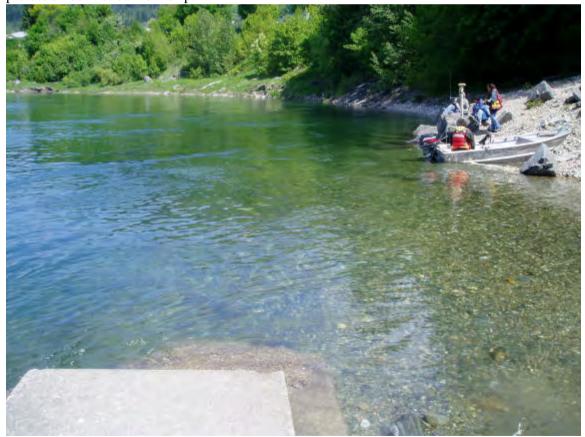
The Mid-Columbia River in the vicinity of the boat ramp provides deep run habitat along the bend with suitable spawning gravels and cobbles along the channel margin (Appendix 1; Plate 38). This habitat has been considered transitional habitat for a number of species found within the Columbia River such as white sturgeon, Kokanee, bull trout and rainbow trout. The gravels and cobbles at the end of the existing ramp and further upstream along the channel margin have been used by Kokanee for spawning (Gadbois 2007). Kokanee usually spawn in gravel/cobble substrate and areas with flow velocities between 0.15 and 0.72 m/s (Ford *et al.* 1993). Close proximity to cover such as deep pools or large woody debris, is also important for the protection of adults while spawning and for emerging fry. Overall, the extreme fluctuations in water levels in this area may reduce the likelihood of channel margins being using as spawning areas if they become dewatered. The water levels during the field assessment were 2 - 3 m above low water levels (Gadbois 2007).

Plate 38. Riverbed substrate that would be converted to concrete if ramp extended.

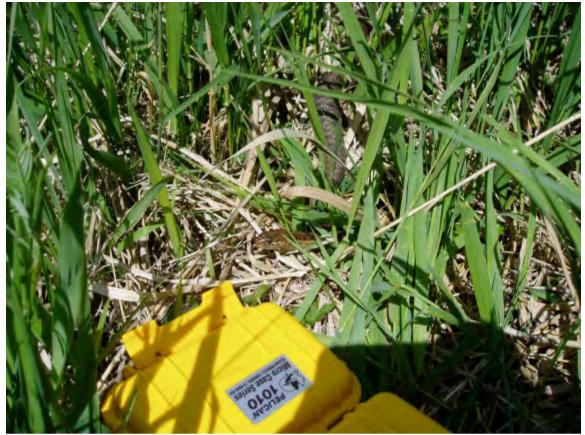
In the areas surrounding Revelstoke, there is potential habitat for a variety of bird species. For example, Machete Island located south of the Illecillewaet River is a known habitat area for yellow warblers (Green and Quinlan 2007). Old cottonwoods, old willows and other shrub species create good nesting and foraging habitat for these and other birds such as osprey. The grassland areas also provide nesting areas for short-eared owls, Canada geese, and other waterfowl. Active great blue heron nest have been recorded around Revelstoke (Machmer and Steeger 2003) but none were observed in the vicinity of the project site. During the field assessment Canada geese were observed on the river and along the bank just upstream of the ramp. Osprey were flying overhead and northern flicker, American robin, dark eyed junco, and western garter snake were observed around the site (Appendix 1; Plate 39).

Plate 39. Western garter snake observed just downstream of ramp in vegetated upslope area.

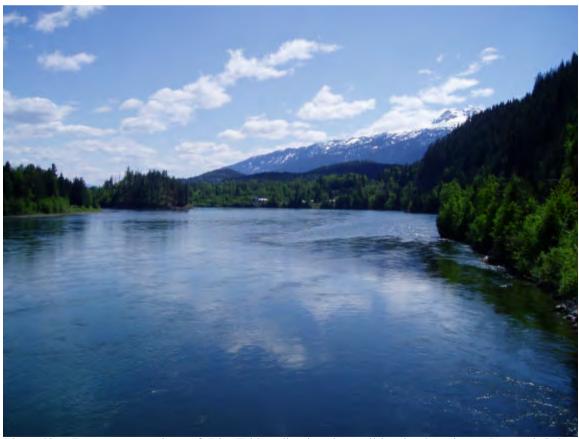
The closest streams, excluding the Mid-Columbia River, to the existing boat ramp at Centennial Park is the Tonkawatla River (WSC: 300-752700) (1.7 km south) and the Illecillewaet River (WSC: 300-675200) (2.1 km south). These streams are known to support populations of torrent sculpins, brook trout, bull trout, Kokanee, Westslope cutthroat trout, and rainbow trout (FISS 2007). The area known as the Big Eddy is located 2.6 km upstream along the right bank and is known to be a holding area for adult white sturgeon prior to spawning in nearby Jordan River and below the Revelstoke Dam (Appendix 1; Plate 40) (UCWSRT 2002).

Plate 40. Downstream view of Big Eddy; dismissed possible site location. Located 8 km downstream of Revelstoke Dam and a known area for white sturgeon.

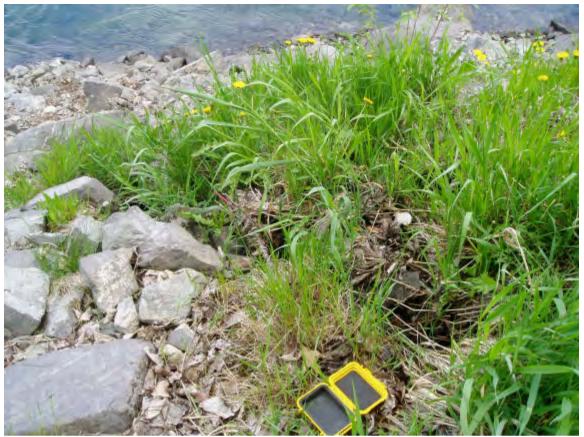
There is one minor seepage located 50 m downstream from the existing boat ramp but is classified as a non-classified drainage (Appendix 1; Plate 41). Although a small gully was present, no defined channel was observed and water flows over the riprap protecting the bank prior to entering the river.

Plate 41. View of non-classified drainage located downstream from existing ramp.
