**RE: British Columbia Utilities Commission (BCUC or Commission)
British Columbia Hydro and Power Authority (BC Hydro)
Electrical Explosion Incident – Marine Building, Downtown Vancouver**

I am writing to provide the results of BC Hydro's investigation into the explosion and fire that occurred in one of BC Hydro's underground vaults (Vault No. 73) on the 300 block of Burrard Street in Vancouver at approximately 6:00 pm on February 24, 2023. Two members of the public were injured, and several businesses were damaged.

12. The scope of this report is to document the investigation of the cause of the explosion and fire that occurred on February 24, 2023 (collectively, the “Incident”).

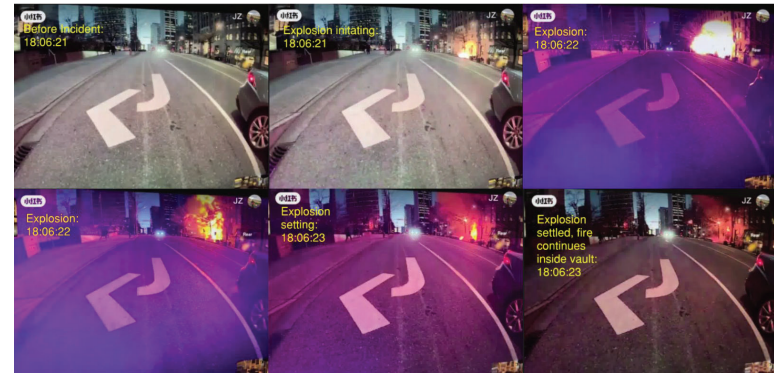
- 26. The video footage captures the initial explosions and flame looking backward from the vehicle. Still captures of the video illustrate the incident in Figure 7. The imaging captures the explosion, which occurred over approximately 2 seconds, before subsequently burning. No visible irregularities prior to the explosion are observable in the video. Time estimates are best estimates based on time in video image and frame counting.

Figure 7: Still captures from video footage of explosion event.

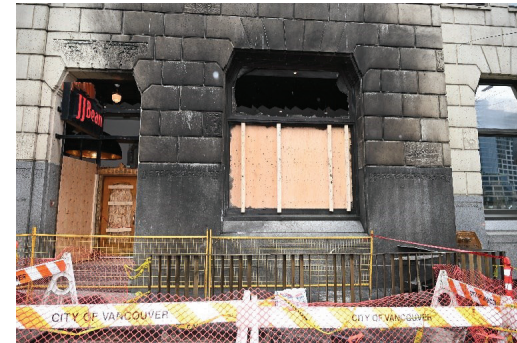
34. The glass windows and door of JJBean were broken from the Incident, as seen in Figure 9. This likely occurred in combination with the initial explosion and the subsequent heat exposure from the fire. The glass above the doorway to JJBean had one pane broken, but two remained intact.

Figure 9: JJBean café east façade.

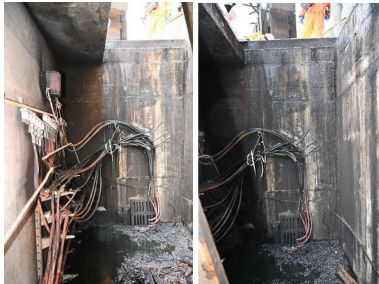
Figure 17: South end of V73.

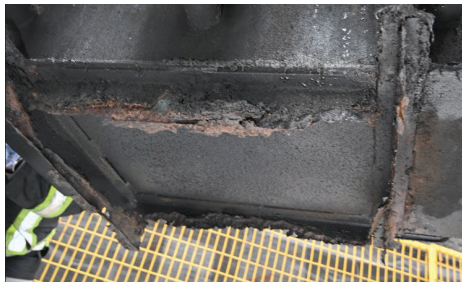
Figure 22: Transformer underside.

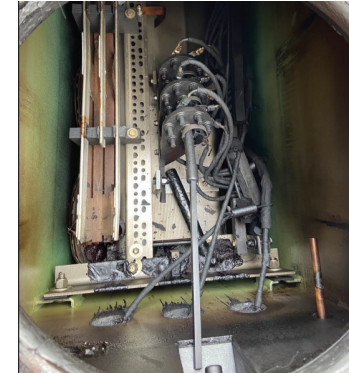
Figure 23: Transformer inside.

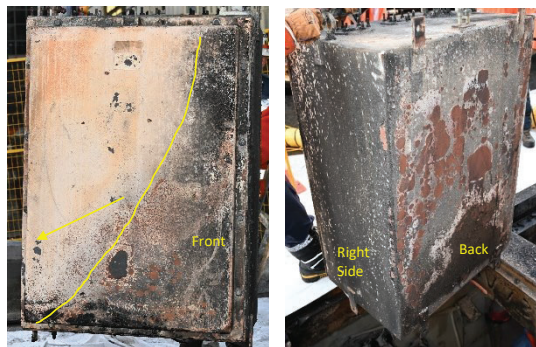
Figure 25: Front of CLF cabinet (left); back-right side of CLF cabinet (right).

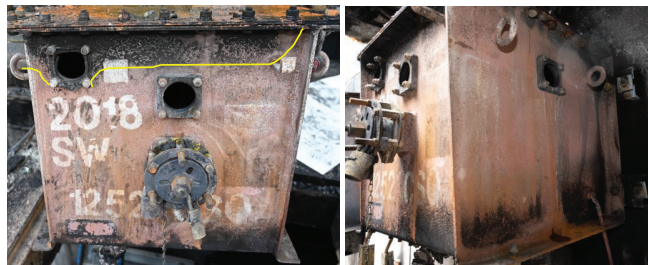
Figure 29: SW2018 front and right-side view.

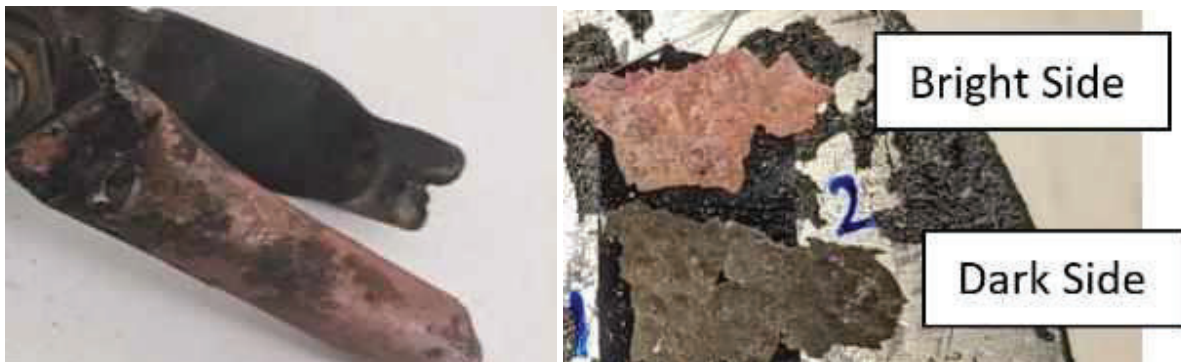
On the surface of the bulk of the blades were darker regions (Figure 15). When analyzed by SEM-EDS for their elemental composition, it showed the dark material to contain copper, but aluminum, tin, calcium, and carbon were the predominant elements. Zinc was also present in minor amounts. When scraped with a blade or abrasive disc, the black region would be removed, exposing a copper surface. This indicates the aluminum on the actual blades was a result of a deposition and not an intrinsic part of the blades.

Figure 15. Dark side/section of switch 2019 blade analyzed

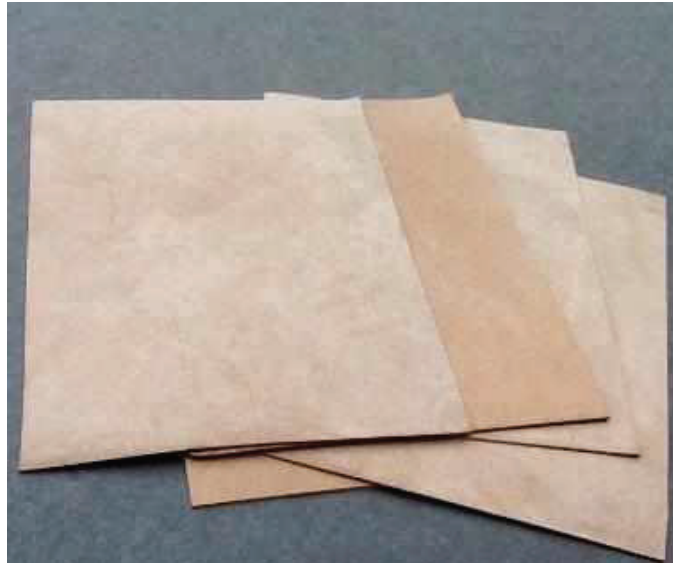
The gasket material used on the switches has a trade name of Nebar (confirmed by BCH field maintenance personnel). Nebar is composed of a rubber chosen for an application, bonded to cork. The material is formed into a flat sheet and cut into the required gasket shape to seal flat surfaces against fluid leakage (Figure 20).

The gaskets in the switches were not always single pieces of Nebar with holes punched out for the bolts. Instead, the gaskets were composed of four separate strips (one for each side of the tank) of the Nebar, with holes punched to allow the bolts to go through. Nebar materials are for use at temperatures less than 100°C (and no more than 120°C). Additionally, Nebar materials should only be used at low internal system pressures (5 bar; 60 PSI or below). Depending on the type of fluid contained in the equipment, various grades of Nebar can be used. However, no Nebar material should be used for sealing highly acidic or highly alkaline fluids, or for fluids that are slightly acidic or alkaline for extended periods of time (months or years), as the non-neutral pH will degrade the cork. To specify a Nebar for a particular application, it is always recommended to contact the manufacturer of the Nebar gaskets to determine which type and if any Nebar material is appropriate for the application.

Figure 20. Photo of some types of Nebar sheets

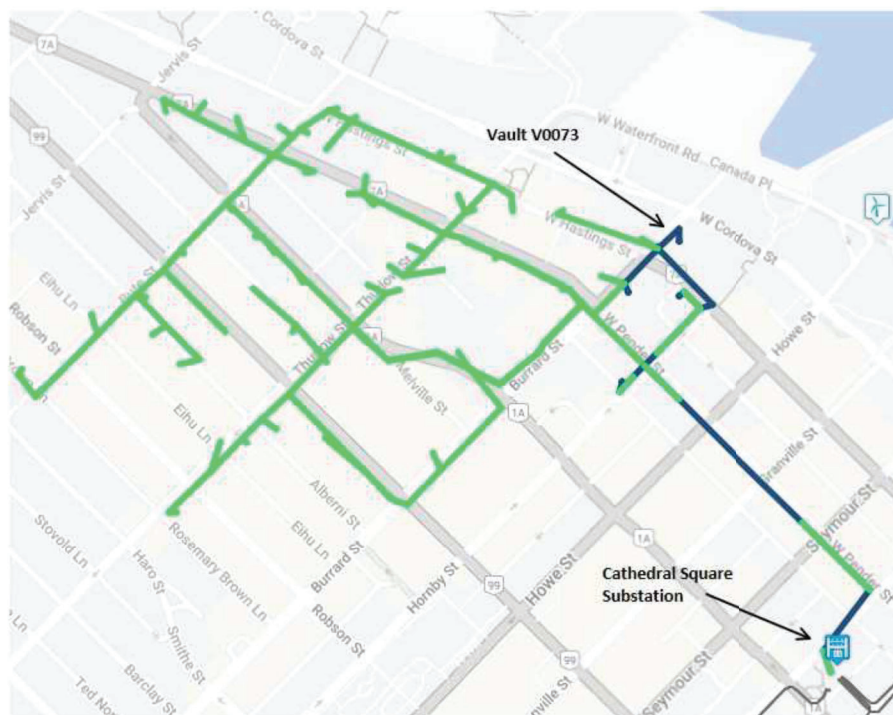
Figure 1 - Circuit Map

Circuits CSQ 12F511 and CSQ 12F521 are fed from the Cathedral Square Substation in downtown Vancouver. Both circuits feed V0073 with CSQ 12F521 acting as the running circuit and CSQ 12F511 acting as the standby circuit. This means that, under normal conditions, the switch fed by the running circuit is closed and feeding power while the switch fed by the standby circuit is open and not feeding power. Both circuits are energized and ready to be operated. In V0073 the running switch is SW2018 and the standby switch is SW2019.

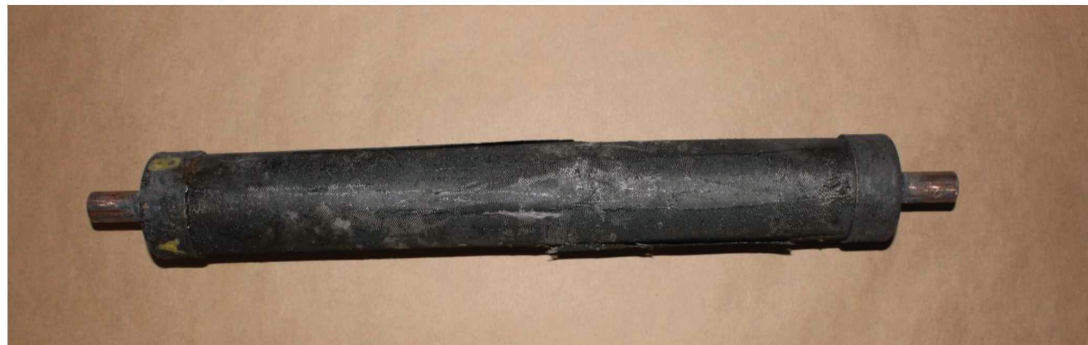
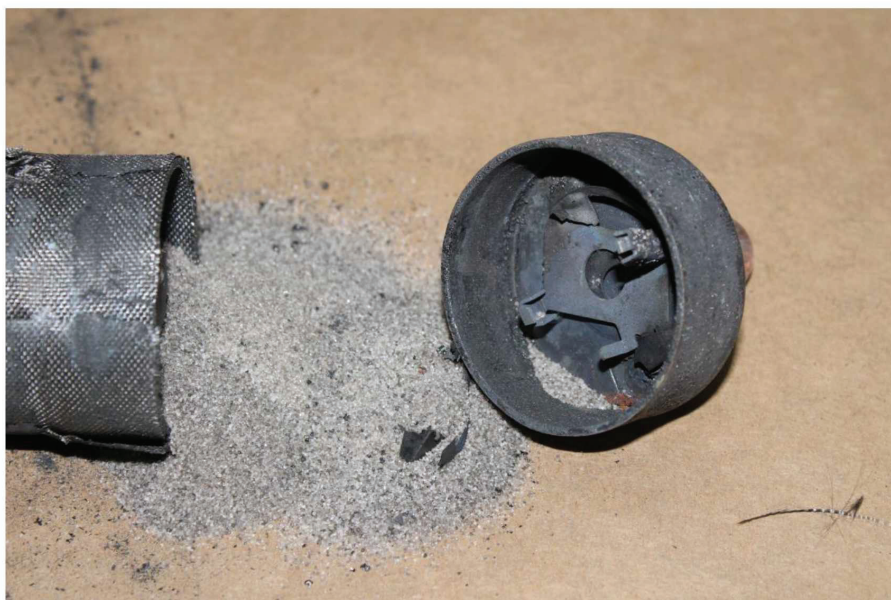
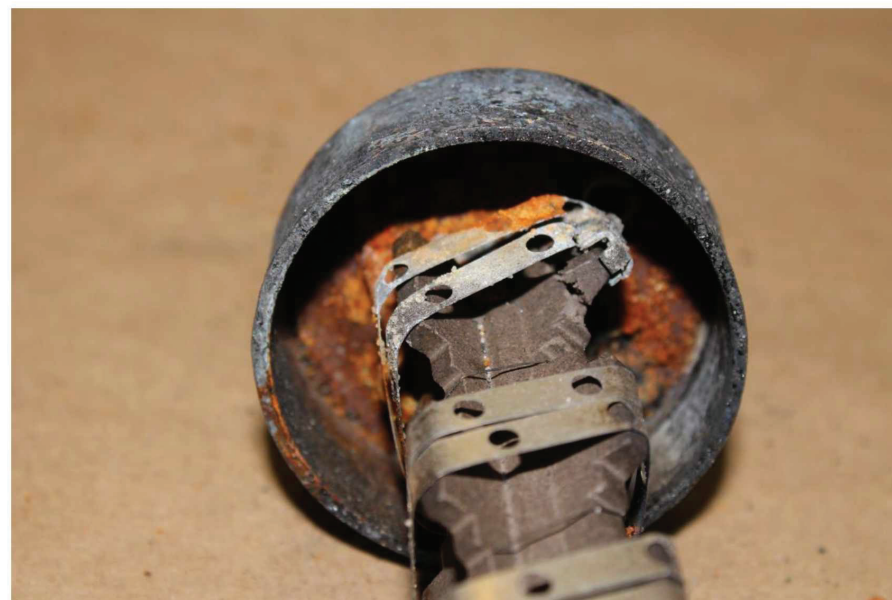
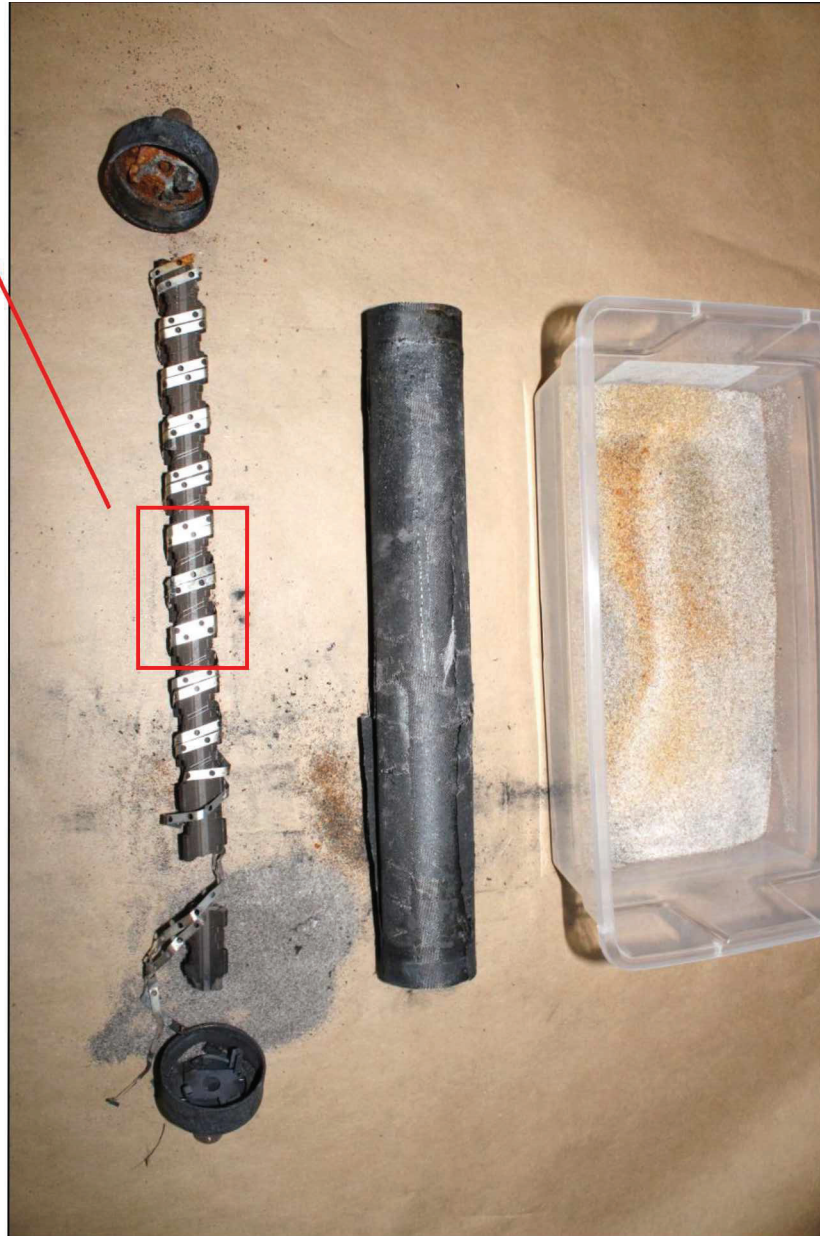
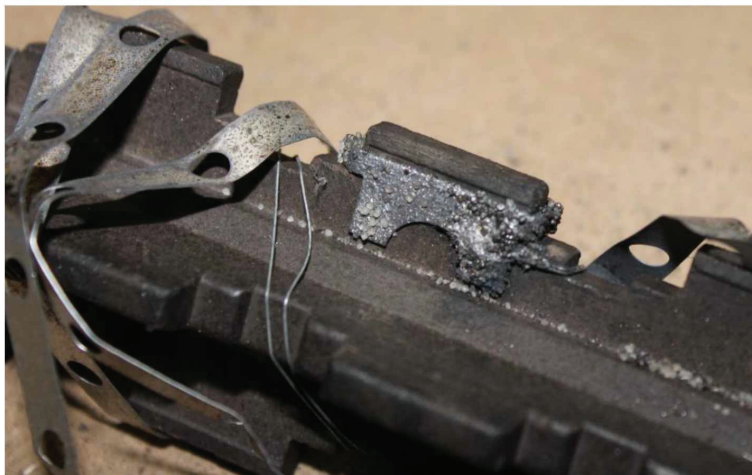
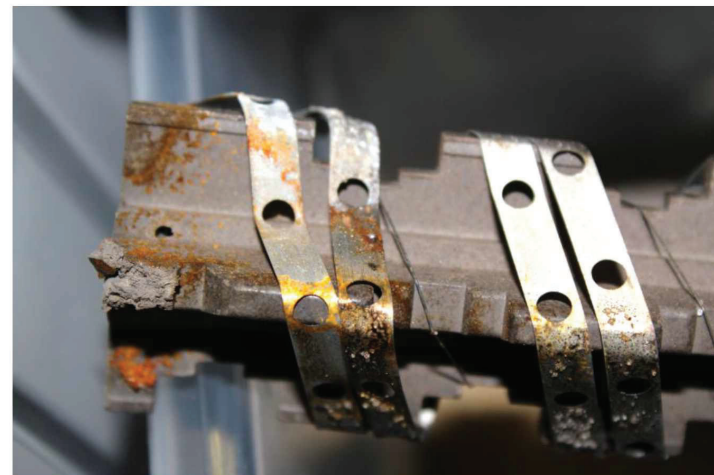
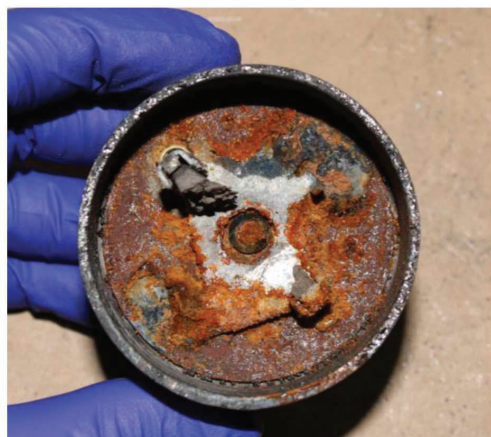
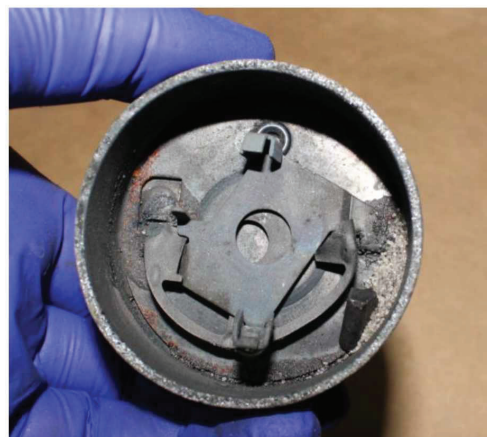
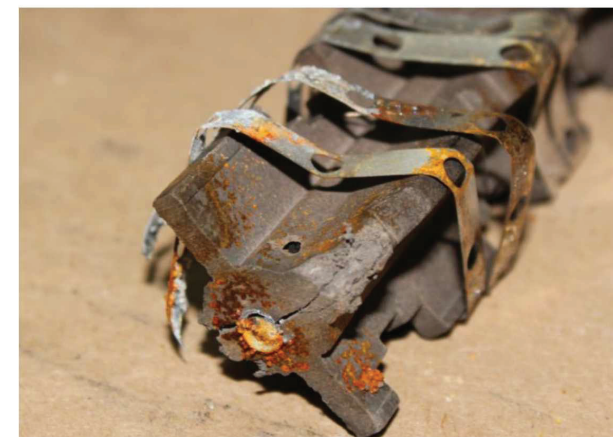
Sample B – Fuse 1

- Fuses were filled with sand.
- Outer shell was a wrap of several layers of (metal?) fiber mesh.
- Sample C - Fuse two had the most visible damage. The outer case was hardened on one end and frayed on the other. Inner beam was broken into several pieces.
- All fuses appear to have some rust on the inside.

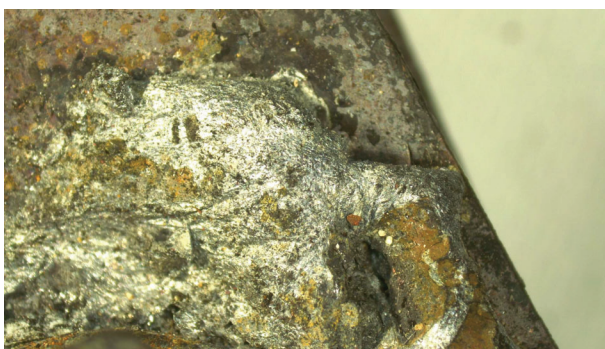
E9 Damage
around Nut

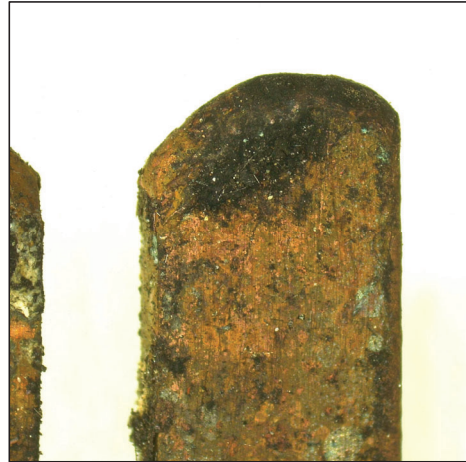
2A Inside

E10 Bolt Side
Inside

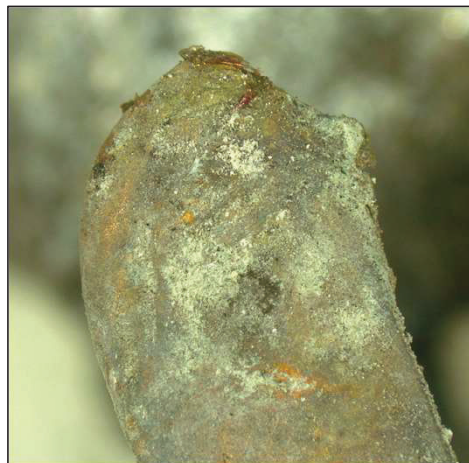
2A Outside

R3 Bolt Side
Outside
